Investigation and hazard assessment of the 2003 and 2007 Staircase Falls rock falls, Yosemite National Park, California, USA

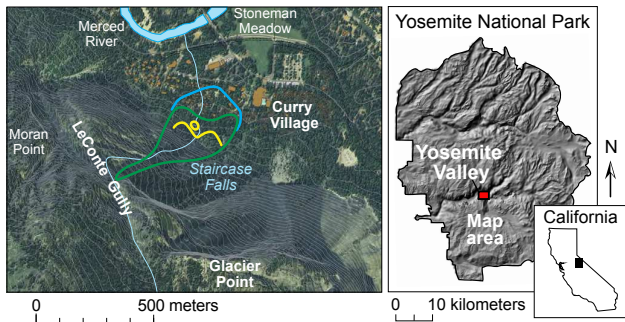
Fig. 1. Map of Glacier Point area in Yosemite Valley, California showing 26 December 2003 Staircase Falls rock fall into Curry Village. Green lines show initial detachment area, travel path, and limit of rock debris; yellow lines delimit areas where trees were knocked down; blue lines show limit of flyrock. Contour interval is 20 m. Inset shows location of Yosemite Valley in Yosemite National Park, California.

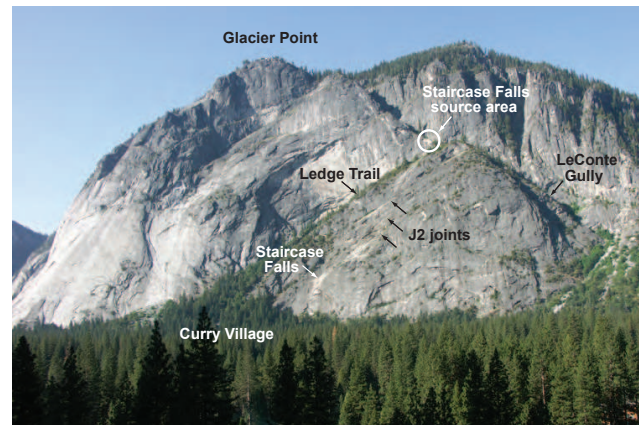
Fig. 2. Western portion of Glacier Point showing Staircase Falls rock-fall detachment area (circled) and path of Staircase Falls and abandoned Ledge Trail along eastward dipping J2 joint sets (see Table 1 for joint orientation data). Cliff faces exhibit influence of vertical regional joints weathered back along J1 exfoliation joints, which are present on nearly all visible rock surfaces.

The Staircase Falls rock-fall detachment area is below and west of Glacier Point, on the eastern edge of LeConte Gully and immediately above Staircase Falls (Figs. 1, 2). The detachment area is at an elevation of 1770 m, 555 m above the floor of Yosemite Valley. Prior to 2003, there were no documented observations of historic rock fall activity from this detachment area, but accumulations of rock debris and a lack of trees on a prominent ledge ~ 20 m below the detachment area suggest earlier (pre-1850) rock-fall activity from the site. The active rock-fall detachment surface is on the upper northeast side of a jointed, weathered bedrock fin that projects out ~ 28 m to the northwest from the eastern edge of LeConte Gully (Fig. 3). Here, Staircase Creek, which originates on the rim of Yosemite Valley near Glacier Point, turns

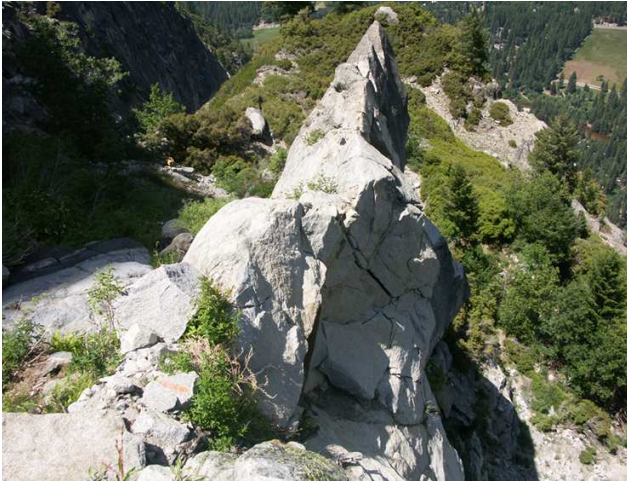
Fig. 3. Staircase Falls rock-fall detachment area, showing narrow projecting bedrock fin. 2003 and 2007 rock falls occurred from center-right side of fin. Floor of Yosemite Valley 555 m below is in upper right of photograph. Staircase Creek flows down left (south-west) side of fin before turning sharply right (northeast) around the base of fin to top of Staircase Falls.

Subsequent observation of the detachment area in April 2004 revealed additional potentially unstable rock in the form of a fractured, jointed, and moderately weathered bedrock fin (Fig. 3). We estimated the volume of potentially unstable rock remaining at the detachment area, in the form of the narrow bedrock fin (Fig. 3), to be $\sim 350\text{ m}^3$. Only a few meters of rock separate the Staircase Creek channel in LeConte Gully from the active detachment surface of the Staircase Falls source area (Fig. 3).

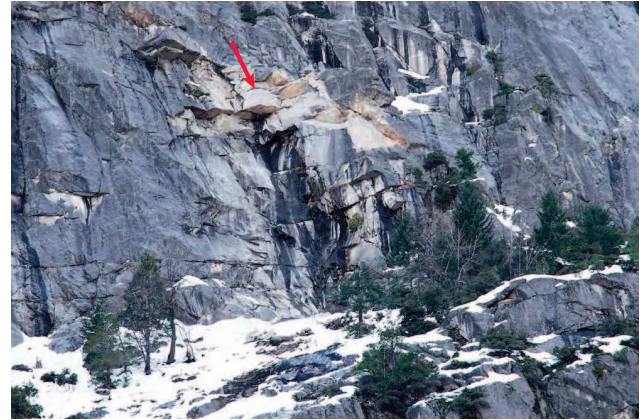
Fig. 4. Photograph of Staircase Falls rock-fall detachment area taken 21 days after 26 December 2003 event, showing light colored joint-controlled detachment surfaces. Rock debris impacted snow-covered ledge immediately below source area, and then fell $\sim 745\text{ m}$ down joint-controlled ledges to Yosemite Valley floor. Note heavy dark drainage paths below detachment area indicating water flow through joints. Overhanging rectangular block in center left of photograph (marked by red arrow) fell during 9 June 2007 rock fall. (Photo by Dan Horner, NPS).

of the Staircase Falls source area taken 21 days after the 26 December 2003 rock fall showed water streaming from joints below the source area (Fig. 4). Water discharging from the source area is adequate to support perennial hydrophytic vegetation. Each failure from the Staircase Falls detachment area decreases the width of the bedrock fin between LeConte Gully and Staircase Creek, potentially increasing infiltration from Staircase Creek through the fin, and also permitting winter ice to form deeper in the cliff face. Each failure thus accelerates joint weathering in this fin, increasing the probability of future rock falls from this location.

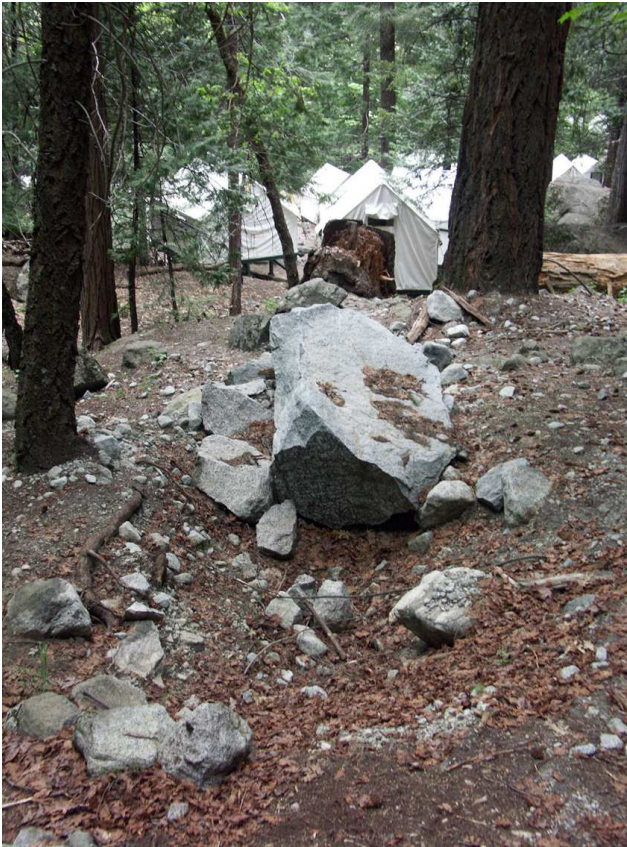
Fig. 5. Part of rock-fall deposit from 26 December 2003 Staircase Falls rock fall. 4 m^3 (11 metric tons) block landed $\sim 120\text{ m}$ beyond base of cliff, leaving prominent impact crater.

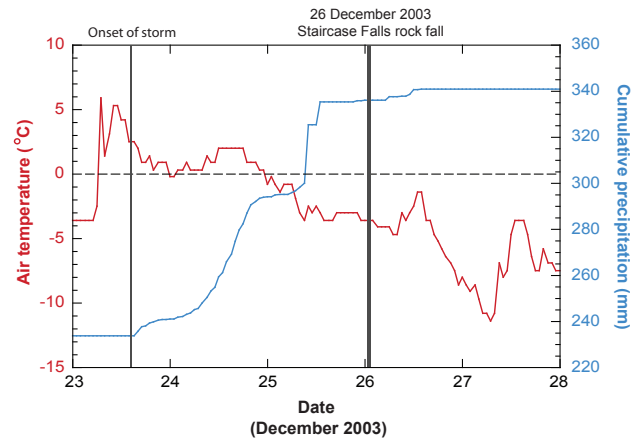
The 26 December 2003 Staircase Falls rock fall was closely associated in time with a severe winter storm that dropped 102 mm of precipitation in Yosemite Valley between 24–26 December (Fig. 7). This storm triggered at least two other rock falls or rock slides in Yosemite Valley (Wiczorek and Snyder, 2004), and also a debris flow from LeConte Gully (Figs. 1, 2). The debris flow emanating from LeConte Gully, immediately adjacent to the Staircase Falls source area, suggests that stream discharge in Staircase Creek was substantially elevated at the time of the Staircase Falls rock fall. Precipitation during the storm fell initially as rain and later as snow, as air temperatures dropped 5.5°C from the onset of precipitation to the time of failure; prior to failure, the detachment area experienced 24 h of subfreezing air temperatures (Fig. 7). Lacking monitoring data from the detachment surface at the time of the rock fall, we are unable to attribute with certainty a specific triggering mechanism to the 26 December 2003 event. However, we suggest that meteorological conditions likely triggered the 26 December 2003 rock fall by one or a combination of several mechanisms. First, increased precipitation and Staircase Creek discharge may have increased infiltration into joints at the source area, increasing cleft (water) pressures and triggering the rock fall. Second, subfreezing air temperatures may have propagated to the detachment surface, causing freezing of water in joints and triggering the rock fall by frost wedging. Finally, the rock fall may have been triggered by a combination of increased groundwater flow and subfreezing temperatures, with ice lenses in near-surface joints constricting groundwater flow and elevating cleft pressures. Regardless of the exact triggering mechanism, temporal correspondence of the rock fall with the 24–26 December storm suggests that meteorological conditions triggered the rock fall.

Fig. 7. Air temperature (red line) and cumulative annual precipitation (blue line) for 23–28 December 2003. Dashed horizontal line marks 0°C. Thin black bar marks onset of storm. Thick black bar marks 26 December 2003 Staircase Falls rock fall, which occurred after 102 mm of precipitation fell over previous 48 h, and after 24 h of sub-freezing temperatures. Data from Yosemite Valley weather station (Station YYV, California Department of Water Resources, California Data Exchange Center, <http://cdec.water.ca.gov/>), with air temperatures scaled to detachment area elevation assuming an adiabatic lapse rate of $-0.65^{\circ}\text{C}/100\text{ m}$ (Lunquist and Cayan, 2007).

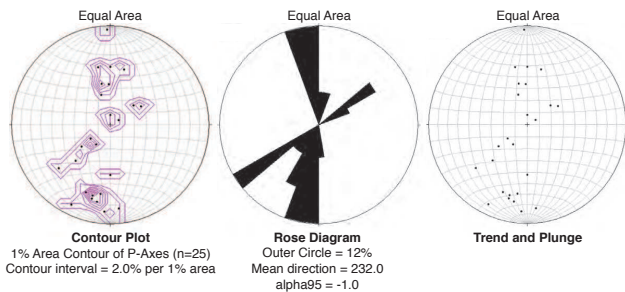
Fig. 8. Contour plots, rose diagrams, and trend and plunge data for joint surfaces at Staircase Falls rock fall detachment area ($n=25$) (see Table 1 for data). More joints exist than were measured.

Measurements of 25 joints at and near the Staircase Falls detachment area (Fig. 8) reveal at least 19 joints of three major joint sets (J6, J9, J13). Assuming a static friction strength of $\geq 35^\circ$ for granitic rock (Barton and Choubey, 1977), we evaluated the initial slope of the detachment area, which dips approximately 60° northeast, with each of the three major joint planes and possible joint plane intersections. The results suggest that the 26 December 2003 failure occurred primarily along a J9 joint surface, with an average dip of 53° north. The subsequent travel paths of rock debris were strongly influenced by the east-trending J2 joint sets that form the Ledge Trail ledge and the treads of Staircase Falls (Figs. 1, 2).

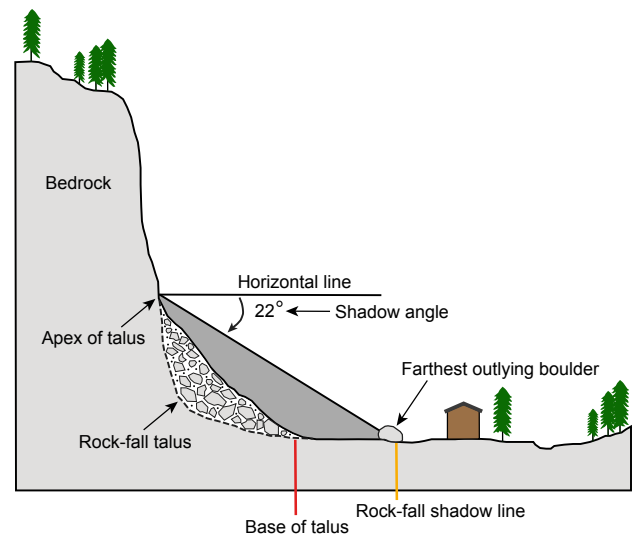
Fig. 9. Schematic of rock-fall talus slope, base of talus (red line), and farthest outlying boulder, illustrating determination of rock fall shadow angle and shadow line (orange line); after Wiczorek et al. (1998, 1999), modified from Evans and Hungr (1993).

To compensate for a lack of subsurface data on the full extent of rock falls, Wiecezorek et al. (1998, 1999) assessed rock-fall hazard beyond the base of talus slopes, where infrequent rock-fall events may stop, using the rock-fall shadow concept (Evans and Hungr, 1993). The rock-fall shadow zone is determined using the angle from horizontal extending from the apex of the talus slope to the farthest outlying boulder (Fig. 9; Evans and Hungr, 1993). Based on analyses of 25 outlier boulders, a minimum shadow angle of 22° was selected to define the rock-fall shadow line in Yosemite Valley (Fig. 9; Wiecezorek et al., 1998, 1999). Determination of the rock-fall shadow line did not take into account large rock avalanche runout distances, potential airblast areas, or flyrock ranges. According to the resulting rock-fall potential map, some existing facilities below Staircase Falls are situated on the toe of talus slopes, and most are within the rock-fall shadow zone (Wieczorek et al., 1998, 1999).

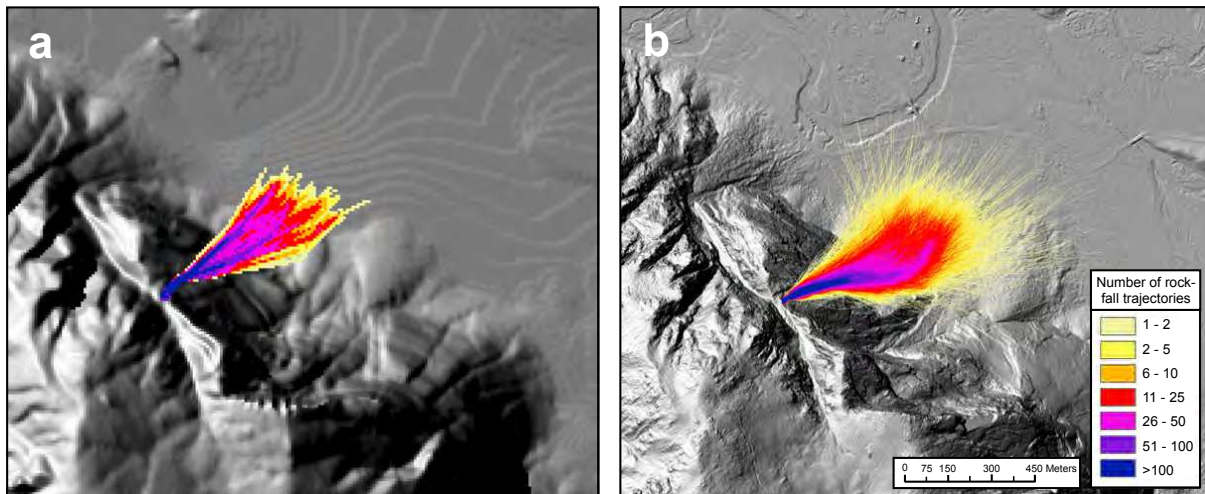
Fig. 10. Comparison of STONE rock-fall simulations on Digital Elevation Models (DEMs) of varying resolution. Colors show number of rock-fall trajectories. (a) simulation performed on 10 m DEM showing 100 blocks launched from each DEM cell of detachment area (6 cells) for total of 600 rock fall trajectories. (b) Simulation performed on filtered (bare earth) 1 m DEM derived from airborne LiDAR data, showing 100 blocks launched from each DEM cell of detachment area (112 cells) for total of 11 200 rock fall trajectories.

First, to assess the affect of varying DEM resolution on model output we simulated an unspecified rock-fall from the Staircase Falls detachment area performed on a 10 m resolution DEM, and compared this with a simulation of the same rock fall performed on a higher resolution 1 m DEM (Fig. 10). The 1 m DEM was produced from filtered (i.e., bare earth) airborne Light Detection and Ranging (LiDAR) data, and reveals subtle topographic features not resolved in the 10 m DEM. As such, the increased resolution of the 1 m DEM significantly improved the resolution of the STONE model results (Fig. 10). It is difficult to directly compare results from the 1 m and 10 m DEMs because they necessarily have a different number of source cells and, hence, produce a different number of rock-fall trajectories. Nevertheless, there are some visible differences between the two simulations. For example, the path of highest cumulative count of rock-fall trajectories shifted to the east in the 1 m DEM simulation, presumably due to subtle topographic features below the detachment area that are not resolved in the 10 m DEM (Fig. 10). The greater resolution of the 1 m DEM increases the dispersion of rock fall trajectories, a result consistent with those described in previous rock fall model comparisons (Lan and Martin, 2007; Agliardi and Crosta, 2003). Rock-fall trajectories generally extended farther from the base of cliffs in the 1 m DEM than in the 10 m DEM (Fig. 10), a

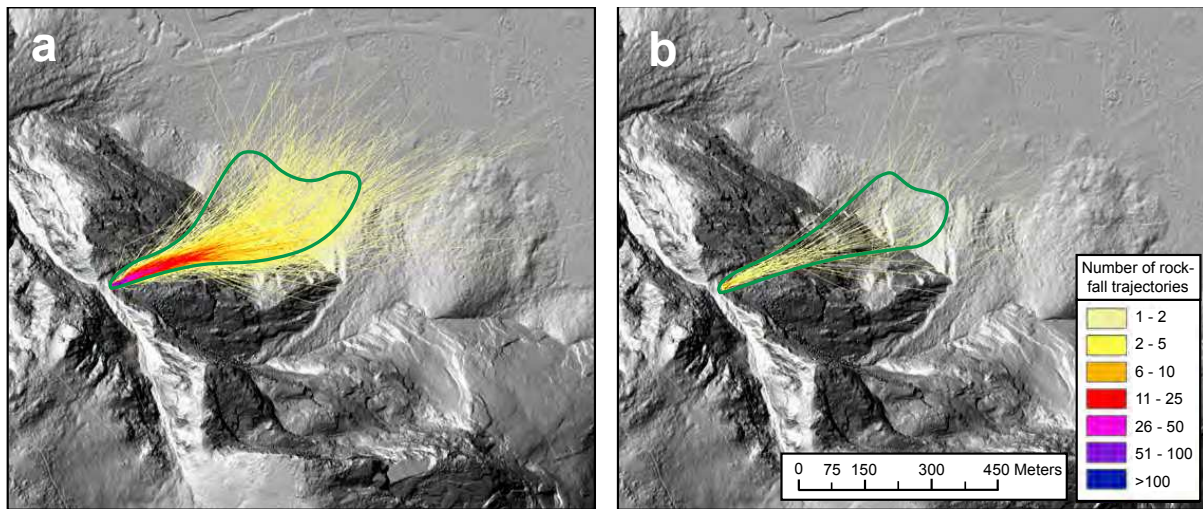
Fig. 11. Comparison of STONE model simulations and mapped extent of rock debris for 2003 and 2007 Staircase Falls rock falls. Colors show number of rock-fall trajectories. (a) Simulation of 26 December 2003 rock fall, with 10 blocks launched from each DEM cell of detachment area (112 cells) for total of 1120 rock fall trajectories. Mapped limit of actual rock debris (excluding flyrock) shown by green line. (b) Simulation of 9 June 2007 rock fall, with 1 block launched from each DEM cell of detachment area (112 cells) for total of 112 rock fall trajectories. Mapped limit of actual rock debris (excluding flyrock) shown by green line.

Using the 1 m DEM, we then simulated the 26 December 2003 and 9 June 2007 rock falls and compared the results with the actual distribution of rock debris mapped in the field (Fig. 11a, b). Overall, the simulated rock-fall trajectories match well the actual mapped distribution of rock debris, with the majority of simulated trajectories falling within the zone of actual rock debris deposition. Furthermore, many observed dynamics of the Staircase Falls rock falls are displayed in the simulations, including the strong influence on trajectories of the east-trending J2 joint surfaces below the detachment area and the morphology of the talus slope (Fig. 11a, b). For both the 2003 and 2007 event simulations, a small number of trajectories extended farther from the base of the cliff than the mapped distribution of rock debris (Fig. 11a, b). This apparent “overshoot” of the simulated trajectories may be due to several factors. First, some values we assume for input data may not accurately represent the range of rock-dynamics (e.g., Lan and Martin, 2007); although we have assumed reasonable values for these input parameters (Lan and Martin, 2007; Chau et al., 2002), specifically calibrated to Yosemite Valley rock falls (Guzzetti et al., 2003), we cannot empirically verify them, resulting in some uncertainty. Second, STONE does not account for certain factors such as block shape, air drag, block fracturing, and/or energy dissipation by vegetation in the impact zone. Although the filtered (bare earth) 1 m DEM is a substantial improvement over the previously available 10 m DEM, even

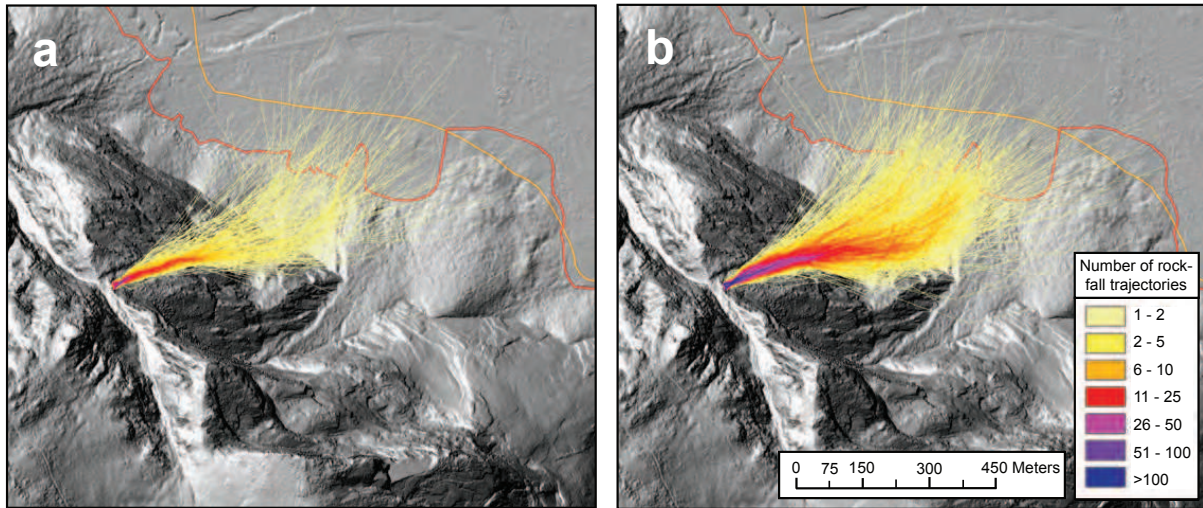
Fig. 12. Assessment of future rock-fall hazard from Staircase Falls detachment area with example STONE simulations of (a) 6 blocks (672 trajectories) and (b) 20 blocks (2240 trajectories) launched from each DEM cell of detachment area (112 cells), representing partial and total failure of remaining rock mass, respectively. Colors show number of rock-fall trajectories. Red line delineates base of talus (including debris flow deposits), orange line is rock-fall shadow line (Wiczorek et al., 1998, 1999).

Finally, considering that $\sim 320 \text{ m}^3$ of potentially unstable rock remains at the detachment area, we used STONE to assess rock-fall hazards associated with potential future Staircase Falls rock falls (Fig. 12a,b). Because STONE treats each block as a dimensionless point-mass, we cannot explicitly simulate an increase in rock-fall volume (Guzzetti et al., 2002). However, by calibrating simulations of the 26 December 2003 and 9 June 2007 rock falls with the actual events, we were able to scale the number of blocks launched from the source area to approximate the volume of potentially unstable rock remaining at the detachment area; in this way, the number of launched blocks serves as a proxy for rock-fall volume. We simulated a range of scenarios, from partial failure of the estimated remaining rock mass (e.g., Fig. 12a) to

total failure (Fig. 12b). The size of the simulated rock-fall runout zones is directly related to the number of launched blocks, i.e., larger rock “volumes” extend farther beyond the base of the cliff (Fig. 12a,b). Depending on the size of future failures from the detachment area, rock debris from future events has the potential to travel farther beyond the base of the cliff than debris resulting from the 26 December 2003 rock fall; this debris may even travel beyond the rock-fall shadow line (Fig. 12b).
