**GIS Evaluation of the Impacts on the Built and the ‘Natural’ Environment of the 11 March 2011 Tsunami in Rikuzentakata, Iwate Prefecture, Japan**

The 11 March 2011 a Mw 9.0 earthquake triggered a tsunami off the Tohoku coast (Japan). To the north of the infamous Sendai plain area, a series of small bays stretches from the North of Miyagi prefecture to mid-Iwate prefecture. At the border between both prefectures, the municipality of Rikuzentakata lies close to the river-mouth of the Kesen River. Both the built and the 'natural' environment of the municipality have been wiped off the map. In order to create more resilient communities, it is important to reduce the costs of reconstruction and restructuring by integrating lessons learned from the present tsunami. Therefore, this contribution provides a GIS evaluation of the different impacts in order to improve further planning. We have used remote-sensing based GIS - ESRI ArcGIS suite – using spatial data from July 2010 and March 2011. The GIS analysis has been completed using data collected in Japan during the period 2006 – 2010. The results show that the shoreline has retreated up to 501 m with the disappearance of the lagoon bar

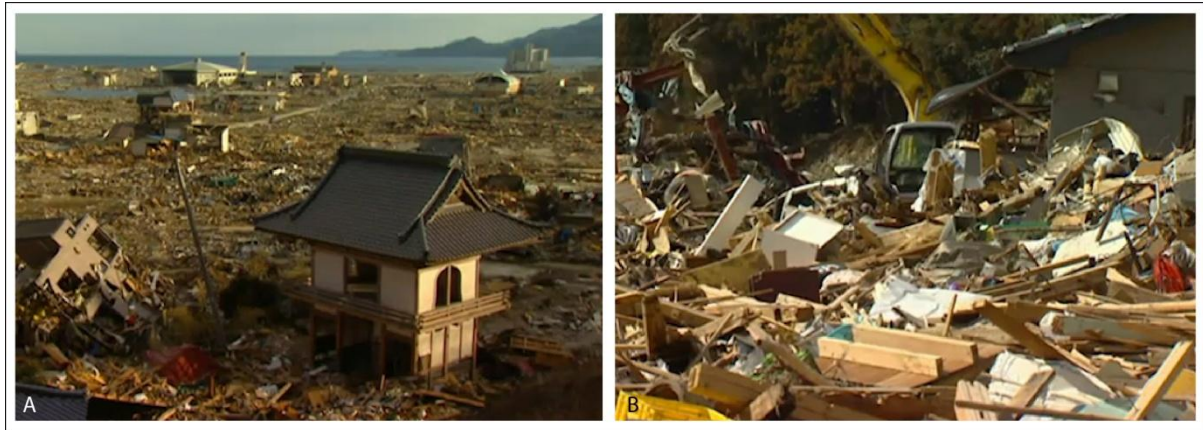
(2011) respectively. As at 1st May 2011, 24,000 people were reported dead or missing and 350,000 were living in refuge areas. One of the areas with the worst damage is the municipality of Rikuzentakata, which is located in Iwate Prefecture on the east coast of the Tohoku region (Fig. 1). It is situated at the back of a 3 km wide bay that opens to the Pacific Ocean, and on the estuary of the Kesen River. The municipality extends over 232.29 km<sup>2</sup> with 23,302 inhabitants in 2010. The population was mainly making a living from oyster farming (40 million yen revenue in 2010) and from the location as a scenic attraction; with the Takata Matsubara Park declared a 'Place of Scenic Beauty' by the Japanese Ministry of Environment from the year Showa 2 (y.1927). The position of Rikuzentakata and the distribution on lowland of the principal infrastructure such as the City Hall and the schools, which are used as refuge location during natural disasters, increased the tsunami vulnerability. As per the mass-media broadcast, most of the city has been wiped from the map (Fig. 2).

Fig. 2 View of the bay in front of Rikuzentakata (A) and zoom of the rubble in the destroyed municipality (source: images extracted and adapted from Al Jazeera, 2011)

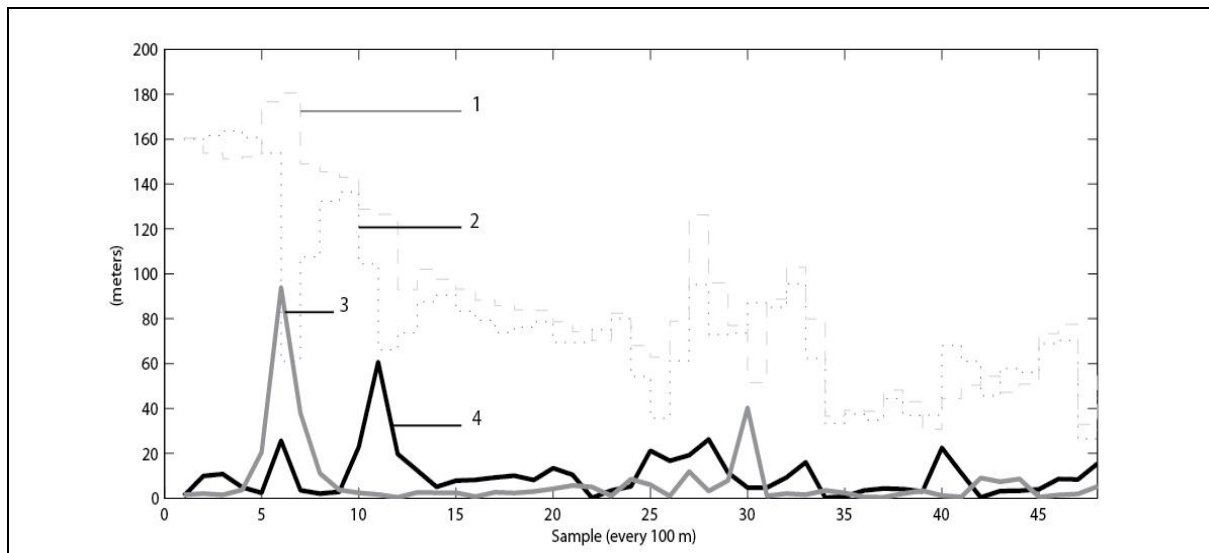
The 4.8 km length of the Kesen River studied here has been impacted by the tsunami. The average width of the active channel has increased from 79 m to 88 m on average (Fig. 5), with a maximum width of 163 m in 2010 that became 180 m after the tsunami. Minimum values have also increased from 26 m to 30 m. The maximum peak of erosion is 94 m for the right bank against 60 m on the left. This exceptionally high value on the right bank is due to the total disappearance of a pointbar located between 50 and 60 m from the river mouth. The maximum erosion for the left bank is also due to a pointbar that developed against the stop-bank in the active channel. It is interesting to note that there is no clear gradient – away from the sea – in the lateral erosion along the 4.8 km, which one would have expected with the progressive energy dissipation. However, the influence of the mingling between build and natural environment makes quantification difficult, and the erosion that took place along the river was all contained between the concrete stop-banks.

Fig. 5 Planform changes of the Kesen River along 4.8 km. (1) Width of the active channel in July 2010; (2) Width of the active channel on March 13, 2011; (3) Lateral erosion of the right bank; (4) Lateral erosion of the left bank.

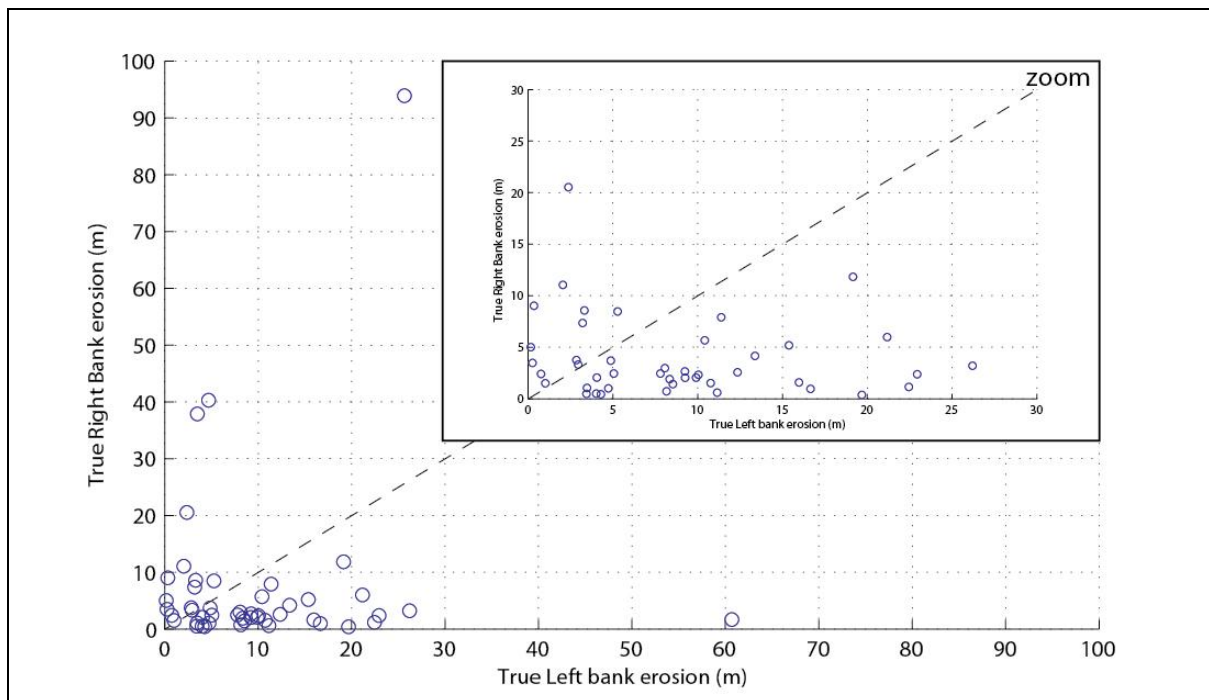
The position of the active channel within the limits of the stop-banks is at the origin of an erosive dissymmetry between the left and right banks (Fig. 6). The left bank (to the East on the figures) has lost 10 m on average, whereas the right bank lost 7 m on average. We can find a similar ratio for the minimum erosion data: 0.16 m and 0.4 m (right and left banks respectively).

Fig. 6 Correspondence of the lateral erosion between the right bank and left bank. The scatter plot shows that there is no strict relation between the lateral erosion of the right and left bank for each sampled transect.

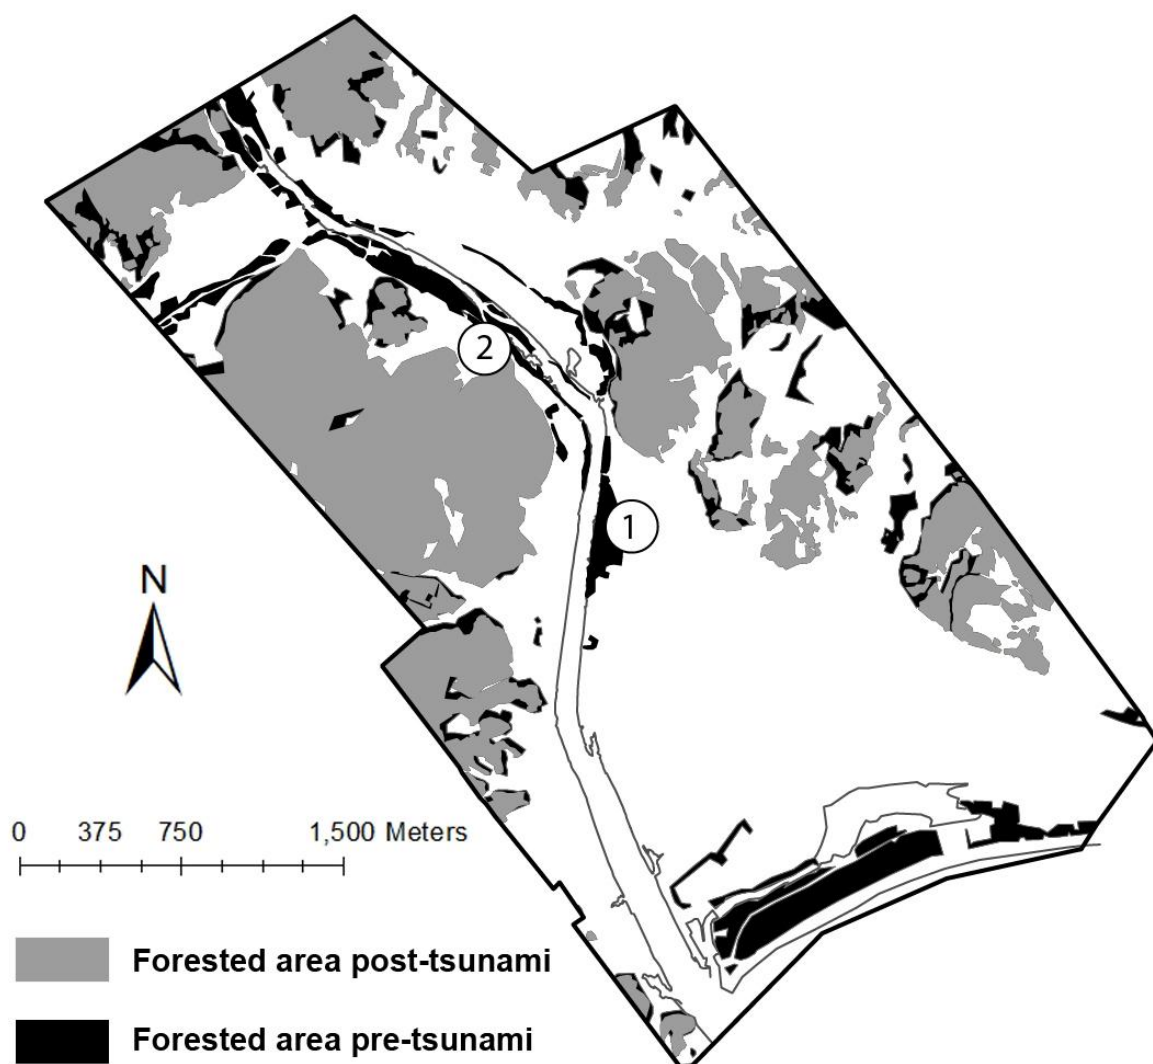
Along the 4.8 km of the Kesen River, all riparian trees have been uprooted and transported or flattened down by the tsunami. The loss of riparian forested area has been 0.29 km<sup>2</sup> along the Kesen river and 0.34 km<sup>2</sup> along the Kesen River and its tributary. The tsunami has destroyed both large and small clusters of forested land. The largest of these is 51,000 m<sup>2</sup>, located between 3 km and 3.8 km from the mouth of the Kesen River. Destruction extends laterally

195 m from the closest bank and 250 m to the active channel central line. The largest area of flattened trees (1 on Fig. 7) measures 42,000 m<sup>2</sup>. It is located on a left pointbar, along the Kesen River, only 2.5 km from the river mouth. The second area, where trees have been flattened is located on a right bar (2 on Fig. 7). It is 5,500 m<sup>2</sup> and it is located 3.6 km from the river mouth.

Because of the physical destruction of the lagoon's barrier, forested land in the area subsequently disappeared as well. This forested area was composed of two curtains of vegetation located on one or both sides of the lagoon with one interruption (Fig. 7). The total loss of forested area is 0.26 km<sup>2</sup>, which is a 100% lost, except for one of the pine-tree. Only 66,000 m<sup>2</sup> of the land that hosted this forested area hasn't been colonized by sea-water, and 38,000 m<sup>2</sup> of this land is located at the back of the lagoon in an area that was protected by a stopbank and around the high-school ground.

Fig. 7 Impacts of the tsunami on forested areas in the municipality of Rikuzentakata; (1) and (2) are areas where the trees has been flattened down.

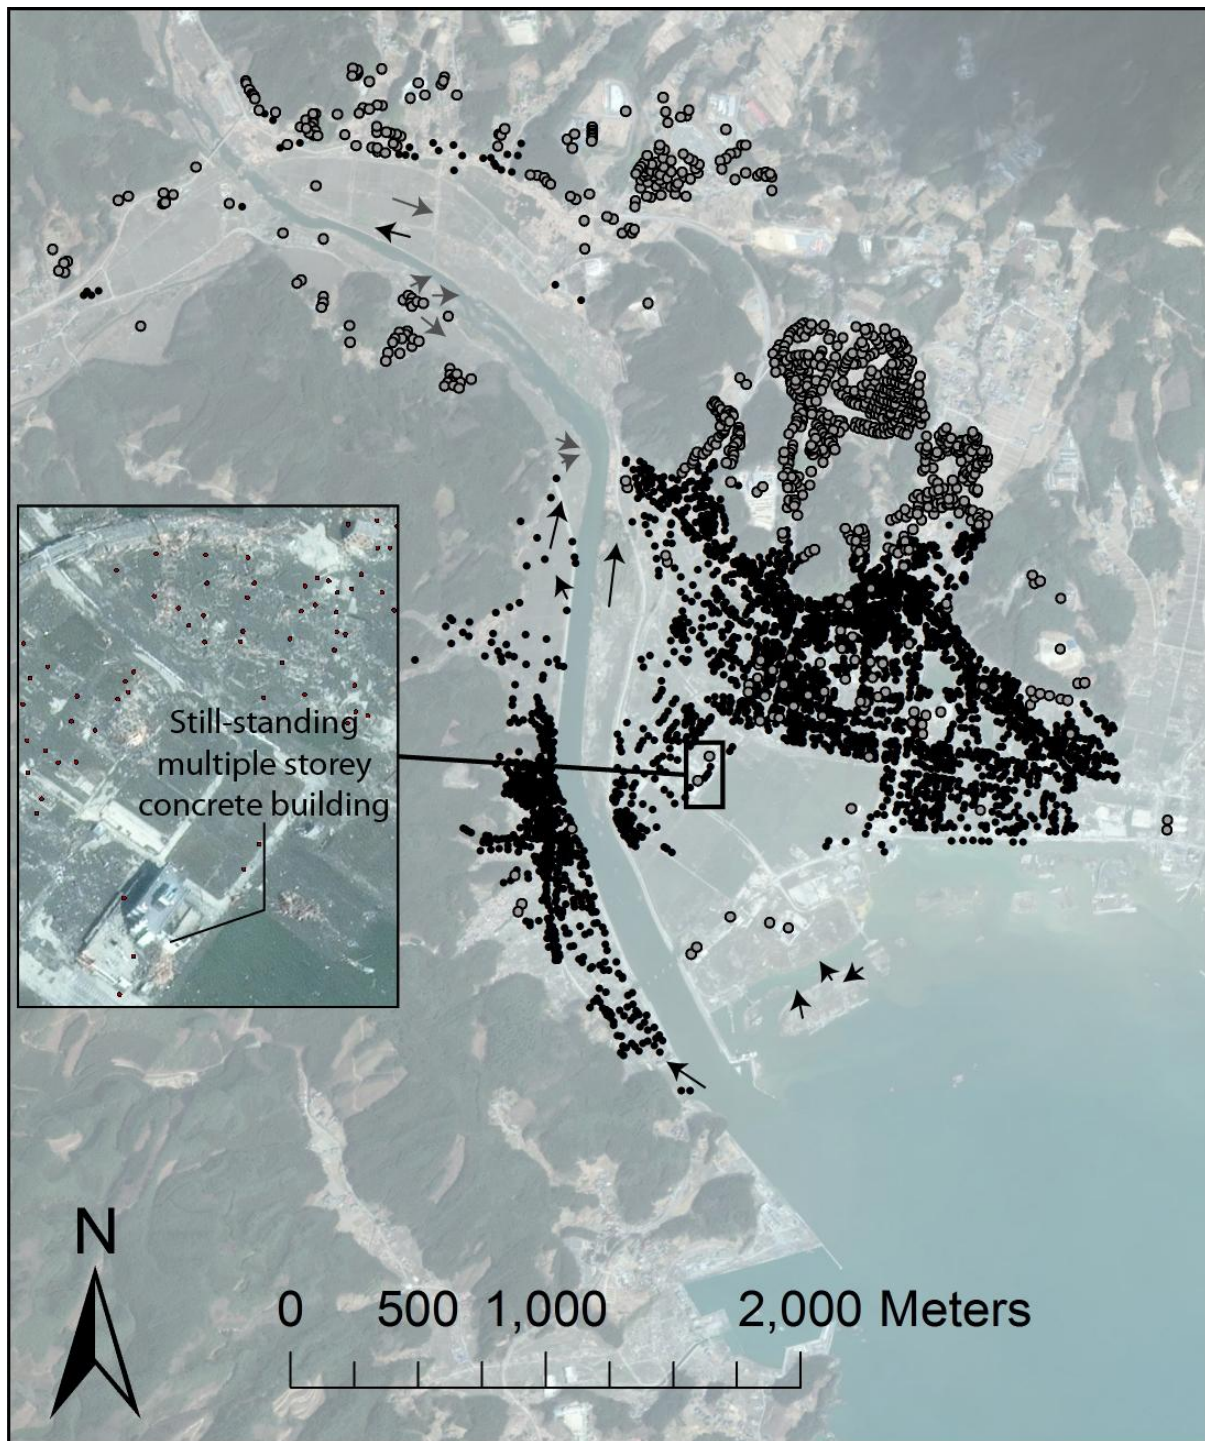
In Rikuzentakata, the ‘light’ constructions have responded poorly to the vertical load and the upward forces produced by the tsunami waves. Based on the image analysis, we have identified different types of destruction: (1) destruction due to sliding over the foundations and/or overturning of the structure, in such a way that we can still observe the concrete slab on the ground; (2) scouring of the surrounding land and of the place where a building was standing. Such destruction has mostly affected timber and steel frame buildings. High-rise buildings (4 storeys and more), with a RC or SRC structure resisted the tsunami (Fig. 10-B)

The area of maximum destruction of buildings is encountered in the lowland plain up to 3 km inland. Buildings have been destroyed (Fig. 10) regardless of the density of the built environment, the orientation of the houses and for most of them their structure (wood or metallic structures). Buildings of the city council, sport-centres and part of school buildings have structurally survived the tsunami. This has moved the barycentre of the Rikuzentakata buildings from 1400 m to 2400 m from the shoreline, modifying the spatial distribution of building density (Fig. 11).

Fig. 10 Location of destroyed buildings (black points) and still standing buildings (grey points); Black arrows are orientation associated with the uprush; Grey arrows are orientations associated with the backwash. The complexity of orientations marker is interesting; however they are very difficult to understand at this stage.

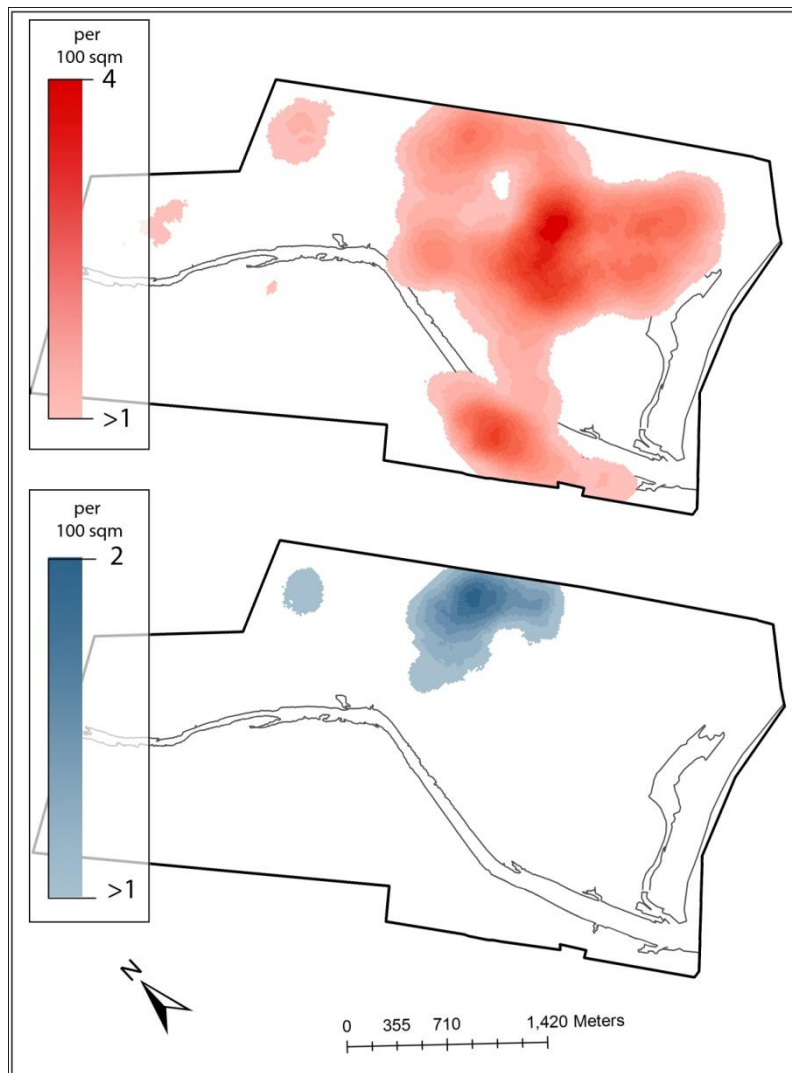
Fig. 11 Change in building density (number of building in a radius of 150 m, data provided in 100 m<sup>2</sup>).
