Failure analysis of carbon black filled styrene butadiene rubber under fatigue loading conditions

J.-B. Le Cam*¹, B. Huneau² and E. Verron²

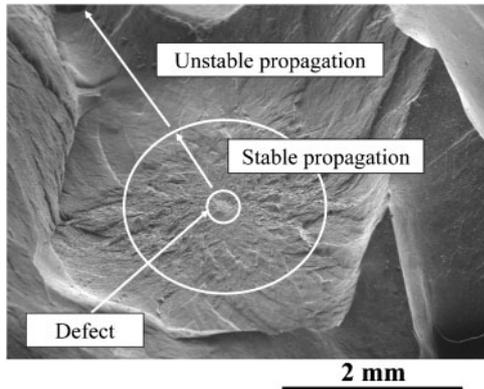
1 Photomicrographs of fracture surface in CB-SBR

The fracture surfaces are observed by SEM; an example of photomicrograph is shown in Fig. 1. To illustrate the discussion, we propose to describe fracture surface with the help of the schematic views presented in Fig. 2.

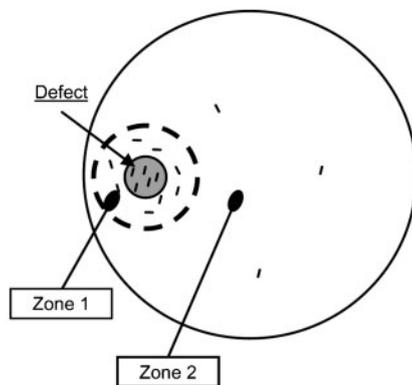
2 Schematic view of fracture surfaces in CB-SBR

Except the nucleation defect area, only two different zones (denoted zones 1 and 2 in Fig. 2a) are observed, independently of the maximum stretch ratio applied.

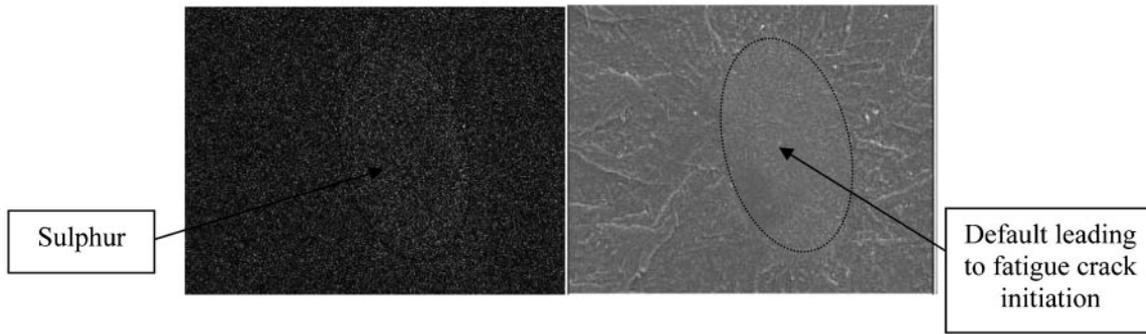
3 EDSX analysis of defects from which crack initiation occurs

Considering several samples, we observe that the nucleation defect is located between sample surface and 6 mm far from the surface and its maximum size is 300 μm in diameter. As shown in Fig. 3, the EDSX analysis demonstrates that these defects contain more sulphur than the rest of the material. Therefore, they correspond to overvulcanised zones in the section. Surface of Zone 1 is rough; it corresponds to a stable propagation of the crack and surrounds the defect. Its size can reach 6 mm in diameter. Zone 2, which surrounds Zone 1, represents the rest of the fracture surface. It corresponds to an unstable propagation of the crack. The surface is relatively smooth and slight bifurcations of the crack can be observed. No fatigue striations are observed for every loading conditions considered in this study.

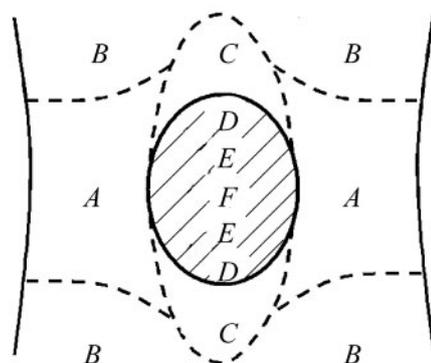
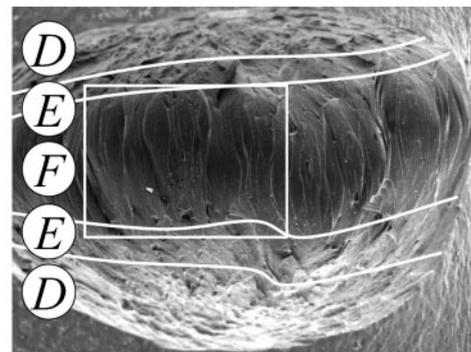
Figure 4 presents the fatigue crack and its surroundings: Fig. 4a shows the schematic view, and Fig. 4b presents a photomicrograph of the three zones D, E and F. As for CB-NR, six different areas can be observed as the samples is stretched to the elongation applied during the fatigue test. Before the occurrence of the crack, there are only two zones: the central zone of the sample, denoted A in Fig. 3a, which is the most stretched part of the specimen, and Zone B situated on both sides of Zone A. When the crack occurs, four new zones appear: Zone C which corresponds to the parts of Zone A that are relaxed during crack opening, and Zone D, E and F which constitute the crack itself. Figure 3b shows that Zone F stands for the crack tip, Zone D represents the smooth surfaces generated during crack growth and Zone E denotes the frontier between them. In fact, the major difference between Zones D and F is their stretching level. These three zones also exist for CB-NR, except that Zone D is covered with numerous wrenchings (*see* Fig. 4 in Ref. 5).

4 a schematic view of crack (D–F) and its surroundings (A–C) and b front view of crack for CB-SBR

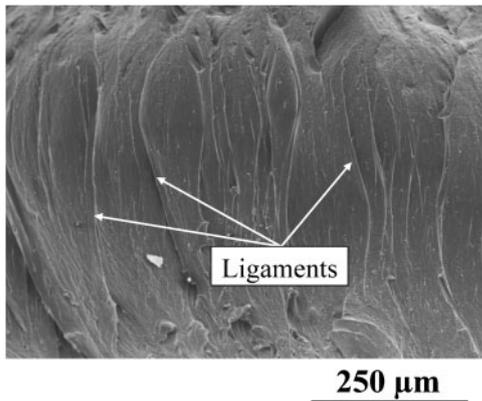
Figure 5 presents magnification of CB-SBR crack tip. This photomicrograph corresponds to the encircled zone in Zone F in Fig. 4b. Many of long ligaments take place at crack tip and the size of Zone E is revealed very small (*see* the top of Fig. 5). Therefore, it seems to indicate that the broken surface generated by crack growth immediately joins both sides of the crack (Zone F). To describe the zone in which the crack propagates, we should continue to zoom in at crack tip. Figure 6 presents two magnifications of the crack tip. As shown in Fig. 6a, every ligament comes from a line that crosses the crack tip (the white dotted line in the figure). This

5 Magnification of Zone F in CB-SBR

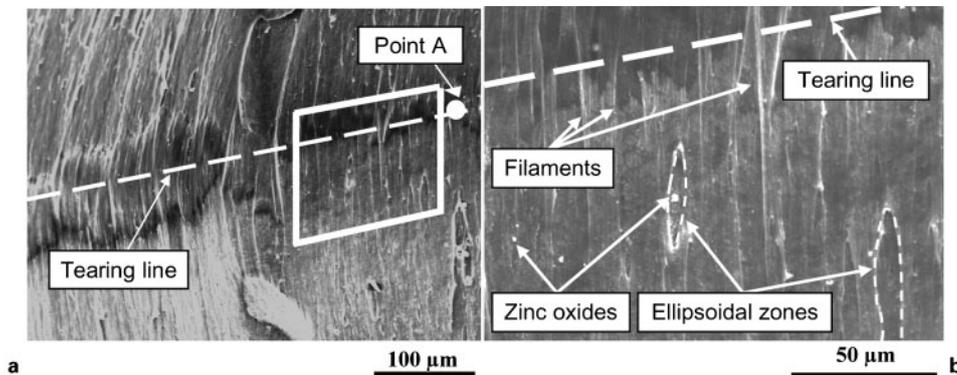
6 Details of crack tip for two magnifications

The zone propitious to microcutting corresponds to the tearing line previously described. It is the zone in which crack grows with the less energy. Thus, crack tip microcutting was performed by concentrating the electron beam at a point of this tearing line (point A, Fig. 6*a*). As material response, a microcut immediately initiates at this point and propagates towards the right side by revealing the zone located behind the crack tip. The artificial microcrack obtained is shown in Fig. 7*a*. It is to note that, for the same adjustment of the electron beam as in Ref. 5 for CB-NR, the time needed to initiate microcrack is inferior to 1 s instead of several seconds for CB-NR. Moreover, ligaments observed all over the crack tip fail without any resistance and for the same energy brought by the electron beam. It seems to indicate that the microstructure of ligaments in CB-SBR is the same whatever the deformation state, i.e. ligaments are not crystallised and the material microstructure is homogeneous at the crack tip. Figure 7*b* is a magnification of the encircled zone in Fig. 7*a*. Here, new ligaments are generated and the microcrack propagates through ZnO particles. Chemical links between ZnO and rubber matrix being highly weak, this zone looks like a cavity opened and stretched. This phenomenon generates two elliptical zones in which ZnO particles are observed. It is to note that elliptical zones observed on both sides of tearing line in Fig. 7*b* proves that this phenomenon takes place also

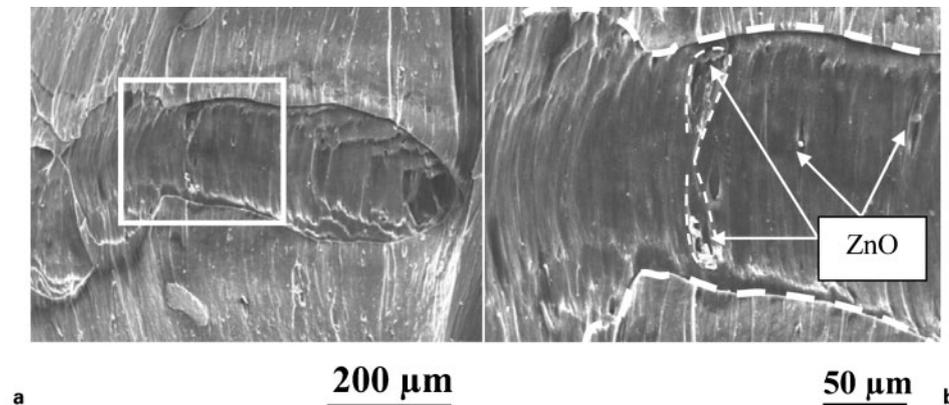
7 Chronology of microcut experiment

a artificial microcrack obtained after concentrating electron beam on point A in Fig. 6*a*; b magnified view of encircled zone of a

naturally (during natural crack propagation). If ZnO particles are not crossed by the crack in their middle, elliptical zones are only observed on one side of the tearing line (Fig. 7b). Finally, the size of revealed cavities being not superior to the one of ZnO particles, our observations do not allow to highlight cavitation from ZnO particles at the fatigue crack tip in CB-SBR. These observations demonstrate that the roughness of fracture surfaces is only due to particles (ZnO, carbon black agglomerates) encountered by the crack during its propagation into a linear zone.
