Global Warming Triggered Heavy Rains and its Effect on the Corrosion of Car Bodies in Uyo Metropolis

Aondona Paul Ihom, Patrick Peters Obot, Ini Umoren Udofia

Aondona Paul Ihom, Patrick Peters Obot, Ini Umoren Udofia. Global Warming Triggered Heavy Rains and its Effect on the Corrosion of Car Bodies in Uyo Metropolis. *Mechanics, Materials Science & Engineering Journal*, 2017, 8, 10.2412/mmse.01.39.008 . hal-01500668

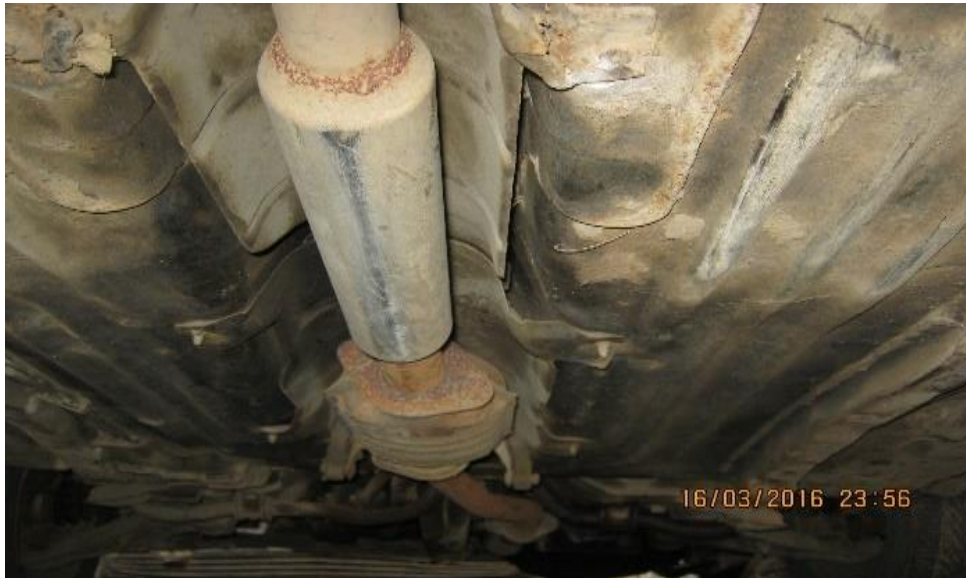
Fig. 1. Underneath Corrosion Effect on a Car in Uyo-Nigeria.

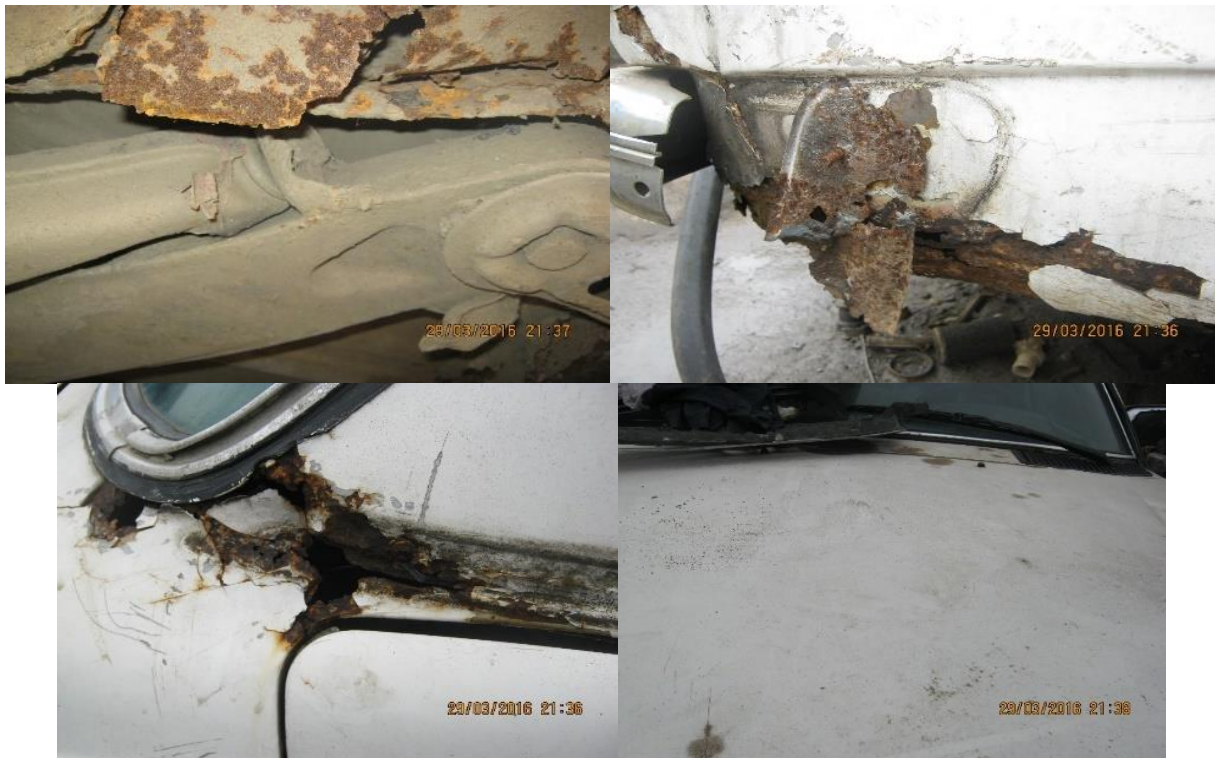
S/N	Manufacturer	Model	Year	Maintenance Culture	Corroding Region	Corroding Material	Corrosion Condition
1.	BENZ	Flat.booth 200E	1975	Nil	Sides panel	Aluminium	Corroded

S/N	Manufacturer	Model	Year	Maintenance Culture	Corroding Region	Corroding Material	Corrosion Condition
1.	BENZ	Flat.booth 200E	1975	When required	Underneath	coated steel	Very high

Fig. 2. Corrosion Effect on different parts of a car body (Manufacturer: Mercedes-Benz Model: Flat booth 200 E, Year of Manufacture: 1975).

Global warming has activated or triggered heavy rains especially in coastal areas; hardly a day passes without rain falling in Uyo this situation has created muddy situation on the untarred roads in the city, trapped muds can be sighted on the underneath of some of the images shown in Fig. 10-31. Polluted air with gas flaring activities, emissions from gen-sets and autos have equally increased the aggressiveness of rain water, the effect on car bodies can be sighted in Fig. 2-9. Hidden areas where moisture is trapped by the cars are badly corroded as in Fig. 2, 5, and 7.

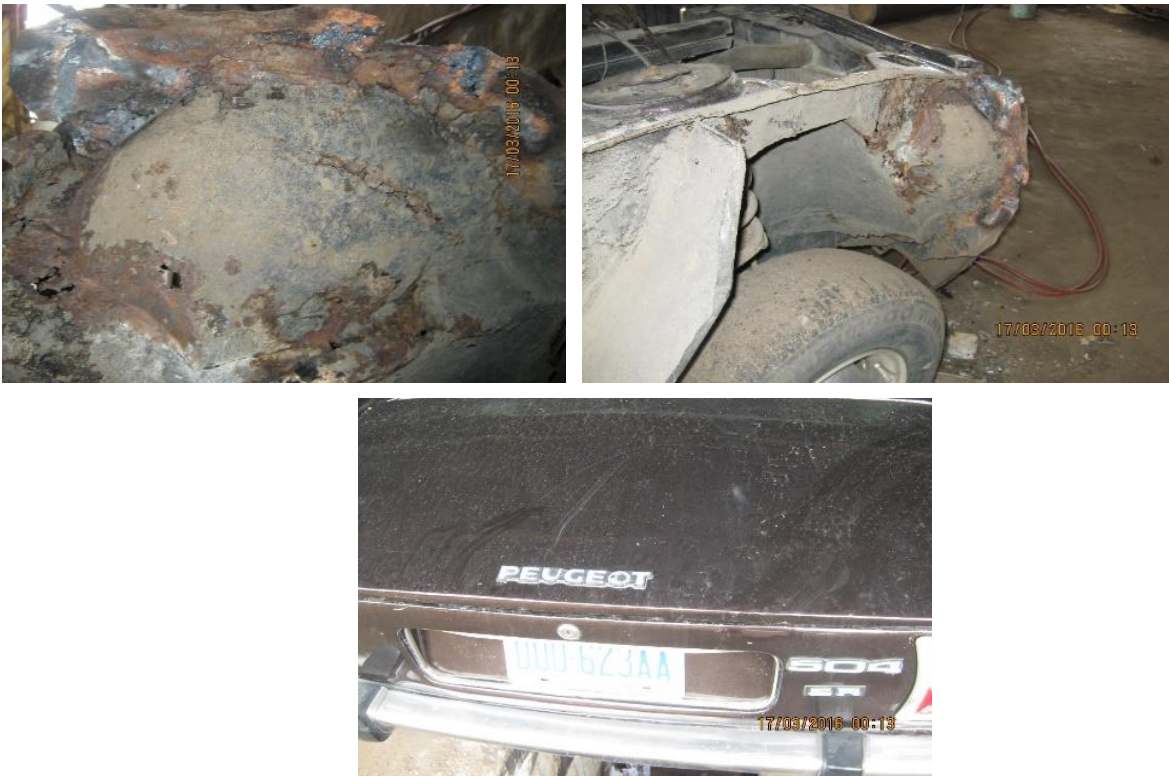
2.	PEUGEOT	SR 406	1985	When required	Roof/body/doors		Faded paint
3.	PASSAT	402	1985	When required	Doors/roof		Corroded
4.	BENZ	V.booth 230.E	1985	When required	Roof/burnet	Aluminium	Faded paint

2.	PEUGEOT	SR 406	1985	When required	Underneath	“	Very high
3.	PASSAT	402	1985	When required	Underneath	“	Very high
4.	BENZ	V.booth 230.E	1985	When required	Underneath	“	Very high

Fig. 3. Corrosion Effect on Different Parts of a Car Body (Manufacturer: Peugeot, Model: 504 SR Year of Manufacture: 1985).

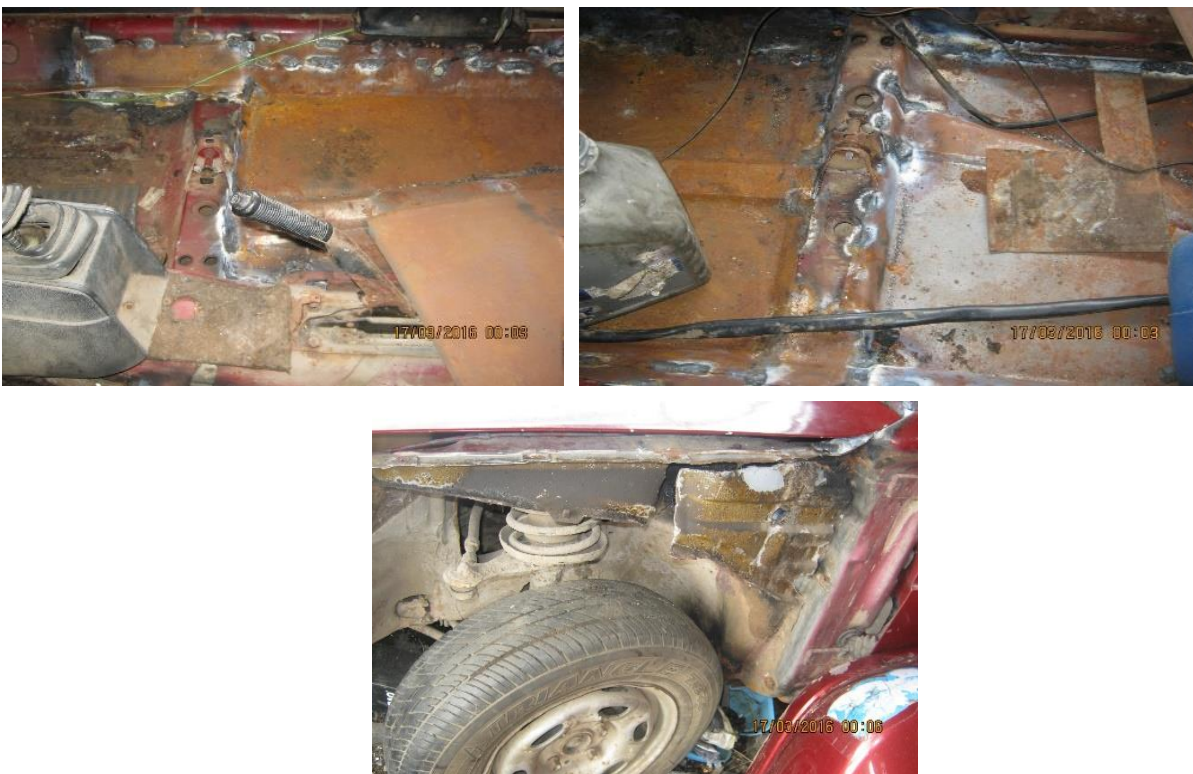
Fig. 4 Corrosion Effect on Different Parts of a Car Body (Manufacturer: Volkswagen Model: Passat 402, Year of Manufacture: 1985)

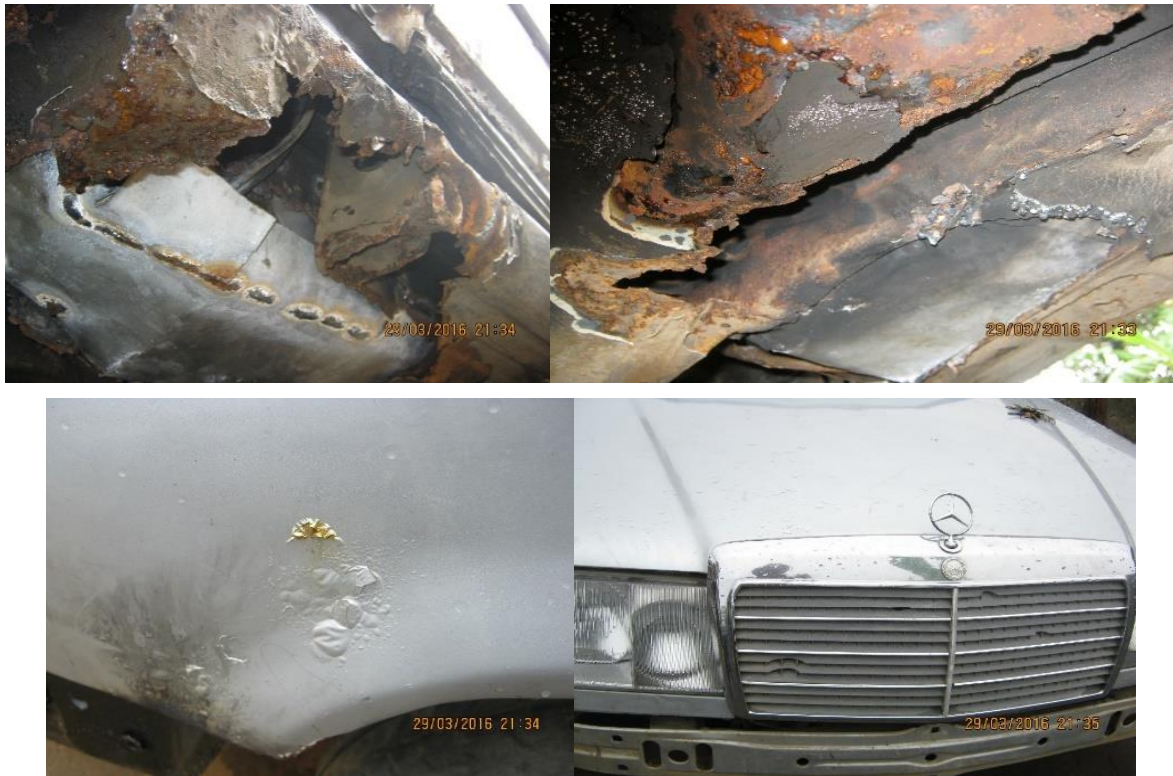
Fig. 5. Corrosion Effect on Different Parts of a Car Body (Manufacturer: Mercedes-Benz Model: V booth 230 E, Year of Manufacture: 1985).

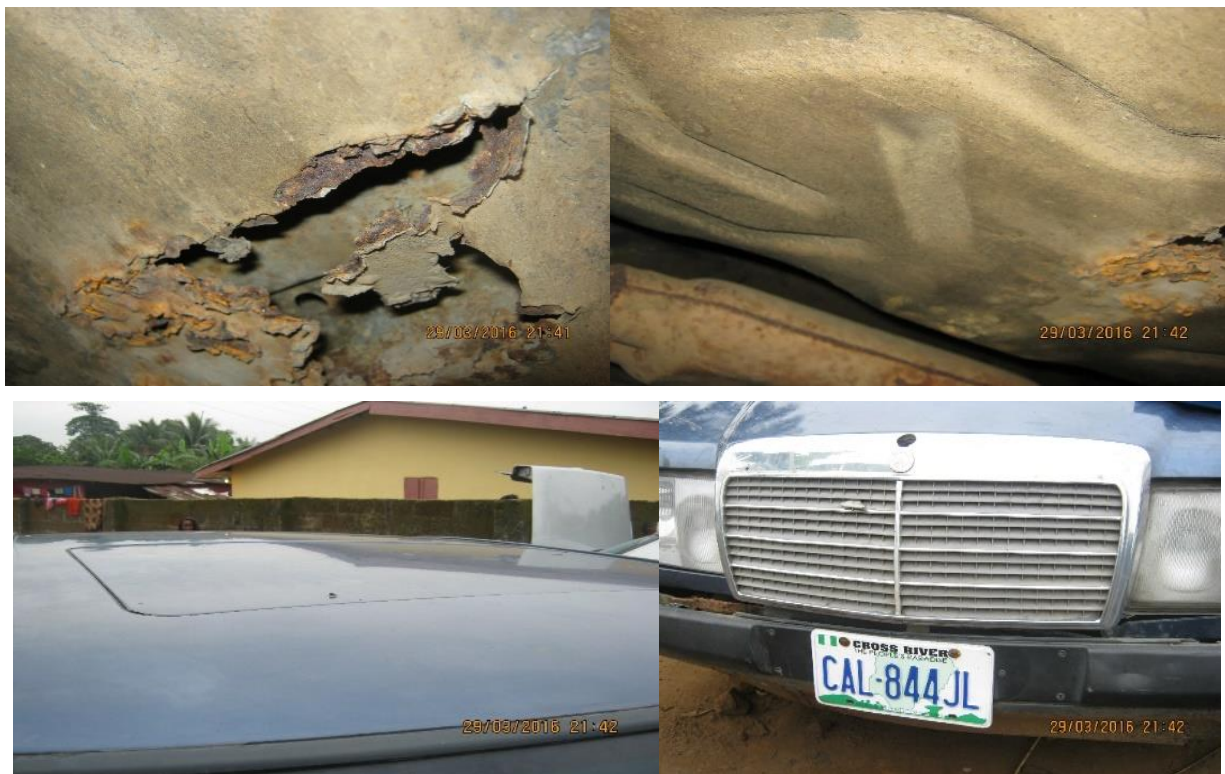
Fig. 6. Corrosion Effect on Different Parts of a Car Body (Manufacturer: Mercedes-Benz, Model: V booth 300 E, Year of Manufacture: 1985).

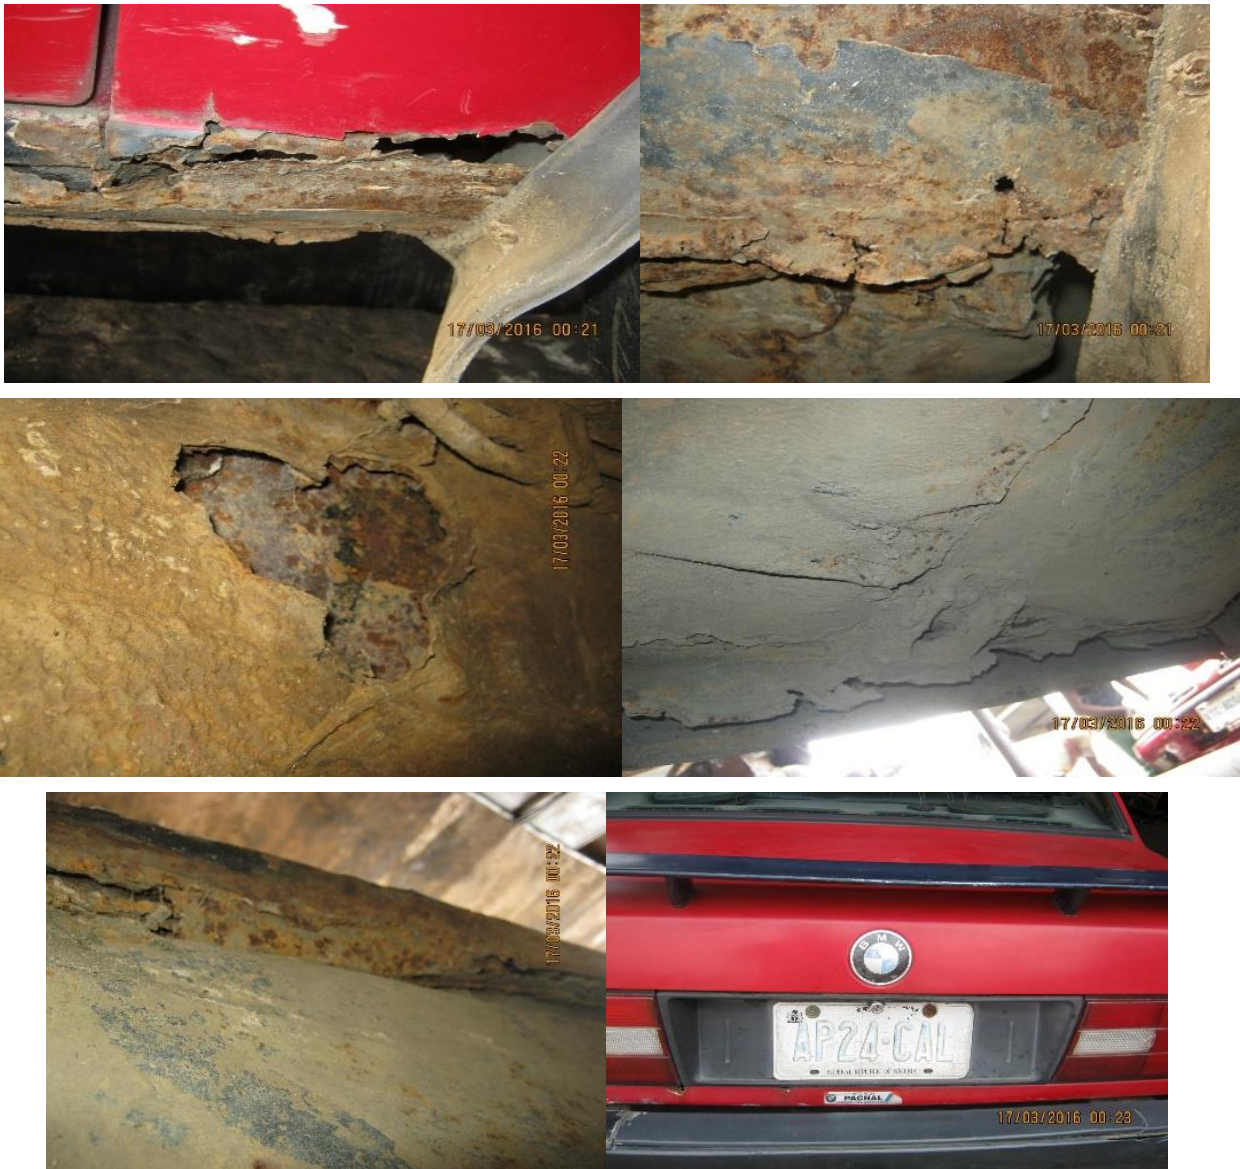
Fig. 7. Corrosion Effect on Different Parts of a Car Body (Manufacturer: BMW Model: E 30, Year of Manufacture: 1987).

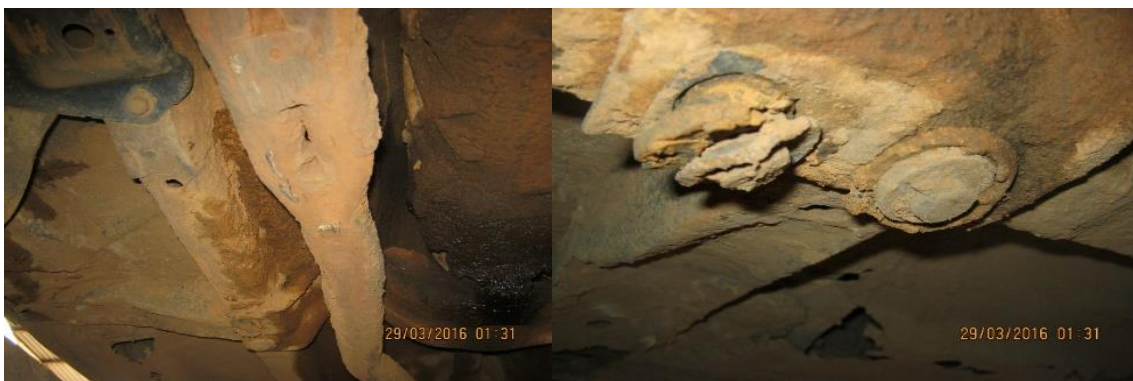
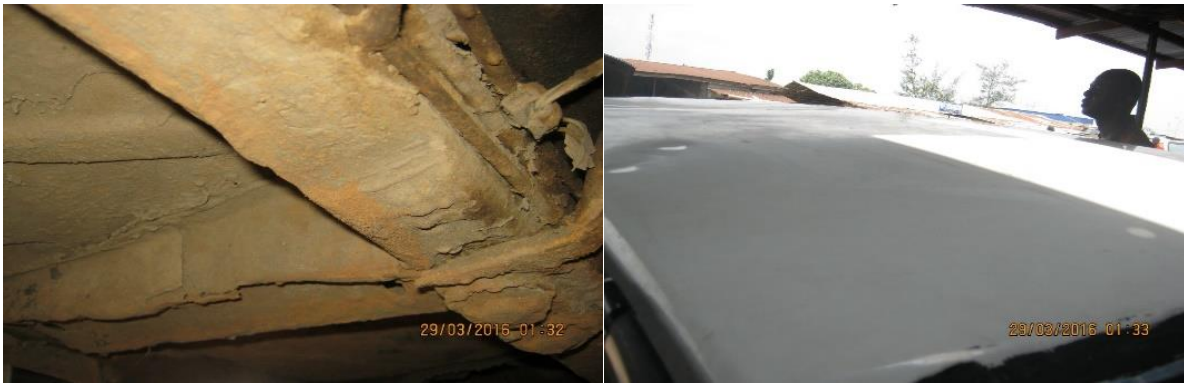
Fig. 8. Corrosion Effect on Different Parts of a Car Body (Manufacturer: VOLVO Model: 240GL, Year of Manufacture: 1987).

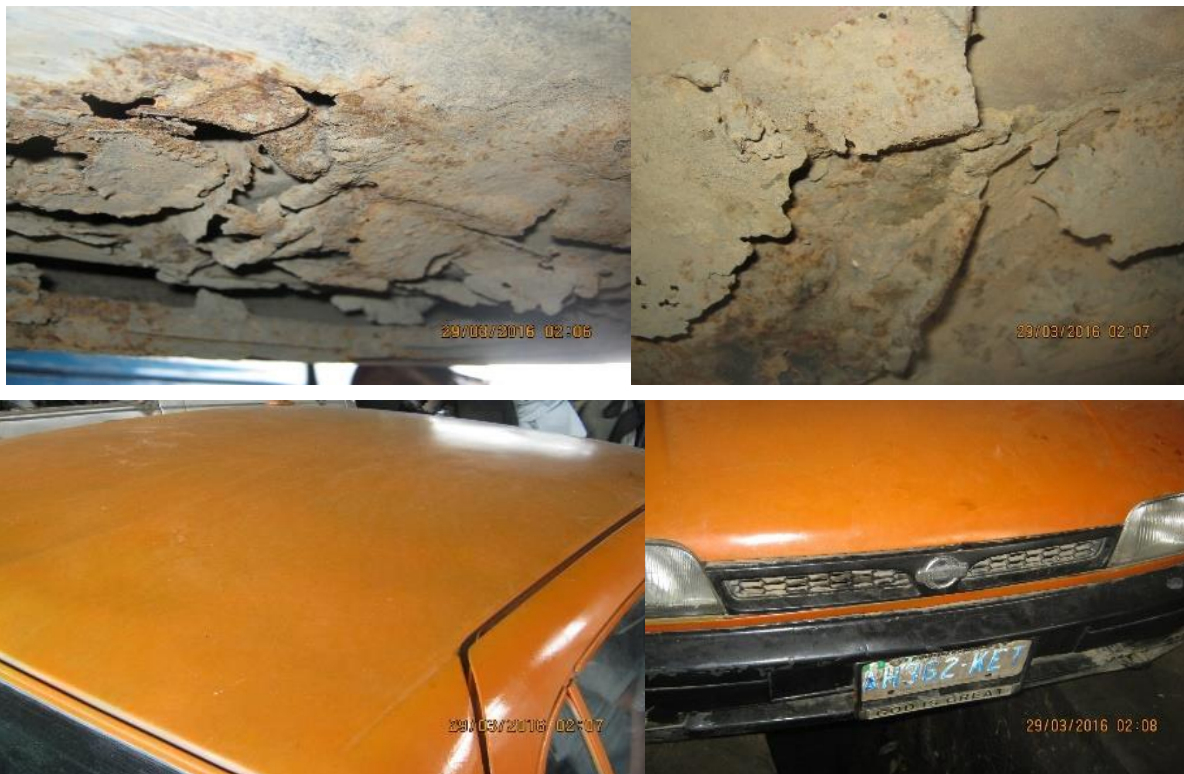
Fig. 9. Corrosion Effect on Different Parts of a Car Body (Manufacturer: NISSAN Model: Sunny 1.4L Year of Manufacture: 1991).

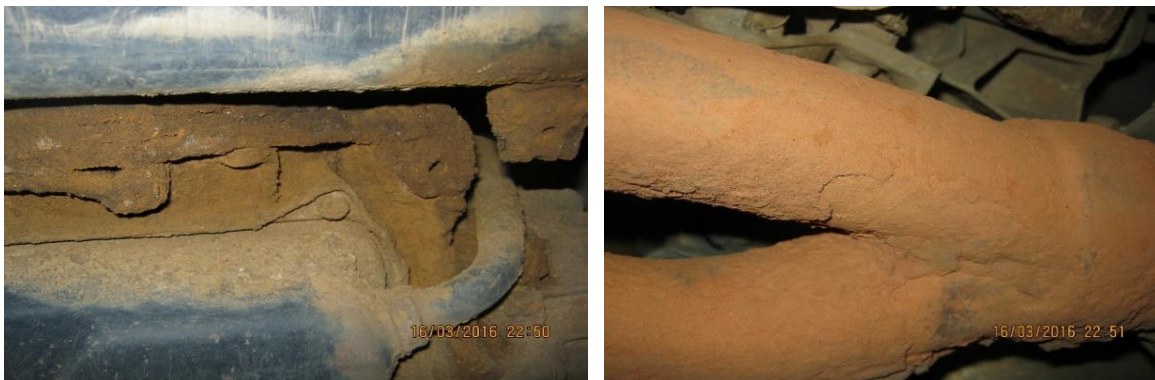
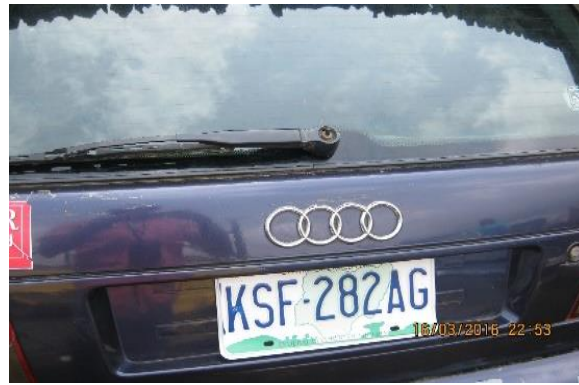
Fig. 10. Corrosion Effect on Different Parts of the Underneath of a Car (Manufacturer: AUDI Model: Avant A6, Year of Manufacture: 1994).

Fig. 10- 31 which are images of the underneath of the various cars investigated clearly shows that the underneath of the cars is badly affected. Critical areas include the exhaust system and areas where muds are trapped. Obviously most car manufacturers still need to work on their exhaust system material to make it more corrosion resistant. The problem of most exhaust system is not just wet corrosion but oxidation as a result of the high temperature of the exhaust gases. The effect of the heavy rains on car bodies as can be seen in the study has to do with fading paints.

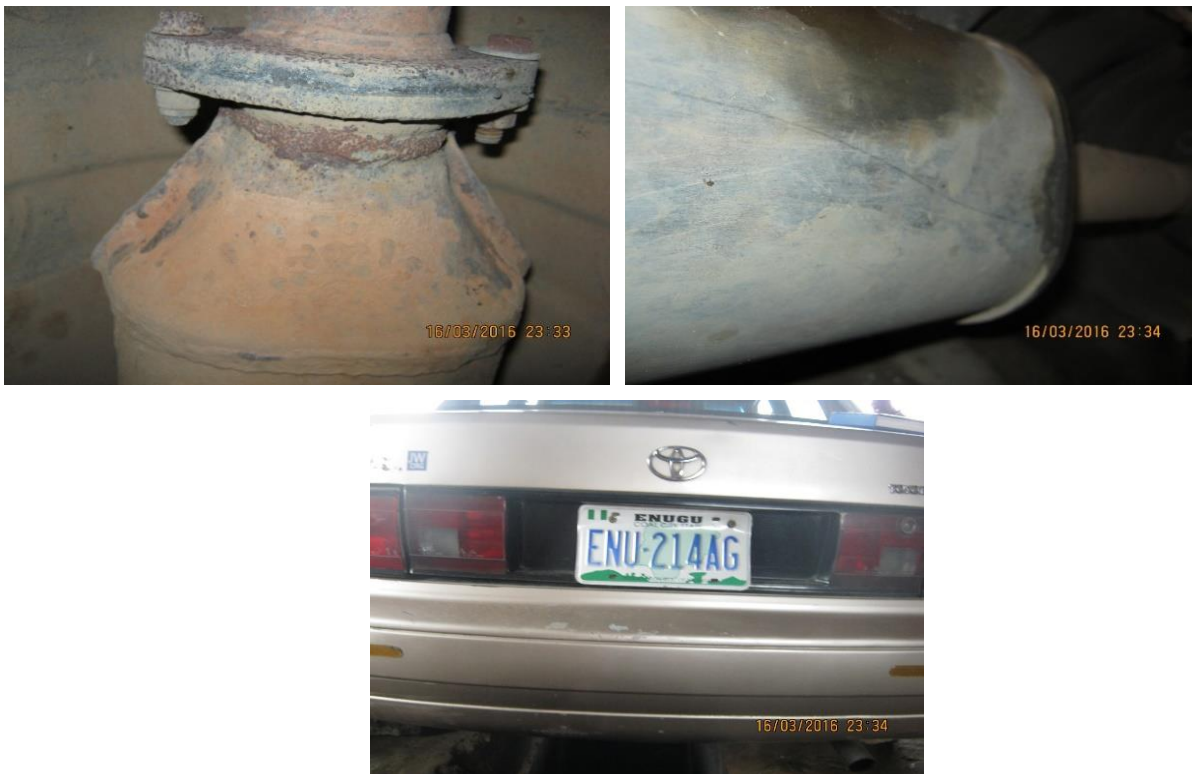
Fig. 11. Corrosion Effect on Different Parts of the Underneath of a Car (Manufacturer: TOYOTA Model: Camry 2.2 GL, Year of Manufacture: 1996).

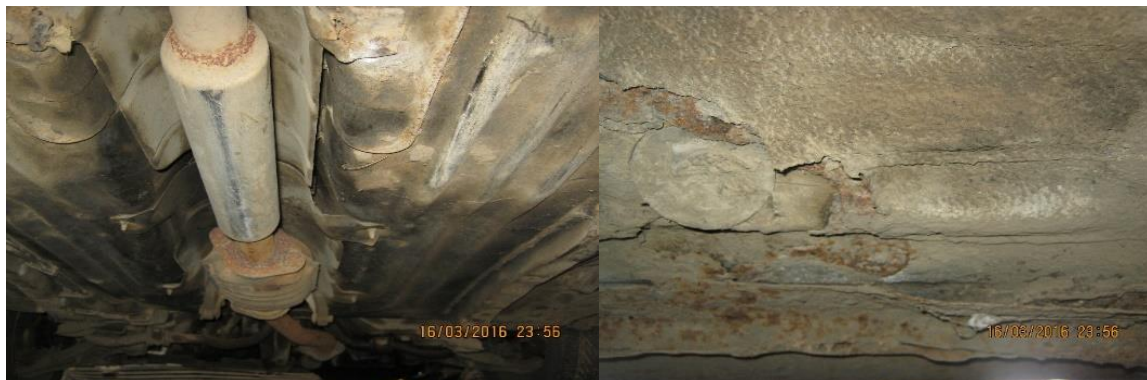
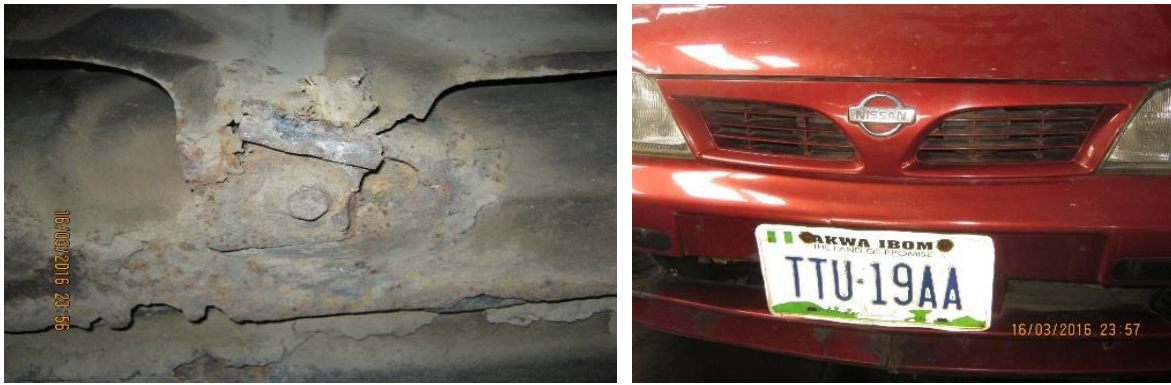
Fig. 12. Corrosion Effect on Different Parts of the Underneath of a Car (Manufacturer: NISSAN Model: Almera 1.6 SLX, Year of Manufacture: 1997).

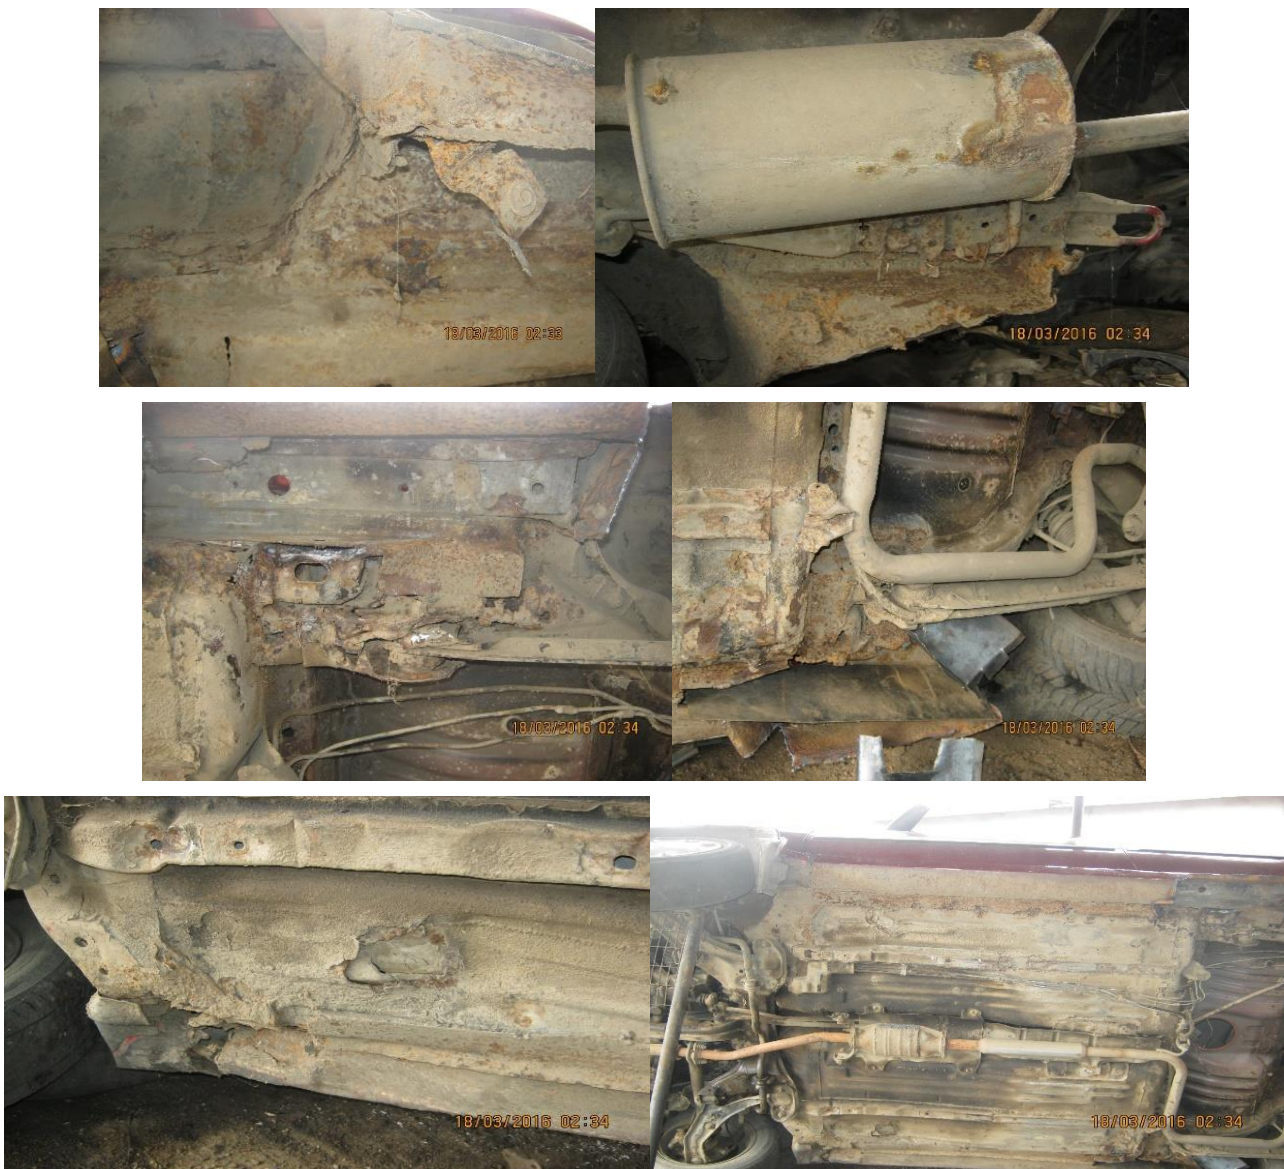
Fig. 13. Corrosion Effect on Different Parts of the Underneath of a Car (Manufacturer: NISSAN Model: Almera 1.6 SLX, Year of Manufacture: 1997).

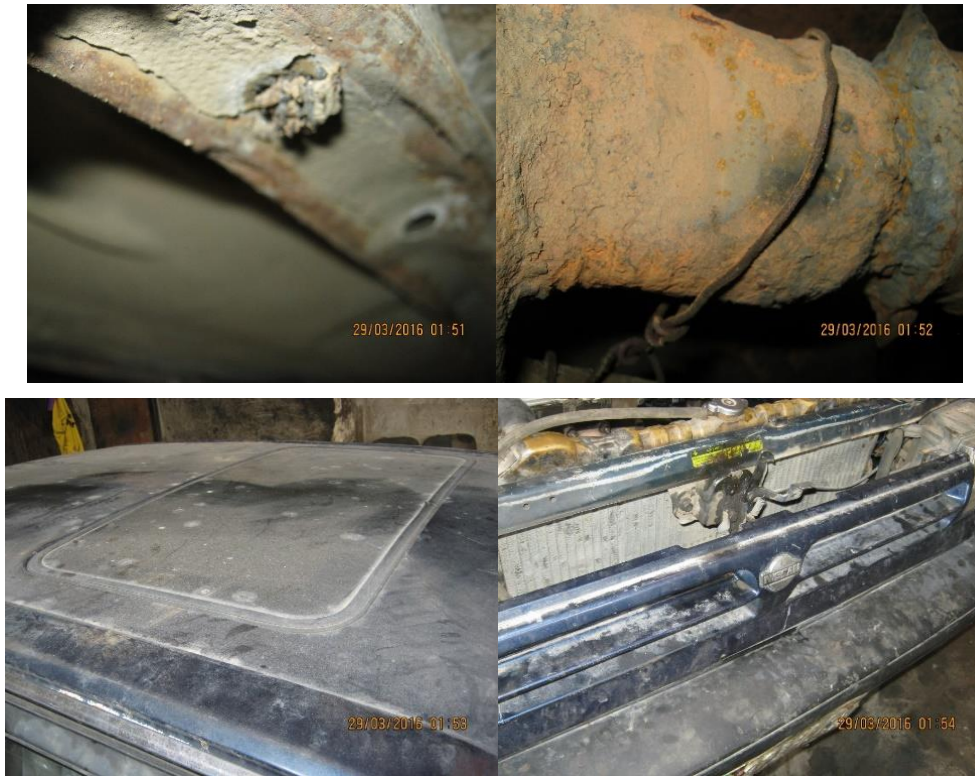
Fig. 14. Corrosion Effect on Different Parts of the Underneath of a Car (Manufacturer: NISSAN Model: Blue Bird, Year of Manufacture: 1998).

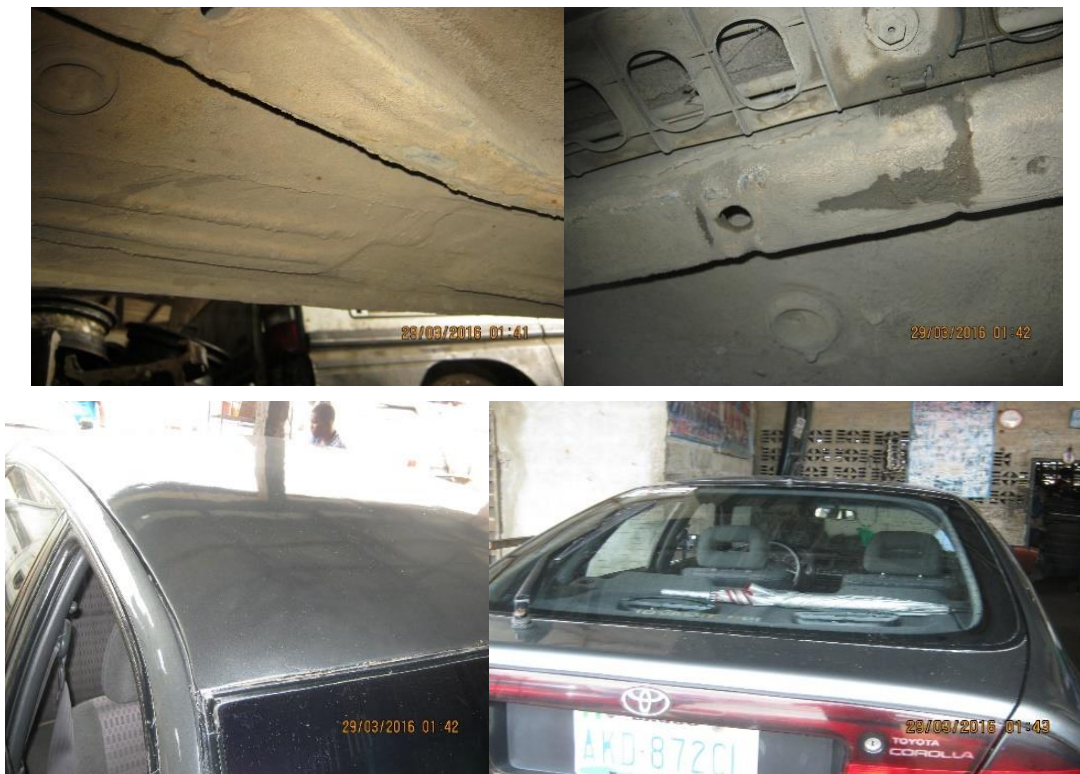
Fig. 15. Corrosion Effect on Different Parts of the Underneath of a Car (Manufacturer: TOYOTA Model: Corolla, Year of Manufacture: 1998).

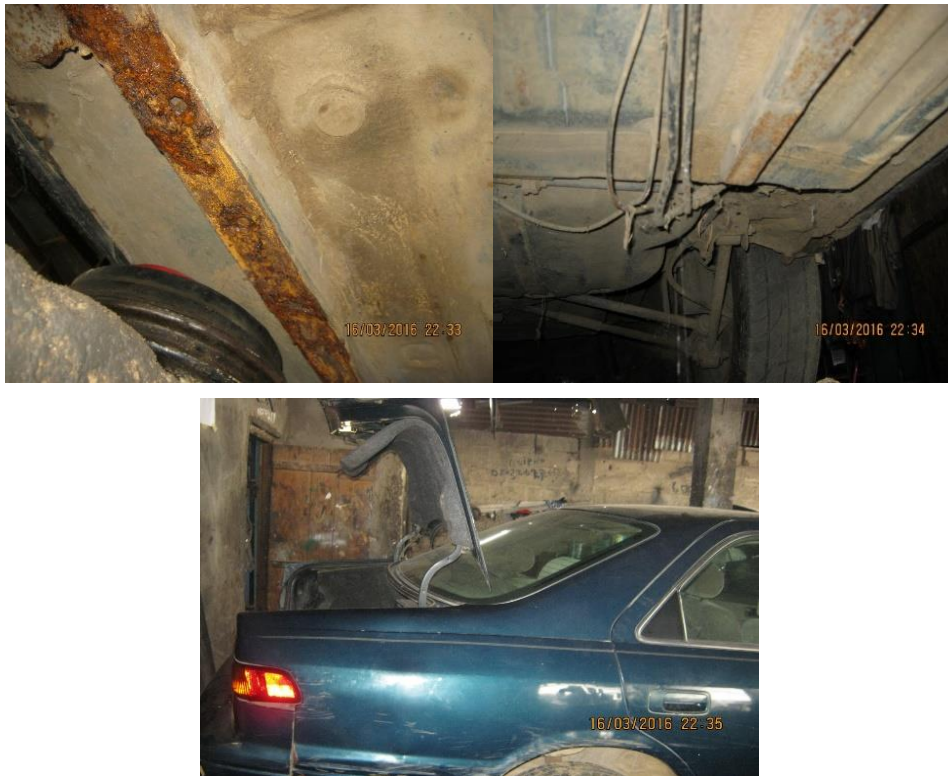
Fig. 16. Corrosion Effect on Different Parts of the Underneath of a Car (Manufacturer: TOYOTA Model: Camry LE, Year of Manufacture: 1999).

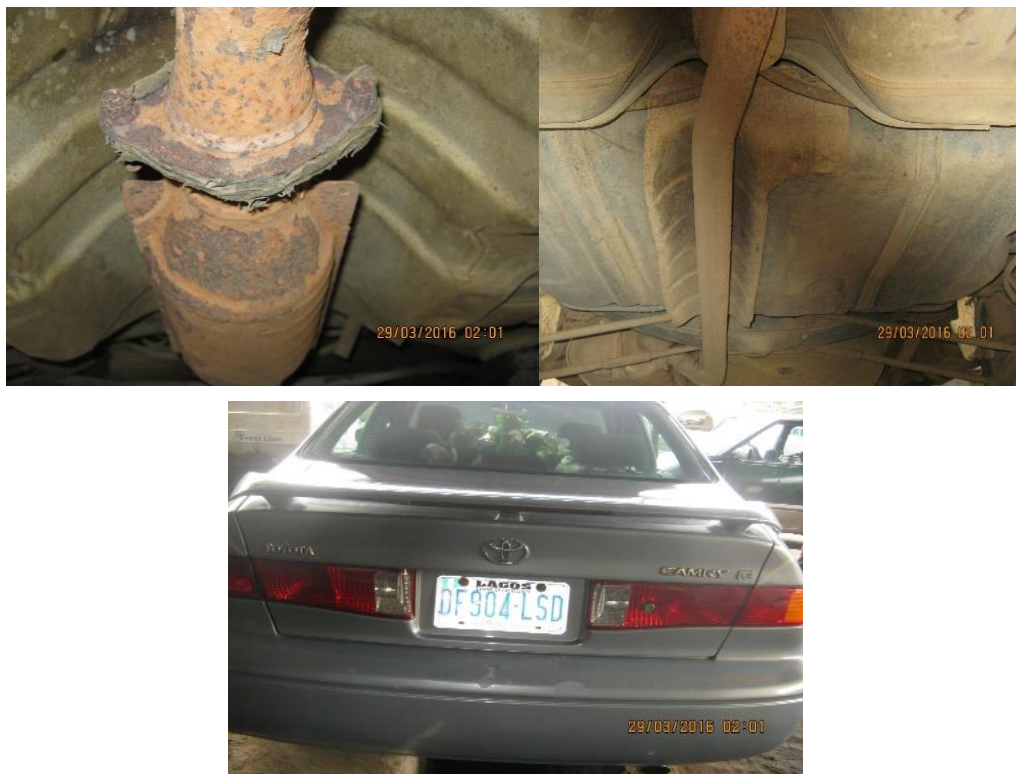
Fig. 17. Corrosion Effect on Different Parts of the Underneath of a Car (Manufacturer: TOYOTA Model: Camry LE, Year of Manufacture: 1999).

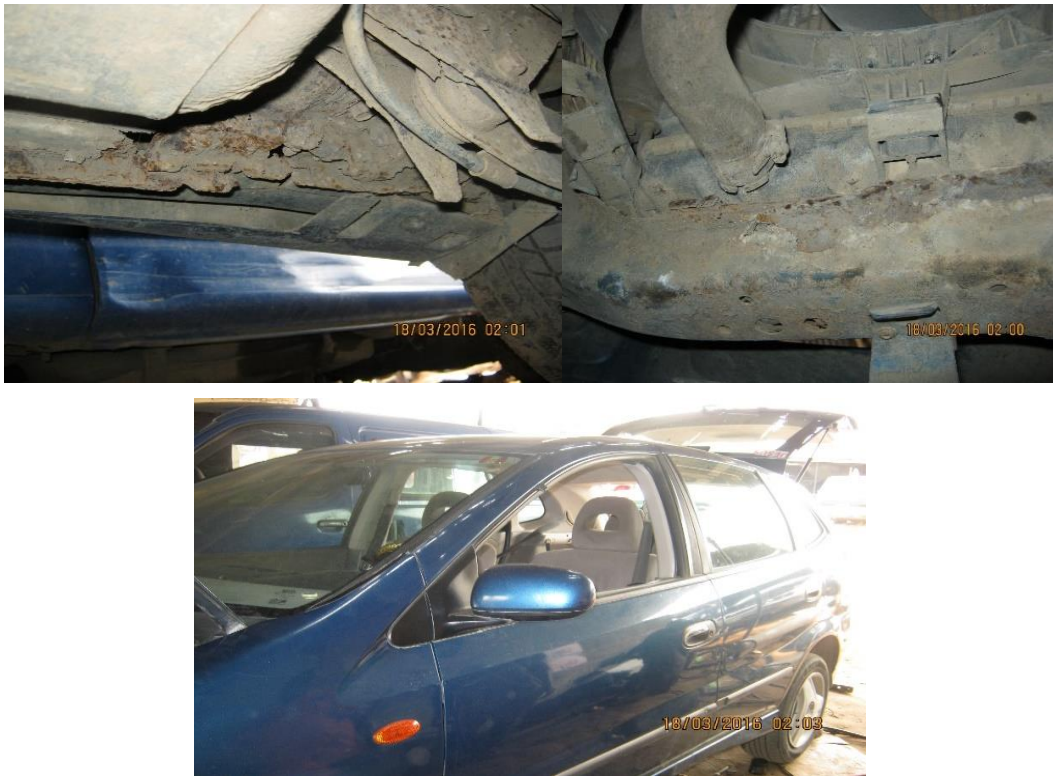
Fig. 18. Corrosion Effect on Different Parts of the Underneath of a Car (Manufacturer: NISSAN Model: Almera Tino, Year of Manufacture: 2001).

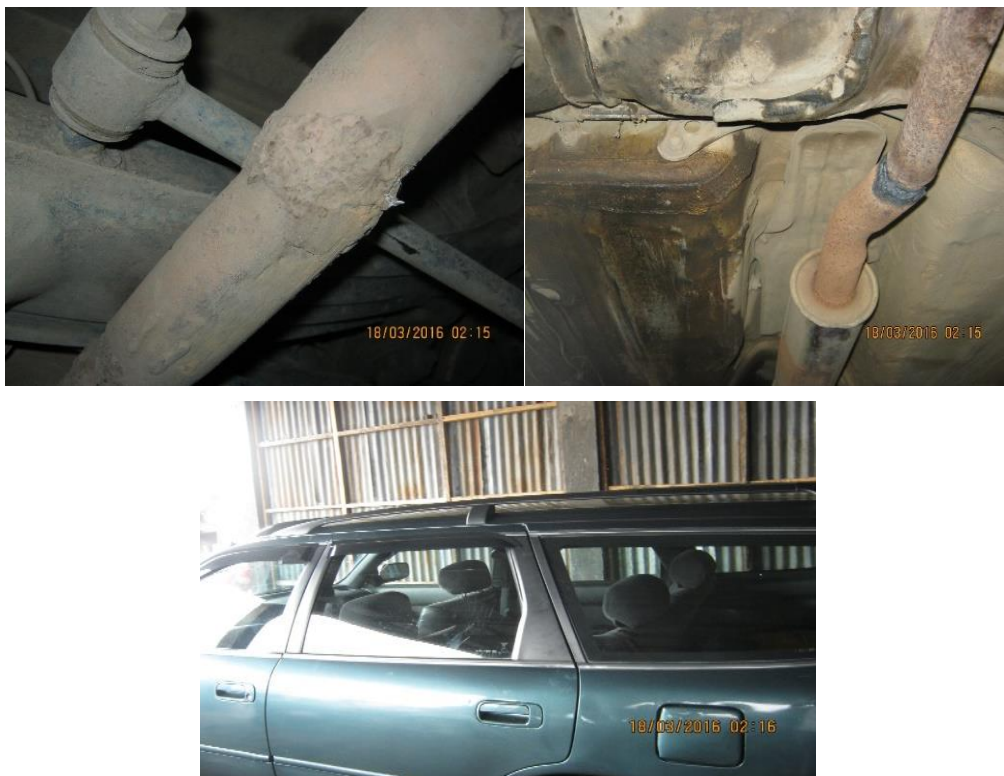
Fig. 19. Corrosion Effect on Different Parts of the Underneath of a Car (Manufacturer: TOYOTA Model: Camry 2.2 XL, Year of Manufacture: 2001).

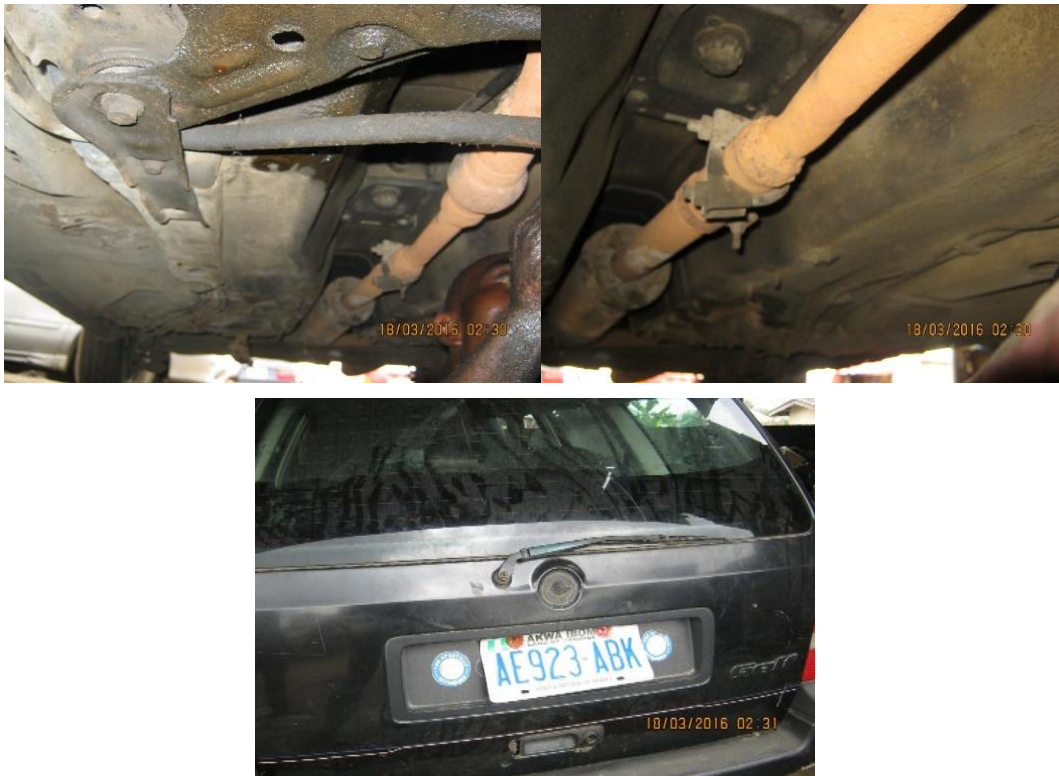
Fig. 20. Corrosion Effect on Different Parts of the Underneath of a Car (Manufacturer: Volkswagen Model: GOLF 3.0 Wagon, Year of Manufacture: 2001).

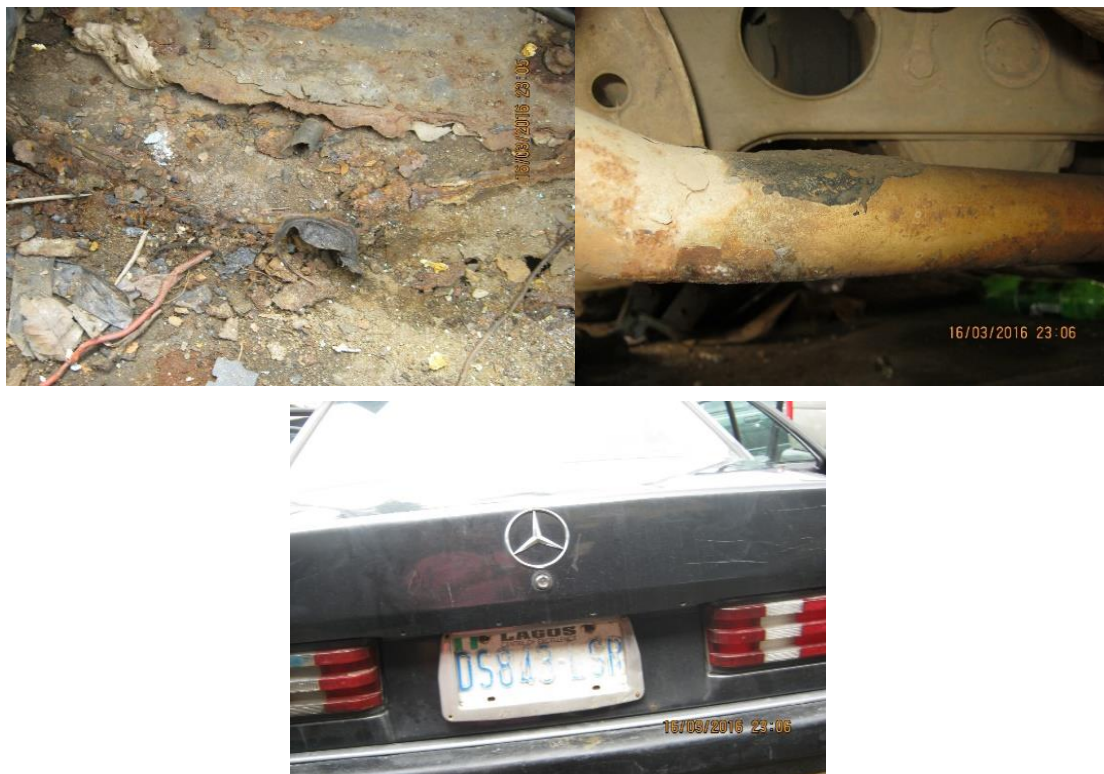
Fig. 21. Corrosion Effect on Different Parts of the Underneath of a Car (Manufacturer: Mercedes-Benz Model: BENZ 190, Year of Manufacture: 2002).

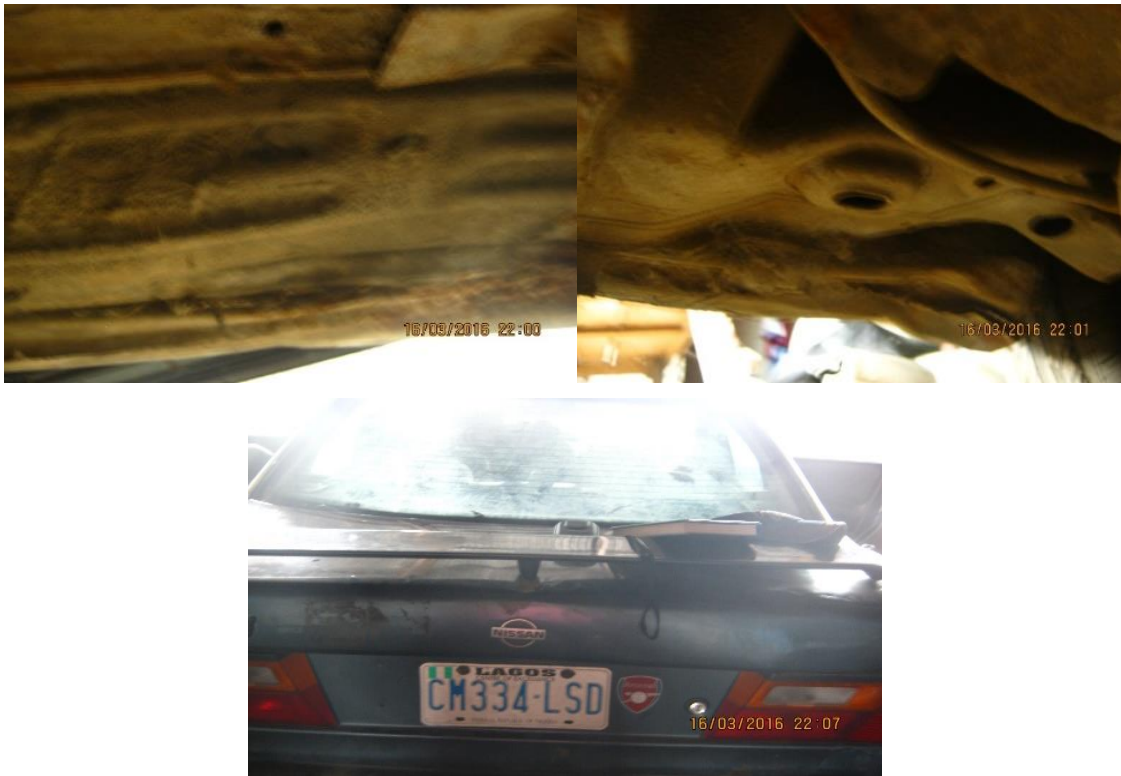
Fig. 22. Corrosion Effect on Different Parts of the Underneath of a Car (Manufacturer: NISSAN Model: Primera, Year of Manufacture: 2002).

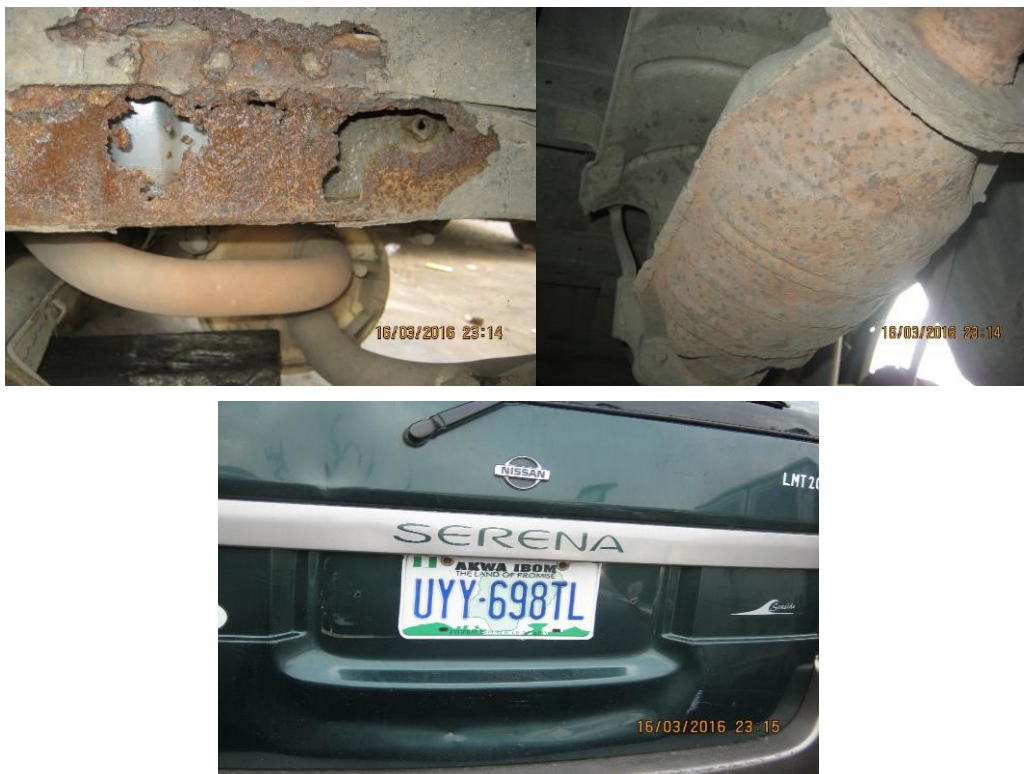
Fig. 23. Corrosion Effect on Different Parts of the Underneath of a Car (Manufacturer: NISSAN Model: Serena LMT 200, Year of Manufacture: 2002).

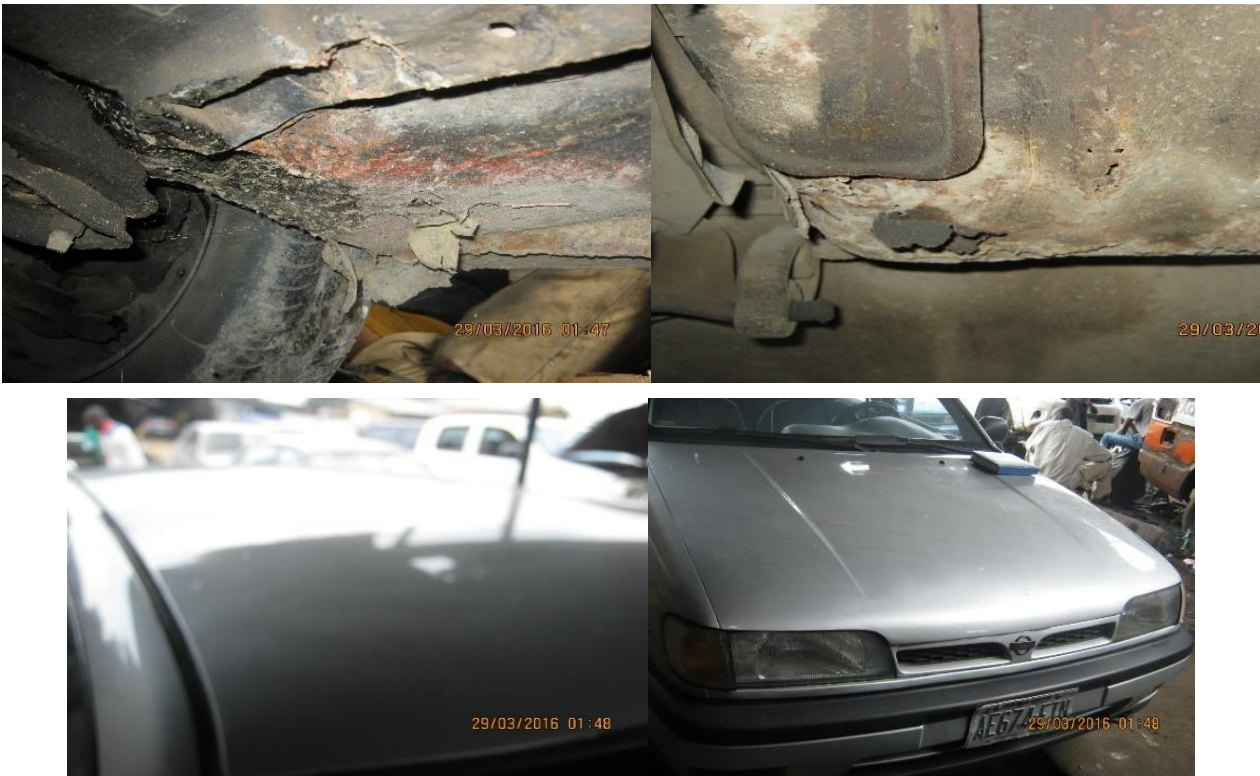
Fig. 24. Corrosion Effect on Different Parts of the Underneath of a Car (Manufacturer: NISSAN Model: Sunny 1.6SLX, Year of Manufacture: 2002).
