Global Warming Triggered Heavy Rains and its Effect on the Corrosion of Car Bodies in Uyo Metropolis

Aondona Paul Ihom, Patrick Peters Obot, Ini Umoren Udofia

Aondona Paul Ihom, Patrick Peters Obot, Ini Umoren Udofia. Global Warming Triggered Heavy Rains and its Effect on the Corrosion of Car Bodies in Uyo Metropolis. *Mechanics, Materials Science & Engineering Journal*, 2017, 8, 10.2412/mmse.01.39.008 . hal-01500668

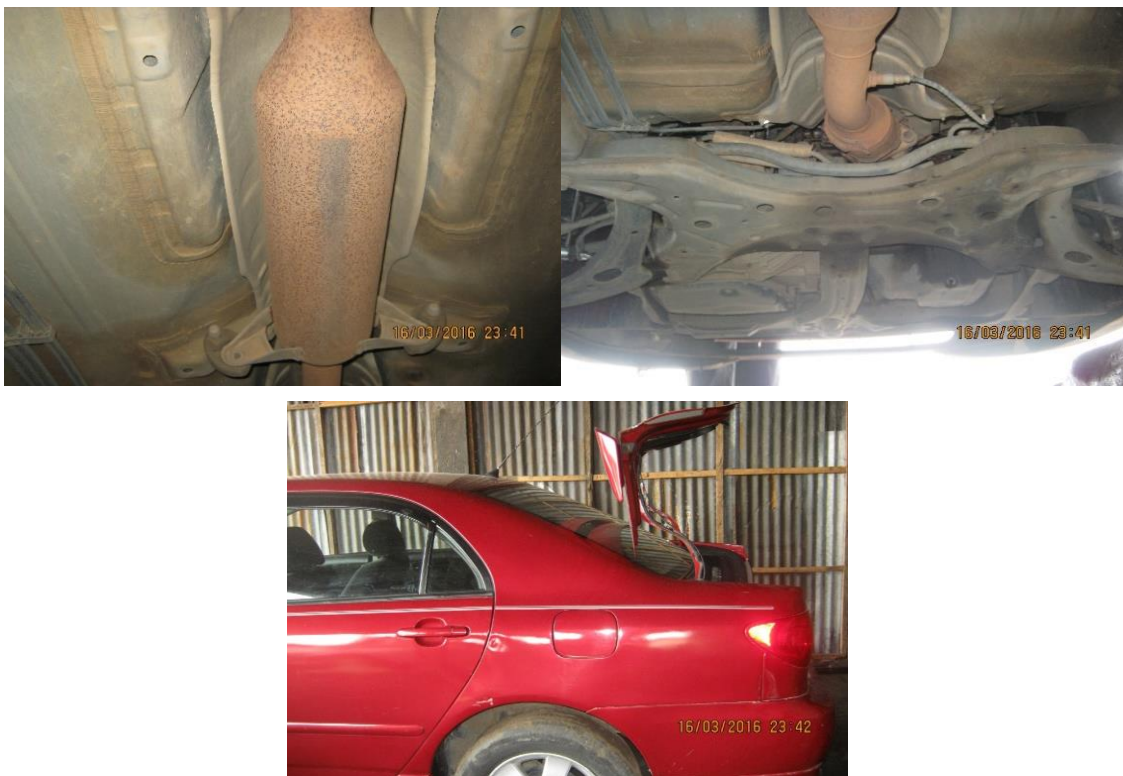
Fig. 25. Corrosion Effect on Different Parts of the Underneath of a Car (Manufacturer: TOYOTA Model: Corolla S Year of Manufacture: 2003).

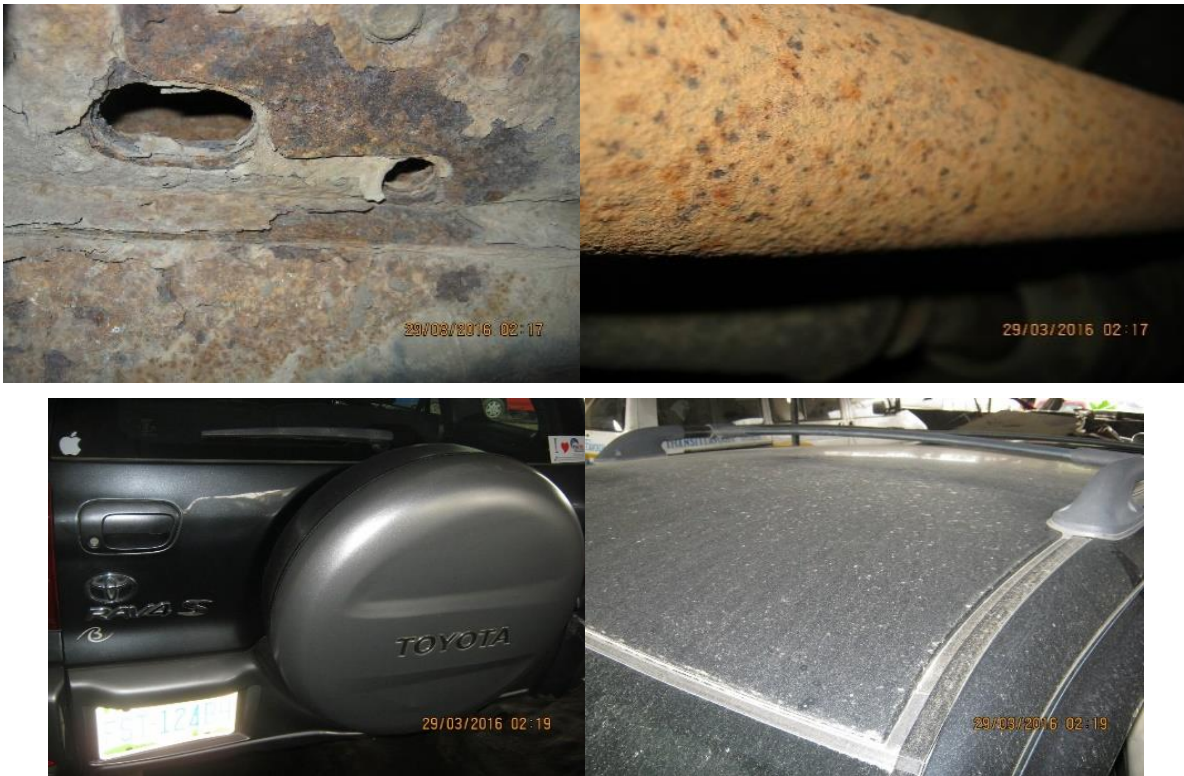
Fig. 26. Corrosion Effect on Different Parts of the Underneath of a Car (Manufacturer: TOYOTA Model: RAV4 S, Year of Manufacture: 2004).

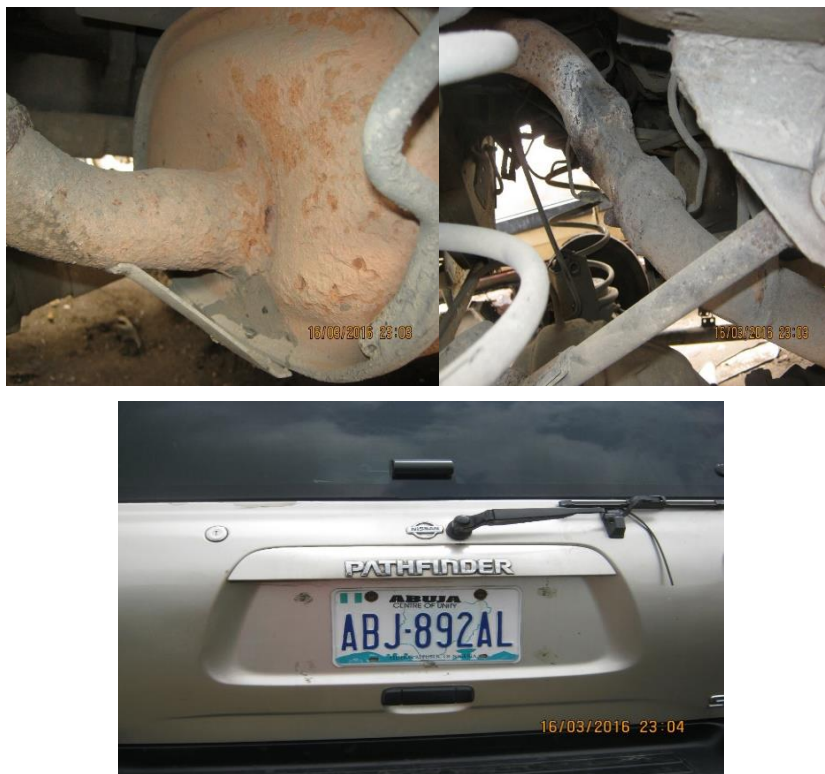
Fig. 27. Corrosion Effect on Different Parts of the Underneath of a Car (Manufacturer: NISSAN Model: Pathfinder, S.E 3.5, Year of Manufacture: 2005).

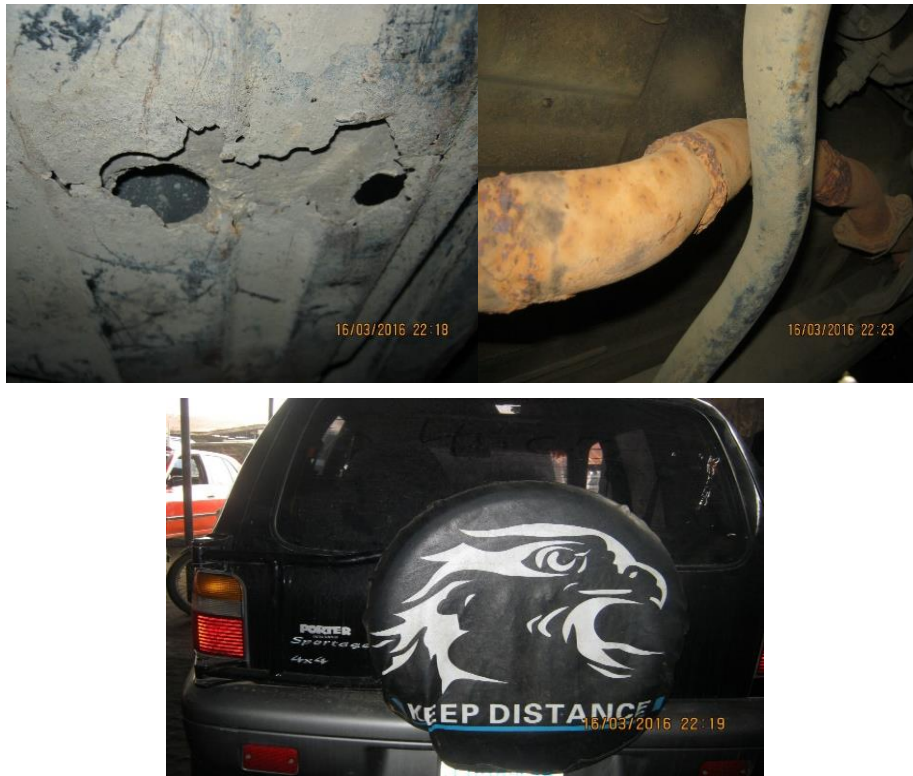
Fig. 28. Corrosion Effect on Different Parts of the Underneath of a Car (Manufacturer: KIA Model: Porter, Year of Manufacture: 2008).

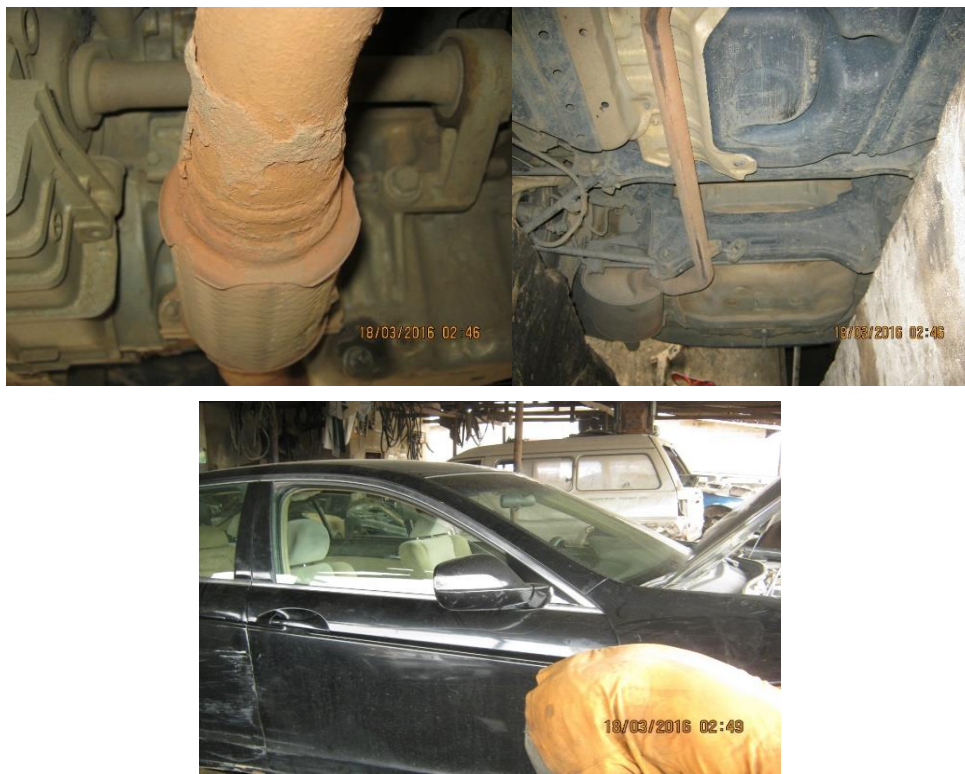
Fig. 29. Corrosion Effect on Different Parts of the Underneath of a Car (Manufacturer: HONDA Model: ACCORD 2.0 LX, Year of Manufacture: 2008).

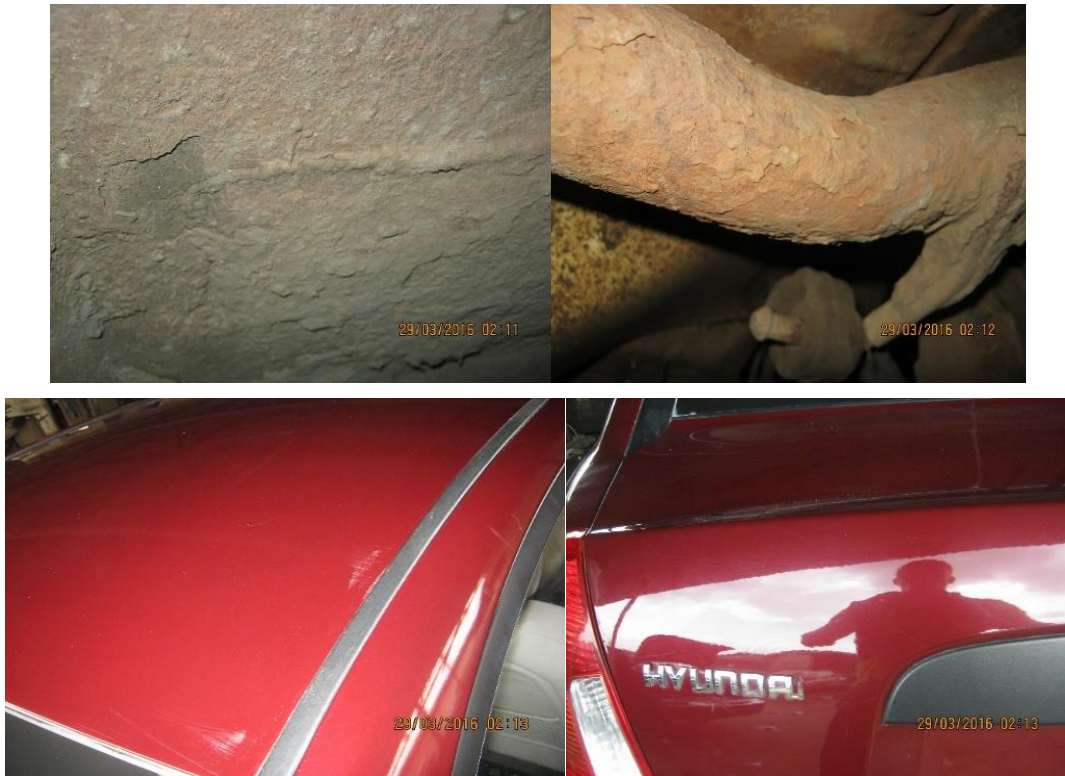
Fig. 30. Corrosion Effect on Different Parts of the Underneath of a Car (Manufacturer: HYUNDAI Model: Accent, Year of Manufacture: 2008).

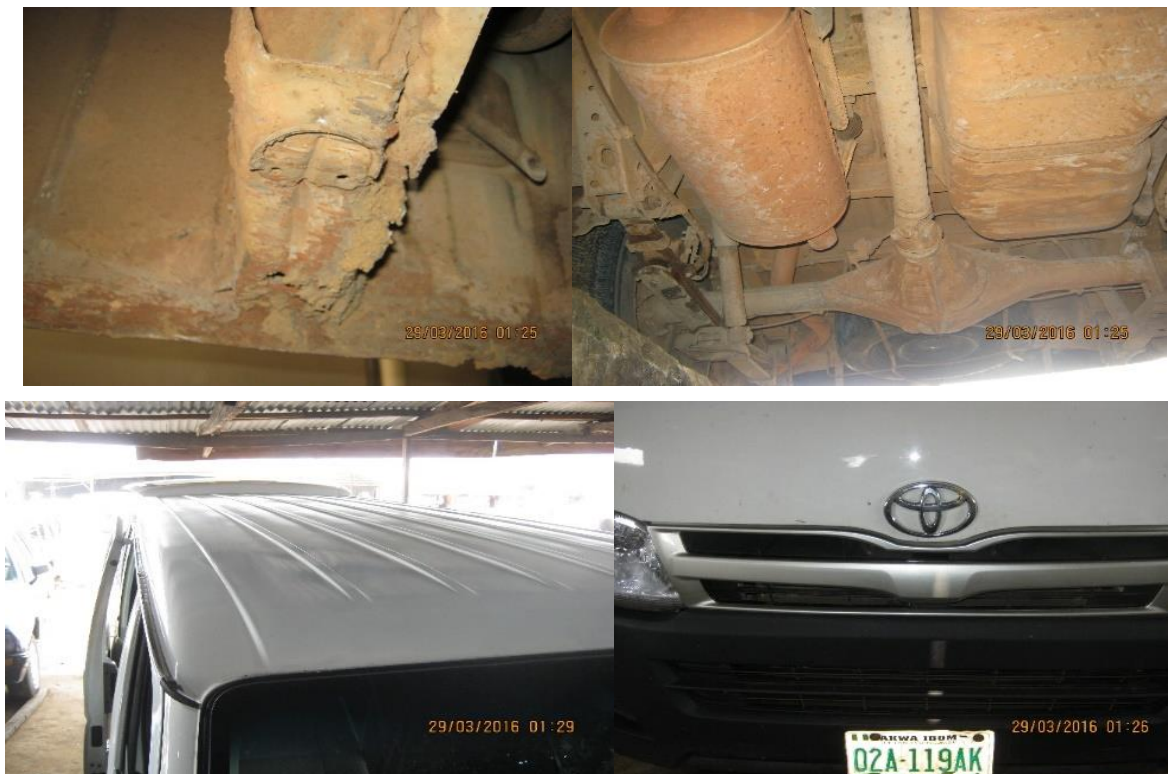
Fig. 31. Corrosion Effect on Different Parts of the Underneath of a Car (Manufacturer: TOYOTA Model: Haice bus, Year of Manufacture: 2009).
