# EXPERIMENTAL ANALYSIS OF FAILURES IN FILLED HOLE COMPRESSION TESTS OF CARBON/EPOXY LAMINATE

Bruno Castanié, Serge Crézé, Jean-Jacques Barrau, Frederic Lachaud,  
Laurent Risse

Bruno Castanié, Serge Crézé, Jean-Jacques Barrau, Frederic Lachaud, Laurent Risse. EXPERIMENTAL ANALYSIS OF FAILURES IN FILLED HOLE COMPRESSION TESTS OF CARBON/EPOXY LAMINATE. Composite Structures, 2010, 92 (5), pp.1192-1199. hal-02048231

In this study, failure modes occurring during Filled Hole Compression (FHC) tests were analysed using post-mortem analysis for failure pattern identification and high-speed cameras for failure scenario (damage initiation and progress). Two different failure scenario were experienced depending upon the stacking sequence :

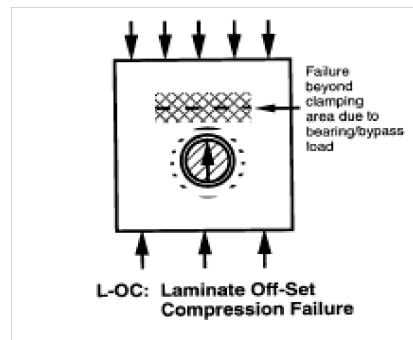
Figure N°1: Laminate off-set failure (reproduced from [1]).

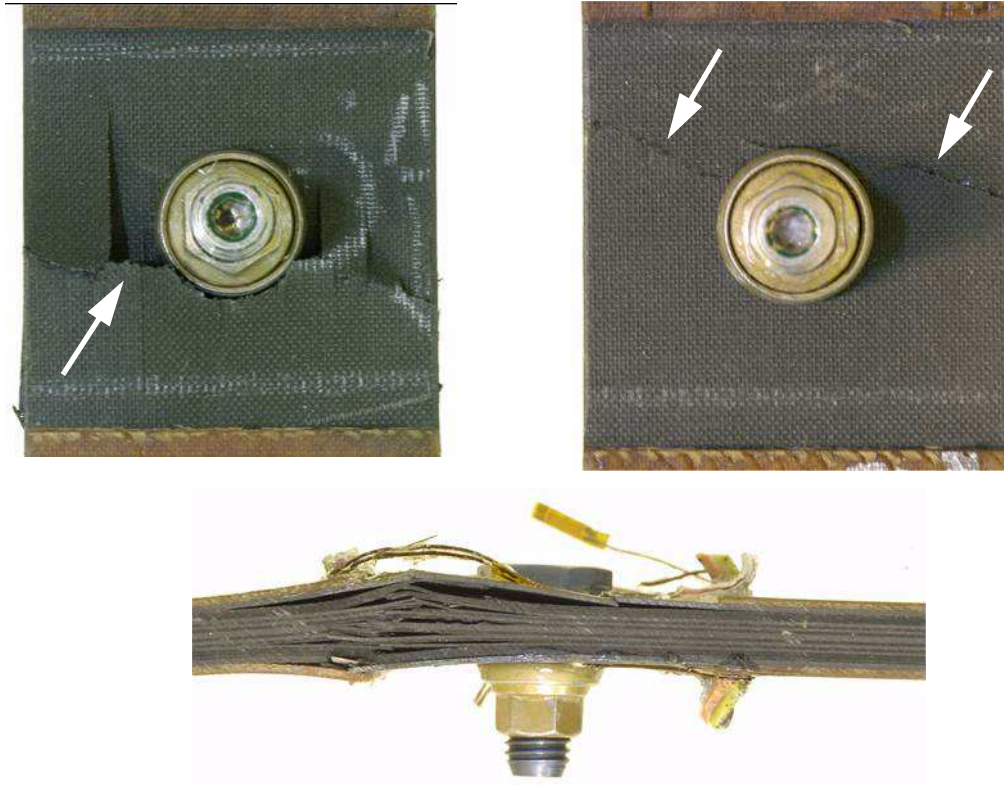
Sample of failures patterns for [10/4/4/2] specimens are shown Figure N° 7 (tightened bolt)

and Figure N° 8 (no lateral constraint). Several failure modes are superimposed with net section compression failure and cleavage. On the edges of the specimens, delamination are also observed. Generally speaking, the pattern is different between the kind of specimen and one can assume that the failure scenario is different. Sample of failures patterns for [2/4/4/10] specimens are shown Figure N° 9. Unlike the previous tests, it is not necessary to make a difference between tightened or not specimens. For all the specimens, fracture lines are clearly visible in the net section (Specimen A) or in off-set sections (specimens B and C). Nevertheless, for tightened specimens the fracture line is always tangent to the bolt. On the edges of the specimens, delaminations are also visible (Specimen C). The different fracture line patterns are summarized in Figure N° 10.

Figure N°7: Post-mortem failure patterns of [10/4/ 4/2] specimens with tightened bolts.

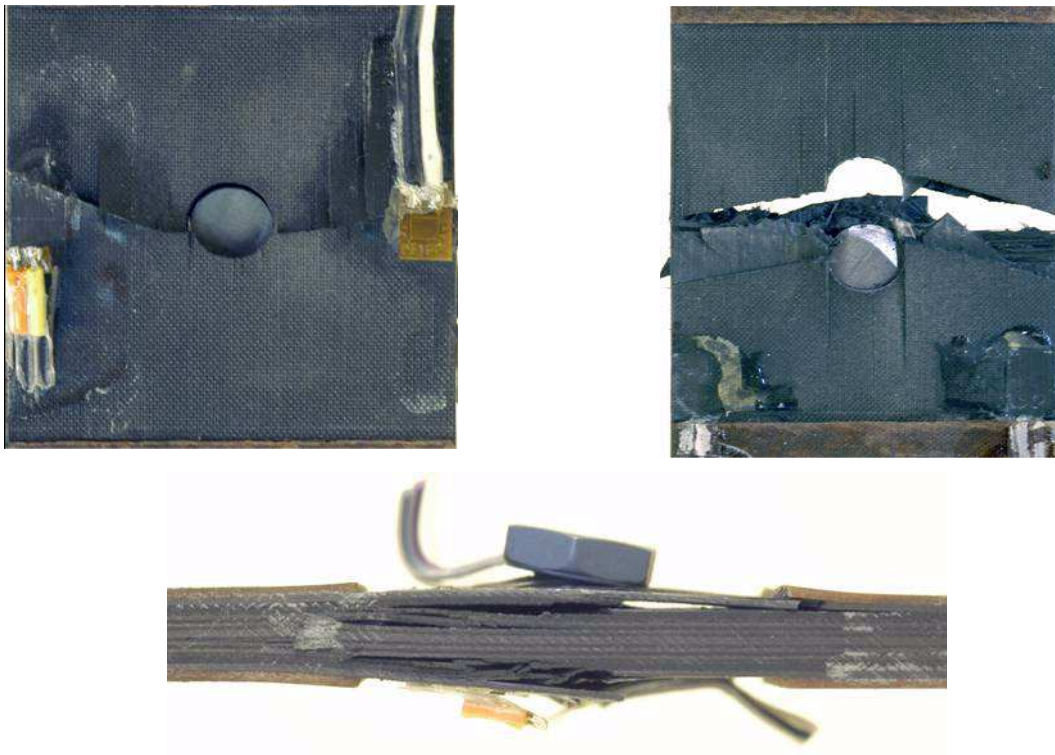
Figure N°8: Post-mortem failure patterns of [10/4/ 4/2] specimens with no lateral constraint.

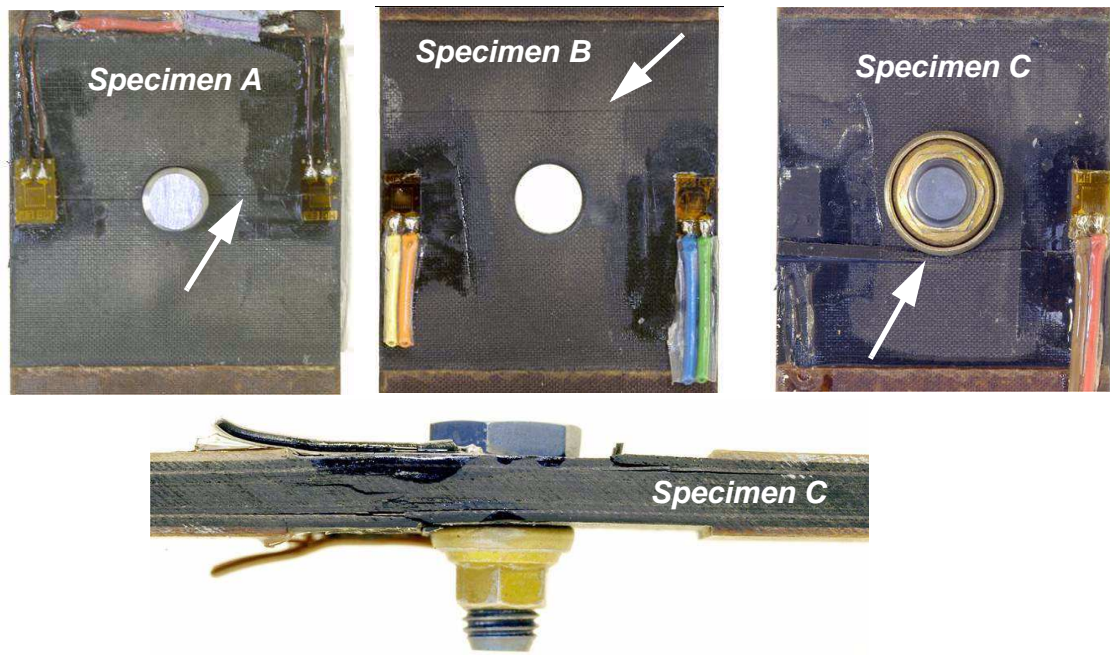
Figure N°9: Post-mortem failure patterns of [2/4/4/10] specimens A,B and C.

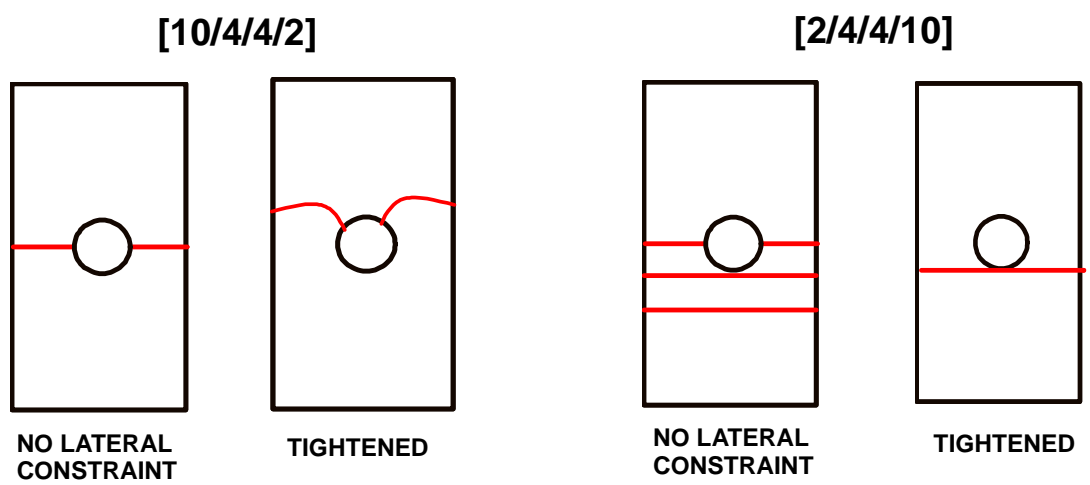
For specimens with no lateral constraint, the wave depends on the delamination which initiates randomly along the edge of the specimen. Thus the tip of the wave can be located anywhere, even in the net section as described Figure N° 10. So for this configuration, the off-set failures cannot be attributed to bearing by-pass failures, as in reference [2]. The off-set failures are due to a specimen effect. It is noticeable that the same scenario was identified for off-axis specimens. A delamination initiates in the edges of the specimens and a local buckling occurs afterwards generating off-axis and off-set fracture lines.

Figure N°10: Fracture line locations.

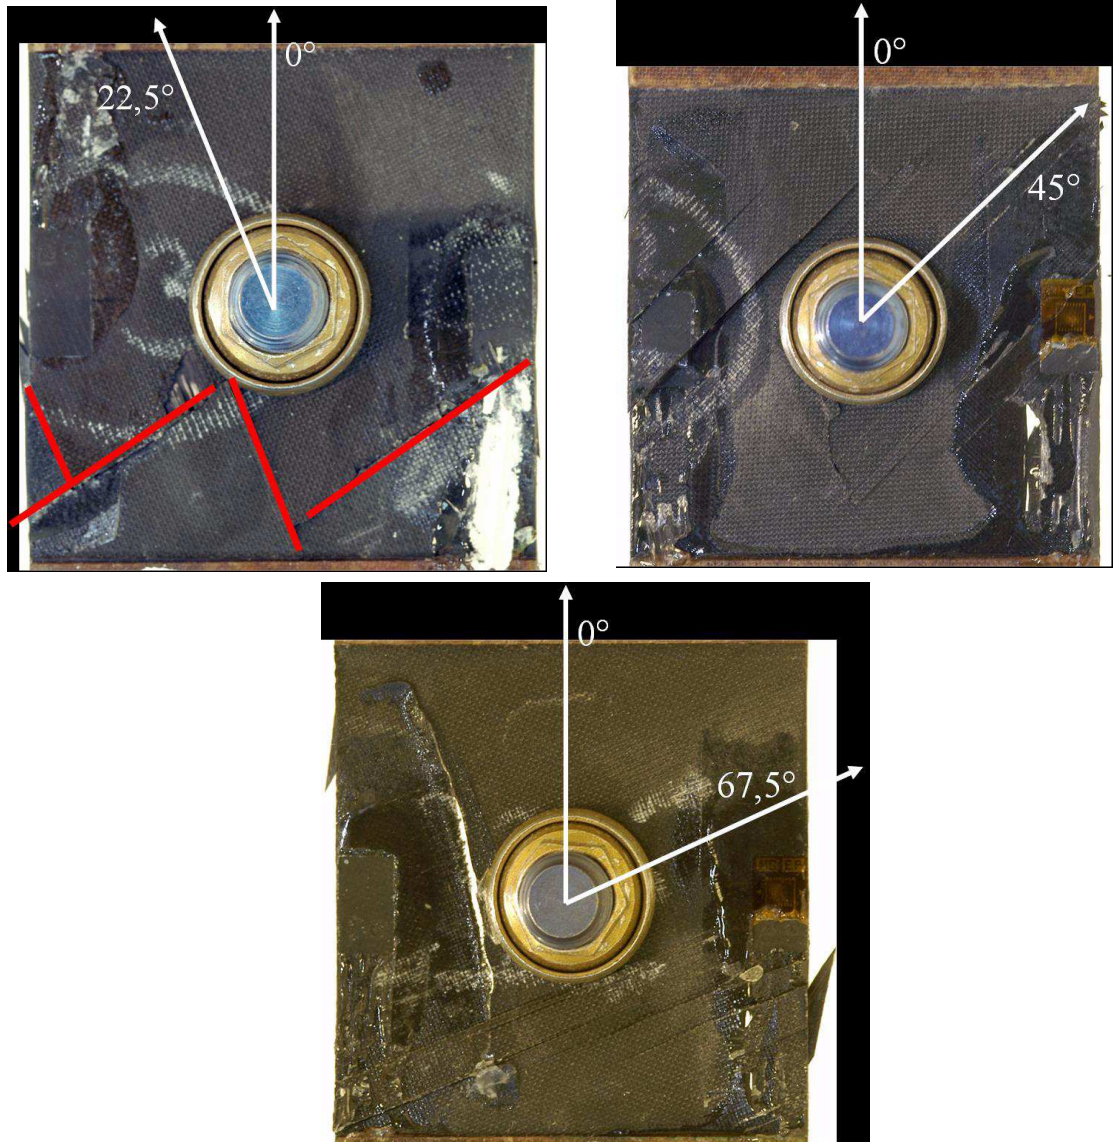
The failure patterns for the off-axis specimen are showed Figure N° 11. The fracture lines follow the main direction of the axis and are not located in the net section. For this original failure pattern, one can speak of "generalized off-set failure".

Figure N° 11: Failure pattern of off-axis specimens .

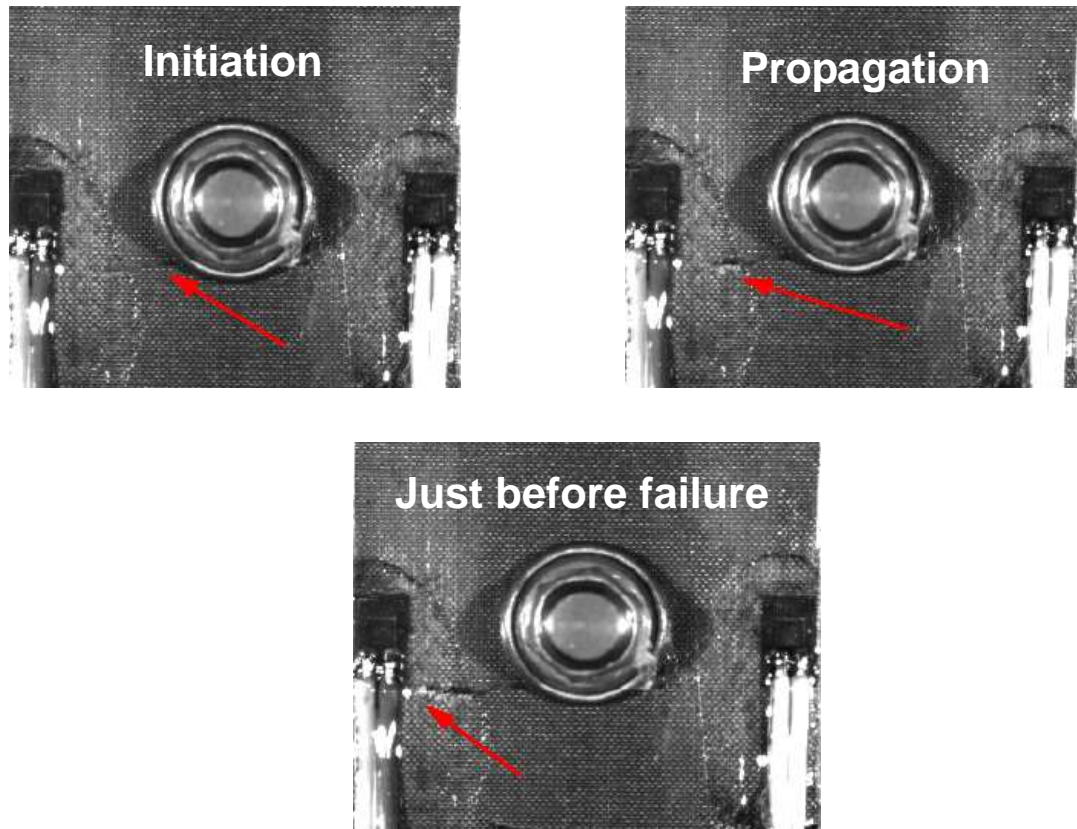
When tested, all the specimen failed in an explosive way and no difference could be visually observed. However, using high speed camera, different failure sequences and speeds were recorded: from 1/100<sup>th</sup> to 1/10000<sup>th</sup> second. The three pictures of Figure N° 12 show the failure sequence in a [10/4/4/2] specimen with a tightened bolt. The crack initiates at the periphery of the bolt for all the specimens with a little off-set from the net section. It then propagates relatively slowly (within several 1/1000<sup>th</sup> second) to the edge of the specimen.

Figure N°12: Failure of a [10/4/4/2] specimen with a tightened bolt.

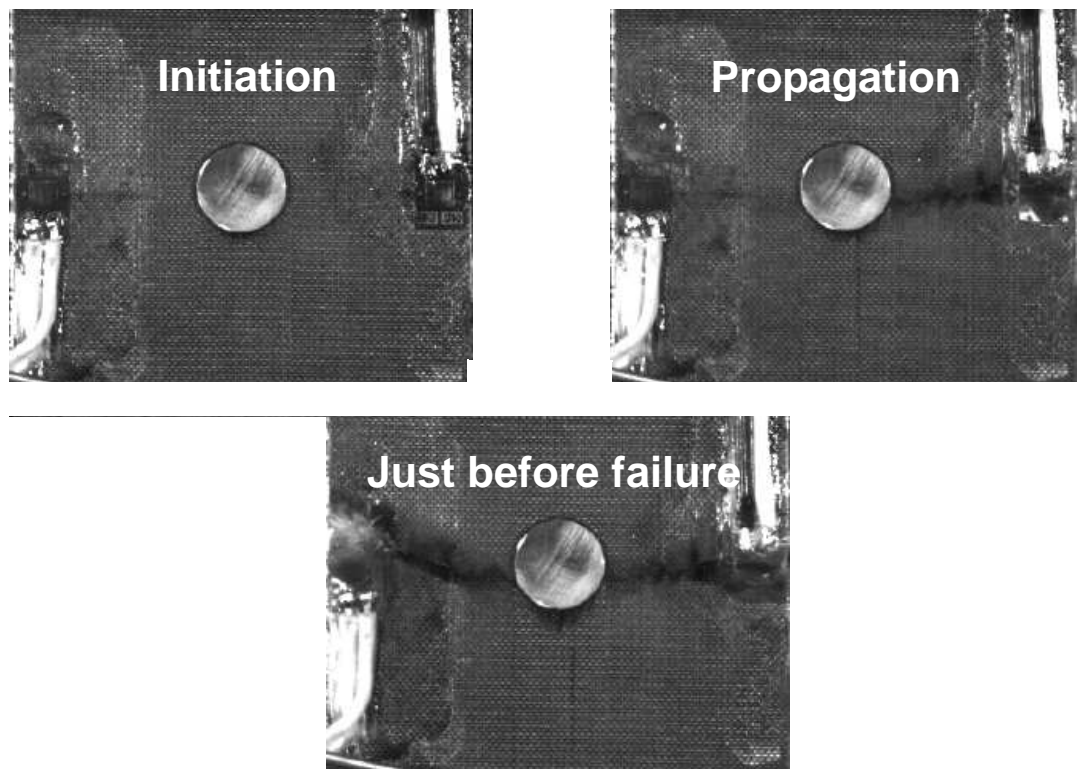
The three pictures of Figure N° 13 show the crack propagation of a [10/4/4/2] specimen with no lateral constraint. The crack initiates in the net section near the bolt and propagates in an explosive way. Therefore, the three pictures were taken every 1/10000<sup>th</sup> second. For both cases, the final failure mode is a static failure of the upper ply oriented at 0°. However, the presence of the nut has however an effect on the location of the initiation of the crack. As the failure seems to be a pure static failure, the bearing stresses and the delaminations may not have any influence. So the tightening modifies the local triaxial stress concentration and load transfer between the hole and the bolt and can explain the difference observed in the failure

Figure N°13: Failure of a [10/4/4/2] specimen with no lateral constraint.

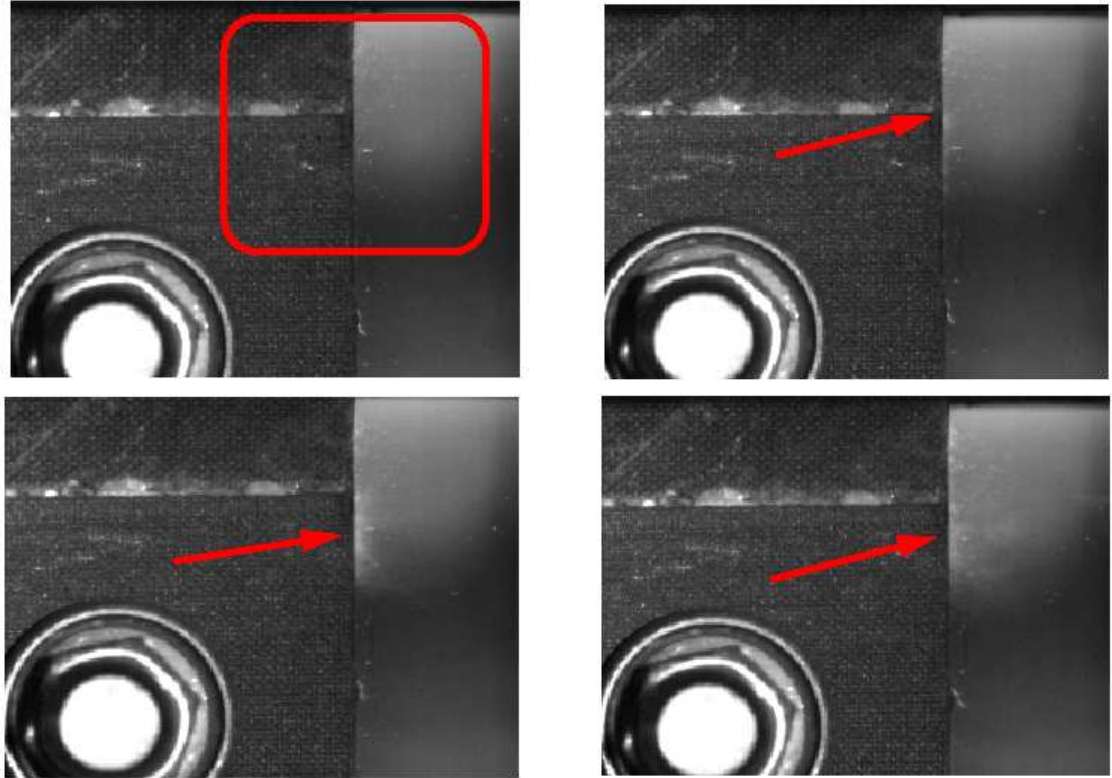
In the sequence of pictures given Figure N° 14, a phenomenon of material ejection is showed. It is localized in the edge of a [2/4/4/10] stacking specimen. This phenomenon was observed only for this stacking and for all the configuration of bolts. The four pictures were taken every 1/10000<sup>th</sup> second, so it is nearly explosive. Moreover, the location of the ejection was never in the net section. It occurs prior to any apparent damage and nothing was detected on the load/displacement curves. In order to identify the mechanisms, some mirrors were installed as described in paragraph 2 and Figure N° 5.

Figure N° 14: Material ejection phenomenon of [2/4/ 4/10] stacking specimen.

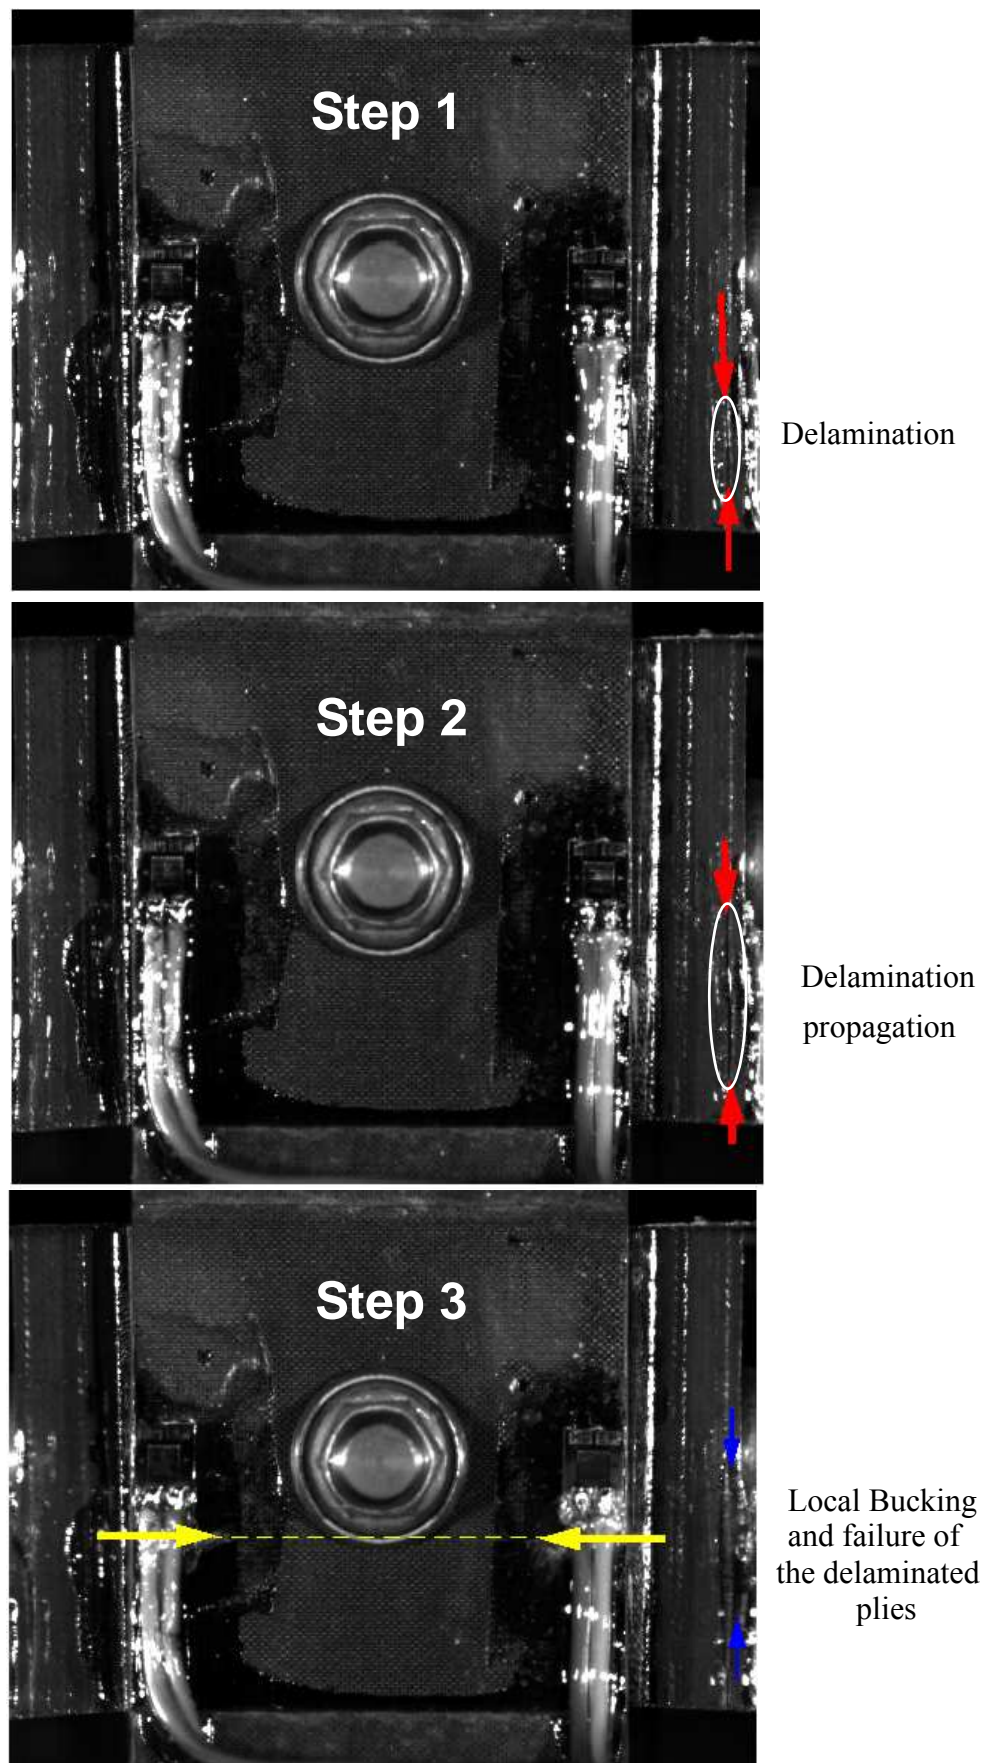
In the sequence of pictures given Figure N° 15, the failure scenario for [2/4/4/10] specimen is showed. Thanks to the mirror, the apparition of a delamination in the edge can be observed (Step 1). Clearly, interlaminar normal and shear stresses occurring in the region near the free edge due to high stress gradients can cause this delamination [18]. Moreover, this observation is consistent with the previous phenomenon of material ejection which seems to correspond to the onset of delamination (Figure N° 14). Afterwards, the delamination propagates relatively slowly (Step 2). The sequence takes about 1/100<sup>th</sup> second. When the delamination area is large enough, a local buckling of the upper plies occurs (Step 3), and a net failure at the tip of the wave happens immediately (Step 3). It is this fracture line which can be observed in the post-mortem pattern (Figure N° 9 and Figure N° 10). This scenario explains the fact that due to a tightened bolt, the buckling wave is always located at the same place. Thus, the stress concentration occurs at the periphery of the bolt and the fracture line initiates only at this place.

Figure N°15: Failure scenario for [2/4/4/10] stacking specimens.
