## Analysis of a J69-T-25 engine turbine blade fracture

Myounggu Park, Young-Ha Hwang, Yun-Seung Choi, Tae-Gu Kim

Myounggu Park, Young-Ha Hwang, Yun-Seung Choi, Tae-Gu Kim. Analysis of a J69-T-25 engine turbine blade fracture. Engineering Failure Analysis, 2002, 9, pp. 593-601. 10.1016/S1350-6307(02)00003-1. hal-01333729

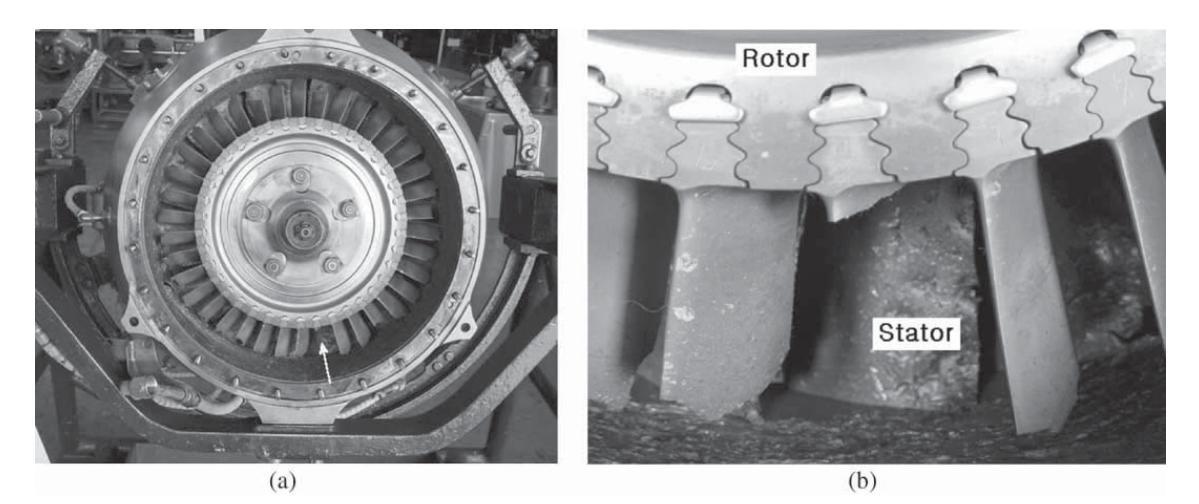
Fig. 1(a) is the rear view of the turbine section of the J69-T-25 engine. One of the 38 blades (see the arrow) separated without any preliminary symptoms and at the same time the fragment hit the other turbine blades, stator and casing. In Fig. 1(b) is the close-up view of the blade fracture site. It reveals that the turbine stator vanes and casing as well as the rotor assembly were badly damaged during the incident.

Fig. 1. The rear view of the turbine section of the J69-T-25 turbojet engine.

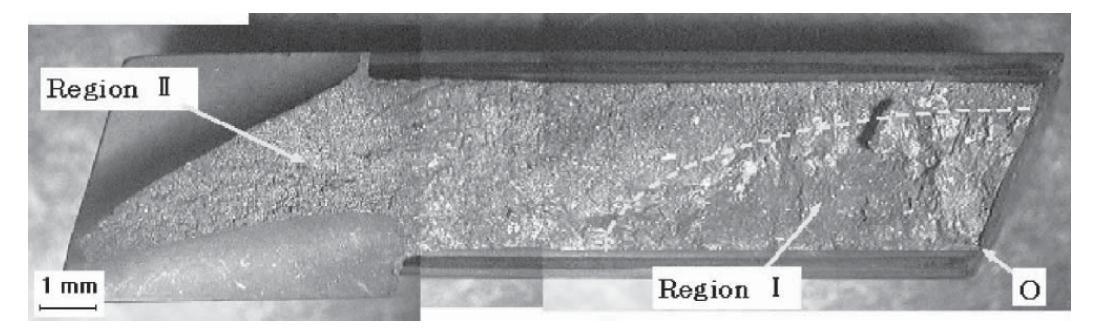
Fig. 2 is a magnified view of the fracture surface of the turbine blade root disassembled from the turbine rotor. Macroscopically there are two distinctive regions on the fracture surface. The region I is called the 'thumb nail' shaped region which is partially discolored. This region has a smooth and flat surface. The region II has a fresher and rougher fracture surface than that of region I. From the surface shape and condition it is thought that the crack origin is at the corner of the fracture region ['O' in Fig. 2(b)]. Fig. 3 indicates the front side of the turbine blade root. It is evident from the rubbing marks that the turbine blade was touched by other objects during revolution and that surface damage might act as a stress raiser for crack initiation. Fig. 4 shows the discolored pattern of the turbine blade. Especially, the discolored pattern on the root area reveals that hot gas flow was directed onto the turbine blade root area which was not a normal situation.

Fig. 2. The cracked and partially discolored turbine blade root  $(6\times)$ .

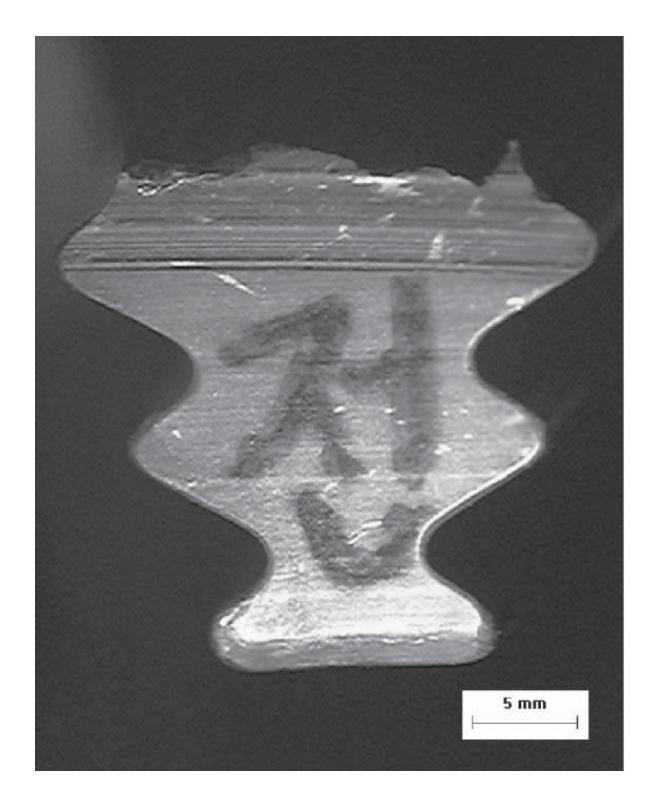
Fig. 3. The front side of the turbine blade root indicating the rubbing mark  $(3\times)$ .

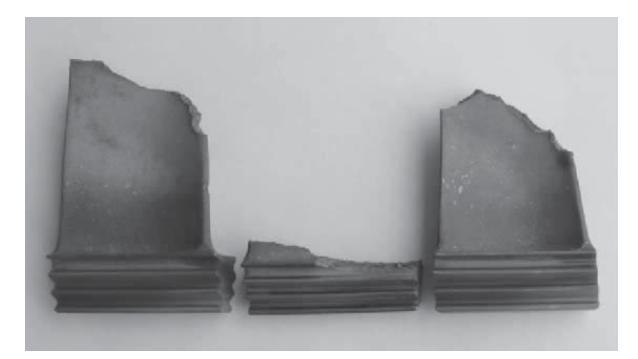
Fig. 4. Abnormal discoloration of the turbine blade root caused by heat damage.

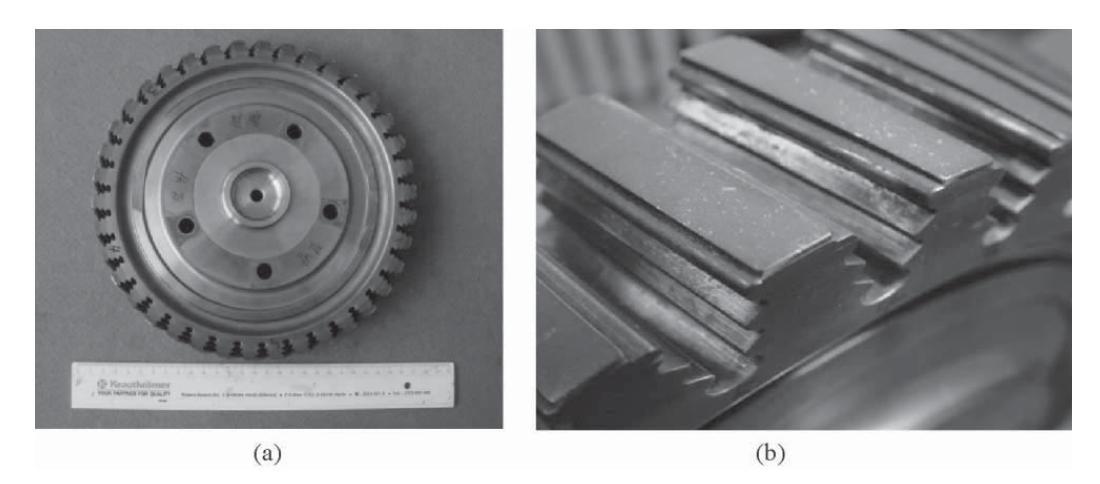
Fig 5.(a) is the hub disassembled from the turbine rotor assembly. The dovetail slots in the hub are severely discolored due to hot gas flow [Fig. 5(b)]. This means that the heated gas stream was not following the normal route, which might explain the heat damage on the slots. On the front side of the dovetail slot in the hub there was a rubbing mark and this observation is in agreement with the turbine blade root having a wear mark on the front side. Therefore, it is obvious that the turbine rotor assembly was touched by an object when it revolved at high speed (see Fig. 6).

Fig. 5. The hub disassembled from the turbine rotor assembly; (a) the overall view of the hub and (b) the discolored dovetail slots in the hub.

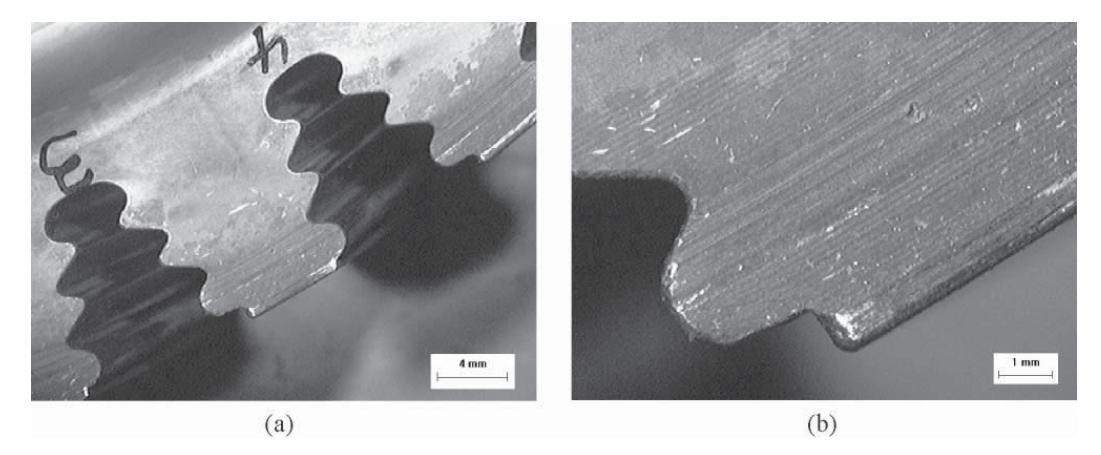
Fig. 6. (a) Wear marks on the front side of the dovetail in the hub and (b) enlarged view of Fig. 6(a).

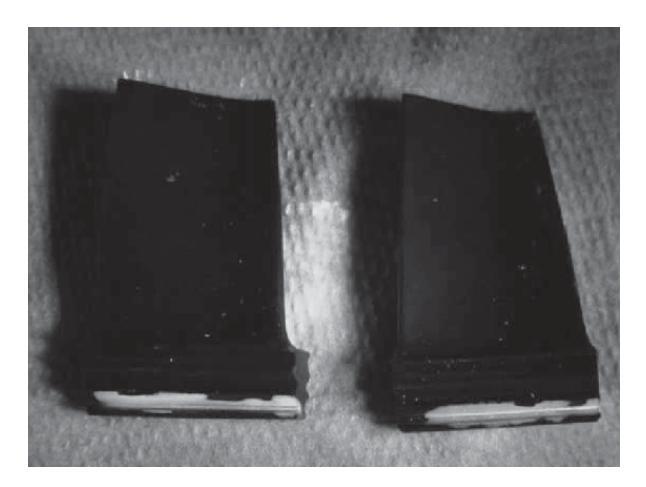
Careful observation using SEM (scanning electron microscopy) showed that most of the fracture surface was covered by corrosion products. So a partial crack which was not much affected by heated gas was chosen for fractographic analysis. This crack was found during FPI (fluorescent-penetration inspection) of the turbine blades. Fig. 7 is the fluorescent indication of a crack on the turbine blade root. Fig. 8 shows the optically observed partial crack. The crack was opened with care after cutting one side. Close observation of the fracture surface revealed striations. From these results it was confirmed that the fracture mode was fatigue [see Figs. 9(a) and (b) and 10(a) and (b)]. At the crack origin fatigue striations were not observed (covered by corrosion product). In the middle and edge regions of the fracture surface, the striation marks are evident and well observable.

Fig. 7. Indication of crack revealed during the FPI (fluorescent-penetration inspection).

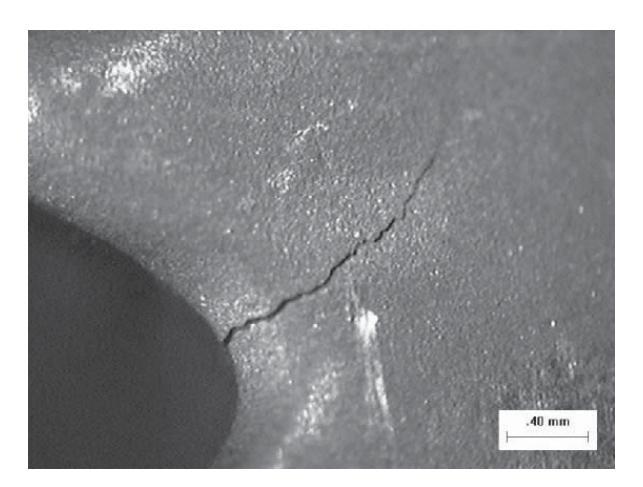
Fig. 8. Optically observed partial crack (40x).

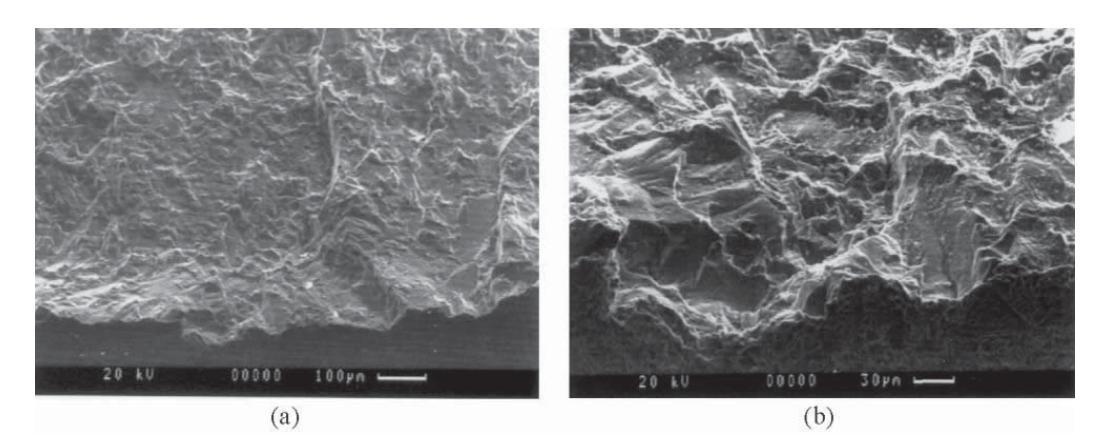
Fig. 9. Crack origin sites; (b) (300 x) is a magnified view of (a) (100 x).

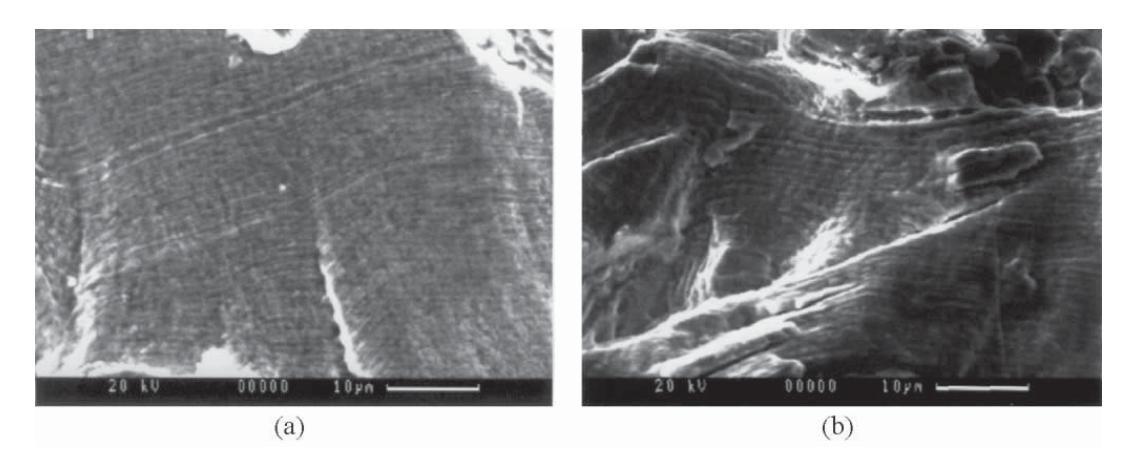
Fig. 10. Fatigue striations; (a) middle region of the fracture surface and (b) edge region of the fracture surface, both 5000 x.

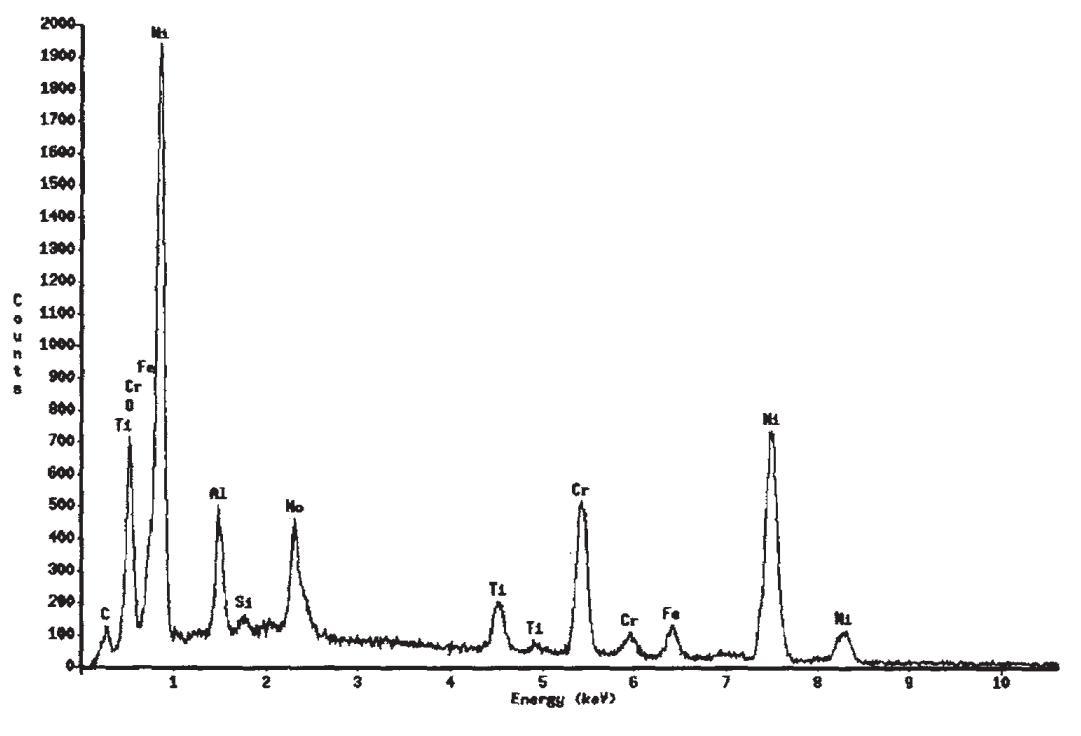
Ni-base superalloy. From the EDX spectrum (Fig. 11) the presence of Al and Ti which produce the gamma prime phase was confirmed. Longitudinal and transverse cross sections were prepared and examined revealing typical cast structure of Ni-base superalloy [Fig. 12(a) and (b)]. No signs of any microstructural anomalies were noticed.

Fig. 11. EDX spectrum of turbine blade.

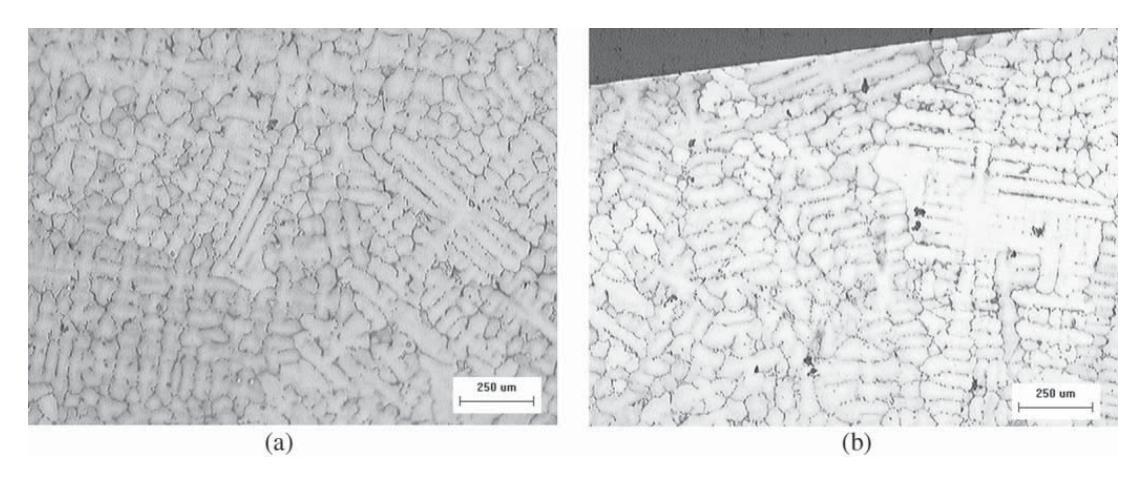
Fig. 12. Etched microstructure of the fractured turbine blade; (a) longitudinal cross section and (b) transverse cross section, both 100 x.

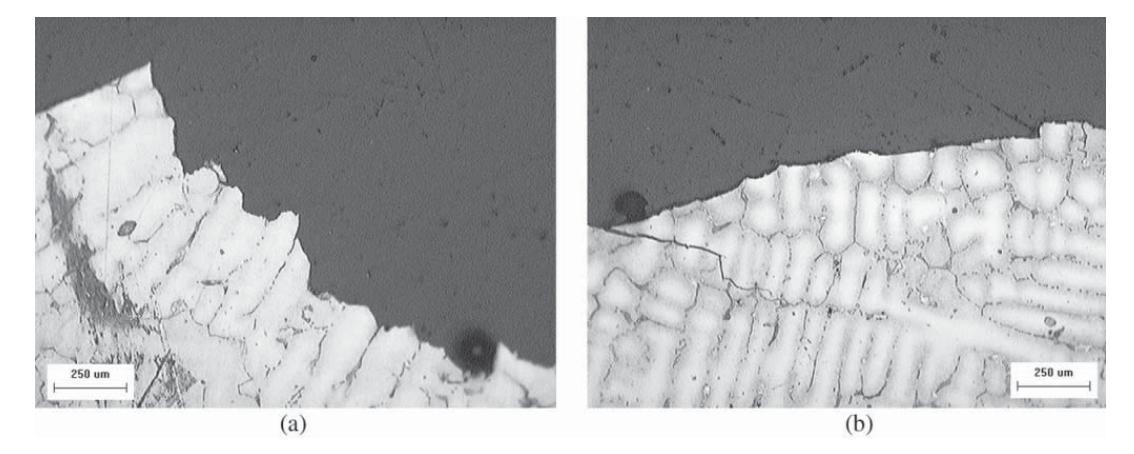
To analyze the cracking path a sample which included flat and rough surfaces was prepared. The sample also has a discolored region on its surface. From the microstructure, it is confirmed that the crack growth mode changed from transdentritic to interdendritic. Transdentritic crack growth indicates that cracking occurred by a fatigue mechanism and interdendritic crack growth by overload. Usually this cracking mode transition phenomenon is one of the typical features of casting fracture by a fatigue mechanism. Fig. 13(a) and (b) shows the cracking path from the origin of the crack to the end of the crack area.

Fig. 13. Cracking path transition; (a) transdendritic; fracture mode is fatigue and (b) interdendritic; fracture mode is overload, both 200x.

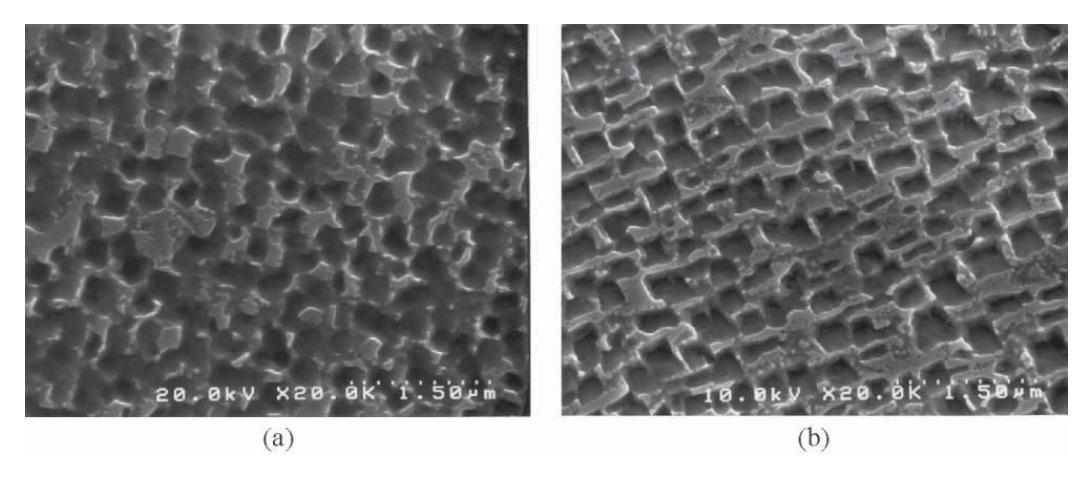
is stable over a relatively narrow range of composition. It is precipitated as spheroidal particles in the early Ni-base alloys, which tended to have a low volume fraction of particles. Later, cuboidal precipitates were noted in alloys with higher aluminium and titanium contents. The examination of the gamma prime of the fractured turbine blade was done using FE–SEM (field emission scanning electron microscope). Fig. 14(a) is the morphology of  $\gamma'$  which is directly affected by heated gas and its shape is not in order. However, as shown in Fig. 14(b) the morphology of  $\gamma'$  which is not touched by hot gas is square and in good order. So it can be guessed that the subsurface region affected by hot gas began to coarsen. Thus, though the fatigue crack initiated by surface damage, the heat damage might have had a contributing effect on the fracture of the turbine blade.

Fig. 14. The morphology of  $\gamma'$  phase; (a) the subsurface region of the fracture surface affected by heated gas flow and (b) the region without heated gas flow, both 20, 000x.

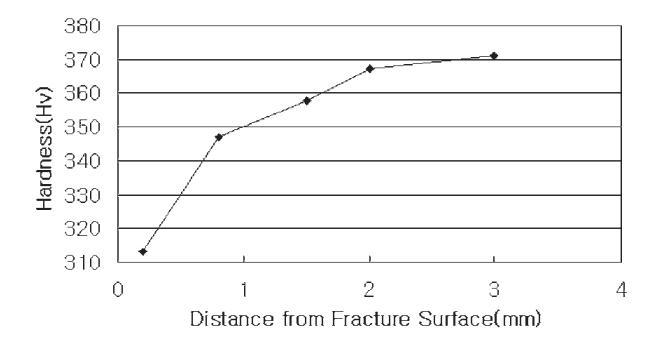
Microhardness measurements were taken on the longitudinal cross section including the fracture surface at a load of 1 kg. The measured microhardness values were converted into Vicker's hardness number and the results are shown in Fig. 15. The subsurface which showed degraded gamma prime had the lowest value and the hardness number increased gradually away from the subsurface. This tendency correlates with  $\gamma'$  phase examination results.

Fig. 15. Hardness test results of the fractured turbine blade.
