REHEAT CRACKING STUDIES BY SCANNING AUGER AND ELECTRON MICROSCOPY INVESTIGATIONS

H. Horn, M. Weiss

H. Horn, M. Weiss. REHEAT CRACKING STUDIES BY SCANNING AUGER AND ELECTRON MICROSCOPY INVESTIGATIONS. Journal de Physique Colloques, 1984, 45 (C2), pp.C2-357-C2-360. 10.1051/jphyscol:1984281 . jpa-00223995

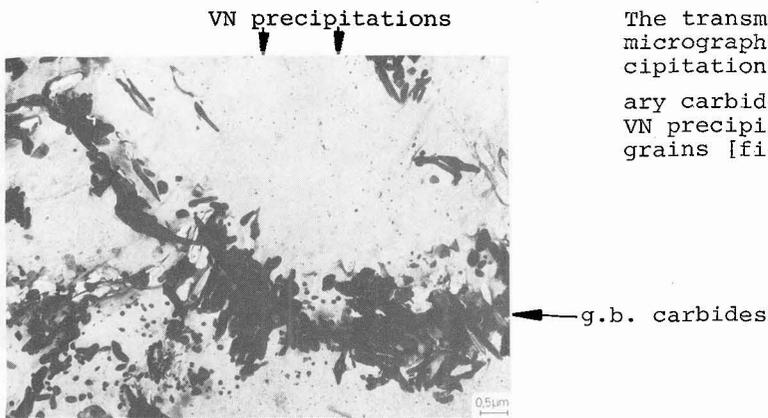
Fig. 6

The transmission electron micrograph shows the precipitation of $M_{23}C_6$ boundary carbides and the fine VN precipitations in the grains [fig. 6].

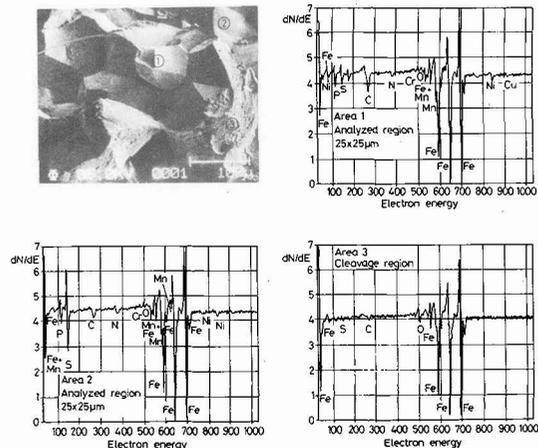
Fig. 7: Auger-Spectrum Steel B

Steel B: In this steel sulphur, phosphorous, nitrogen and manganese are detected along the grain boundaries at a fairly high level [fig.7].

If we convert the peak to height ratio to at.pct. values, in these samples, we find a sulphur to manganese ratio of 2:1. This is greater than the 1:1 ratio in MnS. In steels manganese is very difficult to detect because its Auger peaks overlap those of Fe. In this case we cannot decide whether sulphur segregates without manganese. The Auger map of P and S shows that both impurity elements are enriched on the prior austenite grain boundaries [fig. 8]. It is probable that the grain boundaries contain Sulphur in precipitated (MnS) as well as in an unprecipitated form.

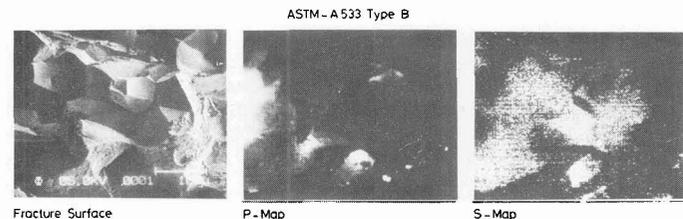
Fig. 8: P and S-Map from the fracture surface

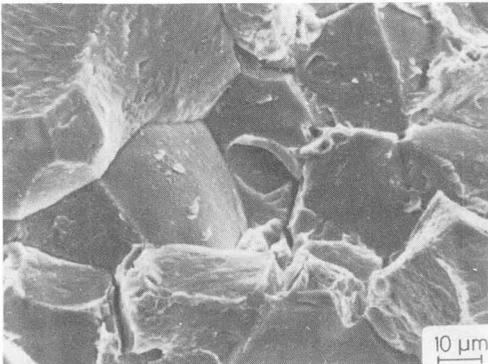
The fracture morphology shows that the samples were predominately fractured along the prior austenite boundaries. We find fracture surfaces with smooth grain boundaries and g.b. with voids associated with MnS precipitations [fig. 9 a, b].

Fig. 9a: Smooth g.b.'s Steel B

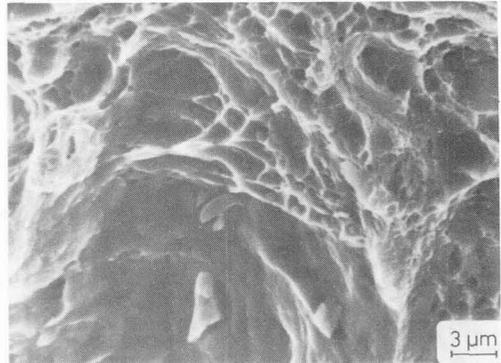
Fig. 9 b: Voids with MnS Steel B

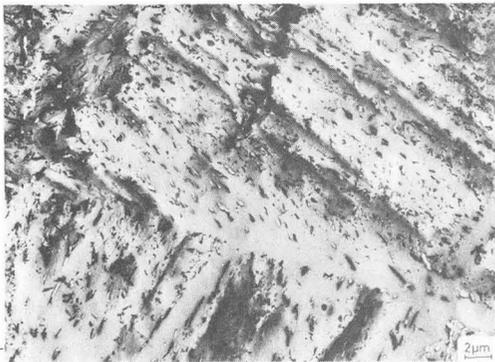
Fig. 10: TEM of the carbide precipitations Steel B

By means of transmission electron microscopy we identified M_3C , M_7C and Mo_2C precipitations mostly in the grains. Often the boundaries are free of precipitation [fig. 10].
