# PHOTOGRAMMETRY FOR THE PREPARATION OF ARCHAEOLOGICAL EXCAVATION. A 3D RESTITUTION ACCORDING TO MODERN AND ARCHIVE IMAGES OF BEAUFORT CASTLE LANDSCAPE (LEBANON)

Pierre Grussenmeyer<sup>a</sup>, Jean Yasmine<sup>b</sup>

**CIPA Special Session**  
**Low Cost Systems in Recording and Managing the Cultural Heritage**

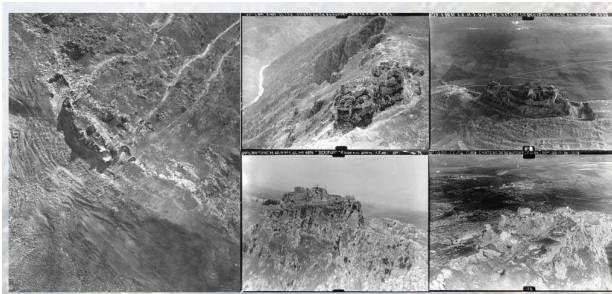
**1930-1936:** Archive images of the French Air Force of the Levant (aerial large format images)

Several archive images of the castle were taken by the French army between the years 1935 and 1937 (vertical and oblique overall views on glass plates). The aim of the project is to use this archive documentation in order to make a 3D restitution of the destroyed and buried historical structures of the castle within a photogrammetric project including both modern and archive images. A comparative restitution makes it possible to locate in a precise way the visible archaeological structures on the archive photographs. The contractor who will be in charge of the restoration will then have all information to release the great quantity of fill around the castle, in order to preserve intact the historical and archaeological structures which would be still *in-situ* below the embankment. The restitution will help the consultant to establish the framework of the excavation and restoration tasks, by showing the destroyed historical structures.

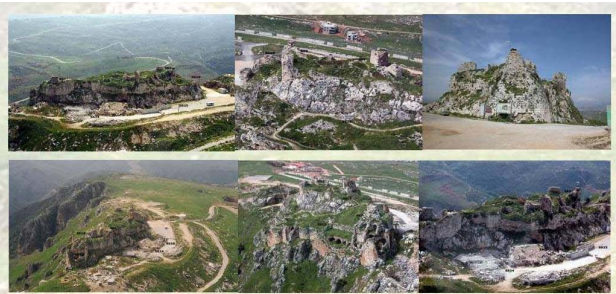
**2003:** Modern digital images (aerial and terrestrial small format images)

In 2002, the castle has been surveyed by geodetic methods (GPS and total station techniques) to establish reference points and a revised map of the area. In 2003, J. Yasmine has completed the survey by aerial oblique images taken by helicopter and terrestrial images, following the recommendations of CIPA 3x3 rules. After the calibration of the different cameras, the block of images has been computed within the PhotoModeler<sup>TM</sup> package, in order to document and draw the parts difficult to reach by traditional topographic techniques and to check the homogeneity of this important historic building (approx. surface of 150m x 75m, height of 30m).

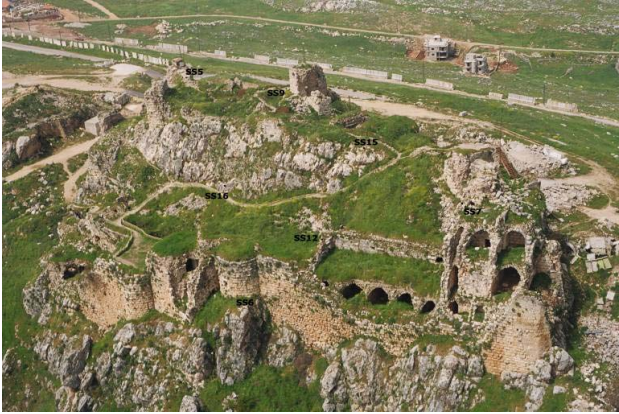
Figure 1. Recent aerial view of the Beaufort castle (Nikon F3, 2003)

After the end of the war, access to the castle became secure. There was a need to manage to realize a complete documentation of the unreachable parts of the castle (basically the eastern elevation over the valley). That's why a helicopter flight was scheduled in 2003. Aerial oblique views were taken (figure 1) in that flight. They were composed of digital images (Nikon Coolpix 5000, 2560x1920 pixels) and film-based small format color slides (Nikon F3, Nikkor lenses, 55 mm, scanned at a resolution of 3000x2000 pixels). Last but not least, a complete documentation requested terrestrial views of the castle; digital images and again film-based small format color slides were taken (figure 5). Thanks to this exhaustive documentation, three-dimensional restitution was possible. All the modern documentation was produced in one day.

- images taken with a traditional reflex camera Nikon F3, equipped with a Nikkor 55mm objective. The calibration was carried out like previously after scanning the slides of the calibration grid;

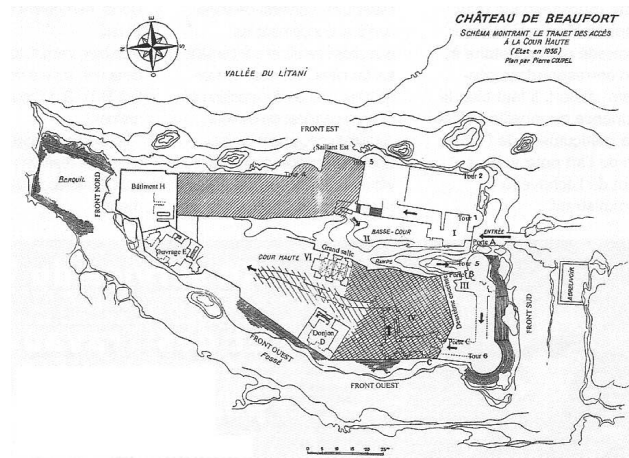
Figure 2. Map of Pierre Coupel (Architect) drawn up during the Deschamps survey (1936)

by the architect Pierre Coupel showing the means of access to upper courtyard of the castle (figure 2). After the independence of Lebanon in 1943, extensive works began.

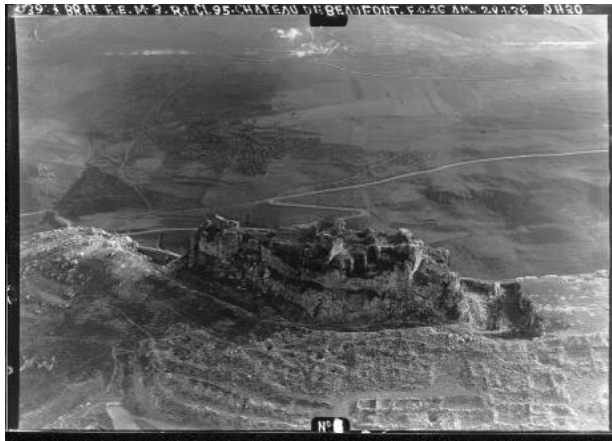
Figure 3. Example of archive photo of 1936 (IFPO), showing in the foreground the archeological hidden remains

**b- Serie 2:** These are photos still existing in the *Institut Français du Proche-Orient* (IFPO) archives (figure 3). All these photos were taken by the French air force of the *Levant* between the years 1930 and 1936. We were able to get duplicates (contact prints) of negatives at a size of 13cm x 18cm, scanned on a desktop scanner.

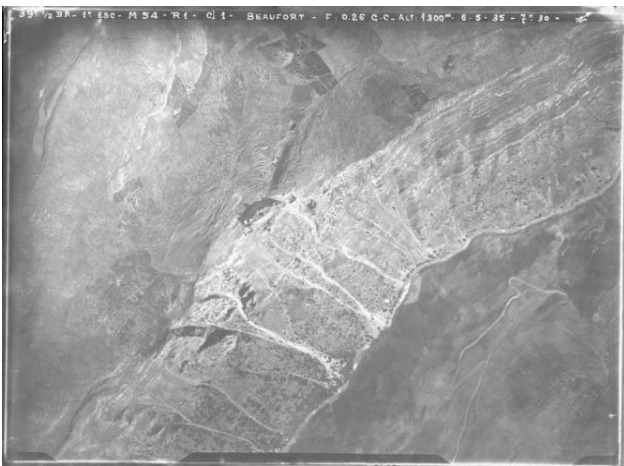
Figure 4. Example of archive photo of 1935 (DGA, area of Beaufort's castle), showing the castle (in the middle) and the landscape (focal length 26cm, flying height 1300m above ground, 2000m above sea level)

**c- Serie 3:** These are photos existing in the archives of the DGA. All these photos were taken by the French air force of the *Levant* between the years 1931 and 1936. They are vertical views (figure 4). Only contact prints at a size of 13cm x 18cm are available; the original negatives were not found. Those contact prints were scanned.

- images (prints or copies of film, see paragraph 3.1) of 1930-1936 scanned with a resolution of 900dpi: unfortunately no photogrammetric information on the characteristics of the cameras used has been found. Several types of glass-plates-based cameras with focal distances of 20 to 30cm were used at that time for the acquisition of aerial and terrestrial views (Roussilhe, 1936). The focal length of the camera used for this archive images is written on the border of the image (26 cm) and the original size of the images (glass plates in the 1930's) was supposed to be 24 cm x 18 cm.

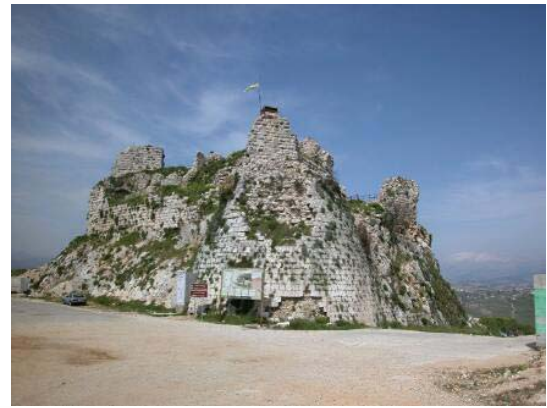
Figure 5. Recent terrestrial digital image (modern documentation, Nikon Coolpix 5000, 2003)

- images from a Nikon Coolpix 5000 camera used in the extreme positions of the zoom (7mm and 21mm). This camera was calibrated in the two positions using the calibration grid proposed in the PhotoModeler software (module "camera calibration");

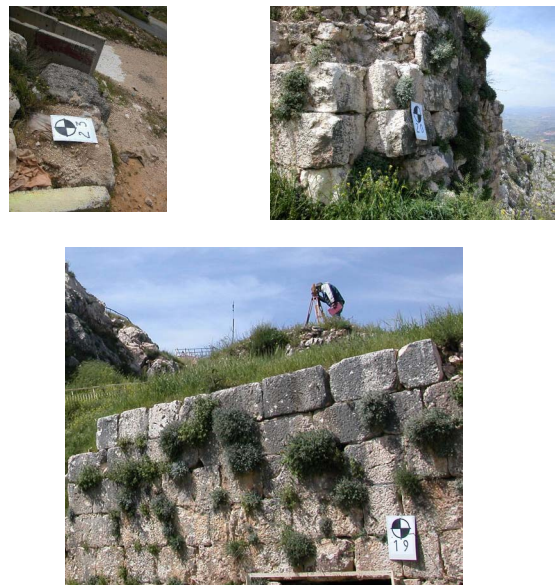
Figure 6. Examples of targets used for the control points

On that same day, while photos were being taken, a team of geodetic surveyors installed reference points on the ground and elevations of the castle. These points (figure 6) were easy to identify on the photos. A total-station was used by the surveyors to measure the reference points. This generated three-dimensional coordinates for these points.

More than 130 images were realized in spring 2003 with the Nikon F3 and Nikon Coolpix cameras (a hundred images on the ground and about thirty in the helicopter). A first block of 18 oblique views of the castle was oriented in June 2003 using the control points materialized on the ground by targets (figure 6). Standard deviations of about 10 cm on the co-ordinates of the points measured on the images have been obtained. We then selected in this project a set of points simultaneously visible on the images of 1931-1936, in order to define approximations of the photogrammetric parameters, and to calculate a block based on a selection of these archive images.

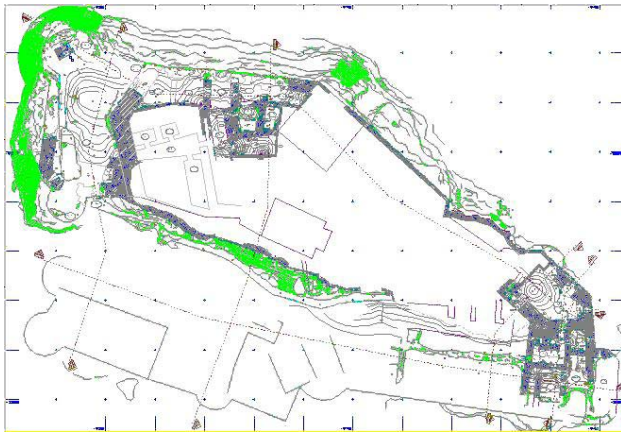
Figure 7. Example of 2D AutoCAD map from the tacheometric survey of 2002 (level 4 of the castle).

The first topographic surveys conducted during the preliminary study were not very accurate due to the difficulties encountered in trying to access some of the areas of the castle. These first surveys were performed using GPS and tacheometric techniques. The AutoCAD maps (figures 7 and 8) used to establish the tender documents for the restoration of the castle were based on these surveys. The inaccuracies of these surveys did not represent a major problem for the restoration of the visible areas of the castle. However, these inaccuracies prevented us from computing the exact position of the archaeological hidden remains. We plan to generate a new AutoCAD documentation showing the surroundings of the castle and the archaeological hidden remains that should be dug out (§5).

From the block of images previously oriented, the restitution initially carried out in 2D in Autocad (e.g. fig. 7 and 8) will be enriched by a 3D restitution corresponding to the objectives of the documentation. We are then able to calculate and draw the visible structures from the aerial and terrestrial photographs of 2003 by digitalizing on the images. One will proceed in an identical way on the archive photographs to measure the archaeological structures currently covered by the remains of the war currently embanked or destroyed (fig. 10), or to plot in 3D parts of the castle (see §6).

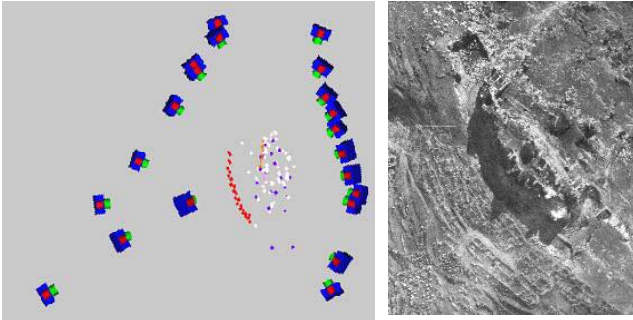
Figure 9. Overview of the camera stations and the block configuration after the exterior orientation. At the right: a vertical view of 1935 allowing the location of the camera stations.

At this stage, the two separately calculated projects are referred to the same reference system. The process of merging (of several projects) proposed in the PhotoModeler software allows

the restitution of three-dimensional elements simultaneously on the photographs of 1936 and 2003, and to superimpose and display these results within a unique project.

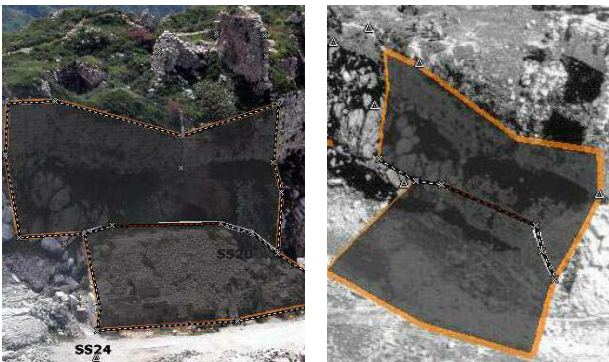
Figure 10. Restitution of the embankment areas: on the left, the boundary of the embankment is marked on a photo of 2003 and on the right, the corresponding surface is projected on an archive photo of 1936

The superposition of the two restitutions makes it possible to highlight the areas of interest (figures 10 and 11) for archaeological work and to estimate work of civil engineering (fill, cubature, rebuilding, etc).

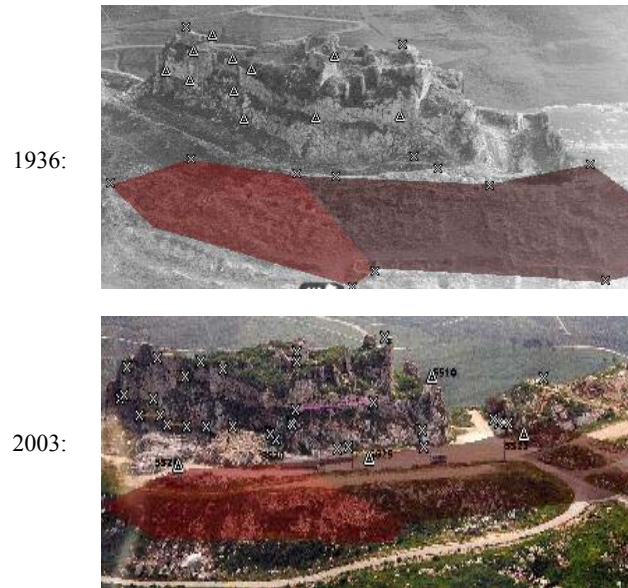
Figure 11. Archaeological structures are measured on the archive images of 1936 and the corresponding surface is shown on the photos of 2003

either from the images of 1936, or of those of 2003. From the resulting 3D photomodels, orthophotos can be calculated for the two periods, as e.g. for the frontages of the castle or the installations around the site covering the archaeological structures (fig. 11).

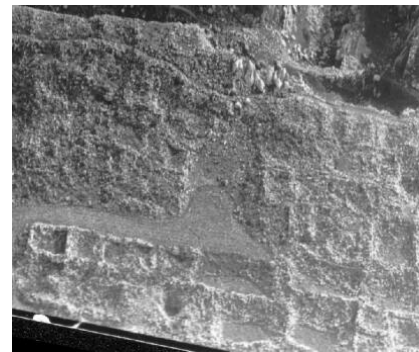
Figure 12. Example of orthophoto of the archaeological structure (computed from an archive image of 1936).

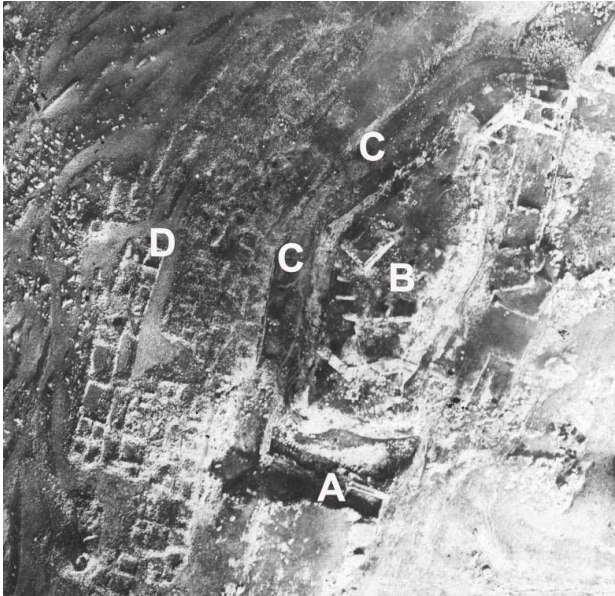
Figure 13. Vertical archive view showing some studied parts

The study is currently focused on different parts of the castle (figure 13). For some of them (as courses of bricks or stoneworks "label B"), a 3D restitution of both archive and recent images is possible.

Parts recovered by embankment are modelled from only archive images (watering place "label A", counterscarp "label C" and archaeological remains on the western part of the castle "label D").

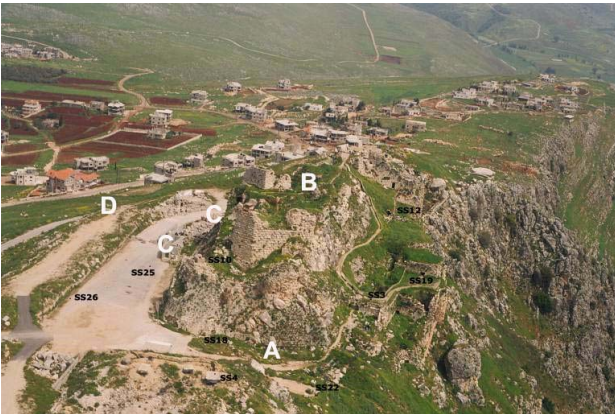
Figure 14. Recent image showing the surroundings of the castle and the current constructions
