MASONRY WALLS SUBMITTED TO OUT-OF-PLANE LOADING: EXPERIMENTAL AND NUMERICAL STUDY

ABSTRACT:

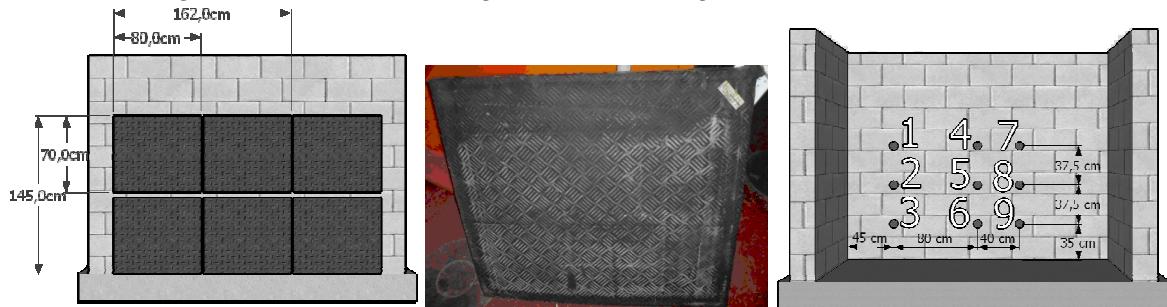
Figure 3. Water-bags on the north side and transducers positioned on the south side of the wall.

The out-of-plane displacement of the structure was measured using linear variable differential transducers (LVDT). Nine transducers were placed on the main unreinforced wall; three transducers were used to measure the displacement of the foundation. A calibrated pressure transducer was used to control and measure the applied water pressure. The positions of the transducers for each wall are indicated in Figure 3.

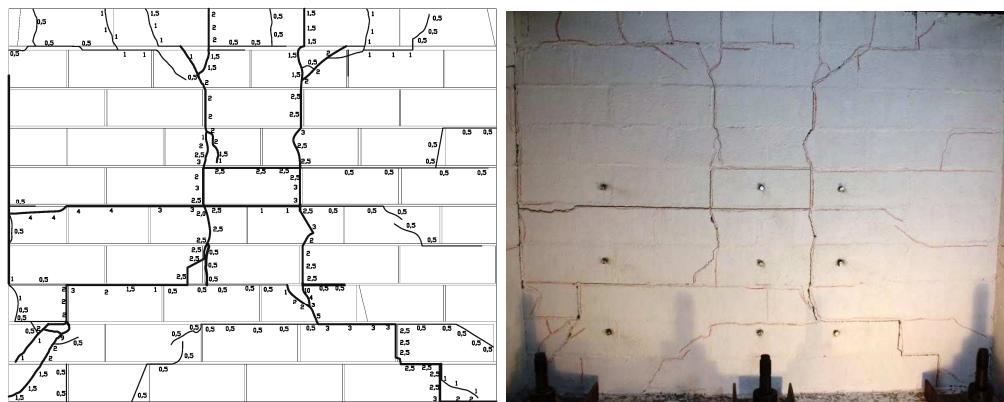
Figure 9. Wall 2- Failure modes of the principal wall

In the case of the two unreinforced walls, two types of cracks were observed on the main wall (Figure 8 and Figure 9): first of all the vertical cracks which are characteristic of the bending loading. These cracks appeared near the centre of the wall, more or less at the midline in the upper part of the wall, which is unsupported. The second type of diagonal cracks formed in the lower part running from each corner. These crack patterns are similar to those predicted by the yield line theory adapted from that for reinforced concrete slabs.
