Structural Health Monitoring of a Smart Composite Bridge Using Guided Waves and Acoustic Emission Techniques

STRUCTURAL HEALTH MONITORING OF A SMART COMPOSITE BRIDGE USING GUIDED WAVES AND ACOUSTIC EMISSION TECHNIQUES

This paper is dealing with the development of a structural health monitoring (SHM) system implemented on a composite footbridge during the regional project "Pays de la Loire" called DECID2. The SHM system was made out of complementary techniques: strain sensors based on optical fibers (out of concern in this present work) and ultrasonic techniques that are presented in this document. Due to the huge size of the composite bridge (20 m * 3 m), only its most critical areas are monitored as the assembling parts and the most solicited areas. To access the structural integrity of the footbridge, two complementary monitoring strategies were presented in this paper:

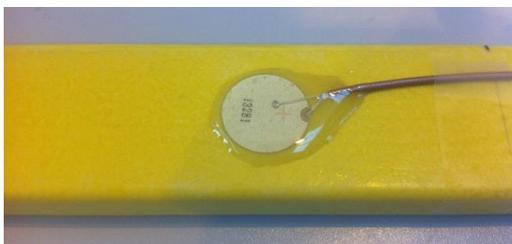
Both of these SHM systems use the same miniature ultrasonic patches that are used alternately as acoustic emission sensors and as ultrasonic guided waves actuators. The first step of this work was to develop these miniaturized ultrasonic patches. The ultrasonic sensor which was chosen for this work is a piezoelectric thin disc with 200 µm thickness and 20 mm diameter. It was coated with two electrodes to get ease of welding to the upper surface. This patch is directly bonded to the pultruded surface with environment-resistant glue. The glue has been tested previously in immersion test for one month at 40°C and showed good aging resistance in terms of mechanical strength and acoustic coupling. The connector includes a coaxial environment resistant “BNC cable” welded directly to the patch upper surface. To protect patch and welds, two different coating are used: an epoxy resin

for the mechanical protection and polyurethane clear coats to ensure UV and water resistance. Patches (Figure 2) qualification required several tests to evaluate its resistance to hygro-thermal aging, sensitivity and durability.

Figure 2: Miniature ultrasonic patches

Sensitivity are evaluated with Hsu-Nielsen source (leads break 2H03) at 5 cm distance from patches (after coating). Amplitude measured is about 72 dBae which is less than value obtained for standard AE sensors (90 dBae). Patch sensors background noise are also compared to standard sensors and was evaluated to 10 dBae in the case of both sensors. Through the measurements of these two parameters, it was concluded that these patches can be used as acoustic emission sensors although they are less sensitive to damage detection than their conventional counterparts. It will remain thereafter to determine the level of sensitivity of these patches to damage detection in pultruded profiles which will allow the deduction of their spacing in the final structure.

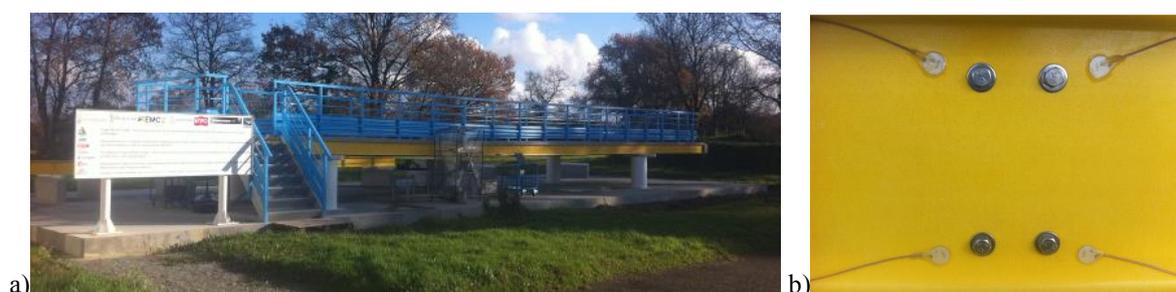
Finally, two composite footbridges were built at the EMC2 Technocampus and IFSTTAR in France to serve as demonstrators (Figure 10). They are made from pultruded composite (glass fiber/vinylester) that are provided with a structural health system in the form of embedded optical fibers and miniaturized ultrasonic sensors glued to the bars. Both active (guided waves) and passive (acoustic emission) structural health monitoring systems were installed. Active method can detect the resin stiffness degradation using guided wave and passive method (acoustic emission) can detect and locate fibres breaks. In this work, miniaturized ultrasonic sensors are developed and validated by various environmental and mechanical tests. Their ability to detect fibres breaks was

demonstrated despite a low sensitivity compared to standard AE sensors. Model prediction of A_0 mode sensitivity to resin stiffness loss was validated by quantitative mechanical experiments at various temperatures. Sensors are installed at critical areas, namely the highest bend area and near bolts. The acoustic emission monitoring system is remotely controlled via an internet connection and configured to warn the supervisor by email-sending once an active damage is detected. The real time detection and location of the degradation provides safety of installation and users and will avoid catastrophic failure.

Figure 10: a) Demonstrator composite Footbridge; b) Miniatures sensors for bolt assembly monitoring.
