Using STED and ELSM confocal microscopy for a better knowledge of fused silica polished glass interface

Rodolphe Catrin,¹ Jérôme Neauport,^{1,*} Philippe Legros,^{2,3,4} Daniel Taroux,¹
Thomas Corbineau,¹ Philippe Cormont,¹ and Cédric Maunier¹

Abstract: Characteristics and nature of close surface defects existing in fused silica polished optical surfaces were explored. Samples were deliberately scratched using a modified polishing process in presence of different fluorescent dyes. Various techniques including Epi-fluorescence Laser Scanning Mode (ELSM) or STimulated Emission Depletion (STED) confocal microscopy were used to measure and quantify scratches that are sometimes embedded under the polished layer. We show using a non-destructive technique that depth of the modified region extends far below the surface. Moreover cracks of 120 nm width can be present ten micrometers below the surface.

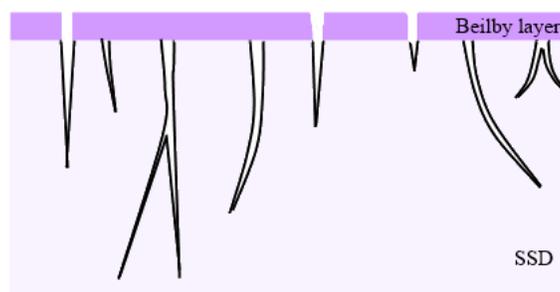
Fig. 1. Schematic structure of the fused silica interface after polishing.

Both SSD and process induce contamination can lead to laser damage at 351 nm. High concentration of ceria in the polished layer induces gray haze *e.g.* during damage testing [4, 5]. Damage density can thus be linked to pollutant concentration for high degrees of pollution [6]. As depicted in Fig. 1, residual SSD can also lead to laser damage [7, 8].

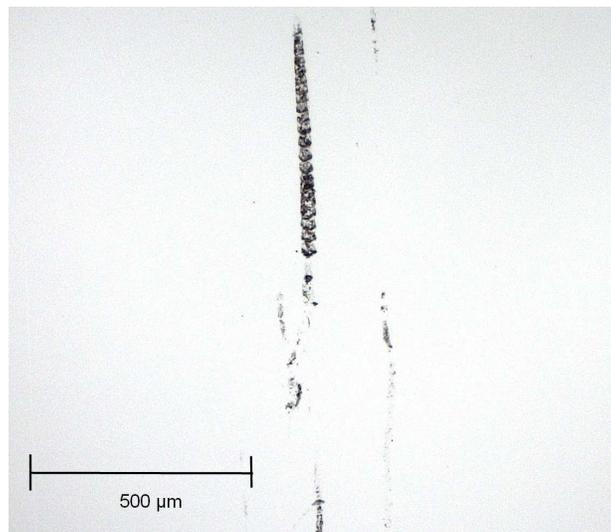
Typical scratches created by this process are shown on Fig. 3. Image was obtained using a bright field microscope in dark interference contrast mode and a 20x objective. Conchoidal shape, trailing indent fractures are created with morphology similar to polishing process induced scratches [13].

Fig. 3. Typical scratch created by the scratching process.

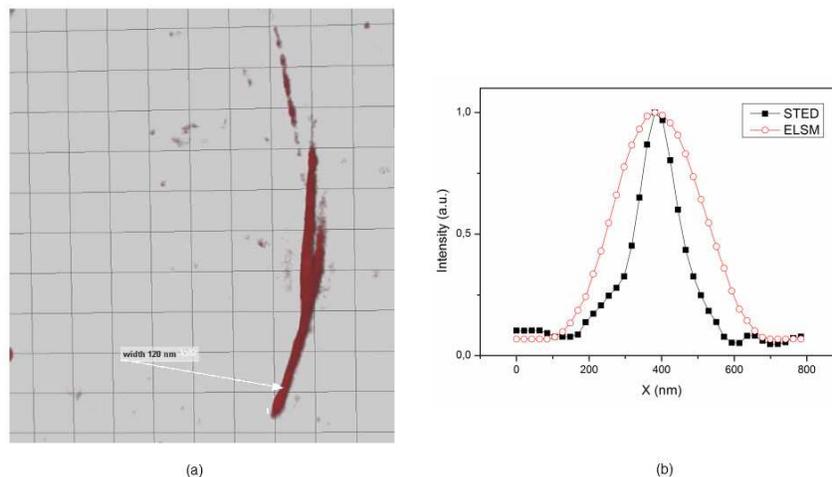
We also used STED stacks of different subsurface fractures to estimate crack width below the surface. An example is given on a single fracture extending about 2.5 μm below the surface and presented in Fig. 11 and in Media 1. A width of 120 nm FWHM (Full Width at Half Maximum) is measured 2.5 μm below the surface in STED mode whereas it is given at 280 nm FWHM in ELSM mode (Fig. 11(b)). Similar sizes can be measured on Fig. 10 on fine details of subsurface fractures and equivalent width are found down to ten micrometers below the surface. This order of magnitude is in good agreement with width of subsurface cracks supposed to play a role in damage initiation at the wavelength of 351 nm [7, 22–24]. For example, Genin *et al.* demonstrated that 100 nm width and few micrometers depth cracks can induce light intensity enhancements of 10x to 100x depending on their orientation [7].

Fig. 11. Measurement of a subsurface fracture width on an isolated fracture (Media 1) at about 2.5 μm below the surface (a) – X-profile of crack width estimated in ELSM (red circles) and in STED mode (black rectangles) at the pointed location (arrow in (a)) (b).
