# THE RESTORATION OF BEAUFORT CASTLE (SOUTH-LEBANON) A 3D RESTITUTION ACCORDING TO HISTORICAL DOCUMENTATION

Pierre Grussenmeyer <sup>a</sup>, Jean Yasmine <sup>b</sup>

CIPA XIXth International Symposium, 30 September- 4 October 2003, Antalya, Turkey  
“New perspectives to save Cultural Heritage”

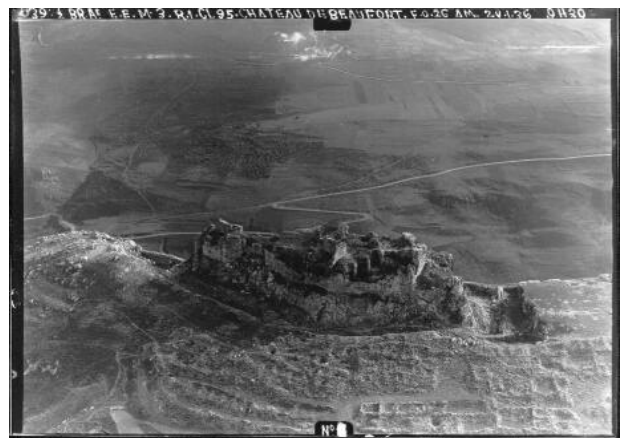
Figure 2. Example of archive photo of 1936 (IFPO), showing in the foreground the archeological hidden remains

**b- Serie 2:** These are photos still existing in the *Institut Français du Proche-Orient* (IFPO) archives (figure 2). All these photos were taken by the French air force of the *Levant* between the years 1930 and 1936. We were able to get duplicates (contact prints) of the original negatives. They were then scanned.

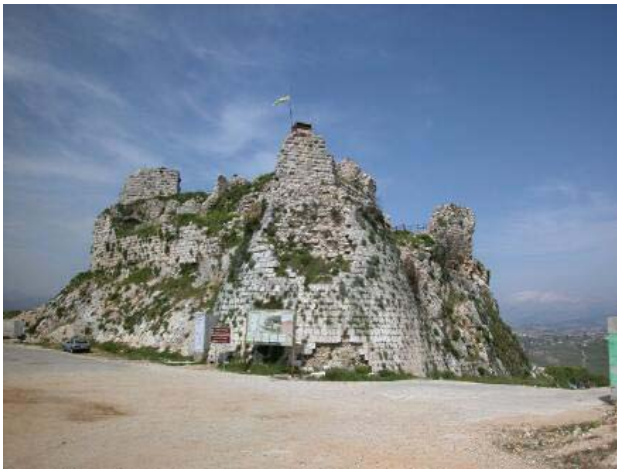
Figure 3. Example of modern photo (Nikon Coolpix 5000, 2003)

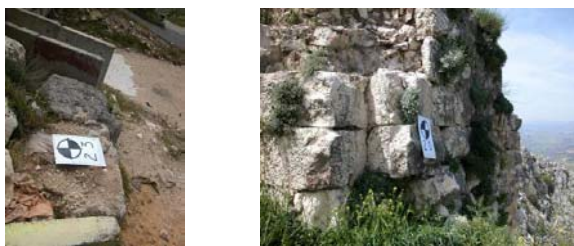
Figure 4. Examples of targets used for the reference points

On that same day, while photos were being taken, a team of geodetic surveyors installed reference points on the ground and elevations of the castle. These points (figure 4) were easy to identify on the photos. A total-station was used by the surveyors to measure the reference points. This generated three-dimensional coordinates for these points.

More than 130 images were realized in spring 2003 with the Nikon F3 and Nikon Coolpix cameras (a hundred images on the ground and about thirty in the helicopter). A first block of 18 oblique views of the castle was oriented in June 2003 using the control points materialized on the ground by targets (figure 4). Standard deviations of about 10 cm on the co-ordinates of the points measured on the images have been obtained. We then selected in this project ten visible points simultaneously on the images of 1931-1936, in order to define approximations of the photogrammetric parameters, and to calculate a block based on a selection of these archive images.

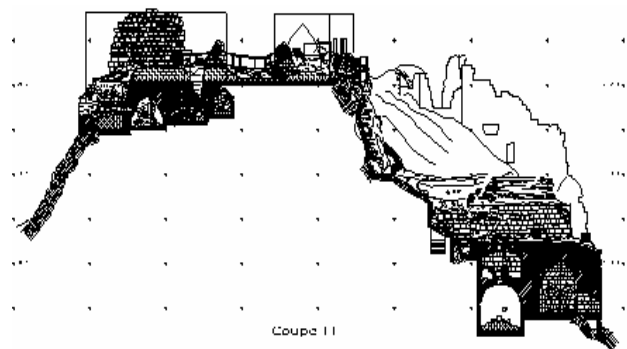
Figure 6. Example of 2D AutoCAD section.

The first topographic surveys conducted during the preliminary study were not very accurate due to the difficulties encountered in trying to access some of the areas of the castle. These first surveys were performed using GPS and tacheometric techniques. The AutoCAD maps (figures 5 and 6) used to establish the tender documents for the restoration of the castle

were based on these surveys. The inaccuracies of these surveys did not represent a major problem for the restoration of the visible areas of the castle. However, these inaccuracies prevented us from computing the exact position of the archaeological hidden remains. We plan to generate a new AutoCAD documentation showing the surroundings of the castle and the archaeological hidden remains that should be dug out (§5).

From the block of images previously oriented, the restitution initially carried out in 2D in Autocad (e.g. fig. 5 and 6) will be enriched by a 3D restitution corresponding to the objectives of the documentation. We are then able to calculate and draw the visible structures on the aerial and terrestrial photographs of 2003 by digitalizing on the images (fig. 8).

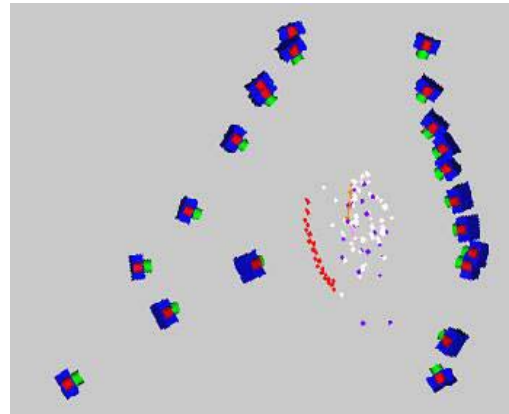
Figure 7a. Overview of the camera stations and the block configuration after the exterior orientation

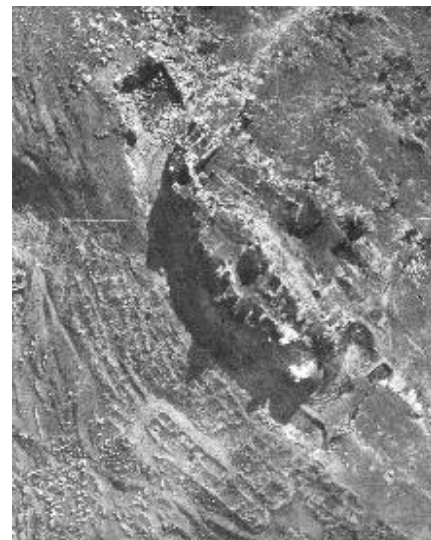
Figure 7b. Aerial view of 1935, allowing to locate the camera stations of the figure 7a

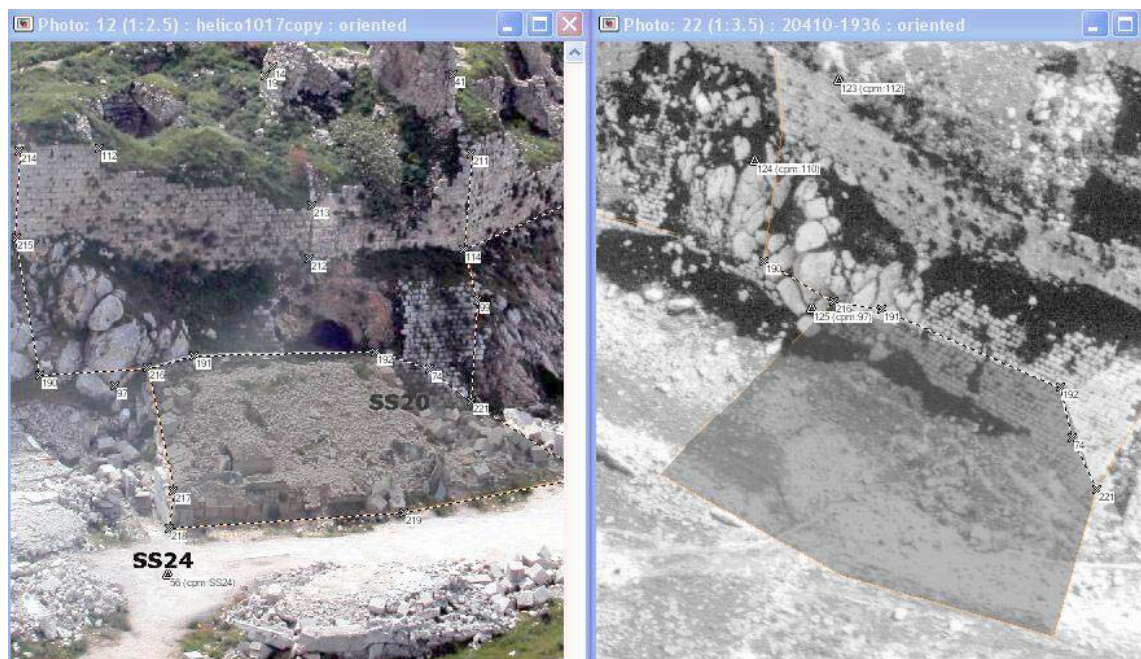
Figure 9. Restitution of the embankment areas.

On the left, the boundary of the embankment is marked on a photo of 2003 and on the right, the corresponding surface is projected on an archive photo of 1936

One will proceed in an identical way on the archive photographs to measure the archaeological structures currently covered by the remains of the war, or to plot in 3D parts of the castle currently embanked or destroyed (fig. 9).

The superposition of the two restitutions make it possible to highlight the areas of interest (figures 9 and 10) for archaeological work and to estimate work of civil engineering (fill, cubature, rebuilding, etc). Moreover, the restitution of the site in wire frame and surface model can be supplemented by the addition of textures

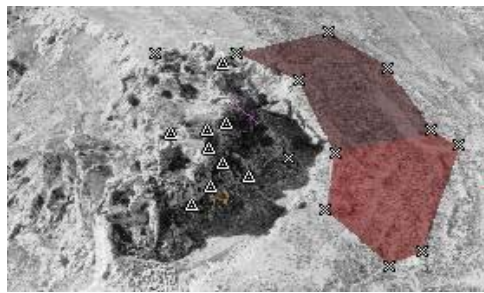
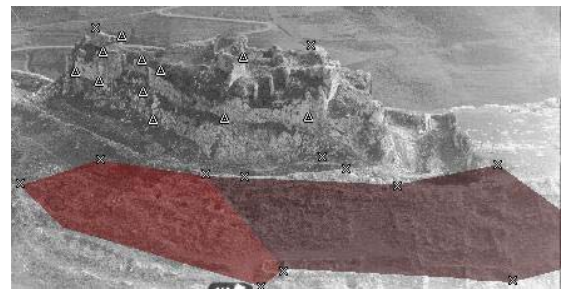
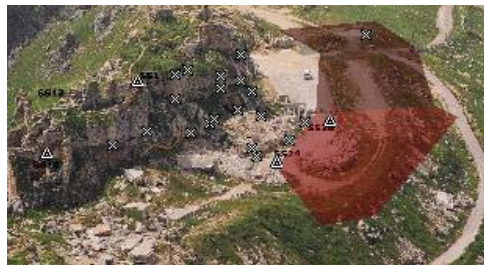
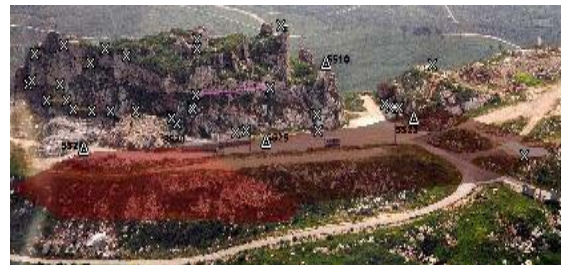
Figure 10. Archaeological structures are measured on the archive images of 1936 and the corresponding surface is shown on the photos of 2003

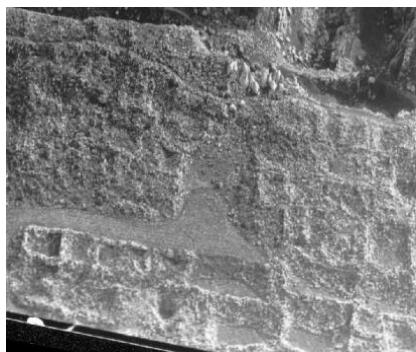
Figure 11. Example of orthophoto of the archeological structure (computed from archive images)

coming either from the images of 1936, or of those of 2003. From the resulting 3D photomodels, orthophotos can be calculated for the two periods, as e.g. for the frontages of the castle or the installations around the site covering the archaeological structures (fig. 11).
