## Recent acoustic upgrades in Verizon Hall at the Kimmel Performing Arts Center

D. Schuette

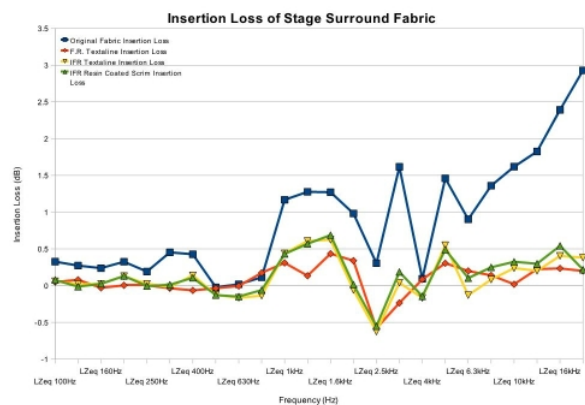
Figure 1: Insertion loss test data

The fabric was found to have an open weave but with a thickness to the individual fibers that was of acoustic concern. Insertion loss testing on the original fabric as well

as a number of alternates led to the selection of a new fabric for use around the stage area that minimized the high frequency roll off provided by the original material.

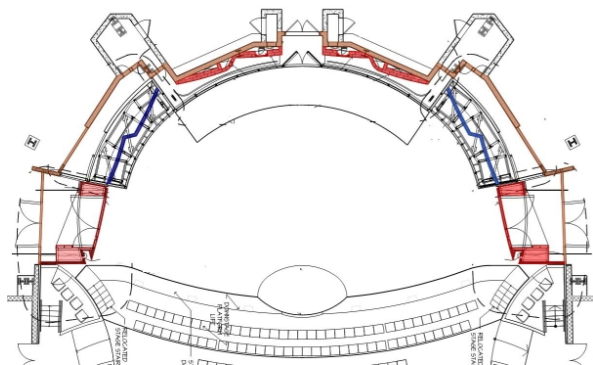
Figure 2: Stage wall diagram – original wall construction is shown in brown and new wall and tower construction in red and blue.

New masonry walls were installed behind the screen in the center upstage area, matching the weight of the original concrete walls in this location for full-frequency support but modifying the geometry slightly. This construction was possible in this area where existing steel framing could carry the weight of the new masonry material.

At the sides of the stage, large moveable seating wagons are in use for almost all performances, and a new system of new walls was installed within these wagons (shown in blue in Figure 2 above) to work in conjunction with the newly shaped upstage wall configuration. As these surfaces had to be installed within moveable wagons, a system of plywood and paper honeycomb was utilized, similar to the new structure above the organ, to provide sufficient stiffness for full-frequency sound reflection but not be so heavy that the mechanism of the wagon movement had to be modified.

New adjustable towers were designed to allow the wall / door area to move inward up to 3.7 meters at each side of the stage, effectively narrowing the stage by 7.2 meters when located in their most on-stage position. The towers carry the weight of the new wood and honeycomb core sandwich panels that provide stiffness for sound reflection in this critical area of the stage but can move on tracks

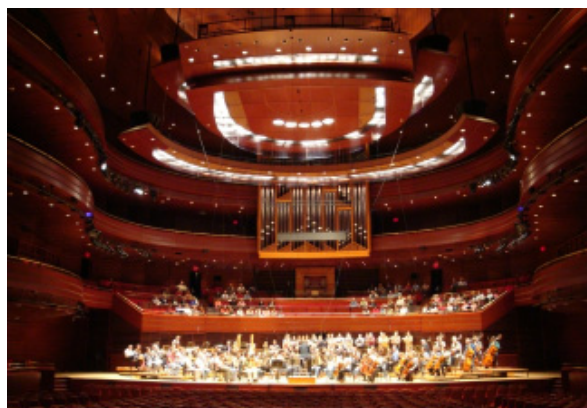
Figure 3: Verizon Hall before modifications.

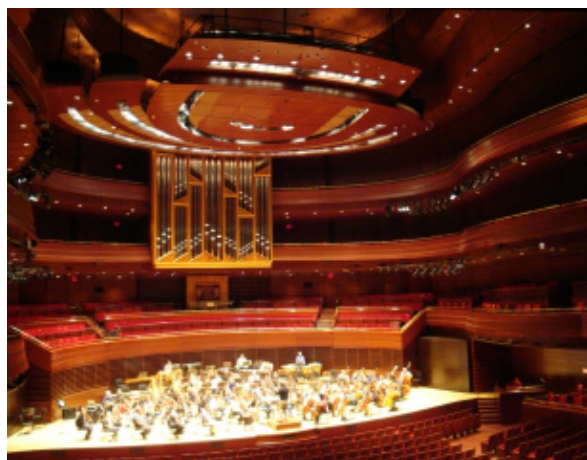
Figure 4: Verizon Hall after modifications.
