# Nondestructive damage evaluation of reinforced concrete structure using infrared thermography

Minh-Phong Luong

Minh-Phong Luong. Nondestructive damage evaluation of reinforced concrete structure using infrared thermography. Nondestructive evaluation of aging materials and composites IV, pp.98-107, 2000, 10.1117/12.385481 . hal-00112273

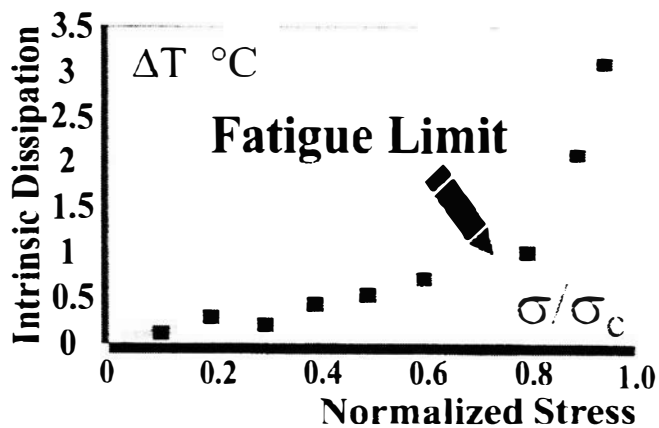
Figure 3. The fatigue limit of the concrete specimen under compressive loading is graphically determined by a drastic change of the dissipative regime.

Experimental results are summarized in Figure 3 that illustrates how the fatigue limit is determined using a graphical procedure. The threshold of critical thermal dissipation is roughly the same for different chosen number of load cycles. It roughly corresponds to the value deduced from standard procedures. These experiments have shown that the infrared thermographic technique can provide the fatigue limit of concrete within a few hours instead of several months when using for instance the traditional standard staircase method. These results are consistent with those obtained on concrete prisms

subjected to compressive fatigue testing<sup>21</sup>. This so determined stress limit could also be understood as a threshold of acceptable damage for plain concrete under compressive loading.

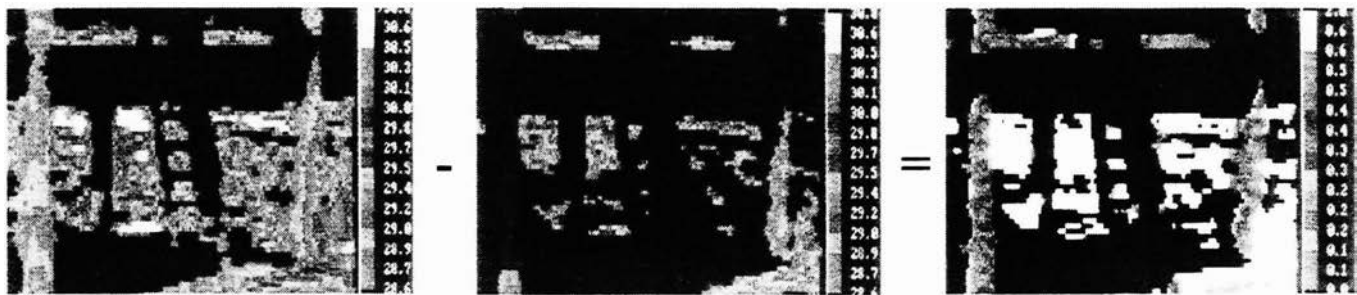
Thermal image after excitation

Thermal image before excitation

Localization of dissipation zones

Figure 11. Subtraction between thermal images after and before excitation evidences the localization of dissipation or damaged zones

The above data processing (heat image subtraction) applied for the overall structure provides useful information about localization of dissipation or damageable zones (Figure 11).
