# The detection of aeronautical defects in situ on composite structures using Non Destructive Testing

Christian Garnier <sup>a,\*</sup>, Marie-Laetitia Pastor <sup>b</sup>, Florent Eyma <sup>b</sup>, Bernard Lorrain <sup>a</sup>

A study of three Non Destructive Testing methods (Ultrasonic Testing, InfraRed Thermography and Speckle Shearing Interferometry, known as Shearography) was carried out on different specific types of composite specimens having a variety of defects. The aim of this study is to evaluate the efficiency of these NDT methods in the detection of in site defects resulting from Barely Visible Impact Damages (BVID) or in-service damages to complex surfaces such as wings or rods. The size and position of all the defects were determined by GVI (General Visual Inspection); GVI being the reference. The evaluation of the three NDT techniques enabled conclusions to be drawn regarding defect detection and size. The first part of the study deals with determining and measuring defects. It appears that only the ultrasonic method enables the depth of a defect to be determined. In the second part of the study, the results obtained by the three NDT methods are compared. Finally

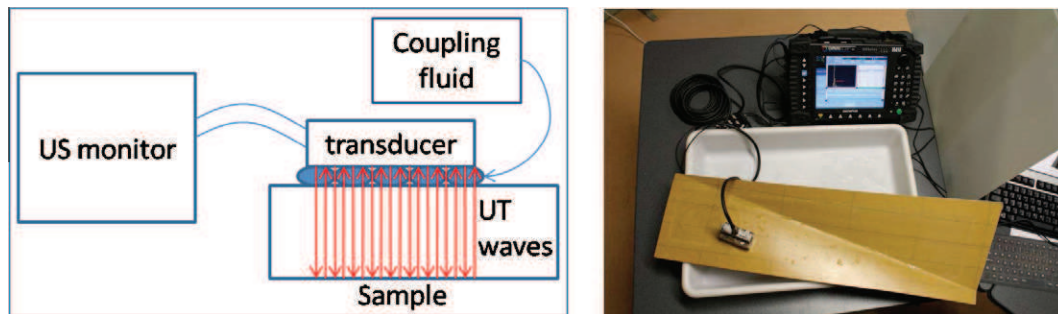
Fig. 3.1. Ultrasonic device.

In this study, a 5L64-NW1 multi-element transducer connected to an Omniscan 32: 128 PR (US monitor) is used as the ultrasonic source and the receiver. The wave velocity depends on the materials. And so, for the three tested specimens, the waves have a velocity ranging from 2600 to 5300 m s<sup>-1</sup> and a frequency of 5 MHz. In order to carry out the experiments, a gel coating was applied (cf. Fig. 3.1) and so the wave ratio transmitted to the sample is much better.

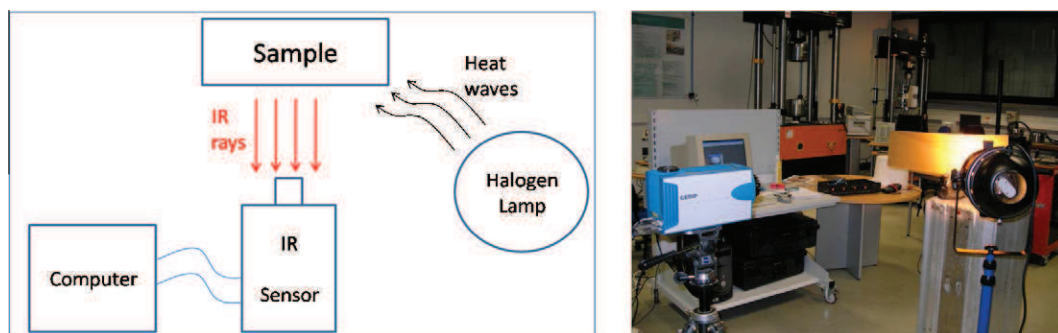
Fig. 3.2. IR Thermography device.

Halogen lamps are used to provide thermal solicitation to the sample. They are positioned 300 mm from the front surface of the specimen. The front surface has been chosen as being similar to an in site inspection. The specimen is heated for 10 s, and a 30 s movie is recorded at 50 Hz. The installation of the experimental device is very fast (around 5 min). The camera is a Flir Titanium and its thermal resolution is 20 mK (cf. Fig. 3.2). In order to detect the defect present in the recording, a relative movie has been created. The relative movie consists of withdrawing the first 10 images from the recorded film in order to eliminate the temperature due to the ambient environment. The presence of the defect appears during heating and cooling time. The defect is most visible in the image corresponding to the inflection point of the temperature curve. For the study, infrared images were taken at this point (example for the carbon plate Fig. 3.3).

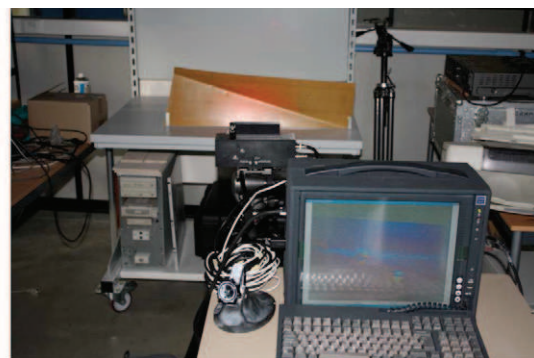
Fig. 4.1. Specimen A: carbone/epoxy rod.

Damage analysis on each of the three specimens is extremely difficult because of their distinctive geometry: Specimen A is a hollow cylindrical rod, 100 mm diameter, 10 mm thick and 1 m long. Its specific shape prevents access to the inside of the rod. In addition, it is coated with blue gloss paint to comply with aeronautical service specifications but in order to improve the quality of optical results, the damaged area has to be matt.

Each specimen has surface damage. The defect on Specimen A is delamination caused by an in-service impact. During a GVI, the size of the defect can be obtained quite simply using a steel ruler. The GVI defect is 98 mm and 18 mm.

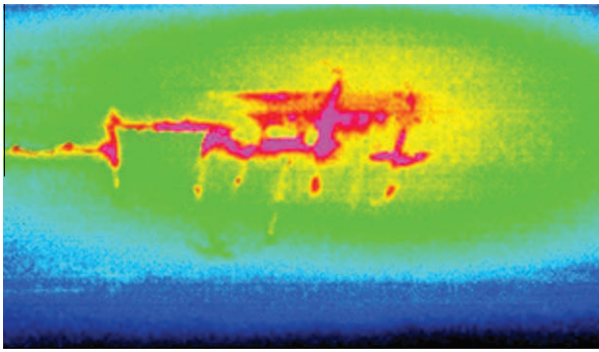
**Fig. 4.2.** InfraRed Thermography map of Specimen A.

The InfraRed Thermography tests made it possible to identify the presence of defects on Specimen A in a very short time, around 30 s (cf. Fig. 4.2). The size of the pixel is calculated from the images. Therefore, the dimensions of the defects can be determined accurately. Indeed, the defect is 97 mm  $\times$  20 mm. It is obvious that the results obtained with InfraRed Thermography are similar to GVI measurements (maximum deviation around 10%).

As mentioned in Section 3.2, the halogen lamps are situated in front of the specimen in order to represent an in site inspection. The specimen surface observed is the damaged surface. In fact, Specimen A being thick and having a hollow circular section, a huge quantity of heat is lost in detecting defects on the rear surface.

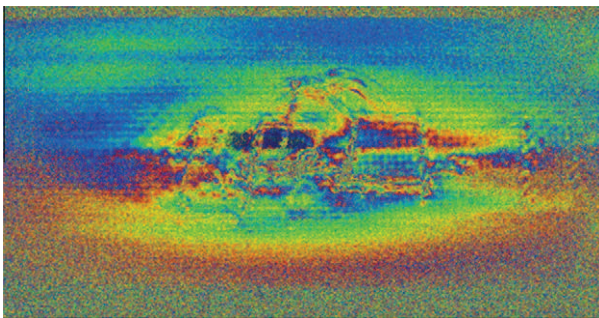
**Fig. 4.3.** Shearography map of Specimen A.

The defects on Specimen A were identified quickly by Shearography tests, around 1 min (cf. Fig. 4.3). It is important to note that the images obtained by Shearography are not easily analysed. There were many defects on this specimen and Shearography detected them all. This means that a considerable amount of the information was shown on the image, making it illegible. Nevertheless, it was possible to determine the size of the defects. The range of the defect area is 107 mm  $\times$  22.5 mm. The difference between the GVI and the Shearography results represents 9% as regards length and 25% as regards width. This measurement variation is due to the difficult in analysis of the shearographic image.

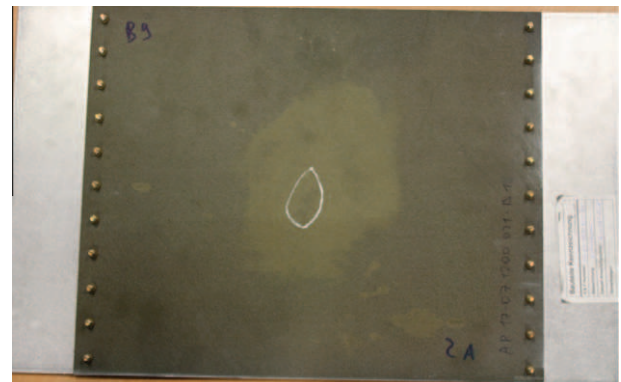
**Fig. 4.4.** Specimen B: carbone/epoxy plate.

Specimen B is a flat plate, 500 mm × 400 mm × 2 mm.

Specimen B damage is the result of a lightning impact which occurred in service. The defect measures 41 mm and 75 mm.

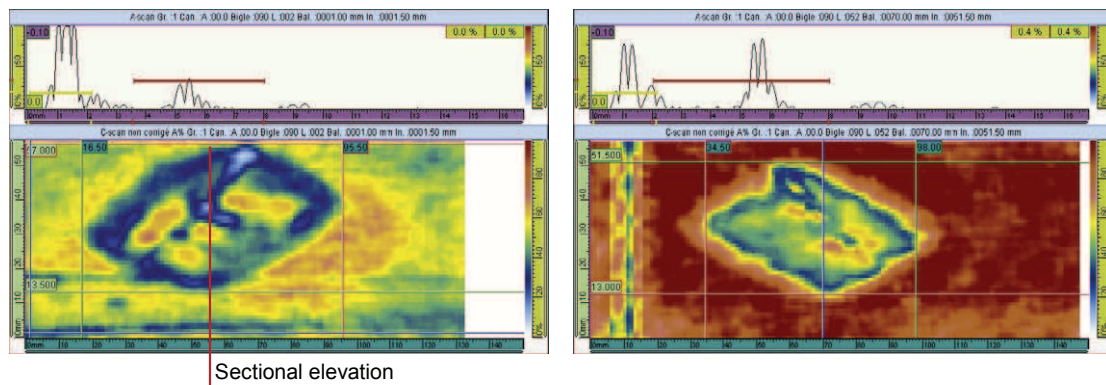
Fig. 4.5. Ultrasonic Testing map of the both faces of Specimen B.

Two C-Scan inspections were carried out : one on the front of the specimen and the other one on the back. For the front surface inspection (i.e. the surface on which the lightning impact is located), the defect measured 43.5 mm  $\times$  79 mm (cf. Fig. 4.5). On the back, the defect measurements were 38.5 mm  $\times$  63.5 mm (cf. Fig. 4.5).

- firstly, signal loss through the thickness of the specimen,
- secondly, surface coating on the back,
- thirdly, position of the probe focus because the defect is on the surface.

The in-depth position is the same from both front and back. The shape of the defect is similar to that of the GVI defect. The actual size of the defect on the specimen and its UT size are virtually the same (around 5%). From the 2D map, a sectional elevation can be traced showing that the defect is on the surface of the specimen (Fig. 4.6).

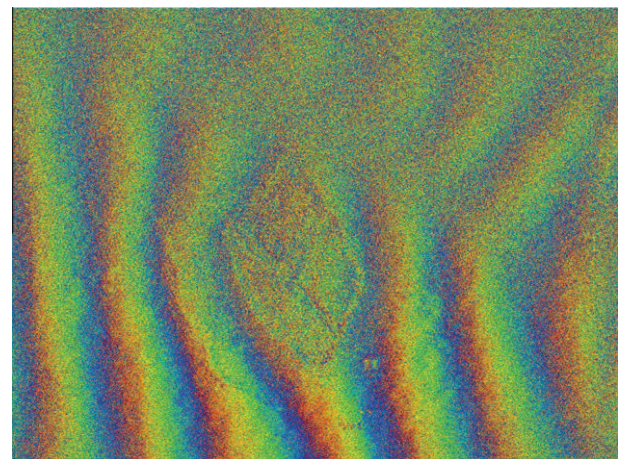
Fig. 4.8. Shearography map of Specimen B.

The defects on Specimen B can be identified by Shearography tests in a relatively short time: approximately 1 min (cf. Fig. 4.8). The size of the defect is 37.5 mm × 59.5 mm. The differences between the GVI and the Shearography measurements are 8% as regards length and 21% as regards width. This difference is due to the fact that the shearographic image is a little fuzzy preventing the size of the defect to be measured properly.

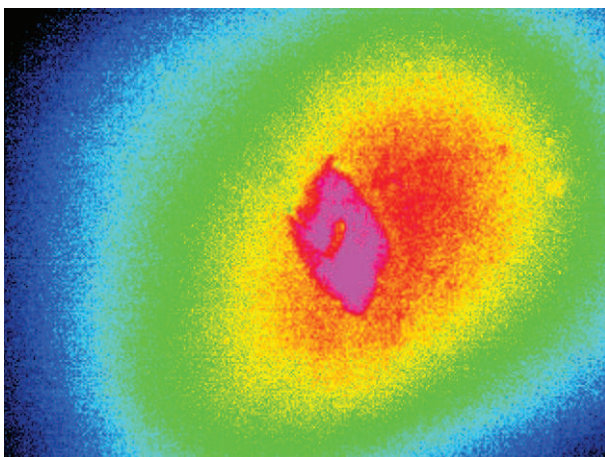
Fig. 4.7. Infrared map of the defect of Specimen B.

2D mapping of the specimen and identification of the defects can be obtained using IR thermography tests (cf. Fig. 4.7).

The size of the revealed defect is 36 mm length and 60 mm width. Its shape is almost the same as the GVI defect on the damaged surface. The variations between the GVI and the IR thermography measurements are 12% in length and 20% in width.

This method is very quick and results can be obtained in 1 min: 30 s to record and 30 s to analyse the results. InfraRed Thermography can therefore be used as a first step to identify and locate the presence of a defect very quickly. Following that, the size of the defect can be determined more precisely using Ultrasonic Testing.

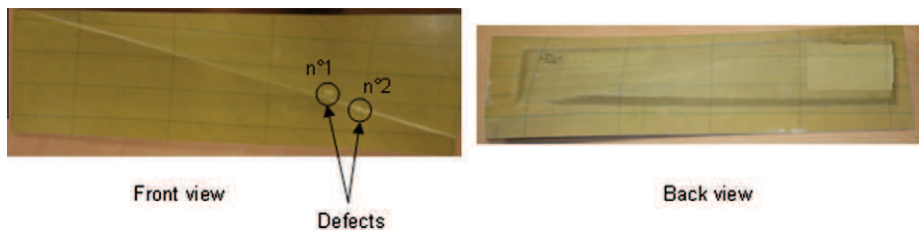
Fig. 4.9. Defects of Specimen C.

The Specimen C defects are two cases of delamination due to the impact of a falling tool or of hailstones. These were created in the laboratory using a drop weight tester. The defect located above geometrical discontinuity is called no. 1 and the defect located on the geometrical discontinuity is called no. 2 (as defined in Fig. 4.9). Defect no. 1 is 13 mm and 9 mm. Defect no. 2 is 18 mm and 8 mm.

For Specimen C, two GVI defects had to be detected. Defect no. 1 was located above geometrical discontinuity and defect no. 2 was located on the angle of this geometrical discontinuity (cf. Fig. 4.9).

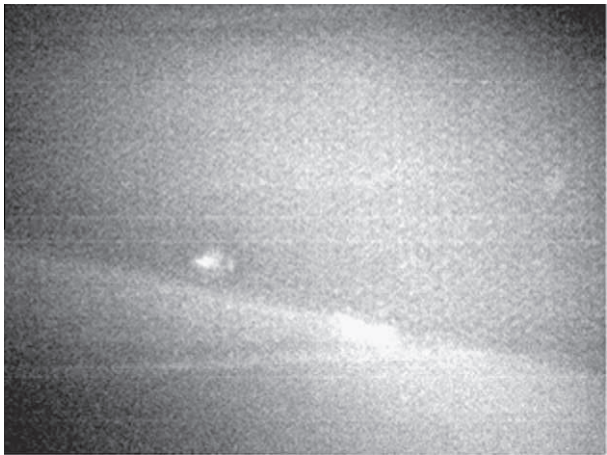
Fig. 4.11. InfraRed Thermography map of Specimen C.

Both defects were determined by InfraRed Thermography within a few seconds (cf. Fig. 4.11). Defect no. 1 is 15 mm × 10 mm. The difference between the GVI and the IR thermography measurements is 15% in length and 11% in width.

The dimensions of the defect no. 2 are 22 mm length and 8.5 mm width. The differences between the GVI measurements and the IR thermography measurements are equal to 22% as regards length and 6% as regards width. The considerable deviation in length can almost certainly be attributed to the focusing problem due to the geometrical discontinuity.

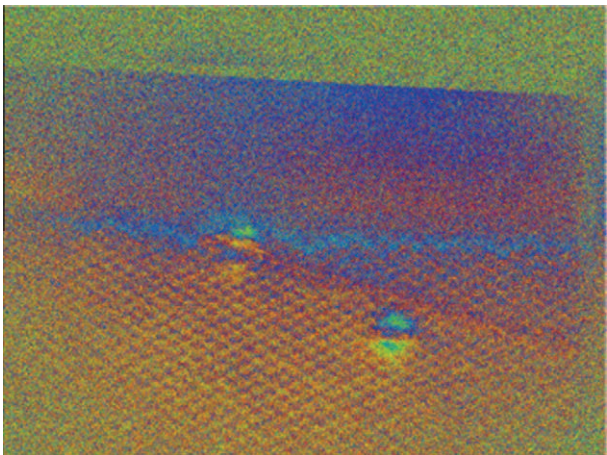
Fig. 4.12. Shearography map of Specimen C.

The defects on Specimen C were identified by Shearography tests within a relatively short time of around 1 min (cf. Fig. 4.12). The image is very clear and the defects are perfectly visible. Shearography therefore seems well suited to the detection of defects in this type of specimen.

Defect no. 1 is 15 mm × 15 mm. The variation between the GVI and the Shearography measurements is 17% in length and 87.5% in width. However, on the shearographic image, the defect appears circular which is not surprising for an impact defect; and so in this case, the GVI measurement may be incorrect.

Defect no. 2 is 15 mm × 8 mm. The variation between the GVI and the Shearography measurements is 16% in length and 11% in width.

With Shearography and InfraRed Thermography tests, defects were determined very quickly. However, the images obtained with Shearography are much clearer and sharper than those obtained with IR thermography. Thus, for this specimen, the most suitable method appear to be Shearography.

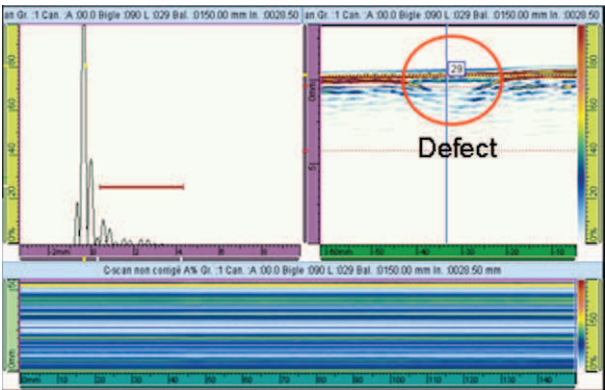
Fig. 4.10. Ultrasonic map on Specimen C.

Defect no. 1 was detected by ultrasonic tests (cf. Fig. 4.10). The geometry of the specimen (defect slightly on the angle) made UT measurement difficult. Thus, only the defect length could be determined: 22 mm. The difference between the GVI and the UT measurements of length is 22%. As shown on Fig. 4.10, the defect was located not only on the surface of the specimen but also in depth.

Defect no. 2 was not detected. Checking this impact was impossible because the device (multi-element probe) was not suitable and the folding angle was variable.
