## Experimental study of corrosion-induced degradation of reinforced concrete elements

Olfa Loukil, Lucas Adelaide, Véronique Bouteiller, Marc Quiertant, Thierry Chaussadent, Frédéric Ragueneau, Xavier Bourbon, Laurent Trenty

Olfa Loukil, Lucas Adelaide, Véronique Bouteiller, Marc Quiertant, Thierry Chaussadent, et al.. Experimental study of corrosion-induced degradation of reinforced concrete elements. International RILEM Conference on Materials, Systems and Structures in Civil Engineering Conference segment on Electrochemistry in Civil Engineering, Aug 2016, LYNGBY, Denmark. hal-01518744

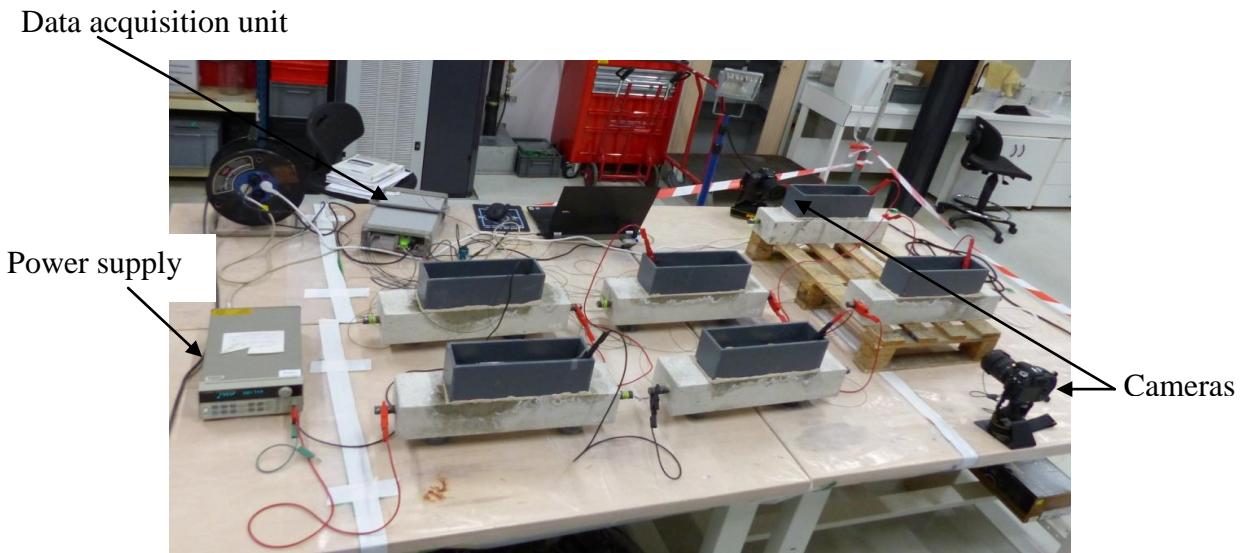
**Figure 2. Accelerated corrosion and monitoring system**

The set-up used for accelerated corrosion test and the monitoring system are illustrated in [Figure 2]. RC samples were corroded using a power supply (Agilent 6614C, 100V, 0.5A) which delivered an imposed anodic current to the steel rebar. The counter electrode (cathode) consisted in an inert platinum titanium mesh (275mm long, 75mm wide) placed into a PVC tank containing the alkaline electrolyte (1 g/L of NaOH, 4.65 g/L of KOH, 30 g/L of NaCl) which was glued on the top side of the concrete (in the middle of the specimen). All the specimens were connected in series and a current density of  $100 \mu\text{A}/\text{cm}^2$  of steel (0.0172A for a steel surface area of  $172.8 \text{ cm}^2$ : diameter 20mm and length 275mm) was applied during the chosen exposure time (7d, 14d, 21d, 28d and 35d). At the end of each considered exposure time, two specimens were disconnected from the electrochemical test set-up. One of the specimens was used for the non-destructive electrochemical characterization and the other one was dedicated to destructive measurements. The accelerated corrosion test was monitored using a data acquisition unit (Keysight 34970A): temperature, delivered constant current, each sample voltage and total voltage were recorded every two hours. Moreover, two cameras were used for the digital image acquisition of the front side of the two specimens subjected to a 35 days accelerated corrosion test.
