## 4D imaging and quantification of pore structure modifications inside natural building stones by means of high resolution X-ray CT

J. Dewanckele, T. de Kock, M. A. Boone, V. Cnudde, L. Brabant, M. N. Boone, Gilles Fronteau, L. van Hoorebeke, P. Jacobs

### Abstract

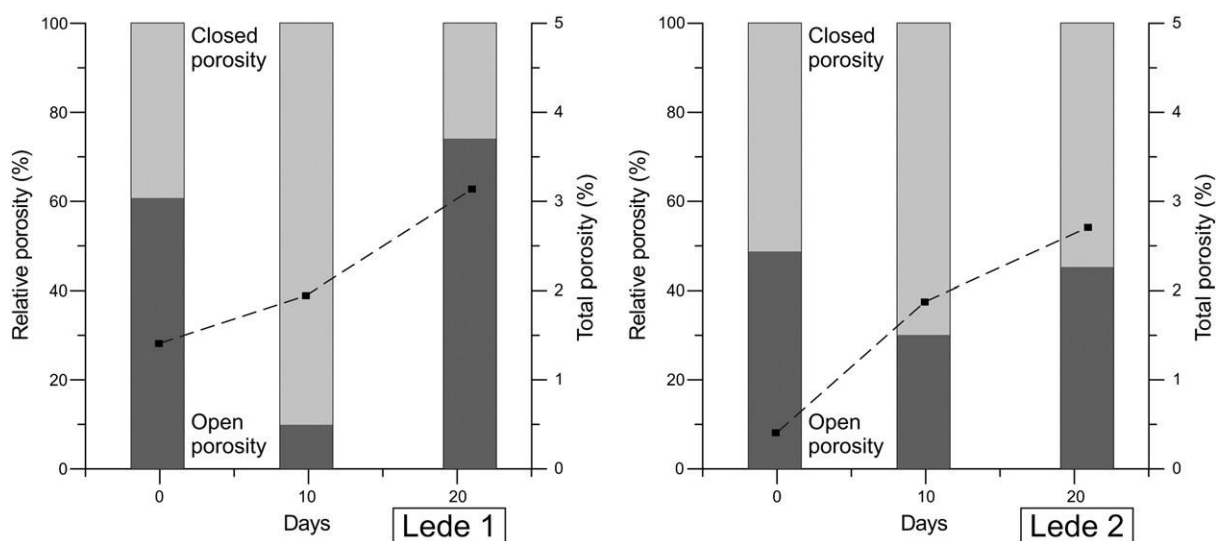
Fig. 10. Total porosity change and change of open and closed pore structures of the Lede 1 and Lede 2 samples at the beginning of the test, after 10 days and after 21 days. The total porosity is indicated by a dashed line. The relative open porosity is shown in dark gray and the relative closed porosity is shown in light gray

Fig. 10 demonstrates that the total porosity of the Lede 1 sample increased from 1.4% to 2.0% after 10 days and to 3.2% after 21 days. On the other hand, the total porosity of the Lede 2 sample increased from 0.4% to 1.8% and at the end of the test to 2.7% (Fig. 10). So for both samples, an increase in porosity is shown after 10 and 21 days. In addition, the ratio of open and closed porosity was calculated for both samples. That ratio is shown in dark gray for the open porosity and light gray for the closed porosity on the same graphs (Fig. 10). For both samples, the open porosity decreases after 10 days and increases again after 21 days. The open porosity for sample Lede 1 dramatically decreases from 60.4% to 10.0% after 10 days and increases to 74.0% after 21 days. A similar observation can be made from sample Lede 2. A significant decrease in open porosity is noticeable from 48.7% to 30.0% after 10 days and an increase to 45.2% after 21 days.

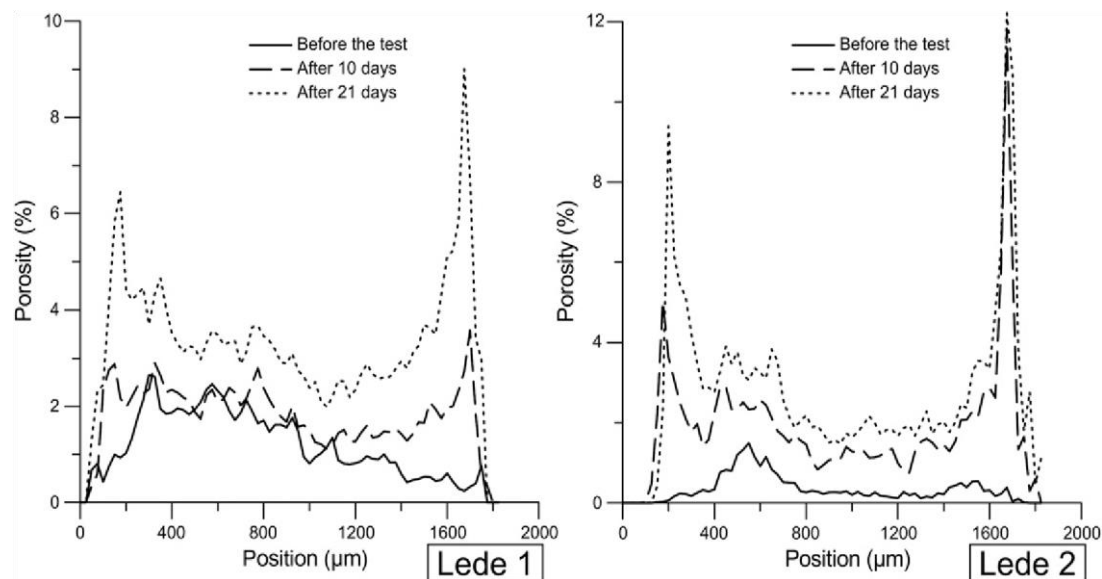
Fig. 12. Porosity in the y-direction for Lede 1 (left) and Lede 2 (right).

Similar to the Lede 1 sample, a large increase at the edges of the sample is visible. The partial porosity in the y-direction (Fig. 12) provides the same structural information as in the x-direction for both samples. The calculation of the partial porosity in the z-direction is presented in Fig. 13. Again, for both samples, the increase in porosity is the highest on the edge of the sample. For The Lede 1 sample, the average partial porosity between 0 and 600  $\mu\text{m}$  increases from 1.0% to 2.2% after 10 days and 3.6% after 21 days. Between 0 and 400  $\mu\text{m}$ , the average partial porosity of the Lede 2 sample increases from 0.3% to 2.6% after 10 days and 3.3% after 21 days. For Lede 1, after 10 days, there is a slight decrease in porosity inside the sample and after 21 days the porosity greatly increases

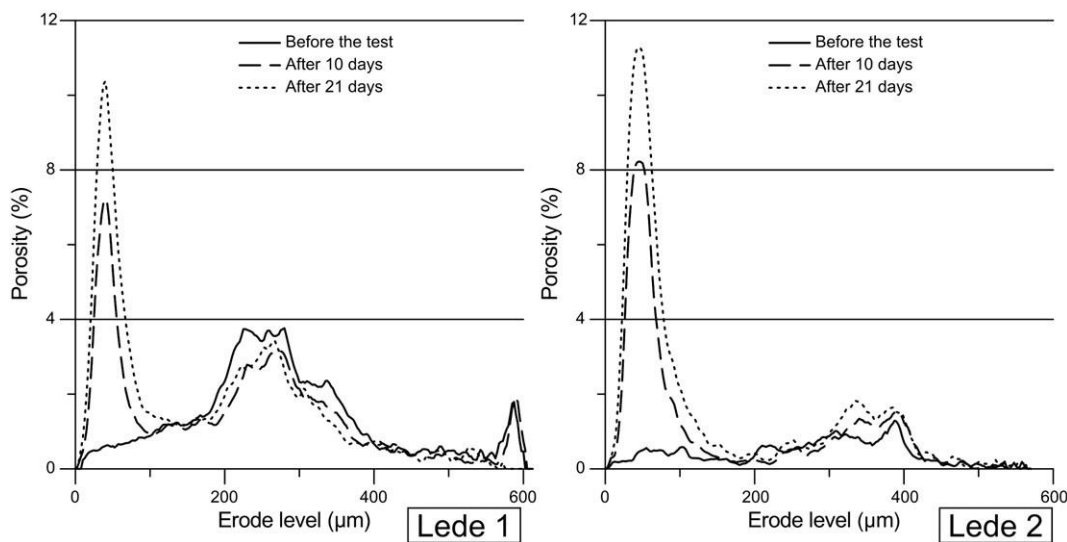
Fig. 14. Radial porosity for Lede 1 (left) and Lede 2 (right).

To avoid overestimated values due to geometrical factors on the edges of the samples, the radial porosity is also measured. Fig. 14 demonstrates that the affected zone for both samples is concentrated in the outer 200  $\mu\text{m}$  of the sample and not in the 400  $\mu\text{m}$  zone as registered with the partial volume measurements. Between 0 and 200  $\mu\text{m}$ , the average radial porosity for the Lede 1 sample increases from 1.1% to 2.0% after 10 days and 3.2% after 21 days. In case of the Lede 2 sample, the average radial porosity increases from 0.3% to 2.1% after 10 days and 3.2% after 21 days.

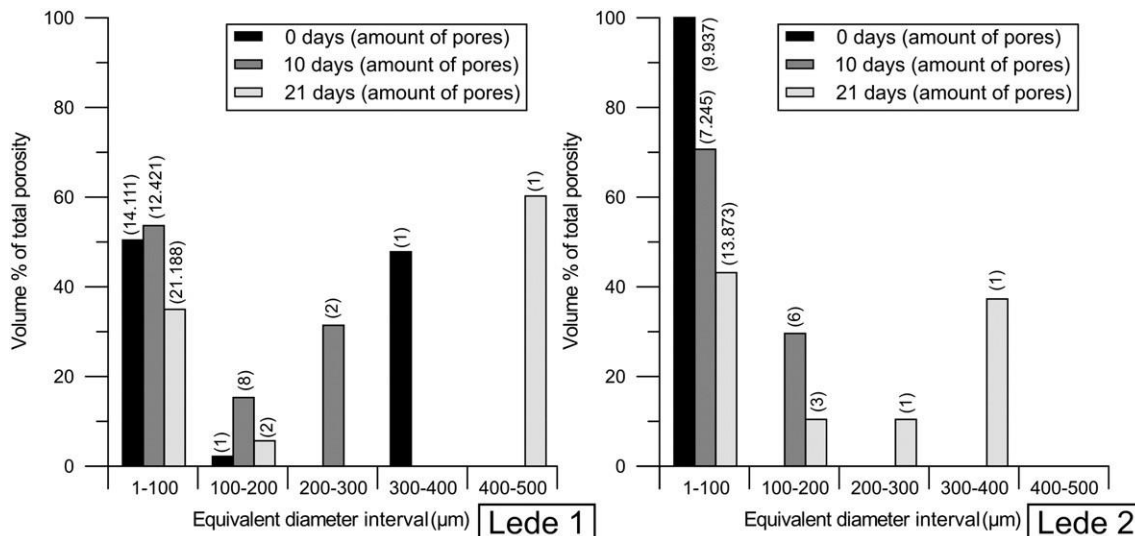
Fig. 15. Dimensional overview of the pore structure in the Lede 1 sample (left) and the Lede 2 sample (right). The volume percentage of the total porosity is given for each equivalent diameter interval after 0 days (black), 10 days (dark gray) and 21 days (light gray). On top of each bar, the total amount of pores is shown.

It is interesting to compare the porosity results with the dimensional changes. Those changes can be obtained by measuring the equivalent diameter (ED) of each pore structure during the different steps of weathering. General trends observed are (1) an increase in ED after 21 days, (2) increase in amount of pores smaller than 100  $\mu\text{m}$  after 21 days and (3) fragmentation of large pore structure after 10 days. Fig. 15 displays the measured ED in function of the volume percentage of the total pore volume. In addition, for each ED interval, the amounts of pores within that interval are given (number above the bar). Both volume percentage and amounts of pores are shown because they

For example, for the Lede 1 sample, in the initial situation (black color on Fig. 15) there were 14,111 pores with an ED smaller than 100  $\mu\text{m}$ , while one pore had an ED between 100 and 200  $\mu\text{m}$  and another pore between 300 and 400  $\mu\text{m}$ . Some 50% of the total porosity was attributed to the pores smaller than 100  $\mu\text{m}$ , 48% to the pores between 300 and 400  $\mu\text{m}$  and only 2% to the pore between 100 and 200  $\mu\text{m}$ . As can be seen on the graph, after 10 days exposure, the pore structure significantly changed. The amount of pores with an ED smaller than 100  $\mu\text{m}$  decreased to 12,421 but amounted to 54% of the total porosity. The two biggest pores had now an ED between 200 and 300  $\mu\text{m}$  (31% of the total porosity). Pores with an ED between 100 and 200  $\mu\text{m}$  increased to 8, contributing 15% of the total porosity.

Finally, after 21 days, a drastic increase in ED is shown in the graph. One big pore was present with an ED between 400 and 500  $\mu\text{m}$  and amounted to 60% of the total porosity. In the ED-interval of 100 to 200  $\mu\text{m}$ , the number of pores decreased to two (only 5% of the total porosity). A significant increase in the amount of pores to 21,188 can be noted in the ED-interval smaller than 100  $\mu\text{m}$ . The latter contributes 35% to the total porosity.
