In-depth investigation of metallization aging in power MOSFETs

Roberta Ruffilli, M Berkani, P Dupuy, Stéphane Lefebvre, Y Weber, Marc Legros

Roberta Ruffilli, M Berkani, P Dupuy, Stéphane Lefebvre, Y Weber, et al.. In-depth investigation of metallization aging in power MOSFETs. *Microelectronics Reliability*, 2015, Proceedings of the 26th European Symposium on Reliability of Electron Devices, Failure Physics and Analysis, SI:Proceedings of ESREF 2015, 55 (9-10), pp.1966-1970. 10.1016/j.microrel.2015.06.036 . hal-01700466v2

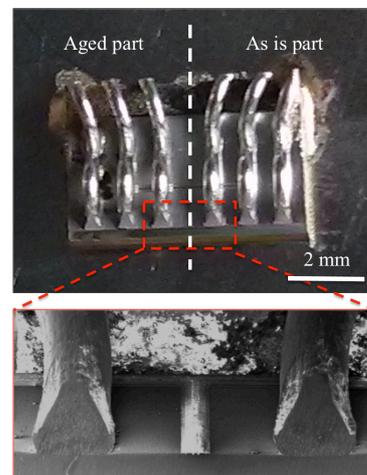
Fig. 1. Power module prepared for microstructural inspection after aging. The left sector is aged (avalanche mode, 400 kcycles) as the right one is as processed. The wires are cut and polished to 45° before being FIB-cut for interface observation.

The device under test (DUT) is a 24V Freescale's SmartMOS technology dedicated to truck application. The active zone is made of 2 MOS sectors, each connected by 3 Al wedge bond wires (Fig. 1). During the tests, only one sector is undergoing repeated electrical pulses, either in avalanche or short-circuit mode (energy density in the order of $3\text{J}/\text{cm}^2$ for each test). Avalanche tests seem to induce a slower aging compared to short-circuits, but more data is needed to verify this point. Electrical wave forms (current, voltage and power) recorded during tests are depicted in figure 2. During the short-circuit phase (600A at the beginning) the high current level induces a high power dissipation.

However, observation of the in-depth structure of the metallization and of the interface under the bond wires requires making cross sectional cuts of the device. This is done through both mechanical grinding (made at 45° of the surface, see Fig. 1, to let access to the ion beam) and Focused Ion Beam (FIB) cross-sectional cuts, performed perpendicular to the surface. These cross-sections are first observed using ionic channeling contrast (Fig. 5), which depends on grain orientation. This gives a first idea of the grain

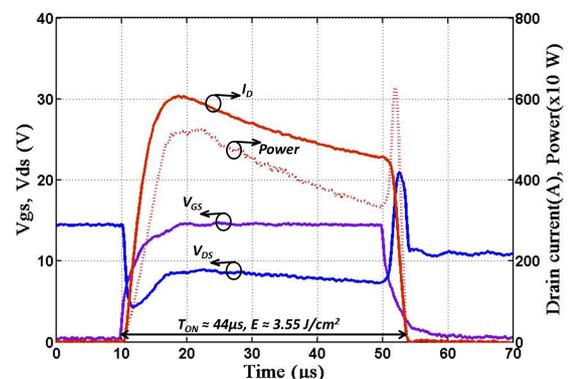
Fig. 2 : Drain current, drain-to-source voltage and dissipated power during short-circuit phase, $V_{DS}=15\text{V}$, $V_{GS} = 15\text{V}$, $T_{on} = 44\mu\text{s}$.

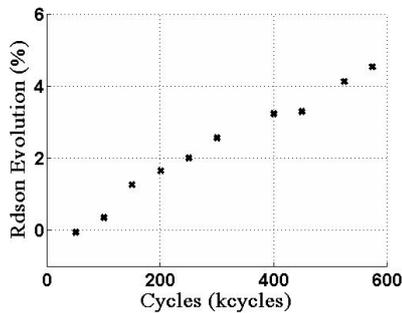
Fig. 3: On state resistance increase during repetitive short circuit tests, $V_{DS}=15V$, $V_{GS} = 15V$, $T_{on} = 44\mu s$.

R_{dson} linearly increases during short circuit aging (Fig. 3). During these tests, the aging of Aluminum surface has been monitored at various stages (1k, 2k, 10k, 100k, 600k cycles) using SEM (Scanning Electron Microscopy).

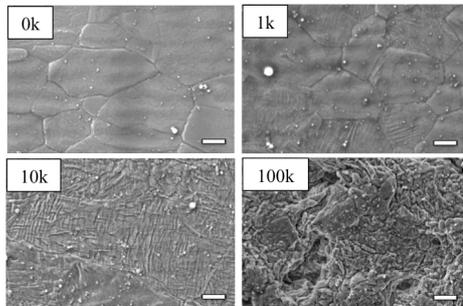
Fig. 4. SEM observation of the metallization surface after 0, 1k, 10k and 100k cycles. Scale bar 2.5 μm .

Surface observation and EBSD (Electron Back Scattered Diffraction) mapping were performed in a Helios 600 FIB/SEM. Figure 4 shows a weak change in the Al surface starting from 10k cycles, but it is only after 100k cycle that we observe a significant increase of the roughness.

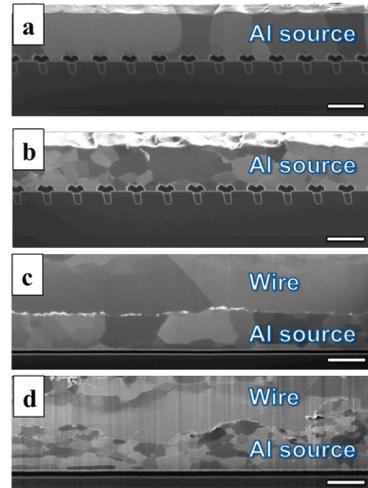
Fig. 5. FIB imaging of the naked metallization in an *a*) as-is and *b*) aged power module and of the wire-source metallization interface in an *c*) as-is and *d*) aged power module.

size (measured by the line intercept method [12]) in both the source metallization and the bond wire. It also allows measuring the deformation imposed to the initial Al layer by the wire bonding process and seeing how this interface behaves during aging.

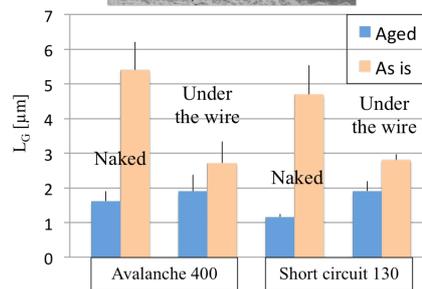
Fig. 6. Sketch of the two locations where FIB cross-sections are made (the arrows indicate the analyzed surface). The plot represents the grain size, measured by the linear intercept method [12], in the metallization both under the bonding wire and outside (naked) for as-is and aged modules in avalanche (400 kcycles) and short circuit (130 kcycles) mode.

Aging seems to lower the average grain size (as measured by FIB in Fig 6 and observed elsewhere [13]), but ACOM mapping shows that most of the grain domains revealed by FIB have a small misorientation (less than 10°). Fig 10 illustrates this as two grains (1 and 2) visible in ionic contrast (Fig. 10a) have only a 8° misorientation when measured using the ACOM system (Fig. 10b). These are then subgrains potentially formed by the gathering of initial dislocations inside a single initially large bamboo grain [10]. Many cracks running from the surface to the Si substrate are observed (Fig. 10). They follow the grain boundaries and are probably the signature of a heavy Al self-diffusion process between the grains [10].

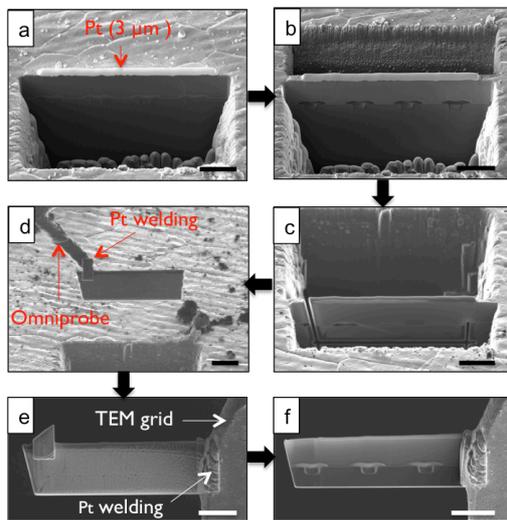
Fig. 7. Cartoon of a typical TEM-lamella preparation by FIB: *a*) deposition of a protective Platinum (Pt) layer on the area of interest, and *b*) matter removal behind the lamellae; *c*) cutting of lamella; *d*) lamella welding and lift out by Omniprobe; *e*) welding of lamella on TEM grid; *f*) final thinning and polishing. Scale bar 5 μm.

A TEM-lamella (Fig. 8) of the same zone is then prepared by removing matter behind the observed zone using the ion beam, lifting out the lamella and thinning it down to electron transparency with decreasing flux of ions (Fig. 7).

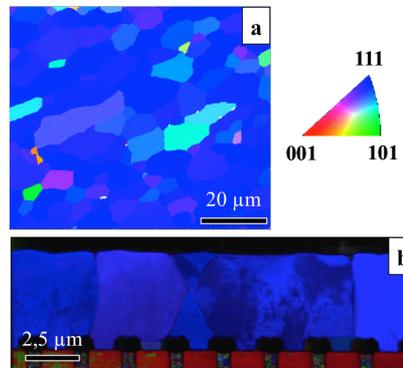
Fig. 9. EBSD mapping of *a*) the surface and *b*) the cross-section of an as is module, showing a strong 111 texture of the Al grains along the deposition direction.

Outside of the wire bonding area, the initial grain size is on the order or larger than the metallization thickness. The structure is called "bamboo" as most of the grain boundaries run perpendicular to the surface down to the substrate. An EBSD map of the initial metallization surface reveals a strong $\langle 111 \rangle$ texture (Fig. 9a) that is confirmed by a TEM cross section oriented through ACOM (Fig. 9b). This last image clearly shows that each grain orientation is conserved from the surface down to the transistor region.

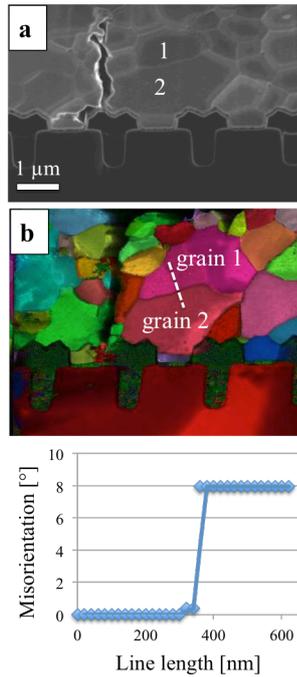
Fig. 10. a) FIB imaging and b) ACOM orientation mapping of the source metal of an aged module (short circuit, 130k cycles) at the interface with the Si substrate. The plot represents the misorientation between the grains 1 and 2 along the white line in b).

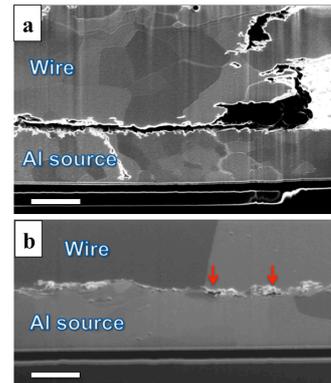
Fig. 11. FIB imaging of the wire-source metallization interface in an aged power module (short circuit 130 keycycles) at a) the edge and b) in the middle of the wire. Scale bar 2.5 μm.

Under the wire, the Al metallization is severely deformed, with plastic deformation ranging from 5 to 25%, in average, in the measured sections. The deformation is measured by taking the initial metallization thickness (away from the wire) in a non aged device as reference. The grain size is systematically smaller in these zones, as it can be seen in Fig. 6 and Fig. 11. In this figure, one can also note that grains in the Al wire are much larger. Upon aging, the amount of plastic deformation perpendicular to the interface does not change significantly, but grain growth is observed, at variance with what happens outside the wire-bonding area. The initial dislocation density is also higher in this zone, which forecasts larger rearrangements, cell formations and subsequent grain boundaries creation. The bonding between the metallization and the wire shows initial imperfections, probably due to Al oxide (visible in white contrast in Fig. 2). Cracks propagate along these imperfections during aging, causing a loss of contact (or a reduced contact area) between the wires and the metallization. This mechanism, coupled with cracks running perpendicularly to the

interface (under and away from the bondings) must cause a R_{dson} increase. This R_{dson} increase implies that subsequent electrical pulses will generate more heat, thus more deformation, and crack propagation. The linear character of the resistance increase is however not linked yet to a total crack surface measurement that is unavailable so far.
