Monitoring of a sediment replenishment operation: The case of the Saint-Sauveur dam in the Buëch River (Southern Alps, France)

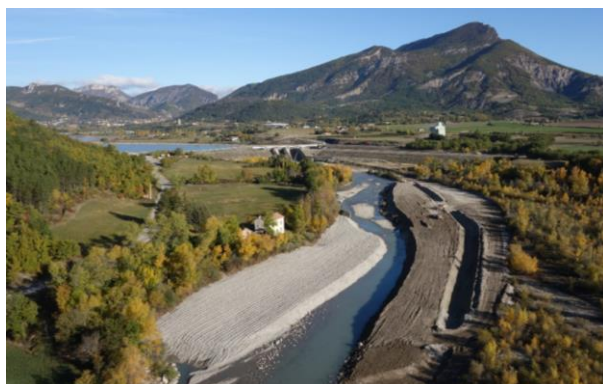
Figure 1 : The replenishment site at the end of the restoration (source: EDF).

deposited along a 400 m reach downstream from the dam, by the creation of two artificial gravel berms according to “point bar stockpile method” (Ock et al., 2013; fig.1). To facilitate the remobilization of the left-side berm, a trench was cut into the deposit. In addition, new rules of hydraulic transparency are established in order to increase sediment input in the restored reach. The general objective of the restoration project is to improve the hydromorphological conditions of the degraded reach downstream from the dam. A complementary objective is to reduce the flooding risk upstream from the dam.

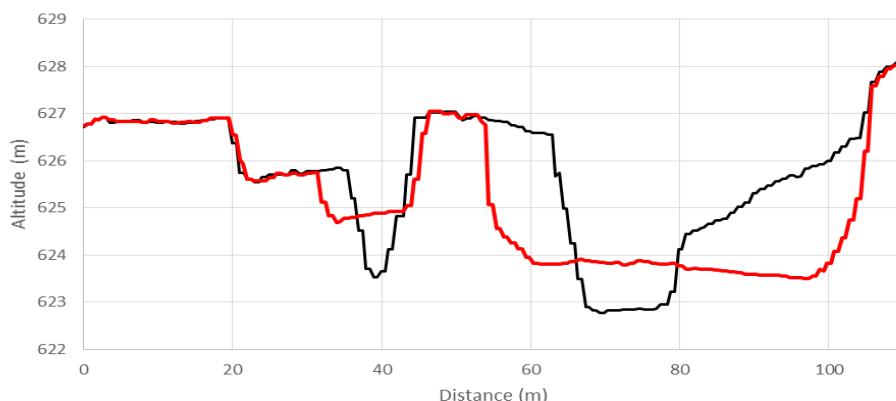
Figure 2: Eroded cross section after Q₁₀ flood.

This graph is obtained by DEM differencing (after restoration in black and after flood in red). See the right and central erosion of artificial berms. Left berm was not really eroded because of not flooded surface and low energy in the trench.

(6100 m³) and on the central berm (13,000 m³) but very low on the left berm (1100 m³, fig.2). The trench has been strongly shortened (380 m to 198 m). Its relative elevation from the main channel increased and its slope decreased from 0.54 to 0.2%.
