Damage of woven composite under tensile and shear stress using infrared thermography and micrographic cuts

T. Lisle¹ · C. Bouvet¹ · M. L. Pastor¹ · T. Rouault² · P. Marguerès¹

Abstract Infrared thermography was used to study damage developing in woven fabrics. Two different experiments were performed, a $\pm 45^\circ$ tensile test and a rail shear test. These two different types of tests show different damage scenarios, even if the shear stress/strain curves are similar. The $\pm 45^\circ$ tension test shows matrix hardening and matrix cracking whereas the rail shear test shows only matrix hardening. The infrared thermography was used to perform an energy balance, which enabled the visualization of the portion of dissipated energy caused by matrix cracking. The results showed that when the resin is subjected to pure shear, a larger amount of energy is stored by the material, whereas when the resin is subjected to hydrostatic pressure, the main part of mechanical energy is dissipated as heat.

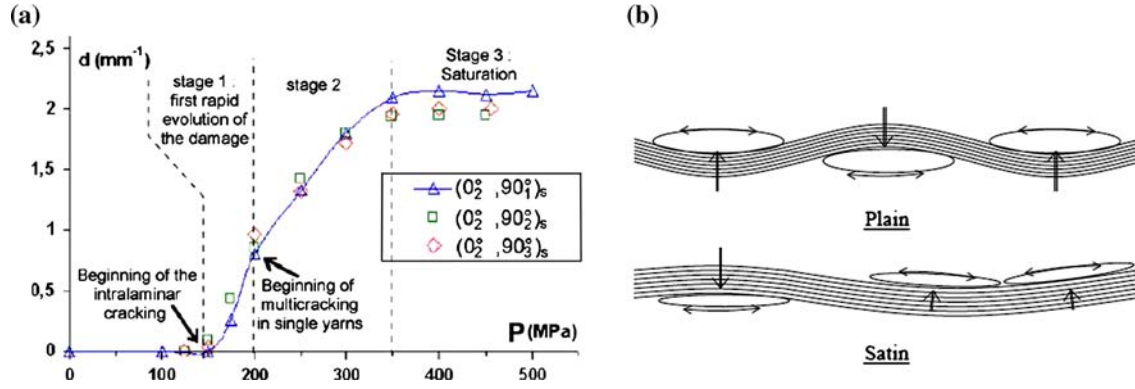
Fig. 2 a Changes in cracks density (cracks/mm) in 90° plies for 4-harness satin balanced glass/epoxy $[0_2, 90_n]_s$ ($n = 1, 2, 3$) woven composites [19]. b Bending loads in the transverse yarns [3]

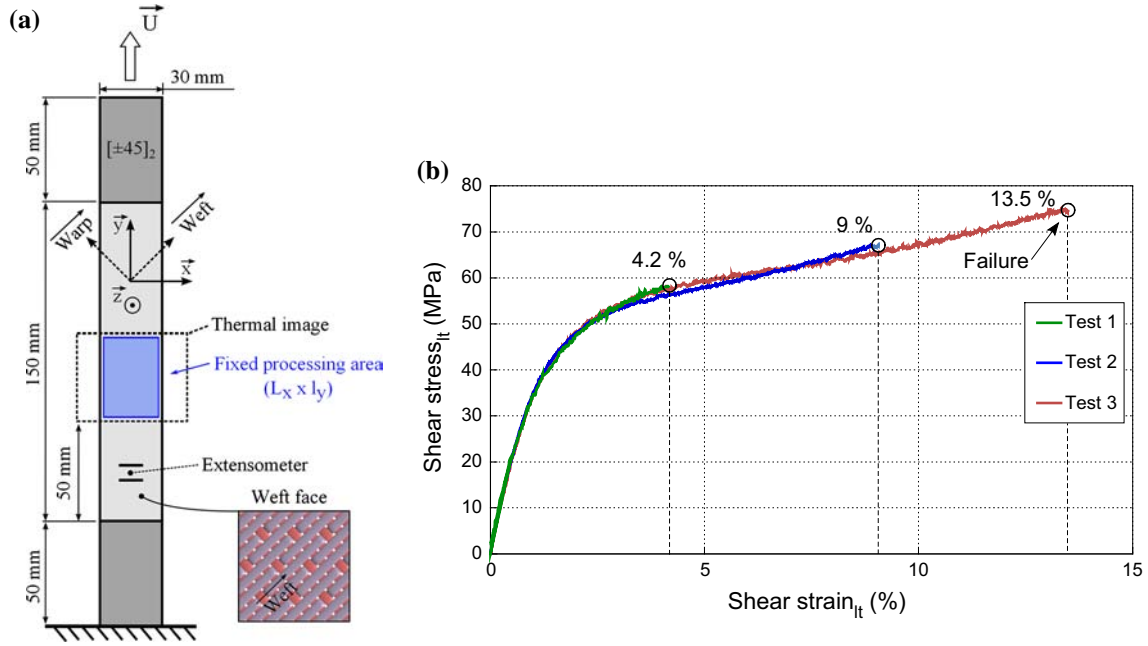
Fig. 7 **a** Geometry of the traction samples $[\pm 45]_2$ and **b** stress/strain curves of different tests

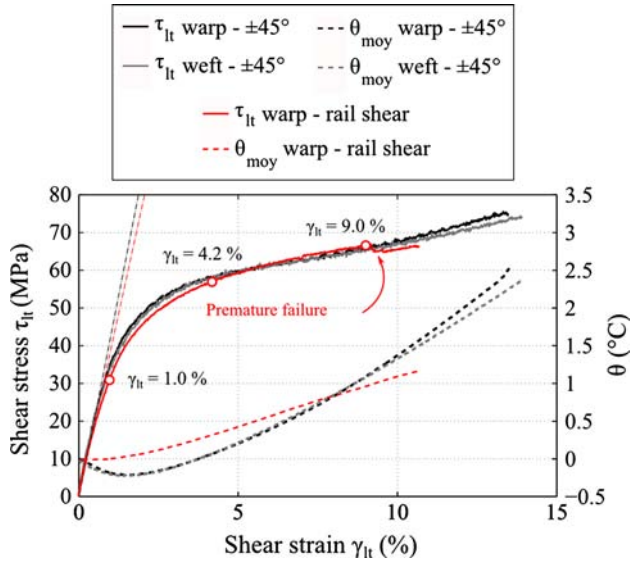
The results obtained on weft and warp faces (for two different specimens) are presented in Figs. 10 and 11. The stress/strain curves (Fig. 10) are identical until a shear strain of about 9 %, beyond which the macroscopic behaviours of the two specimens differ slightly. Nevertheless the evolution of the average temperature follows the same trend. The warming of the weft face specimen decreases slightly compared to that observed on the warp face (Fig. 10) around a shear strain of 9 %. The weak difference observed is certainly due to a problem of experimental reproducibility. Let us note that this divergence appears for a strain level where yarn reorientation is observed.

Fig. 10 Stress/strain curve and evolution of the average temperature of two different $\pm 45^\circ$ tensile tests and a rail shear test

The change in the average temperature on the warp face are plotted in Fig. 10. Contrary to the off-axis tensile tests, no thermo-elastic cooling phase is observed during the elastic linear phase. The temperature variation is equal to

zero. For a level of strain of approximately 0.9 %, the temperature increases linearly until the appearance of the early failures on the specimen edges where the test is stopped (Fig. 10). Taking into account the previous micrographic observations (no micro-crack), this increase represents the heating generated by the “pseudo-strain hardening” of epoxy resin in shear. This heating is comparatively weaker than the one observed during the $\pm 45^\circ$ tensile tests, but more homogeneous (Fig. 15a).

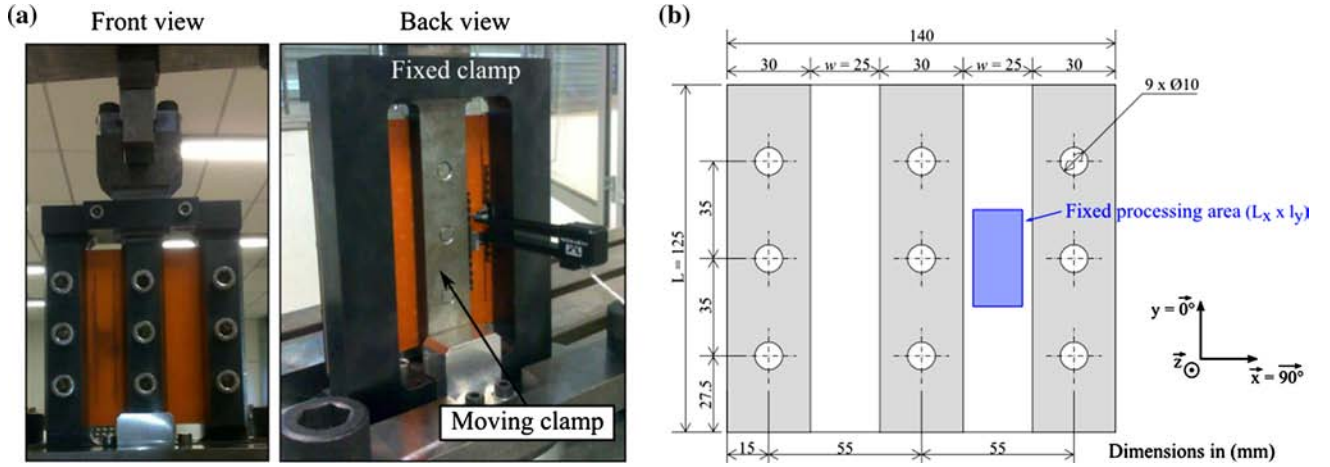
The moving clamp (Fig. 13a) is moved at 3 mm min^{-1} , which corresponds to a rate of shear strain ($\approx 0.8 \times 10^{-3} \% \text{ s}^{-1}$) approximately 8 times lower than the shear strain rate obtained during the off-axis tensile tests ($\approx 6.7 \times 10^{-3} \% \text{ s}^{-1}$). The comparison of the stress/strain graphs (Fig. 10) shows a good correlation between the two tests until a shear strain of approximately 9 %. From this strain level, a stiffening generated by the fibre reorientation appears on the $[\pm 45^\circ]_2$ specimens, and a premature shear breaking of the specimens occurs in the specimen corners near the embedded edges. Figure 14 presents a micrograph cut (MEB) obtained for a shear strain of 7.2 %. At this value, inelastic strains and stiffness reduction are observed by [14], whereas the material does not present any damage on a microscopic scale. Indeed, no resin micro-cracking or “crazing” is observed. This failure mode occurs in areas exhibiting important hydrostatic strain or strong localized plasticity. This phenomenon is due to development of 10-nm diameter micro-porosities propagating perpendicular to the tensile direction until a crack is created [26]. The crack planes are then connected by a fibril network (polymer fibre made up of several macromolecular yarns) of a few nanometres in diameter. If the damage occurs on such a scale, it cannot be detected using the current method. These observations are consistent with those of [14] that shows only some isolated microscopic cracks for a cyclic loading, which is insufficient to justify the degradation of the macroscopic behaviour. This behaviour differs from the $\pm 45^\circ$ tensile behaviour where micro-cracking appears for lower strains (Fig. 8). Reference [27] showed through several tests (traction, compression, shear) that the epoxy resin behaviour and its failure mode strongly varied according to the amplitude of the hydrostatic part of the stress tensor. The authors show that when the hydrostatic part is important (tensile test), the resin presents a

Fig. 13 **a** Experimental set-up of the rail shear test and **b** geometry of the associated sample [13]

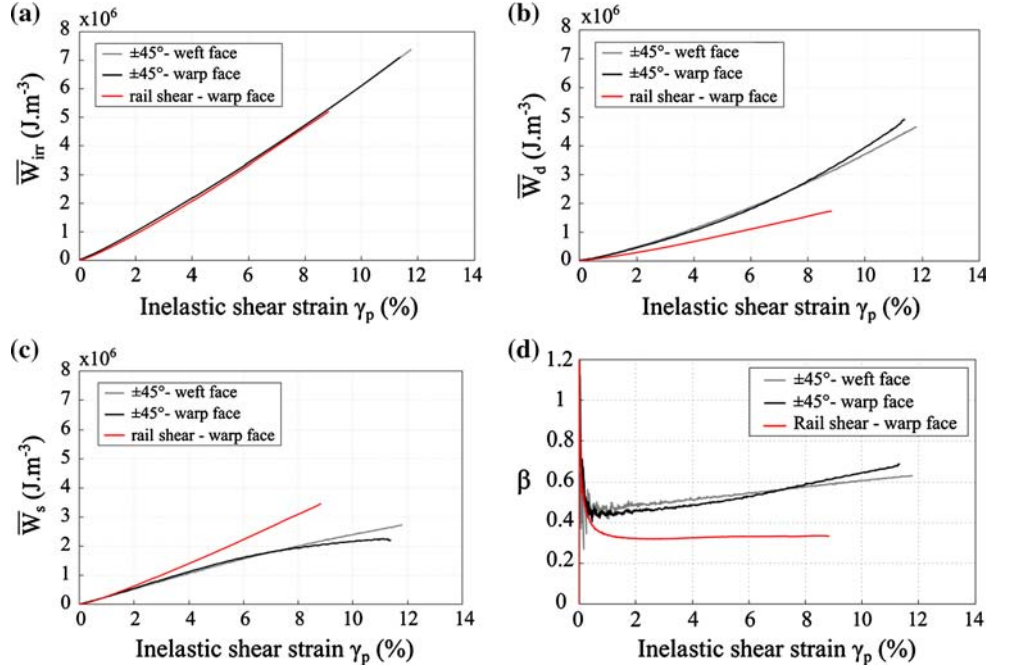
A comparison of the energy W_{irr} , W_s and W_d obtained from tensile test and rail shear test is presented in Fig. 17 versus the permanent shear strain γ_p . The evolution of the volume irreversible mechanical energy (inelastic energy) is similar for tensile and rail shear tests. It increases nearly linearly versus the inelastic deformation (Fig. 17a).

In spite of the fact that the irreversible energy is similar for both tests, the rail shear test dissipates less heat energy density compared to the tensile test. As previously

Fig. 17 Comparison between the $\pm 45^\circ$ tension test and the rail shear test of **a** the irreversible energy, **b** the dissipated energy, **c** the stored energy and **d** the β coefficient

mentioned, a larger dissipation is obtained for the off-axis tensile test due to the development of micro-cracks in the transverse bundles.

Figure 17c shows a comparison between the evolutions of the stored energy densities. The evolution of irreversible energy being similar between the two types of tests, the stored energy density is logically superior for the shear test ($W_s = W_{irr} - W_d$). As previously mentioned, for the same material and the same mechanical energy (which is the case here), a purely pseudo-plastic process tends to store more energy than a process combining brittle damage and inelasticity; this is consistent with the observation of a less dissipative process like the rail shear test. Concerning the off-axis tensile tests, whatever the viewing side, the evolution of the different energy densities remains similar up to about 8 % of inelastic strain which coincides with the apparition of the phenomenon of stiffening due to bundle reorientation. The similarity between the energy dissipated on the two sides of the woven fabric supports the assumption of homogeneous source fields throughout the thickness.
