Fatigue crack growth in thin notched woven glass composites under tensile loading. Part I: Experimental

M. Bizeul^a, C. Bouvet^{a,*}, J.J. Barrau^a, R. Cuenca^b

ABSTRACT

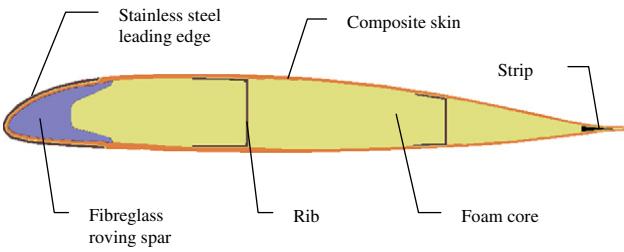
Fig. 1. Typical helicopter blade section.

For example, the skin of helicopter blades is often made of a few woven plies (Fig. 1). In these thin structure parts, a through-the-thickness crack might appear in service; such a crack could initiate and propagate from existing defects caused by manufacturing processes, stress concentration or low-energy impact [1]. In order to anticipate such a scenario which could slightly modify the rotor dynamic behaviour, it seems useful to study the crack propagation in these skins in fatigue. Blade loads are mainly defined by centrifugal forces and flap and drag bending moments due to cyclic aerodynamic loads. These structures are therefore subjected to fatigue stresses where the primary load is tension due to centrifugal effects.

In analyzing a typical blade section (Fig. 1), it can be stated that the skin has to follow the longitudinal strain of the spar mainly loaded by centrifugal effect. This remark leads to the development of a technological fatigue test specimen (Fig. 2) having a width 50 mm. A severe notch is performed on one edge with a 0.2 mm diameter diamond thread to limit the through-the-thickness crack initiation duration. On the other edge, a strip of T300/914 unidirectional carbon fibres having a stacking sequence of $[0]_2$ is placed to get closer to the real loading conditions and plays the role of spar. It also reduces the likelihood of global inelastic strains occurring

Usually, helicopter blade skins are mostly made of ±45° woven plies in order to ensure the torsional stiffness of the profile (Fig. 1). Thus, fatigue tests at controlled strain ratio are carried out on specific specimens (Fig. 2) with carbon strip on one edge in order to represent the blade spar and ±45° woven laminate elsewhere. The propagation of a white damage zone is monitored in particular test configurations detailed below. With the initial specimen (Fig. 2), the crack growth is very slow and even stops even in the case when the notch length is increased. A damage zone appears in the tip of the notch in a V-form (Fig. 8) and stays stationary. Owing to back-illumination, this zone appears in dark on the

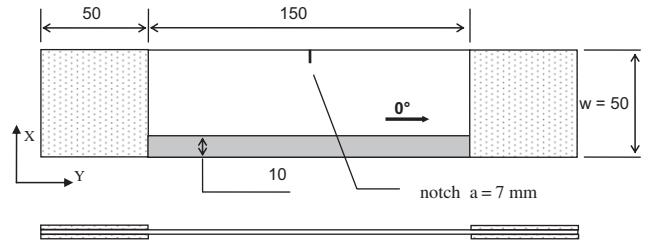
Fig. 2. Fatigue specimen test characteristics.

under fatigue loading. The fatigue tests are conducted under strain control at room temperature (about 20°C) on a 100 kN closed-loop servo-hydraulic Instron tension machine, with an extensometer placed on the carbon strip, at a frequency of 20 Hz. The imposed strain levels are $\varepsilon_{\min} = 10^{-3}$ and $\varepsilon_{\max} = 3 \times 10^{-3}$. This maximum fatigue strain level corresponds to the infinite life asymptote in $S-N$ curve [7-11] and is widely used as design fatigue strain for structures made of glass plies. The specimen is cooled down to room temperature by a fan and its temperature is saved (the thermocouple sensor is located 10 mm under the notch). Furthermore, no increase in temperature was recorded.

In order to study the crack growth in a larger domain and to reduce the mean initiation duration, the geometric characteristics of the specimen have been modified (**Fig. 2**): The ratio a/w has been increased in order to limit the initiation duration and the specimen width is larger.

Stacking sequences of blades skins are mostly a combination of those simple ones previously studied. In accordance with this remark, the crack growth in $[45; 0; 45]$ "quasi-isotropic" laminates is investigated. The warp direction of the 0° woven ply corresponds to the loading direction. The specimen is similar to that used for the warp and weft campaign (Fig. 2) and thus presents a carbon strip on one edge. The other test characteristics are identical.

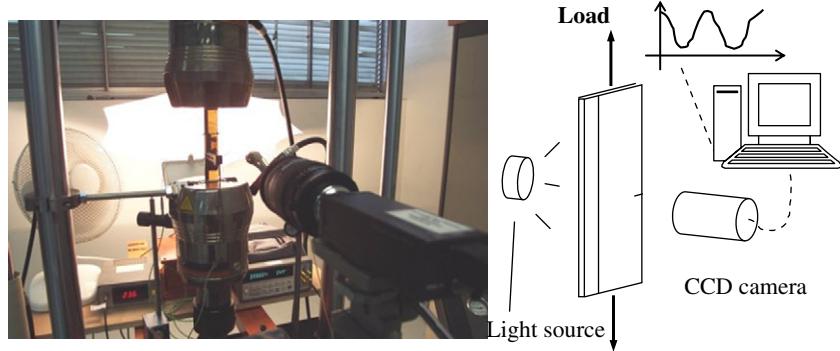
The crack growth is monitored with the help of a CCD camera (Fig. 3). The different devices are driven with the help of a Labview program. Due to the relative transparency of the glass fibres reinforced plastics, the propagation of a white damage zone by back-illumination is observed. This kind of phenomenon was also described by [5,9]. In a previous work [12], this damage zone was identified as a through-the-thickness crack all along by microscopic investigations. Since the beginning of the crack growth, this damage zone has presented tows breakage even in the tip. This damage zone also contains transverse yarn cracking and delaminations [13].

Fig. 3. General and schematic views of the experiment setup.

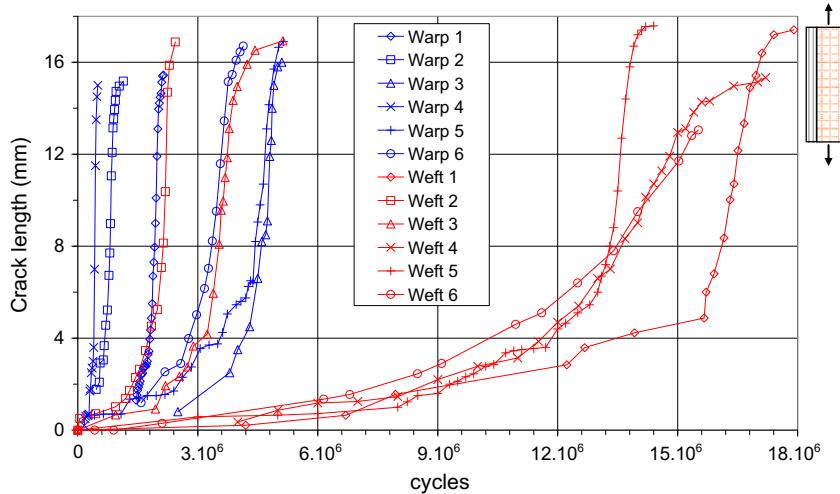
Earlier experiments [12] showed a different behaviour between warp and weft directions of the studied balanced woven ply under static loading as well as in fatigue, especially in crack propagation tests in samples of 30 mm width (Fig. 4). The main fact underlined by these results is the large dispersion between samples in both cases, either for the laminates with warp tows coinciding with load direction, or for the weft ones. It can be noted on this figure, the six warp and weft samples are exactly the same, only the initial crack tip position relative to the yarns should be different (this manufacturing parameter is difficult to control). These differences have been connected to the crack initiation time [12] which depends on the solicitation direction and on the initial crack tip position relative to the yarns position. In fact, more the initiation time is long, more the crack growth decreases because of the extended of the damage zone. This fact may be due to the small number of plies [14] and perhaps because the experiments are led in strain controlled. Moreover, the crack growth initiation duration in warp laminates was lower than in weft laminates. As the weft direction undulation is more severe, the matrix damage in this direction appears sooner. So, the initiation phase lasts more and the crack growth rate decreases because of the extended damage zone.

Fig. 4. Fatigue crack growth in warp [0]₂ (a) and weft [90]₂ (b) laminates in samples of 30 mm width.

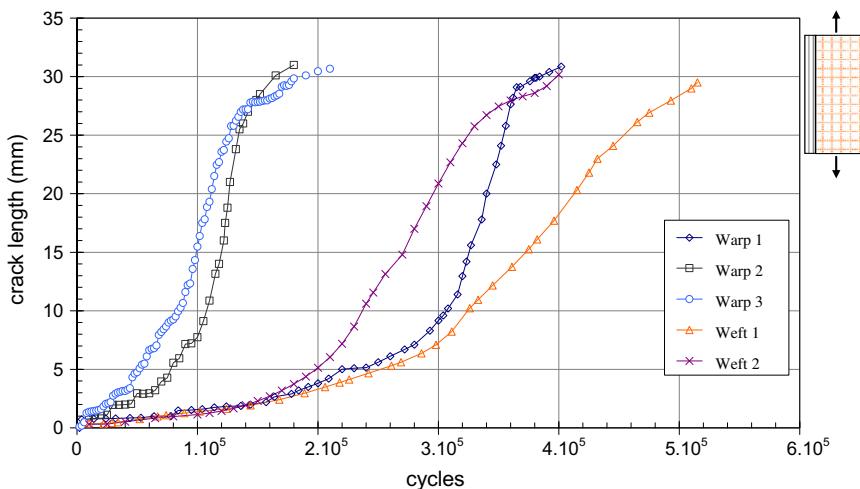
The crack growth in 50 mm width samples exhibits qualitative similarity (**Fig. 5**). It can be noted, on this figure, the three warp and the two weft samples are exactly the same, only the initial crack

position relative to the yarns should be different. Three stages are easily noticed: the first two are commonly observed [3,4]: the "initiation" phase where crack length does not exceed 3 mm and the "stable propagation" phase. The last one corresponds to the crack arrest due to the carbon strip influence.

Fig. 5. Fatigue crack growth in warp [0]₂ and weft [90]₂ laminates in samples of 50 mm width.

Actually, two main observations are noteworthy. First, the different behaviour between warp and weft directions in crack propagation does not subsist, as the crack growths are similar and even

overlap for two warp and weft samples. The second point is about the crack propagation test duration. This period of time is divided by around 10 compared to the previous geometry where the specimens' width was equal to 30 mm. Moreover, as the crack initiation duration does not vary as much as the one corresponding to 30 mm width specimens, the crack growth rates are of the same order (Table 1). Table 1 recalls the extreme results of crack growth in 30 mm width samples of the previous experimental campaign and specifies key results of crack growth in the 50 mm width samples. The initiation duration is determined owing to the typical decrease of crack growth rate at the beginning of the propagation (Fig. 6). This phenomenon is associated with the microstructure influence on crack growth [3,4]. Bizeul et al. [12] stated that crack growth evolves regularly when three to five tows are broken. In other words, as the yarn width is equal to 0.5 mm, microstructure influence seems to exist when the crack length is less than 3 mm.

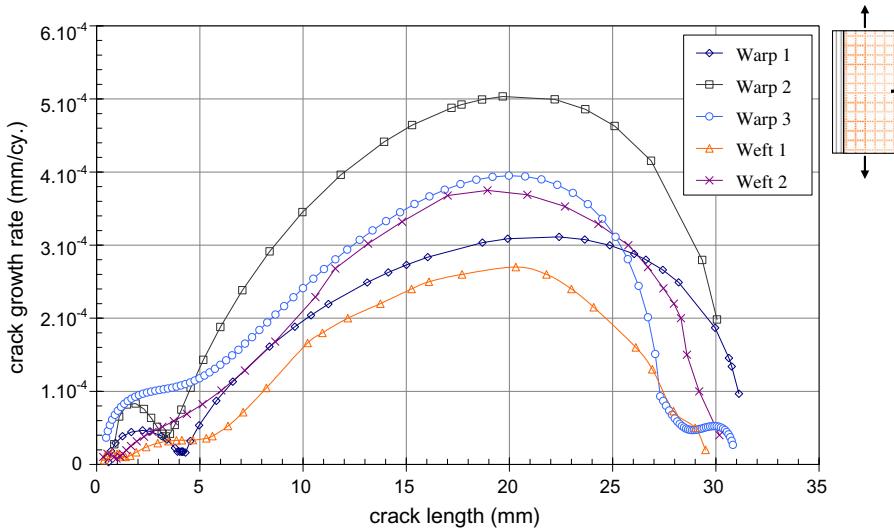
Fig. 6. Crack growth rates versus crack length in warp $[0]_2$ and weft $[90]_2$ laminates in samples of 50 mm width.

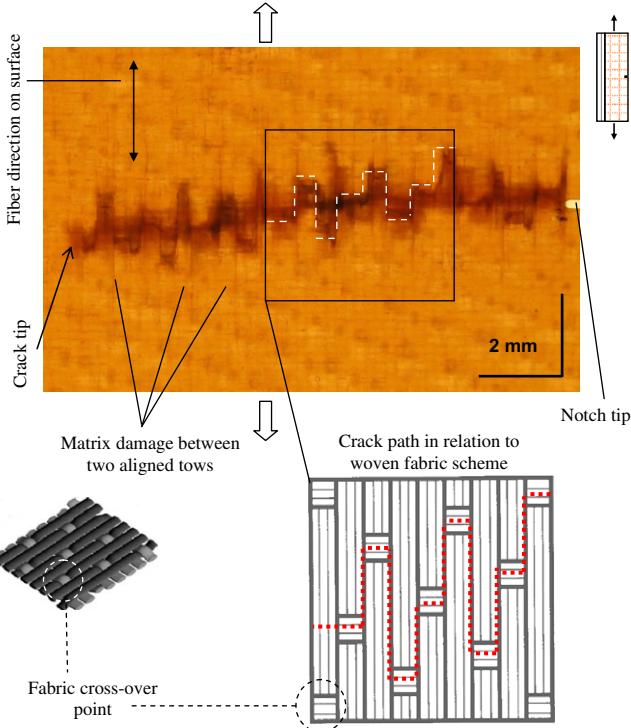
The microstructure of the studied woven ply acts not only on the initiation duration but also on the crack path. It is interesting to examine the local crack path in relation to the woven scheme (Fig. 7). The warp side of the woven ply is observed on the photograph; the warp tows are then visible on the surface and lined up with the fatigue tensile load. The theoretical basic 8-harness satin weave pattern is shown next to the photograph. The crack path is overall straight but in focusing on the local crack path, it can be seen that the cross-over points of the woven plies are ideal places for fibre tow failure. The photograph also highlights that thin longitudinal matrix cracks are localized in the interstice between two consecutive tows and their lengths are limited by cross-over points.

Fig. 7. Crack path in relation to woven fabric scheme in $[0]_2$ notched laminate loaded in fatigue.

These observations are in accordance with [5,8,10,15,16] where fatigue damage in the on-axis directions is initiated by cracks in transverse fibre yarn, and are deflected along the longitudinal yarn (meta-delamination) and finally leads to 0° tow fracture at crimp regions.

Additionally, from examination of the crack, it seems realistic to say that a tow of fibre always breaks entirely. This remark is consistent with the work of [17]. The crack extends in a discrete manner and is linked to tow width [2].

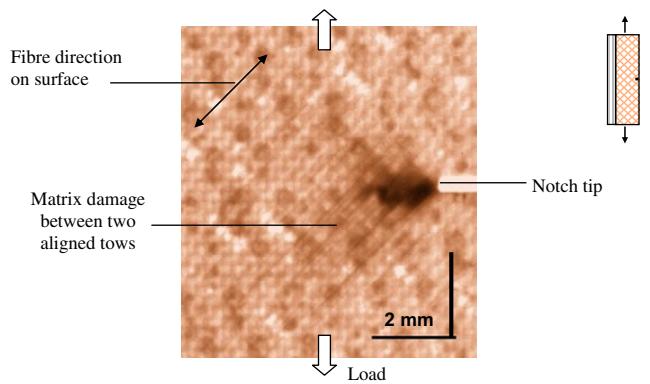
photograph taken at the maximum fatigue strain level (5×10^6 cycles), which results in a through-the-thickness crack of less than 2 mm. It should be pointed out that matrix damage extends over the crack tip in the form of thin and straight matrix cracks between aligned tows.

Fig. 8. Crack length after 5×10^6 cycles in $[45]_2$ notched laminate loaded in fatigue.

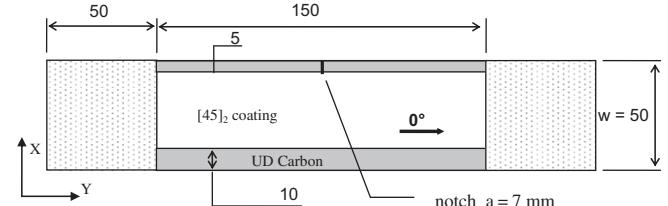
The accumulation of matrix damage specific to [±45]_n laminates [18], tends to limit the stress concentration in the vicinity of the crack tip and basically the crack growth. Hence, changes are made on the specific specimen to improve the initiation and the propagation of a through-the-thickness crack in [45]₂ laminates while maintaining the fatigue strain levels previously fixed. In order to get closer to the complex service loading conditions of blade skins, the trailing edge strip influence has been taken into account (Fig. 1). This rear strip has many functions such as closing the torsion box of the profile, dragging a part of centrifugal load and adding trailing flexural stiffness to the blade. The fibres of this structural part are then aligned with the blade longitudinal axis like leading edge spar fibres. Yet, the initial specific specimen lacks longitudinal stiffness on the notch side and the main part of the tensile load goes on the other side in the carbon strip. A small part of the load is thus drained in the notch tip, slowing even the crack initiation. In order to observe a fatigue crack growth in these bias woven laminates, the technological specimen has been modified accordingly (Fig. 9). A similar UD carbon strip has been placed on the other edge of the sample, acting as a trailing edge spar. After polymerization and cutting a notch with a diamond thread, whose length is narrowly greater than the strip width.

Fig. 9. Fatigue specimen test characteristics modified for $[45]_2$ laminates.

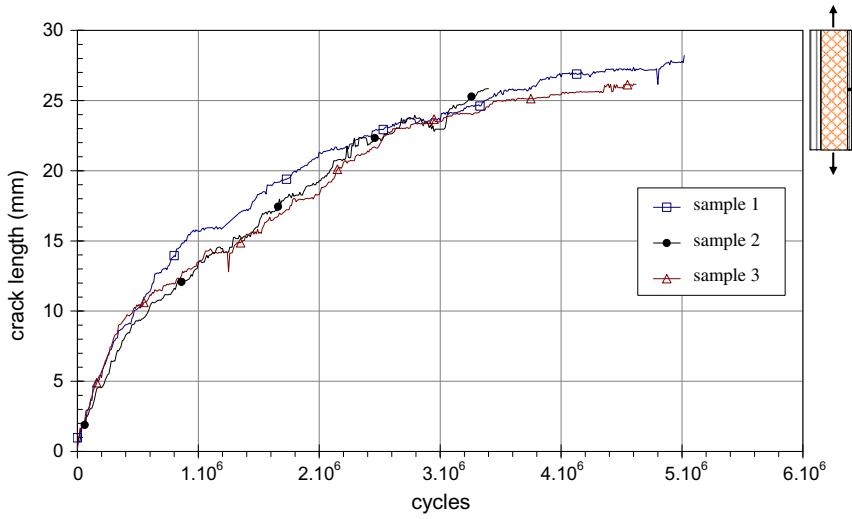
The crack initiation is instantaneous with such a test configuration (Fig. 10), however the crack growth tends to slow down gradually. The fatigue tests show very similar results and have a duration of about 5×10^6 cycles. This may be attributed to the fact that in the beginning of the test, crack growth rate is high, the crack initiation duration remains thus low and relatively close to a specimen to another. Unlike oriented laminates, the initiation duration has negligible influence on crack growth.

Fig. 10. Fatigue crack growth in $[45]_2$ laminates with two carbon strips.

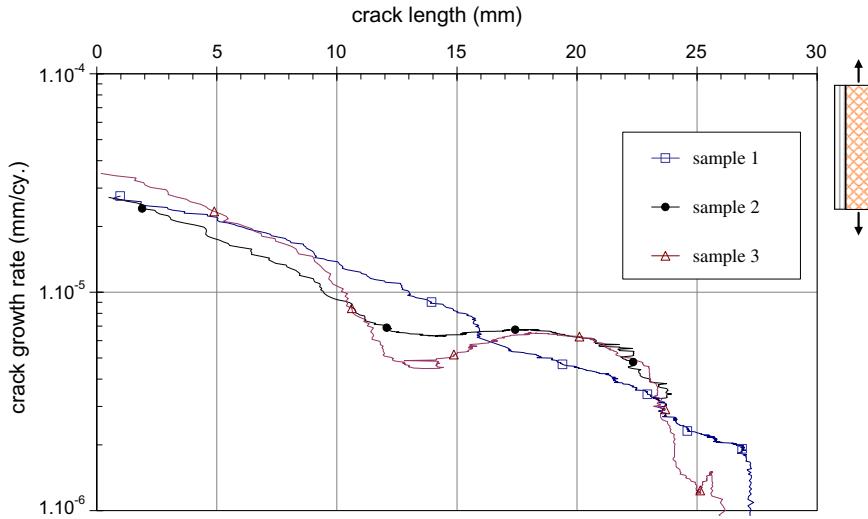
After measuring the crack growth in fatigue, the crack growth rate is deduced and plotted versus crack growth for each sample (Fig. 11). In the beginning of the crack growth, its rate decreases and then reaches a steady state when crack length is between 10 and 20 mm. Finally, the crack growth tends to "stop" when the crack length measures 25 mm, corresponding to a distance of 8 mm from the carbon strip acting as a leading edge spar. Thus, inelastic strains are likely to occur in fatigue in [45]₂ laminates as reported by [8,19], especially in the vicinity of the crack tip. This phenomenon is due to the damage of the resin under shear solicitations and to the fibres rotations. As the fatigue tests are led in a strain control environment, the stress concentration in front of the crack is reduced with the appearance and development of inelastic strains. It seems that there is a threshold below which propagation cannot occur, as underlined by the fatigue tests on specimens without UD reinforcement corresponding to blade rear strip.

Fig. 11. Fatigue crack growth rate in $[45]_2$ laminates with two carbon strips.

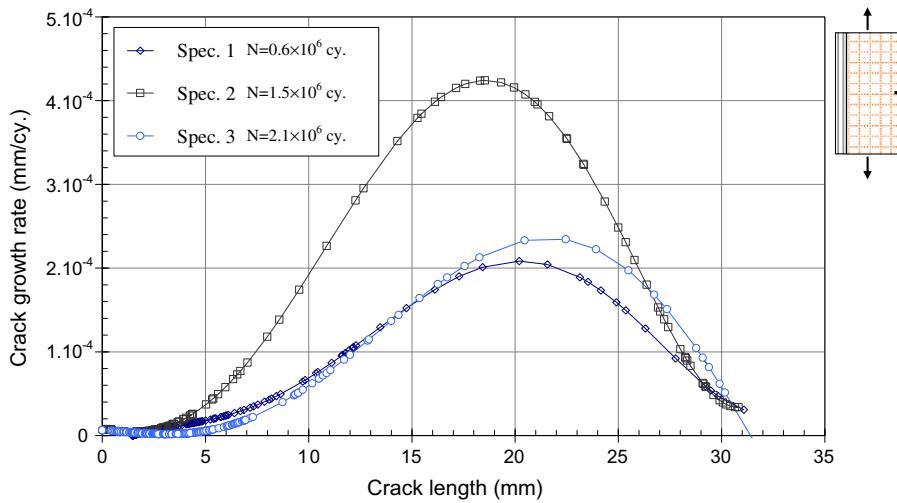
The crack growth in "quasi-isotropic" laminates follows the same three stages of the warp laminates i.e., the crack growth is very slow when the crack length remains less than 3 mm, then the crack growth rate increases until it reaches a maximum corresponding to a crack length of 20 mm and eventually decreases quickly (Fig. 13). The maximum crack growth rate levels are very close to those recorded in warp laminates. Nevertheless, it should be noted that the first stage of crack growth, usually called 'initiation phase', lasts a long time in comparison with the warp laminates one. The test duration is between 0.6×10^6 and 2.1×10^6 cycles and the 'initiation phase' corresponds to 70% of this period, while the test duration for warp laminates is four times lower and the first related stage is equal to 40% of this time.

Fig. 13. Fatigue crack growth rate in [45; 0; 45] laminates.

These comparisons seem to show that the fatigue crack propagation in "quasi-isotropic" laminates amounts to crack growth in warp laminates whose initiation duration lasts a long time. Therefore, the layers at $\pm 45^\circ$ tend to slow the through-the-thickness crack initiation and its growth, at least until reaching a certain length. Then after this time period, the fatigue crack growth in "quasi-isotropic" laminates is similar to that found in the warp laminates. Marissen et al. [6] mentioned the same type of influence for $\pm 45^\circ$ plies in notched quasi-isotropic laminates.

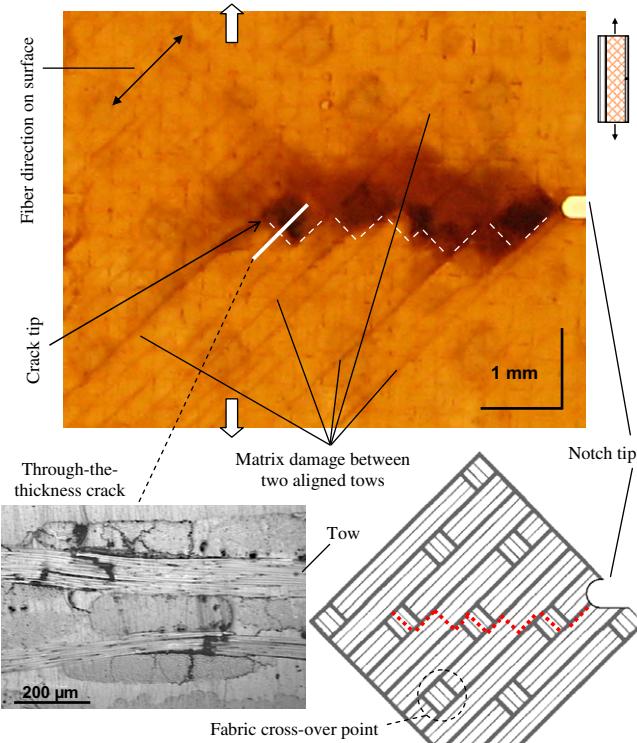
The visible white damage zone which propagates corresponds to a through-the-thickness crack (Fig. 12). Tow breakage are easy to recognize in microscopic investigations if observations are carried out perpendicular to the fibres. Tow fracture mainly appear in the fibre undulation areas. Typical damages in woven ply also exist i.e., meta-delaminations, transverse microcracks, etc.

Again, optical analysis reveals that the local crack path in $[45]_2$ laminates is influenced by the weave pattern and the tow width (Fig. 12). As observed by Woo et al. [16], the through-the-thickness crack propagates perpendicular to yarn fibres and thus shifts alternately between $\pm 45^\circ$ directions. The entire crack path remains overall straight and perpendicular to the load direction. In addition,

Fig. 12. Crack path in relation to woven fabric scheme in [45]₂ notched laminate loaded in fatigue.

it is noticeable that the crack extends according to the fibre tow width and the tows always seem to break completely.

Once more the crack path has to go through the nearest cross-over points of the woven plies; yarn failures mainly occur in these crimp areas. Finally, it is interesting to note that matrix damage surround the crack path. These consist especially of thin and long matrix cracks parallel to the fibres. It seems appropriate to associate these observations with the matrix degradation in the gap that exists between two consecutive yarns. Only the thin cracks parallel to the fibres closest to the surface are visible. They form a halo around the crack which extends over a length around 2–3 mm in the direction of fibres on both sides. Damage in V-form is visible in the crack tip.
