Damage assessment of ancient masonry churches stroked by the Central Italy earthquakes of 2016 by the non-smooth contact dynamics method

Francesco Clementi, Angela Ferrante, Ersilia Giordano, Frédéric Dubois,
Stefano Lenci

Keywords Non-smooth contact dynamics · Central Italy earthquake · Historical structures · Apennine churches · Damage survey

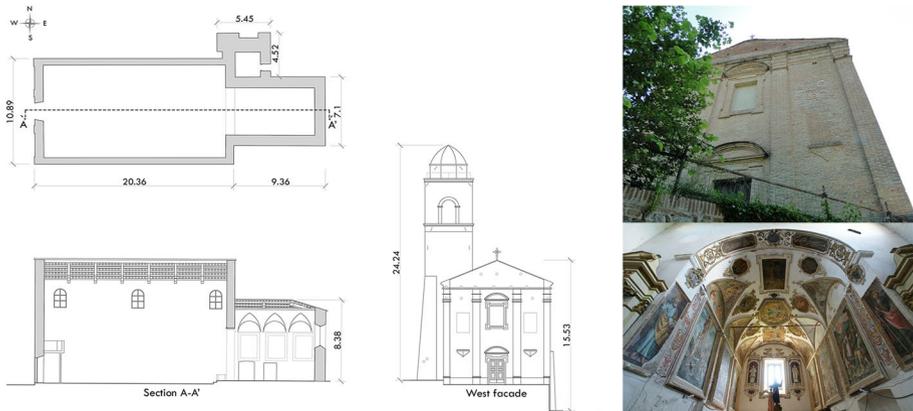
Fig. 2 Geometric configuration of San Francesco's church, Montefortino

The San Francesco Church was built in the fifteenth century on the remains of the ancient Santa Maria of Girone church. The church has a Romanesque-Gothic style, featured with a unique nave with a length of 10.89 m, and a width of 20.36 m, and a maximum height of 15.53 m. The apse has dimensions 9.36 m of length and 7.1 m of width and covered by a barrel vault. The belfry is on the north façade with a height of 24.24 m (see Fig. 2). Following the earthquake occurred in September 1997, the church suffered serious damages on the façade, on the vault of the apse and the upper part of the tower and some retrofitting interventions were carried out in the following years. The roof is made with timber elements. The bearing structure is made of disordered rubble stone masonry.

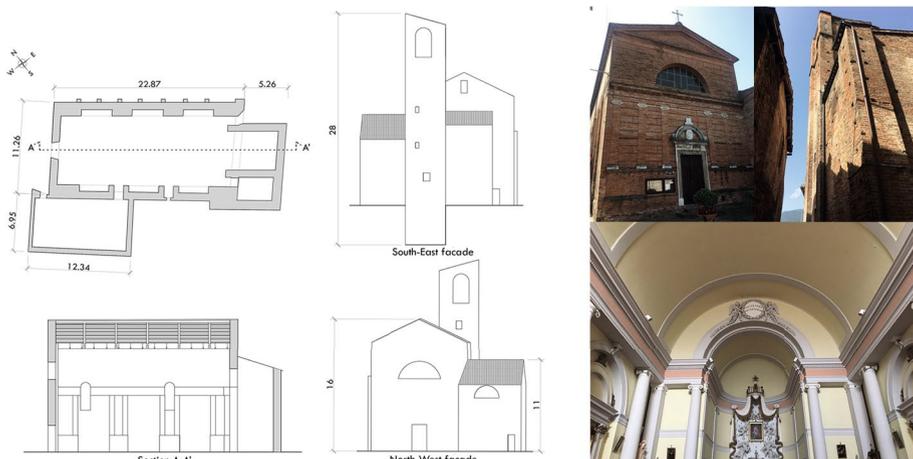
Fig. 3 Geometric configuration of San Francesco's church, Sarnano

The church goes back to the fourteenth century, and it was renovated in 1833; during this restoration, the church was elevated of about 4 m to make grant lighter, then a camorcanna barrel vault (it is featured with camorcanna, a type of vault made of a wood structure where reed mats are hanging and subsequently plastered) and ionic columns were added. Between 2014 and 2015 the church was restored again. The building has a unique nave of 11.26 m wide, 22.87 m long with a maximum height of 16 m and the tower has dimensions of 5 m×6.5 m and a height of 28 m. On the south-west the church is connected with a little chapel, with a rectangular plant of 12.34 m length and 6.95 m width, the maximum height is of 11 m (see Fig. 3). The church has a timber roof. The bearing structure is made of solid bricks masonry.

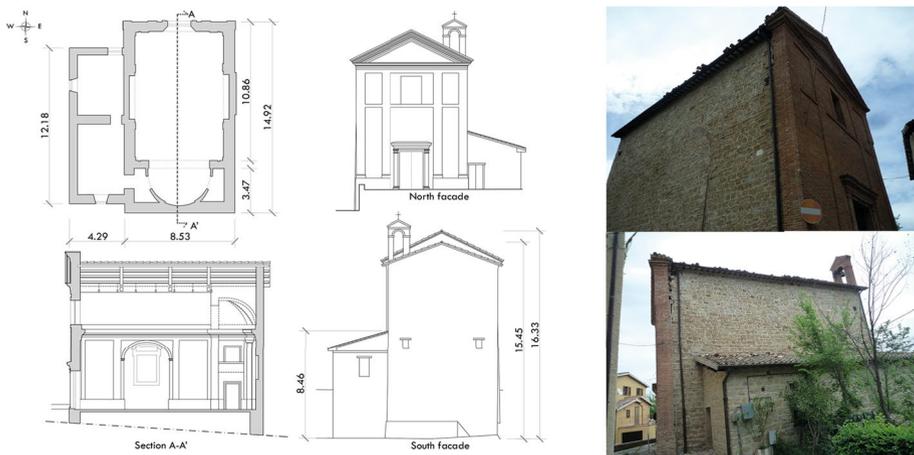
Fig. 4 Geometric configuration of Sant'Anna's church, Camerino

It was built in the thirteenth century and erected in place of a church seriously damaged by a quake occurred in 1799. During the seismic event of Umbria-Marche in 1997, the church had a structural failure of the foundation; the retrofitting intervention was executed in 1999. The church has a unique nave of 8.53 m wide, 14.92 m long and with a maximum height of 16 m. The thickness of the walls is in the range 0.7–0.8 m. The bearing structure is made with disordered rubble stone masonry; the façade is covered by brick masonry. The triumphal arch separates the apse from the nave area. The arch is embedded in a brickwork board, with a circularly molded opening that is about 0.6 m thick. On one side there is an annex that has a rectangular shape with dimensions of 12.18 m × 4.29 m and a maximum height of 8.46 m (Fig. 4).

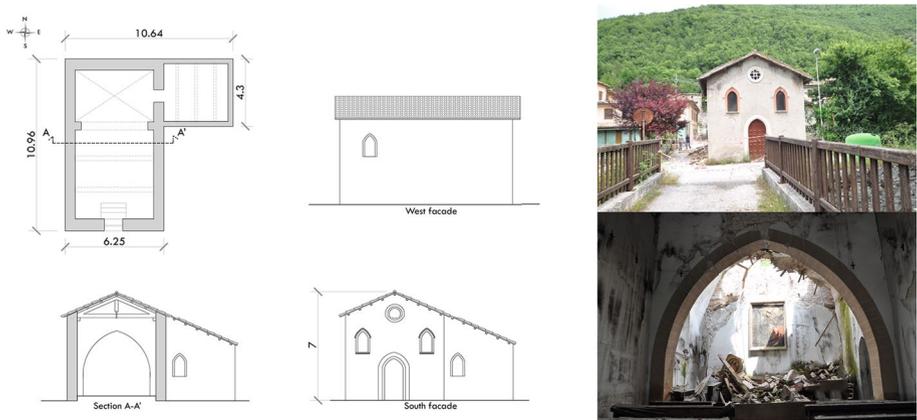
Fig. 5 Geometric configuration of Sant'Antonio's church, Ussita

The little church goes back to the seventeenth century; it has suffered serious damage after the 1997 seismic events. The church has a unique nave of 6.25 m wide, 10.96 m long and maximum height of 7 m. The thickness of the walls is about 0.60 m. The bearing structure is made of disordered rubble stone masonry. The triumphal arch isolates the nave region from the apse, and it is embedded in a brickwork divider, with a gothic mold. The nave is covered with wood roof and the apse has a light camorcanna vault. On one side there is an annex used as a sacristy. It has dimensions of 4.3 m × 4.4 m and height of 3.6 m (Fig. 5).

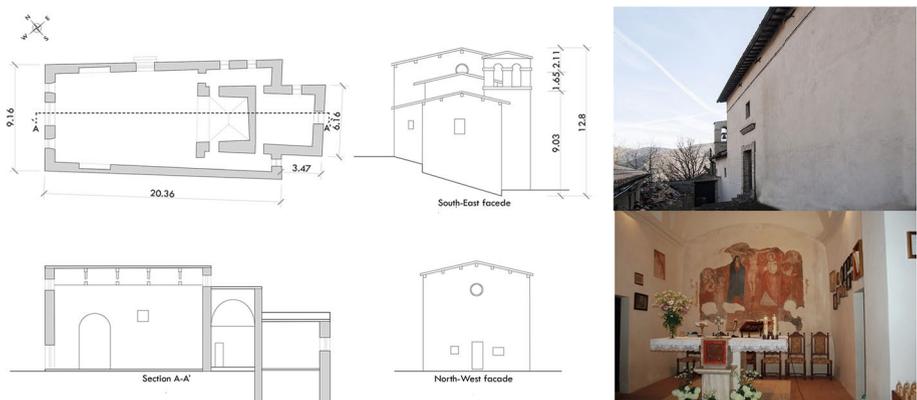
Fig. 6 Geometric configuration of Valcora's Sanctuary, Fiuminata

It is located in the upper valley of the Potenza river, near the village of Fiuminata. The first documents date back the church between 1406 and 1435. The construction is simple, and

it was extended in 1728. The church currently has a single nave of 9.16 m wide and 16.2 m long, with a gable roof. The thickness of the limestone walls ranges between 0.5 and 0.8 m. The apse is the only part belonging to the original dwell and it dates to the fifteenth century (Fig. 6).

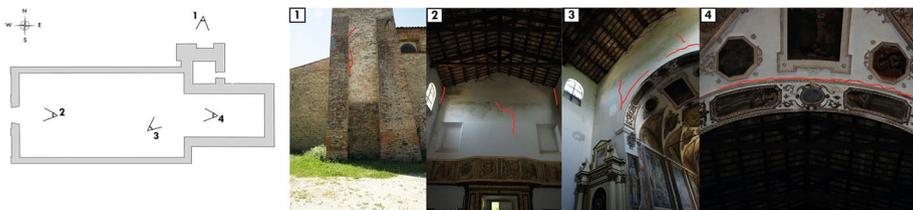
The major cracks appeared on the barrel vault of the apse, decorated with rich stuccos. The presence of a crack, between the bell-tower and the apse, suggest the possibility of the activation of bell tower rotation as also reported in the AEDDES[®] (Zuccaro and Cacace 2015) fast sheet. Some little cracks were developed between the façade and the walls of the nave, on the middle of façade, on the triumphal arch and the connection between the north wall and the bell-tower, Fig. 7.

Fig. 7 Damage survey in the church of San Francesco in Montefortino after the Central Italy Earthquakes of 2016

Comparing the control points #1 and #3, Fig. 15, namely those on the main façade and on the triumphal arch, at varying of the main shocks we can observe that the resultant displacement of #1 is bigger than #3 for the shocks of 24th August and 26th October but becomes comparable with the shock of 30th October, and this confirms what happened in situ, i.e., that the major damages were associated with the main seismic action, where also some residual displacement is noticeable. In fact, comparing the enlargement of Fig. 15 with Figs. 16, 17, and 18, we see an evident out-of-plane displacement of the main façade (with more significant displacement on the top of it) and an in-plane action of the triumphal arch, and incidentally, confirm the real damages in Fig. 7.

occurred on the vault on the apse, namely point #4, where an evident collapse is noticeable with the main shock of the sequence, and again the damage is comparable to the real one reported in Fig. 7.

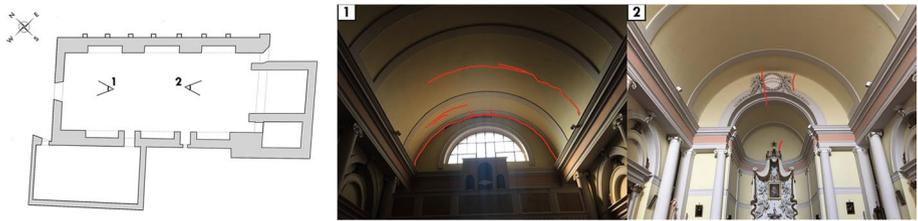
It suffered minor damage; the cracks appeared on the light camorcanna vault of the nave in the middle and in correspondence with the façade, while other little cracks are visible on the triumphal arch, and on the light barrel vault of the apse, Fig. 8.

Fig. 8 Damage survey in the church of San Francesco in Sarnano after the Central Italy Earthquakes of 2016

shock of 26th October, even if the residual displacement of #7 is about 6 cm. Except for the 24th August, the point on the north-east wall of the nave (#5) also shows a high displacement, mainly due to the activation of an out-of-plan mechanism as can be observed from the Fig. 21. Finally, the main façade (#1) always shows a high displacement for all earthquakes leading to an out-of-plane mechanism, clearly visible in the enlargement of Fig. 19 with a significant sliding between the blocks, and this coincides once again with what is observed in reality and reported in Fig. 8.

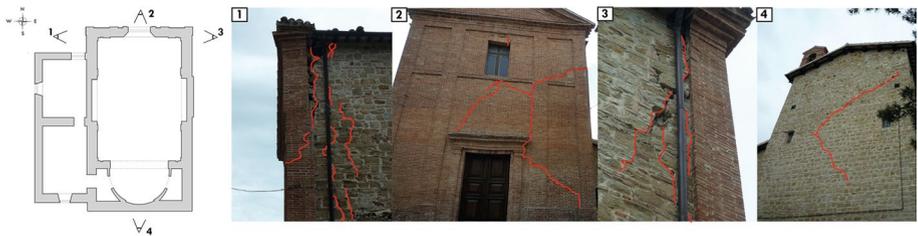
It suffered significant damages mainly on the façade, where a diagonal crack is visible. It is provoked by the separation of the covering in brick masonry from bearing structure, thus the

Fig. 9 Damage survey in the church of Sant'Anna in Camerino after the Central Italy Earthquakes of 2016

activation of the overturning of façade is evident, with cracks that appeared between it and the longitudinal walls of the nave. The south façade clearly shows diagonal cracks, Fig. 9.

most vulnerable part of the church, as well as the façade, as also demonstrated by the real damages in Fig. 9.

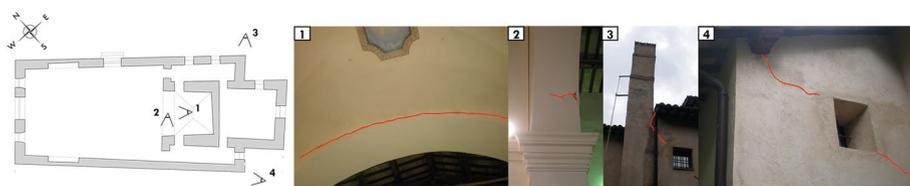
The major crack appeared on the barrel vault of the apse. Minor cracks are widespread on all the complex. The cracks between the church and the bell-gable underline the possible activation of the overturning mechanism, Fig. 11.

Fig. 11 Damage survey in Madonna of Valcora Sanctuary in Fiuminata after the Central Italy Earthquakes of 2016

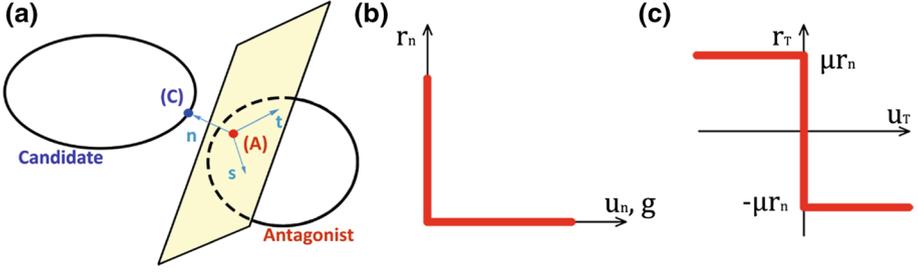
The non-smoothness in the interaction laws are written as multi-valued mappings between contact reactions and the relative velocity, in the framework of the NSCD method (Dubois et al. 2018). This method grants fairly large time steps. In fact, the multi-contact problem resolution consists in solving two groups of unknowns which are global ones, as kinematic space unknowns related to the blocks, and local ones as contact space unknowns, related to interactions, linked together thanks to kinematic and duality relationships.

Fig. 12 Relation between candidate and antagonist in 3D space (a), Signorini's impenetrability condition (b), and friction à la Coulomb (c)

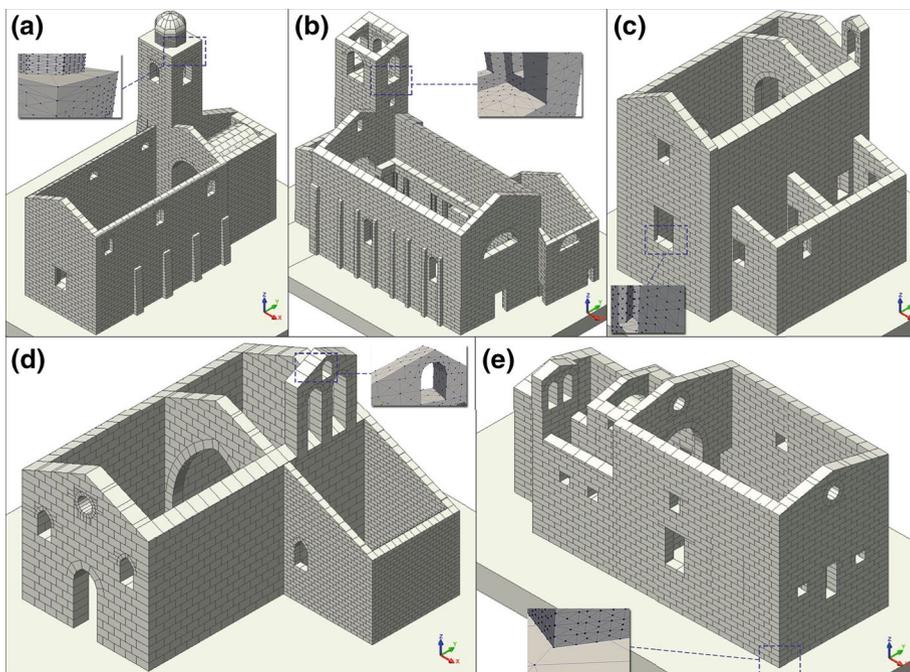
The blocks are represented as convex polyhedral in 3D with each face being a planar convex polygon with rectilinear edges. Here there is mainly face to face contact with four contact points as reported in the enlargements in the Fig. 13. In general, the masonry units (rigid body discretisation) are regularized and expanded to include the thickness of the joints. Because of this procedure, the bricks units are modelled by blocks of different sizes, based on dimensions and characteristic of walls, and the joints have zero thickness. The values adopted for masonry mass density are taken in agreement with the real structures as also suggested by the (Ministero dei Lavori Pubblici e dei Trasporti 2009). The friction coefficient usually varies between 0.3 for old and/or not good masonry, to 0.8 for brand new or repointed masonry (Vasconcelos and Lourenço 2009). Furthermore, it is important to underline that in real old masonry buildings, the degradation of the mortar over time contributes to deteriorating the friction coefficient. As a first attempt, we assume the value $\mu=0.5$ for the interface block/block, and $\mu=0.9$ for the interface block/foundation to observe, mainly, the dynamics of the churches without the structure-foundation interaction. This value, which is kept constant in all simulations, in our opinion provides a good

Fig. 13 The numerical models with the NSCD method for San Francesco's Church in Montefortino (a), San Francesco's Church in Sarnano (b), Sant'Anna's church in Camerino (c), Sant'Antonio's church in Ussita (d), Valcora's Sanctuary in Fiuminata (e)

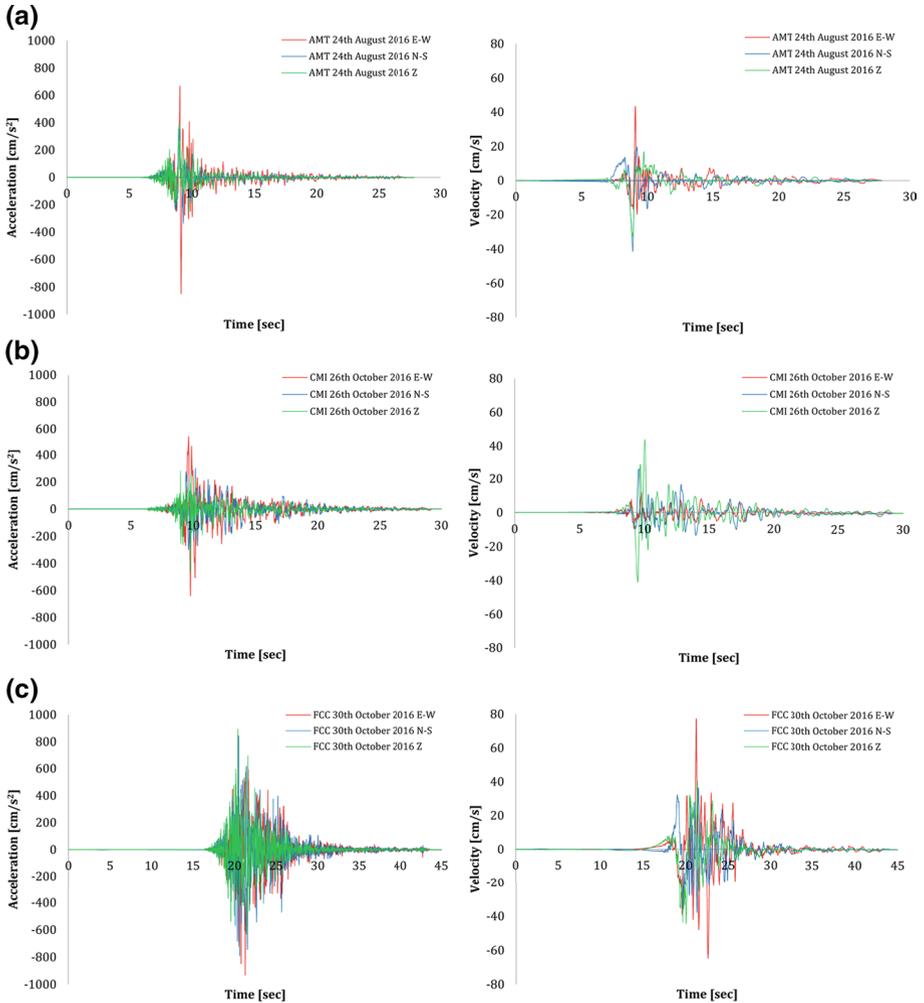
Initially, gravity load has been assigned to the system. Then, several simulations were performed by varying the ground acceleration of the basement: the excitations of real earthquakes are applied to the basement, and the damage due to real earthquakes is investigated. In particular, the analyses were carried out using the horizontal and vertical components of the three main shocks recorded during the Central Italy seismic sequence of 2016–2017, with the aim to analyze the damaged caused by the seismic activity. Considering that there are no available recordings of the accelerations and velocities in all villages where the churches are located, it was necessary to use those registered in the epicenters of the three main shocks: (1) 24th August 2016 Amatrice with $M_L=6.0$ and $M_W=6.0$ (AMT station in Italian Accelerometric Archive (ITACA)), (2) 26th October 2016 Campi with $M_L=5.9$ and $M_W=5.9$ (CMI station in ITACA), (3) 30th October 2016 Forca Canapine $M_L=6.1$ and $M_W=6.5$ (FCC in ITACA). The comparison between the recorded accelerations is reported in Fig. 14. In Table 1 are reported the characteristics of the seismic events used, where (Kadas et al. 2011):

Fig. 14 The components of the three main ground accelerations and velocities recorded for: the 24th August 2016 Earthquake in the station of Amatrice (AMT) (a), the 26th October 2016 Earthquake in the station of Campi (CMI) (b), and the 30th October 2016 Earthquake in the station of Forca Canapine (FCC) (c)

of the velocity in *N-S* direction is attained (Fig. 14), the displacement of about 24 cm. The displacements are comparable between the two points for both 26th and 30th October earthquakes, in the last with a residual displacement of about 5 cm at the end with evident misalign of the block in the out-of-plane direction of the main walls of the nave.

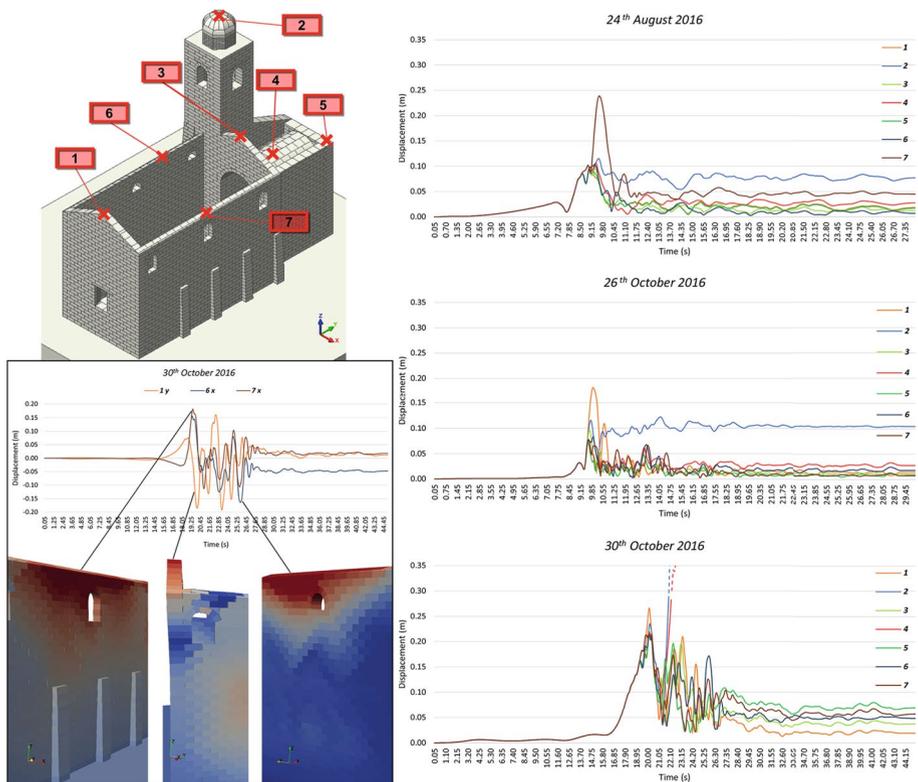
Fig. 15 Displacements time histories of different control nodes for the Church of San Francesco in Montefortino (FM) for the three main shocks of Central Italy seismic sequence of 2016

The main results in terms of Time Histories (THs) are reported in Fig. 15 for different control points on the top of the Church and of the tower. In general, it is quite clear to observe that the earthquake of 30th October 2016 first produces the major displacements on the church and belfry, then the main damages.

Comparing the TH of points #6 and #7 in Fig. 15, and the numerical damage in Figs. 16 and 17, we can observe a different behavior of the two walls of the nave: with the shock of 24th August the point #7 reached immediately for $t \sim 9.65$ s, i.e., when maximum value

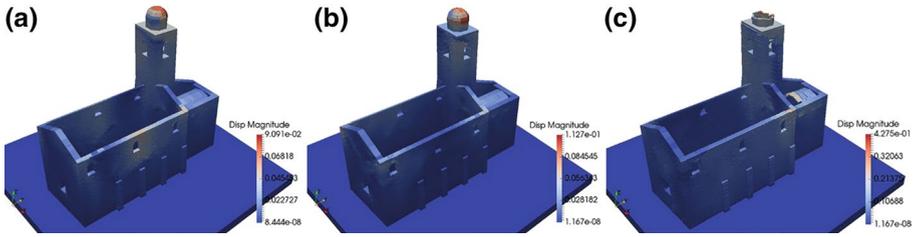
Fig. 16 Damages of the Church of San Francesco in Montefortino (FM) under the earthquakes of 24th August 2016 (a), 26th October 2016 (b), and 30th October 2016 (c)

On the belfry, namely point #2, no evident damages are noticeable with the first two shocks, but a clear collapse is observable in Figs. 16, 17 and 18 with the earthquakes of 30th October and, with right approximation due to the distance between Montefortino and the epicenter, as we once again observed in situ, where lower intensity of the earthquake was detected, and then minor damages on the belfry are observable. The same situation

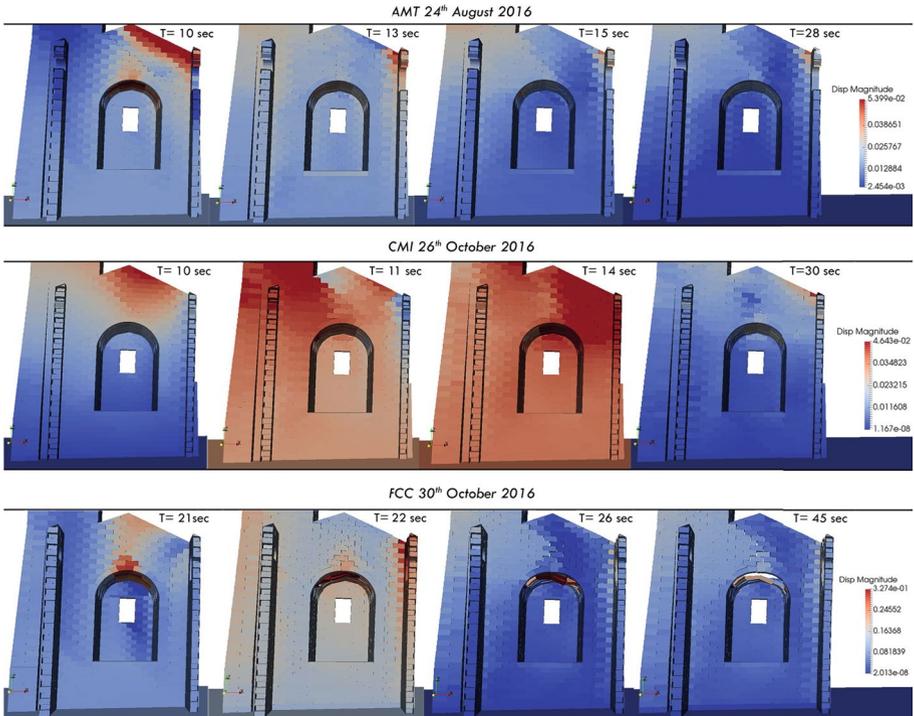
Fig. 17 View of mechanism in the triumphal arch and in the vault of San Francesco in Montefortino (FM)

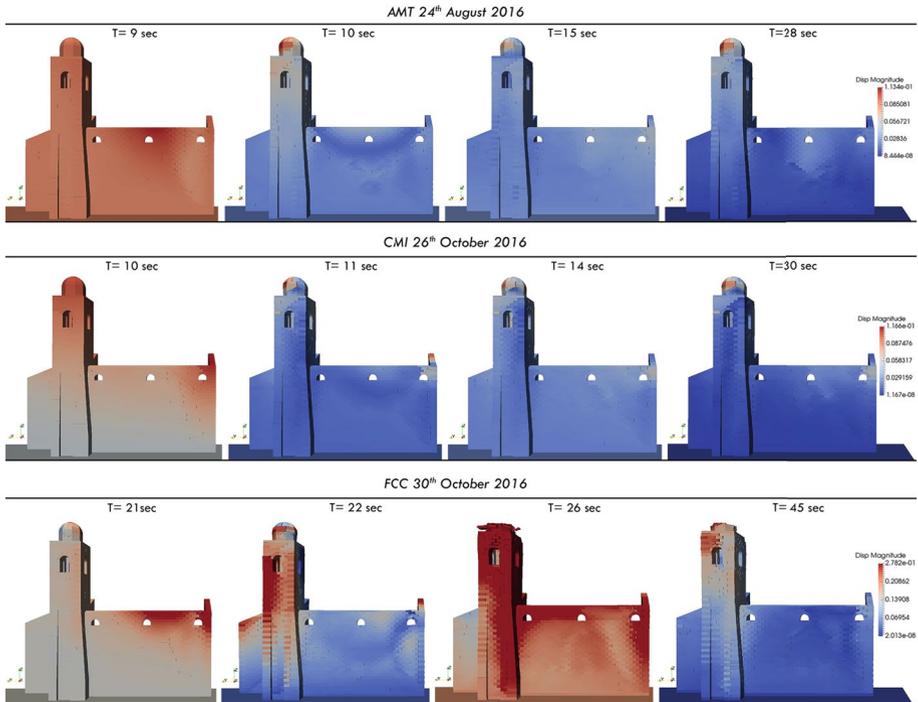
Fig. 18 Failure mechanism of the bell-tower of San Francesco in Montefortino (FM)

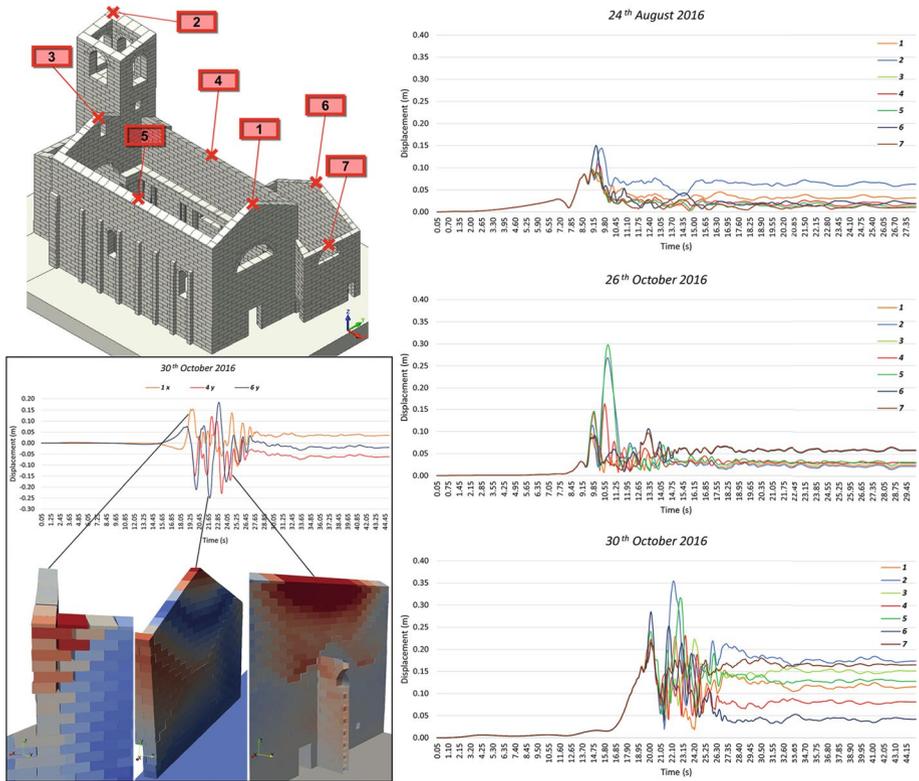
Fig. 19 Displacements time histories of different control nodes for the church of church of San Francesco in Sarnano (MC) for the three main shocks of Central Italy seismic sequence of 2016

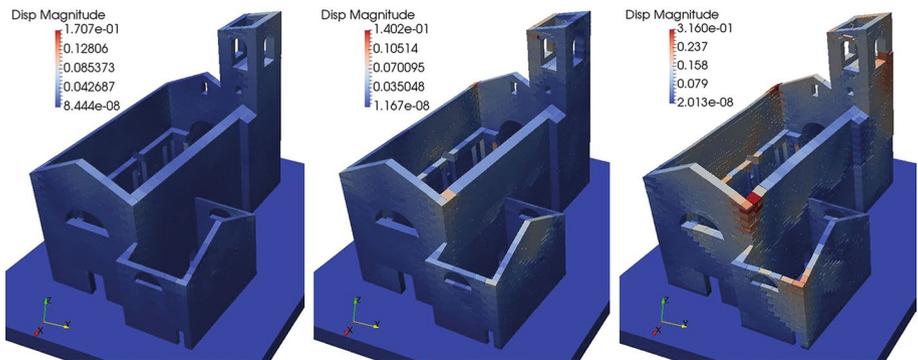
Looking at Fig. 20, a clear picture of the damage at the end of the shocks is visible, confirming the presence of extensive damage of the triumphal arch and of the bell tower, also displayed by Figs. 21 and 22. In the TH of 24th August, the activation of out-of-plane mechanisms related to points #6 and #7 of the annex are noticeable, which turns into an overturning collapse during the 30th October event (see #7 of south-west façade of the annex) as shown in Fig. 20. These activations are not so evident with the

Fig. 20 Damages of the Church of San Francesco in Sarnano (MC) under the earthquakes of 24th August 2016 (a), 26th October 2016 (b), and 30th October 2016 (c)

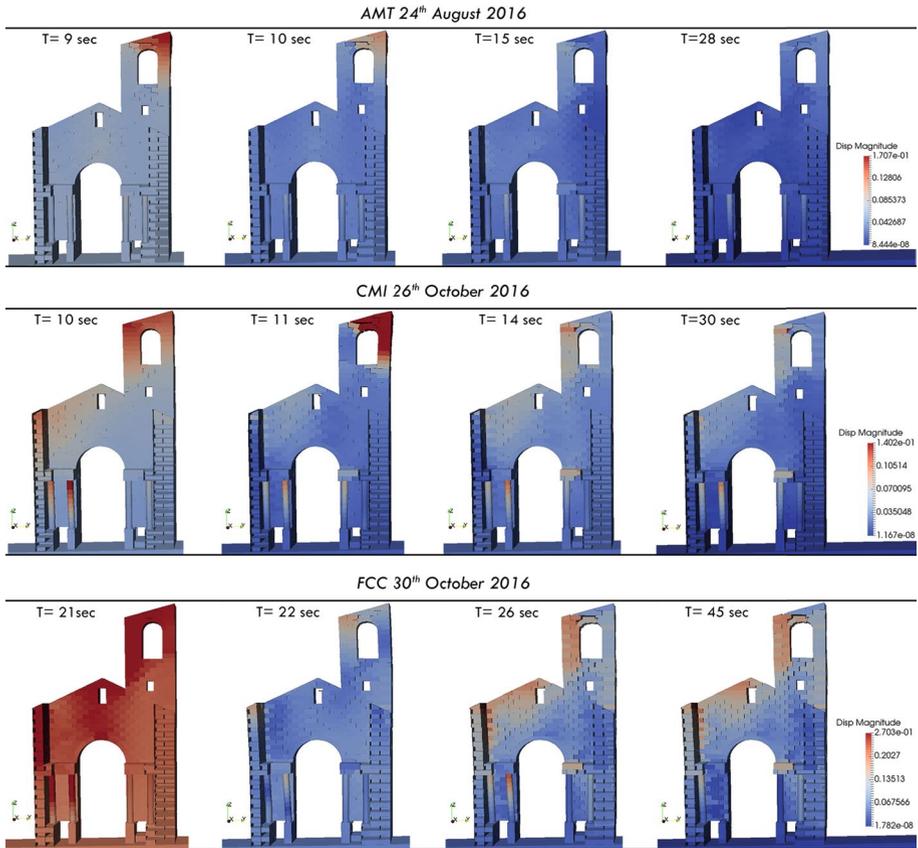
Fig. 21 Shear mechanisms in the triumphal arch of San Francesco in Sarnano (MC)

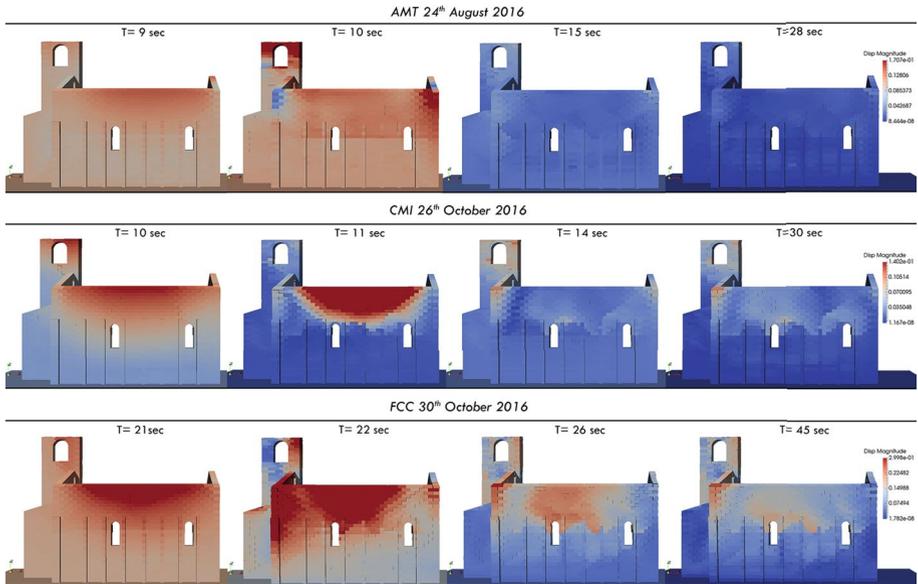
Fig. 22 Failure mechanism of the bell-tower and triumphal arch of San Francesco in Sarnano (MC)

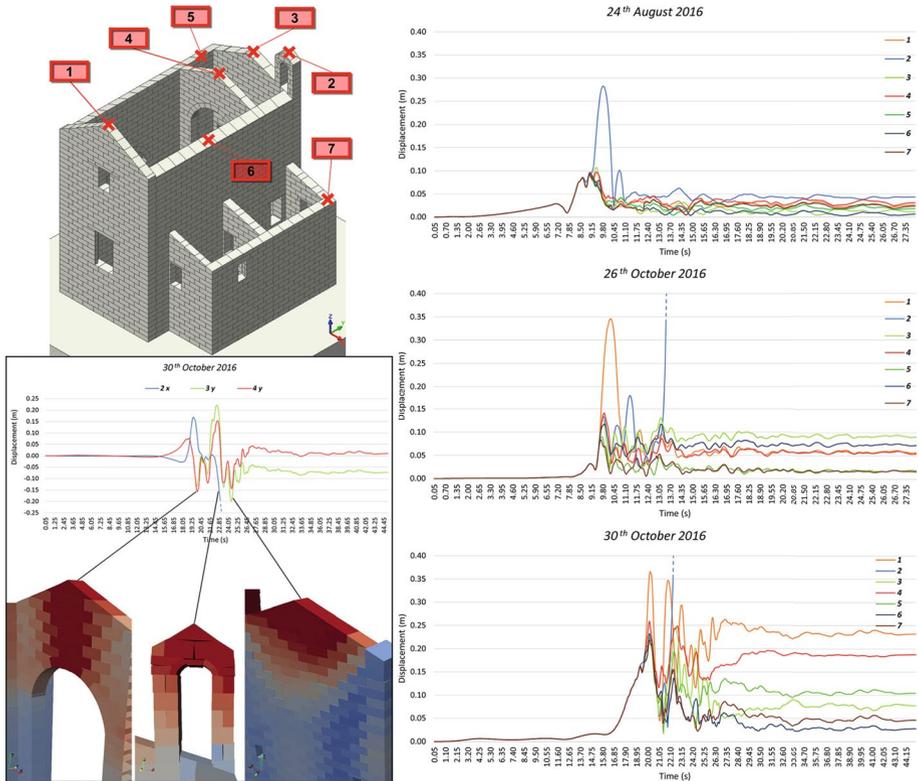
The main results of the nonlinear dynamic analyses with the NSCD method are reported in Fig. 23 in term of TH for the three-main earthquakes used as a reference, and at the end of the simulations in Fig. 24. Starting from the 24th August earthquake, it is possible to observe that the bell-gable (namely the control point #2) is the most involved part of the church with a maximum reached displacement of about 29 cm in correspondence of the main jump of the velocity (see Fig. 14a). Comparing the THs of the main façade

(#1), of the triumphal arch (#4) and of rear façade (#3) we can observe the same displacement, with a residual value of about 3 cm at the end of the shock. The bell-gable (#2) is subjected to large displacements to which correspond high damage but does not apparently manifest collapses (Fig. 24). Looking to Fig. 25, it is possible to observe the activation of the overturning mechanism of the main façade due to a not proper interlocking between the block, and this is comparable with the real damage reported in Fig. 9. Observing the three main longitudinal walls of the church, namely the walls containing control points #5, #6 and #7, residual displacements are always observable, and from Fig. 24 and Fig. 26, the starting of a little out-of-plane mechanism is visible in the upper part of the wall of the nave due to the pushing of the triumphal arch at last.

Fig. 23 Displacements time histories of different control nodes for the Church of Sant'Anna in Camerino (MC) for the three main shocks of Central Italy seismic sequence of 2016

out-of-plane mechanism with a significant displacement in the middle. Comparing the control points #5 and #6, namely those of the walls of the nave, it is clearly visible the effect of the pushing of the triumphal arch which increases first the displacement and then the residual deformation of #5 respect to #6. Furthermore, there are no activations of clear mechanisms in the annex (see #7 in Fig. 23), but only a trigger of a detachment between it and the nave. Finally, also in this case, the bell-gable (see #2 in Fig. 23) is

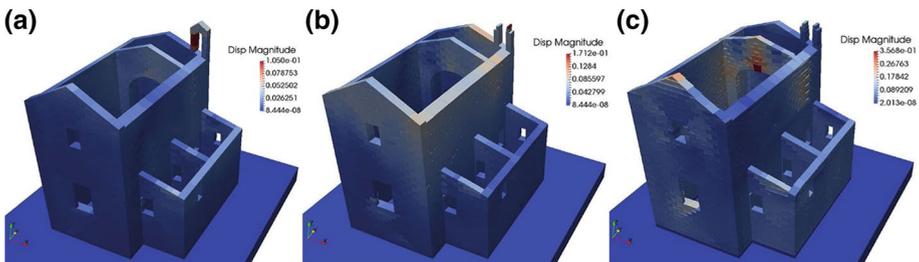
Fig. 24 Damages of the Church of Sant'Anna in Camerino (MC) under the earthquakes of 24th August 2016 (a), 26th October 2016 (b), and 30th October 2016 (c)

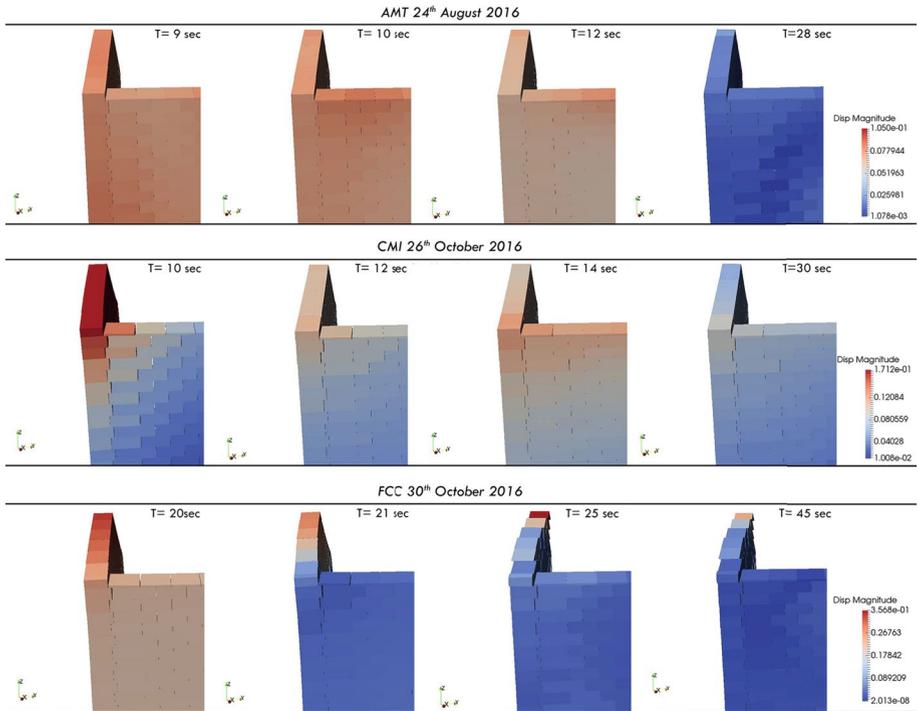
Fig. 25 Failure mechanism of the facade of Sant'Anna in Camerino (MC)

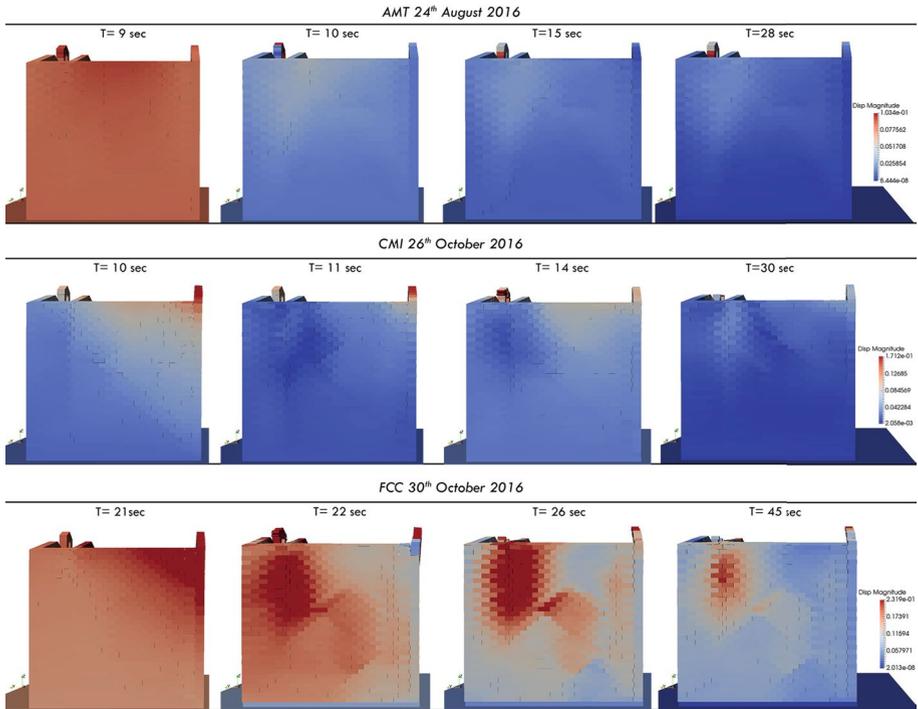
For the earthquake of the 26th October, a quite similar behavior is observed except for the control points #1 and #2, which have an opposite behavior compared to what we saw before. With the first jump of the velocity (see Fig. 14b) we can see an increase on the displacement of the main façade (#1), that corresponds to a more visible overturning mechanism in Fig. 25 to which follows an increase in the vertical seismic action that strongly stresses the bell-gable until it collapses. Then a general higher deformation along the church is noticeable if compared to the previous case, with some more evident misalignment of the blocks in the out-of-plane direction in the left upper part of the wall of the nave (Fig. 26), corresponding to the connection with the triumphal arch.

Fig. 26 Failure mechanism of the façade, wall, and steeple of Sant'Anna in Camerino (MC)

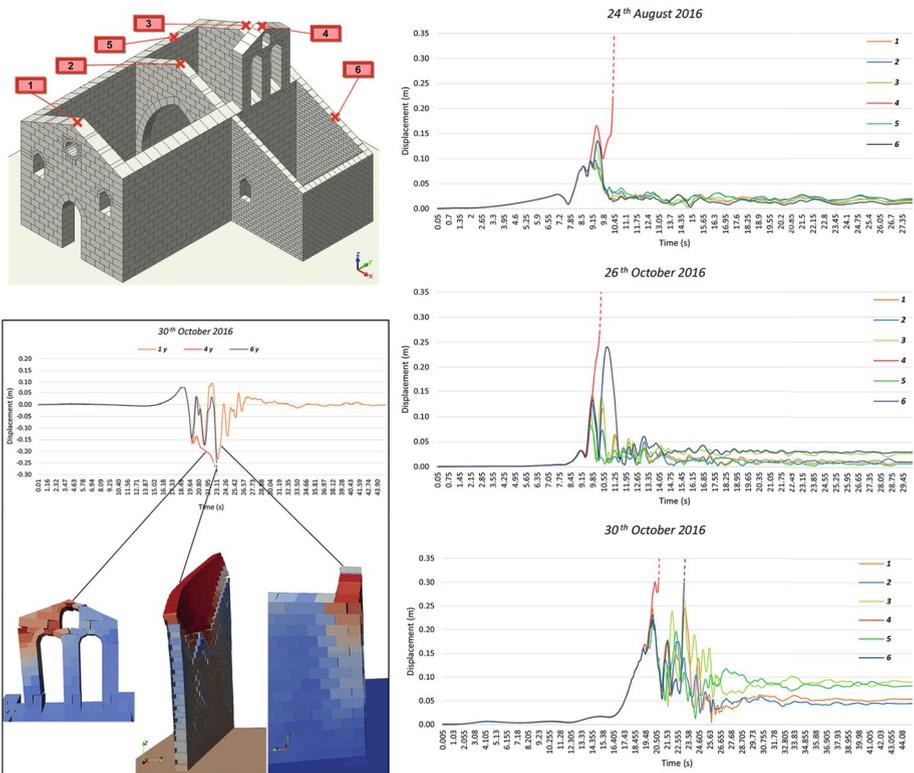
The Sant'Antonio's Church is the most damaged one of the analyzed stock of "Apennine churches." The THs of different control points in the top of the main parts are reported in Fig. 27. Comparing the points #1, #2 and #4, respectively on the main and rear façades, and on the triumphal arch, a global out-of-plane overturning and in-plane shear actions, with apparent failure under the rose window and the two classical windows, are clearly visible in Figs. 28, 29 and 30. In particular, with the shock of the 24th August, only a first activation of these mechanisms is visible with a residual displacement (less than 5 cm) in all parts of the church at the end of the TH, Fig. 27.

Fig. 27 Displacements time histories of different control nodes for the church of Sant'Antonio in Ussita (MC) for the three main shocks of Central Italy seismic sequence of 2016

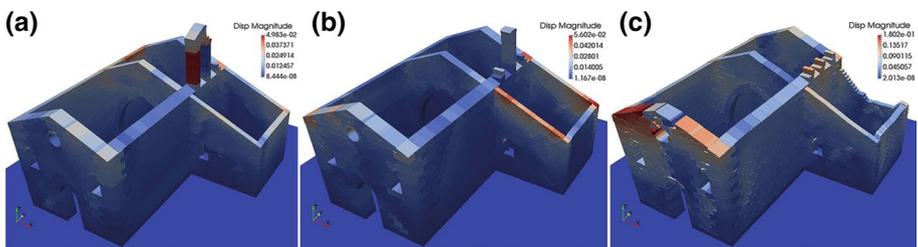
Fig. 28 Damages of the Church of Sant'Antonio in Ussita (MC) under the earthquakes of 24th August 2016 (a), 26th October 2016 (b), and 30th October 2016 (c)

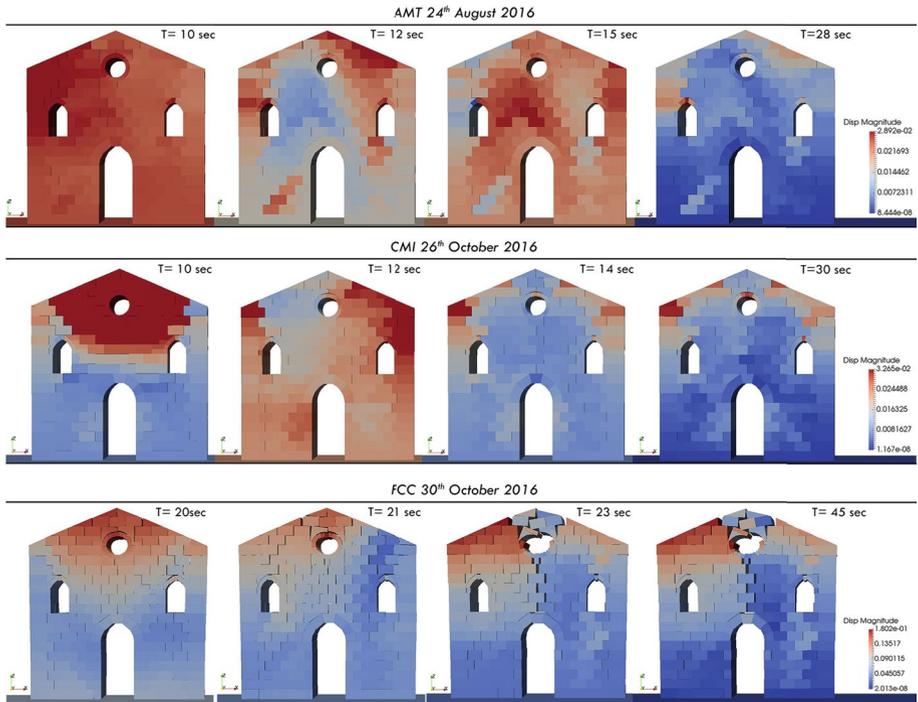
Fig. 29 Shear mechanisms of the façade of Sant'Antonio in Ussita (MC)

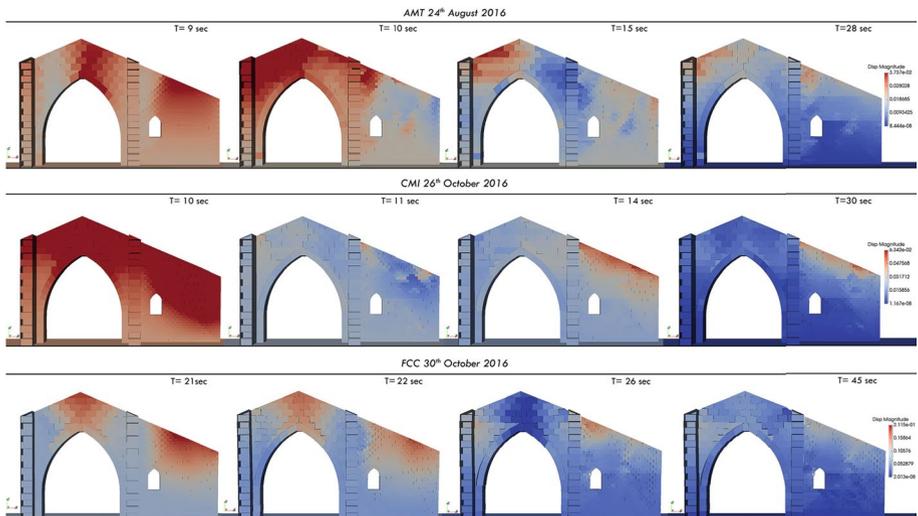
The same considerations should be applied to the shock of 26th October 2016, where the maximum displacement attained to the various parts are the same of the previous analyses, confirming the high vulnerability of the main façade and of the triumphal arch where the first vertical cracks appeared, due to the activation of out-of-plane and in-plane mechanisms respectively. Looking at control point #3, a clear overturning mechanism is activated, and a first evident detachment due to the lack of firm connections between the wall of the annex and the nave is also visible (see Fig. 30).

Fig. 30 Shear mechanisms of the triumphal arch of Sant'Antonio in Ussita (MC)

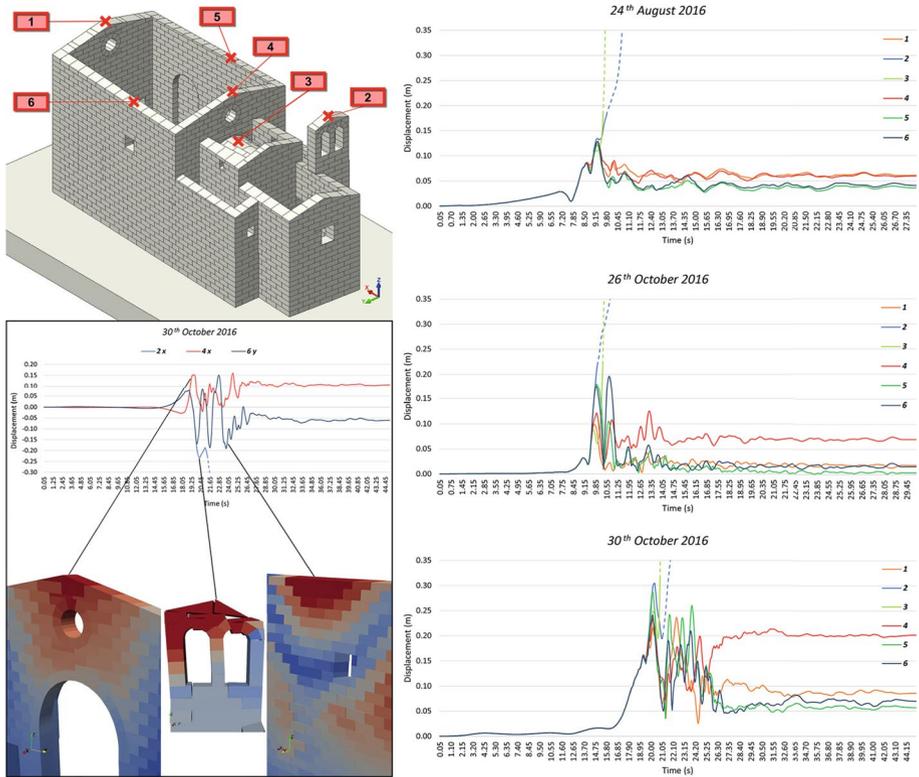
In Fig. 31 are plotted the THs of six control points chosen on the top of Valcora sanctuary, for the three main shocks. This church reported a widespread crack in all its parts. Observing the TH of the 24th August it is noticeable that in correspondence to the first jump of velocity most of the points show the same displacement (control points #1, #4, #5, and #6),

Fig. 31 Displacements time histories of different control nodes for the sanctuary of Madonna of Valcora in Fiuminata (MC) for the three main shocks of Central Italy seismic sequence of 2016

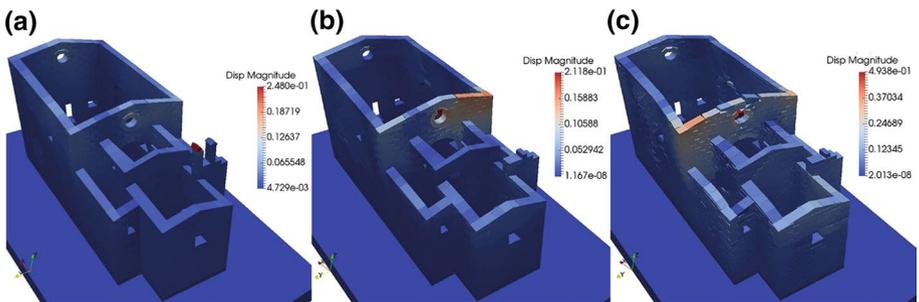
Fig. 32 Damages of the sanctuary of Madonna of Valcora in Fiuminata (MC) under the earthquakes of 24th August 2016 (a), 26th October 2016 (b), and 30th October 2016 (c)

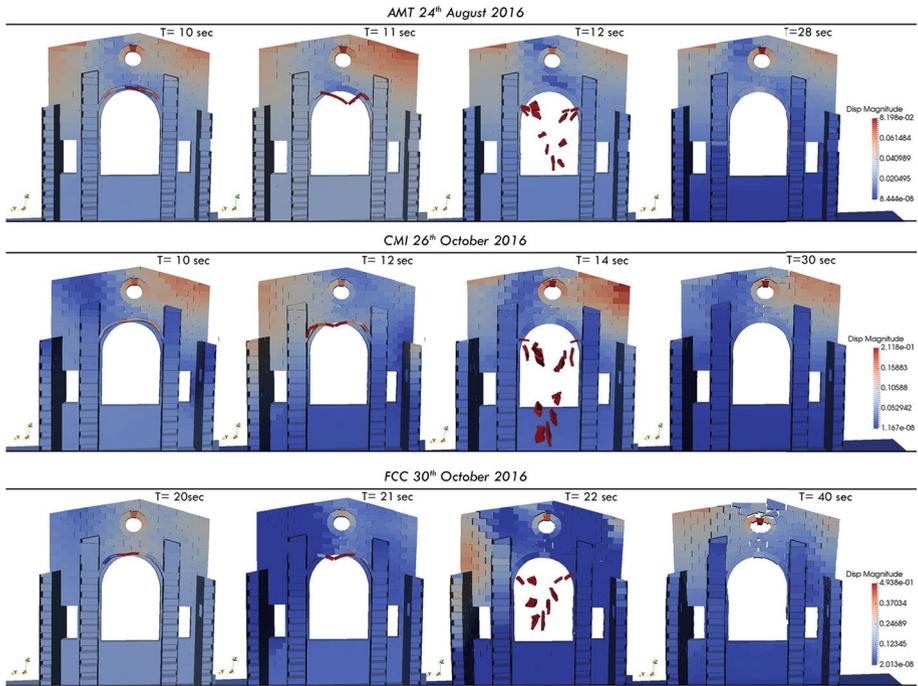
of the nave (i.e., points #6 and #5) at the first peak of velocity exhibit the maximum displacements: this underlines a possible activation of in-plan mechanisms as shown in Fig. 34. At the end of the event, the triumphal arch (#3) has the maximum residual displacement ≈ 8 cm, highlighting an initial activation of an in-plane mechanism that can be observed in Fig. 33 for $t = 30$ s.

Fig. 33 Failure mechanism of the barrel vault of the apse of the sanctuary of Madonna of Valcora in Fiuminata (MC)

For the earthquake of 26th October the vault (#3) and the bell-gable (#4) display more extensive damage (see Figs. 33 and 34) after the first increase of velocity as in the case of the 24th October earthquake. Contrary to what was noticed before, the walls

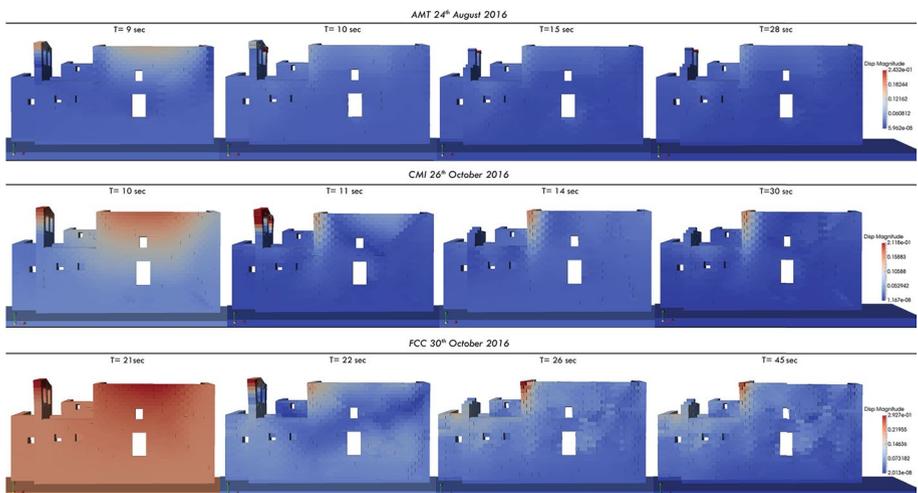
Fig. 34 Failure mechanism of the bell-tower and the triumphal arch of the sanctuary of Madonna of Valcora in Fiuminata (MC)
