The development of Kangiqsualujjuaq and the threat of snow avalanches in a permafrost degradation context, Nunavik, Canada

Armelle Decaulne, Najat Bhiry, Janie Faucher-Roy, Clara Pelletier Boily

Espaces et sociétés arctiques

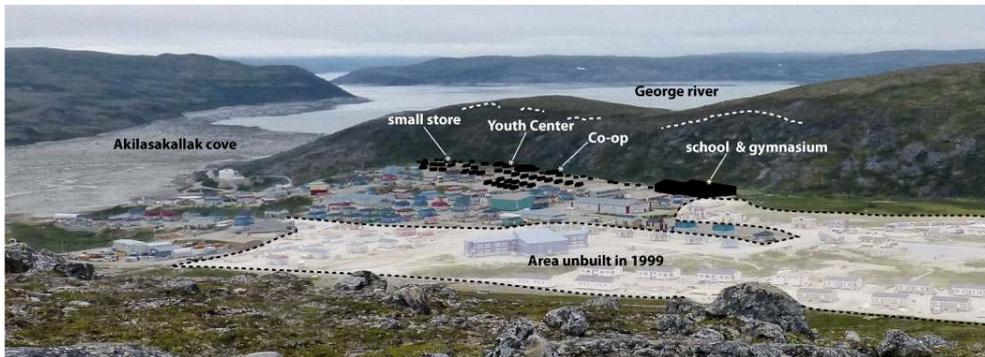
Figure 6 – Kangiqsualujuaq in 2019.

In black, a schematic reconstruction of the location of former buildings, which today corresponds to the exclusion zone, and known damaged buildings by snow-avalanche events prior to 1999; the white dashed lines represent the departure zones of those snow avalanches.

- 13 Previously, other snow-avalanche events had been observed (Figure 6A), but these did not cause such extensive damage and harm to people. The dates for these events are not precise [Stethem *et al.*, 1999; Hétu, 2001]:

- the “small store” was hit in March or April 1981 or 1982, catching one person who was not injured; the runout of the snow-avalanche from the foot of the slope was approximately 20 m;

- the back wall of the Co-op store was hit twice, in March or April 1982, 1984 or 1986: canoes were damaged in one of the two snow avalanches, and one person was caught in the other one, without sustaining an injury; the runout distance to the Co-op was about 20 m;

- the back wall of the Youth Centre was hit in March or April 1984 or 1986; no one was injured, although the runout distance to the building is the shortest, at only 14 m;

- the back wall of the school gymnasium was hit in March 1993, and the steps leading to the door were buried under 1.5 m of snow; two people were buried but extracted alive, although one was injured; the runout distance was 40 m.

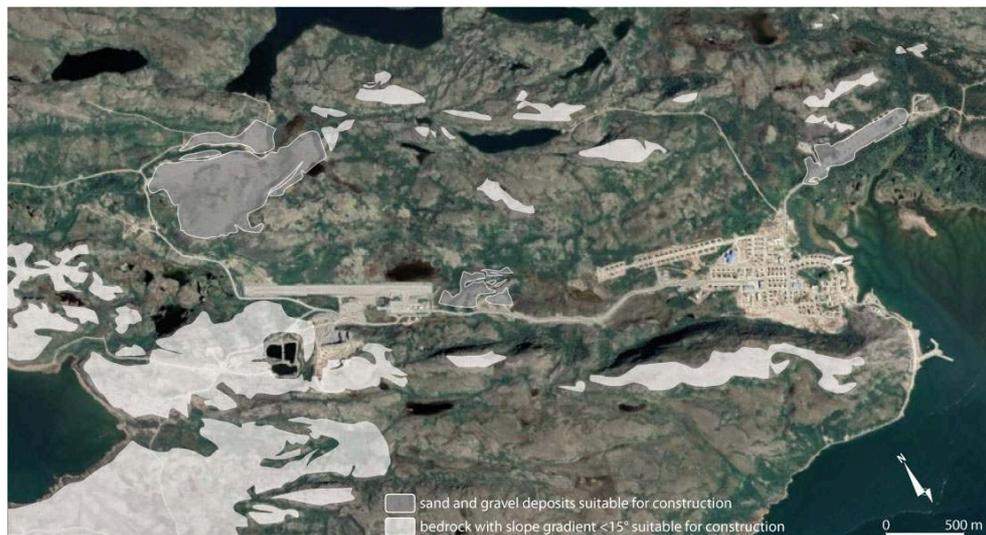
Figure 8 – Location of the suitable construction areas on surfaces where permafrost thawing and active layer fluctuations have little effect on the stability of the surface, away from active slope processes areas (modified from Aubé-Michaud et al., 2017).
