Green Roof performance in sub-arctic climates: water quality and vegetation survival on a green roof in northern Sweden

Anna Magnusson, Maria Viklander, Godecke-Tobias Blecken

Urban Water Engineering, Department of Civil, Environmental and Natural Resources Engineering, Luleå University of Technology, 971 87 Luleå, Sweden; annmag@ltu.se; marvik@ltu.se; godble@ltu.se

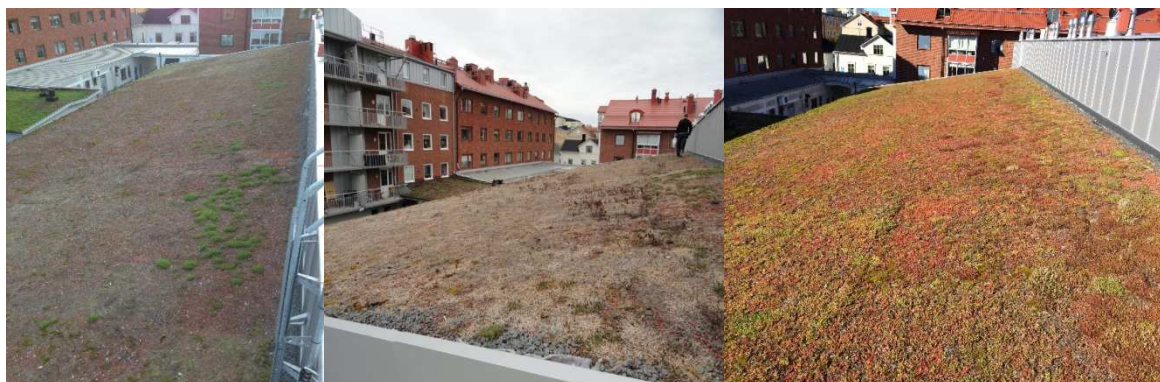
Figure 1: View of the same roof section. Left: end of May 2014, middle: early September 2014, right: early September 2015.

The visual inspections in both 2014 and 2015 revealed that only a few of these species (mainly *Sedum acre* and occasional plants of *Sedum album*) had survived on the roof in Luleå (Figures 1 and 2). *Sedum acre* is native to** northern Sweden, (inter alia) in the Luleå archipelago. When laid, the turf had almost complete vegetation cover, but by August 2014 there was only about 20-30% cover, with an increase to 35-40% cover in August 2015, based on the images, (figure 1-3).
