# ARCHAEOMETRICAL CONTRIBUTIONS IN THE JAPANESE ARCHITECTURE IN FRANCE: THE PAVILIONS OF ALBERT KAHN'S GARDENS (BOULOGNE-BILLANCOURT, FRANCE)

This study takes place within the framework of an ambitious restoration project of the two Japanese lodges situated at Boulogne-Billancourt, in France. The philanthropist banker Albert Kahn builds a set of gardens during the 19<sup>th</sup> century with a Japanese "village". Manhandled by the time, restorations were decided with, in parallel, an exhaustive archaeological investigation of these buildings. The AKAHN project: "Albert Kahn: archaeology of a Japanese Heritage" began in 2015. Exploratory analysis were made to direct a part of the work and in particular to find the original colors. The measurements were realized according to non-destructive methods and techniques mainly *in situ*. The present results are not complete and are in the continuation especially for the wood. They concern the dendrometrical studies on both houses and the characterization of their polychromies. They also participate in the implementation of a database on Asian woods in France: in the 19<sup>th</sup> century in Europe, during the period named "Japanism", nu

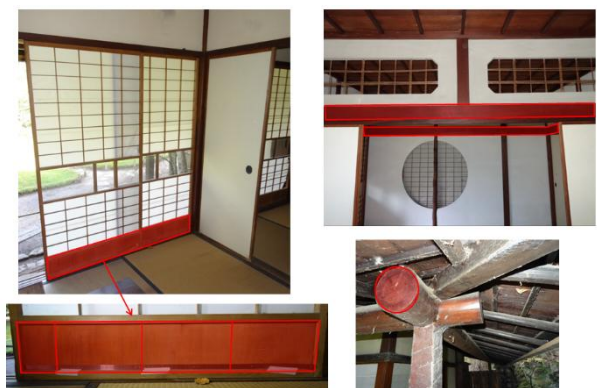
**Figure 4:** Example of measured timbers (in red). Left: the lower parts of shōji; Top right: tie beams; Bottom right: an outdoor round beam.

During the preliminary study, tree-rings measurements were performed on visible transverse faces of 4 outdoor round beams (two in each house), 8 tie beams of West lodge (East house have none) and on lower parts of 25 shōji<sup>2</sup> (12 in the East lodge and 13 in the West house) for a total of 87 boards with 81 measured (Figure 4).

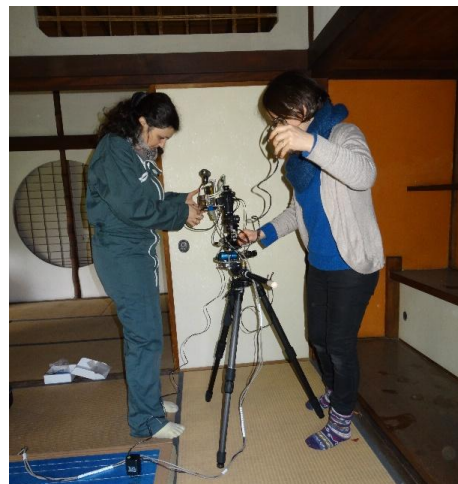
**Figure 7:** Preparation of the fluorescence X machine for in situ measurements. (Photo : C. Lavier)

To better characterize these paintings, we decided at first to perform XRF analysis *in situ* (Figure 7) to try to identify the chemical elements present. Colorimetric measurements were also performed. These methods were chosen because they are non-destructive, portable, fast and commonly used.
