Uncovering a 70-year-old permafrost degradation induced disaster in the Arctic, the 1952 Niiortuut landslide-tsunami in central West Greenland

- The hitherto undescribed 1952 Niiortuut landslide-tsunami disaster in Greenland can be attributed to permafrost degradation.
- This is the earliest recorded historical disastrous permafrost degradation landslide in the arctic.

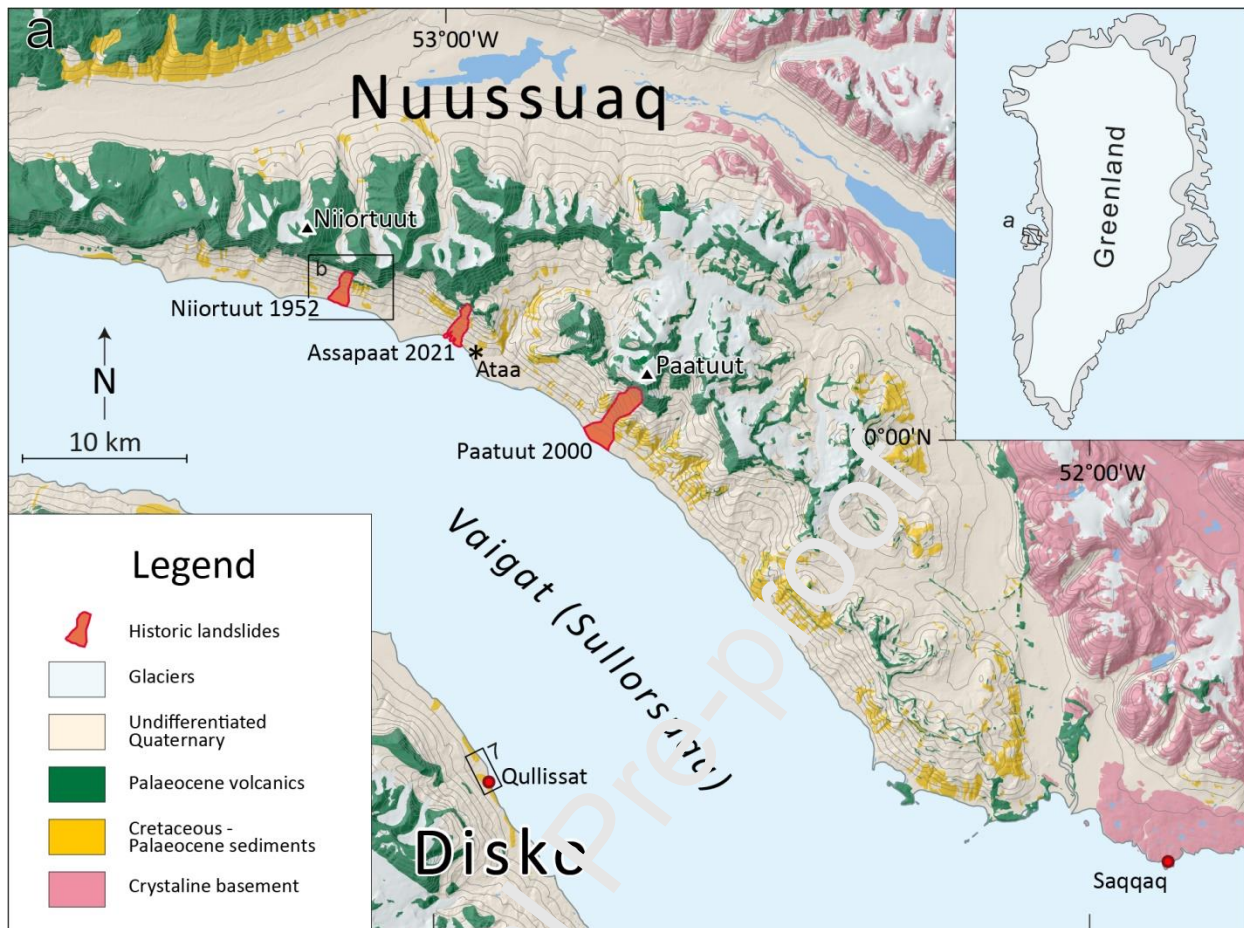
*Figure 1 (1/1 page) a) Simplified geological map of the Vaigat area based on the 1:100 000 scale geological maps from GEUS (Rosenkrantz et al., 1976; Pedersen et al., 2001, 2007). Historical landslides are shown along with place names mentioned in the text and position of Fig. 1b and Fig. 7. The estimated position of where the fisherman died is shown with a * at Ataa. b) orthofoto of the area of the landslide from the Danish Agency for Data Supply and Infrastructure (SDFI) from 2016. The onshore part of the landslide is shown with stipled blue outline. The positions of photos in Fig. 2 and 5 are shown along with the detailed maps in Figs. 3 and 6.*

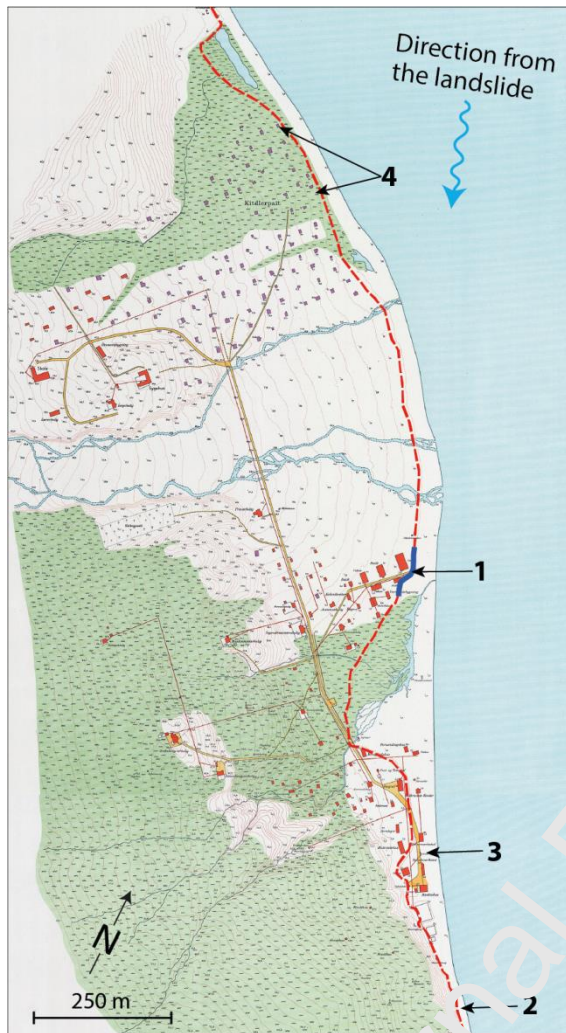
Figure 7 [single column width, text to the side or below] Observed (blue) and inferred (red) runup marked along the 2.5 m contour from the 1952 Niiortut landslide-tsunami in Qullissat. 1 shows the position of eyewitness Hans Anton Lynge, 2 the approximate position of the driver Hans Møller and 3 the position of the coal crane and power plant that was reported damaged during the tsunami. 4 marks the position of the lowermost houses in the northern part of the town that were presumably not inundated. The direction from the landslide is shown with a blue wavy arrow in the upper left corner. Background map is an extract of a topographical map of the town surveyed in 1948, published in 1950. Red polygons on the map are public buildings and purple are private houses. See Fig. 1a for location.

The tsunami's impact on the town of Qullissat is described in *Avangnâmiok*, based on eyewitness accounts of the driver Hans Møller, who was in his car on the way to the mine entrance south of town when the first wave hit (Fig. 7). According to Møller, the mass of water was enormous. The waves washed fish that seemed to be halibut up onto the road to the mine. These fish are usually found in

deep water far from the coast. Møller mentioned that there were several waves, of which the third one was the largest, powerful enough to wash up ice and debris into his car. Records of the damages to the infrastructures in the community are limited. Eyewitness Frederik (Fari) Mathiassen says that no buildings were damaged following the event, but that water entered the power plant, located at 2 m elevation above msl in the southern part of the town (Fig. 7). Unconfirmed word of mouth accounts mention that the concrete foundation of a coal crane at 1.7 m elevation above msl on the beach was damaged (Fig. 7).

Based on the above records we estimate that the tsunami runup was 2 - 2.5 m above msl in southern Qullissat. Compensating for the low tide of presumably -0.2 m gives a total runup height of 2.2 - 2.7 m here. We have not found any records of tsunami runups in northern Qullissat, where we would have expected a higher runup, as this section of the coast is more exposed towards the direction of the landslide (Fig. 7). The northern part of the town has exclusively private houses, which were located above 5 metres elevation at the time of the event. The lowermost two houses were at 3.1 m and 3.5 m above msl respectively (marked 4 in Fig. 7). We can assume that here, the wave runup was lower than 3.1 m, as damage to these houses would presumably have been reported.
