Détection de l'endommagement dans un composite tissé PA66,6/Fibres de verre à l'aide de techniques ultrasonores en vue d'une prédiction de la durabilité de pièces automobiles

T H È S E

**Damage detection in PA 66/6|Glass woven fabric composite material using
ultrasonic techniques towards durability prediction of automotive parts**

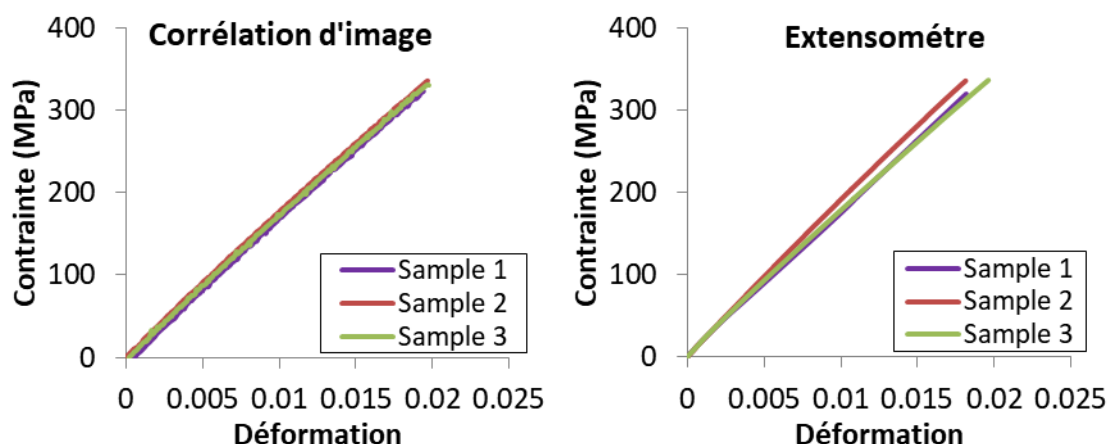
Figure 4 : Réponses contrainte/déformation obtenues par corrélation d'image (Gauche) et extensomètre (Droite) sur trois échantillons dans la configuration 0° .

avec la caméra, pour la corrélation d'image, sur trois autres échantillons chargés jusqu'à atteindre la rupture. Les principaux résultats sont résumés dans le Tableau 2 pour les deux configurations. Ces résultats concernent le module d'élasticité ainsi que la résistance maximale en traction moyennés sur tous les essais. Le calcul de cette moyenne est possible car comme visible sur la Figure 4 et Figure 5, les mesures par corrélation d'image et extensomètre présentent une très bonne reproductibilité.

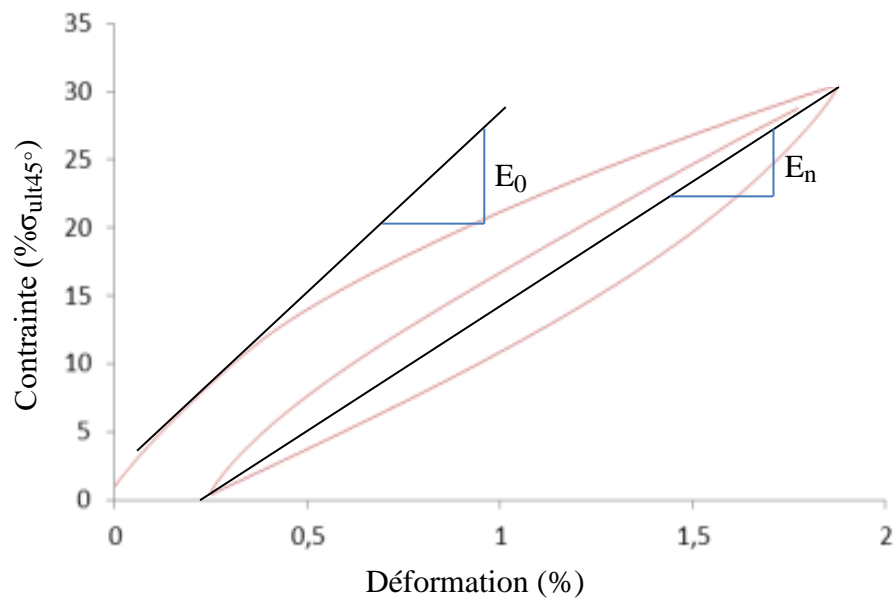
Figure 7 : Mesure des modules E_0 et E_n sur une courbe charge/décharge.

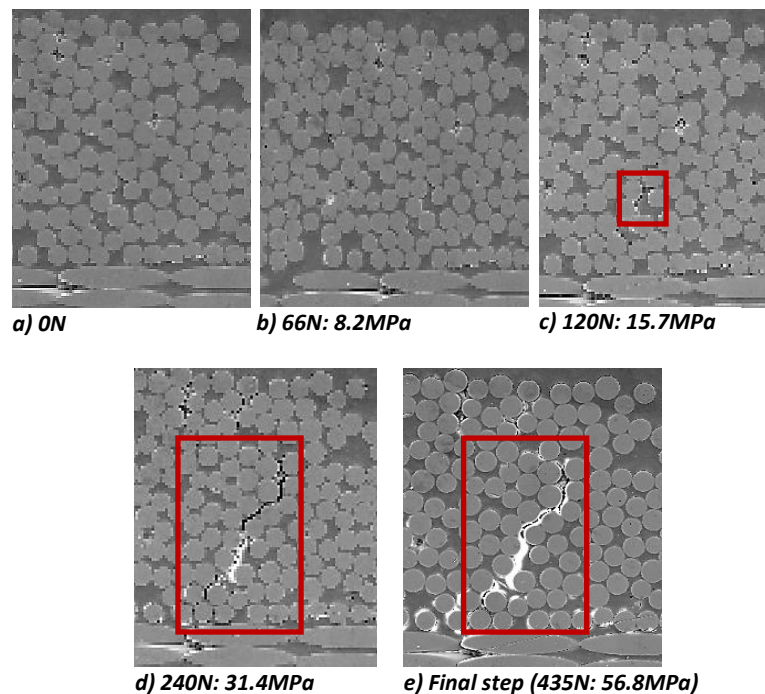
Figure 9: Images MEB lors d'essais de traction in-situ pour différents niveaux de changements appliqués suivant l'axe des fibres

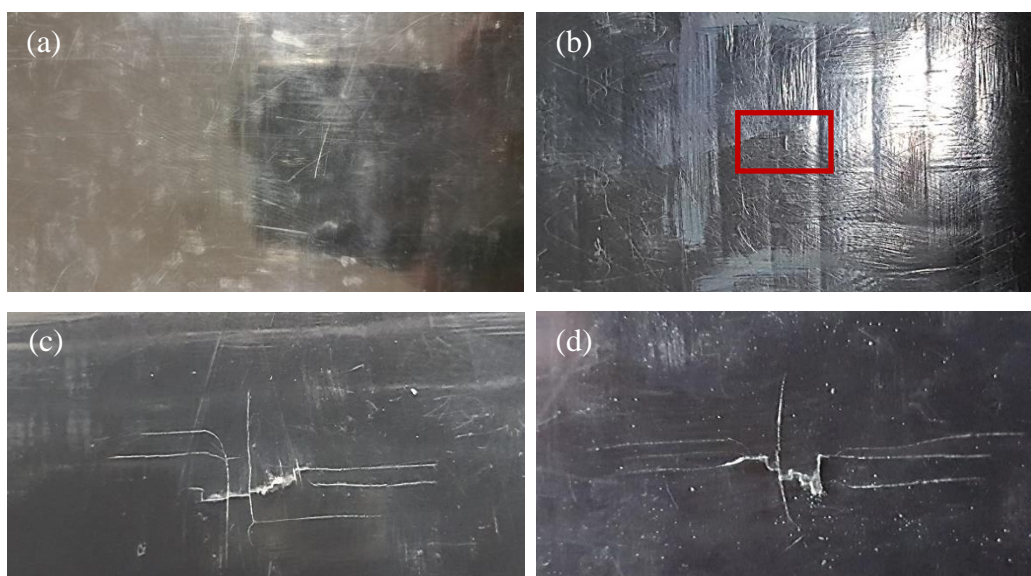
Figure 26 : Faces non-impactée des plaques pour des énergies d'impact de (a) 10 J, (b) 15 J, (c) 17.5 J, et (d) 20 J.

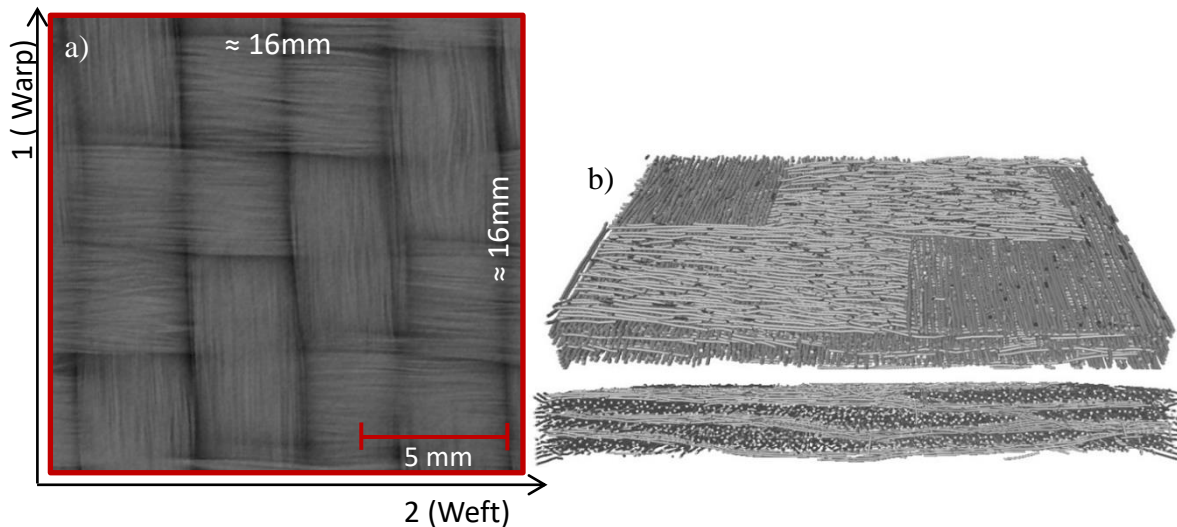
Figure 46 : (a) RVE of the material and (b) 3D representation of the 2/2 twill weave fabric of the Vizilon_{TM} SB63G1-T1.5-S3 obtained by X-ray tomography

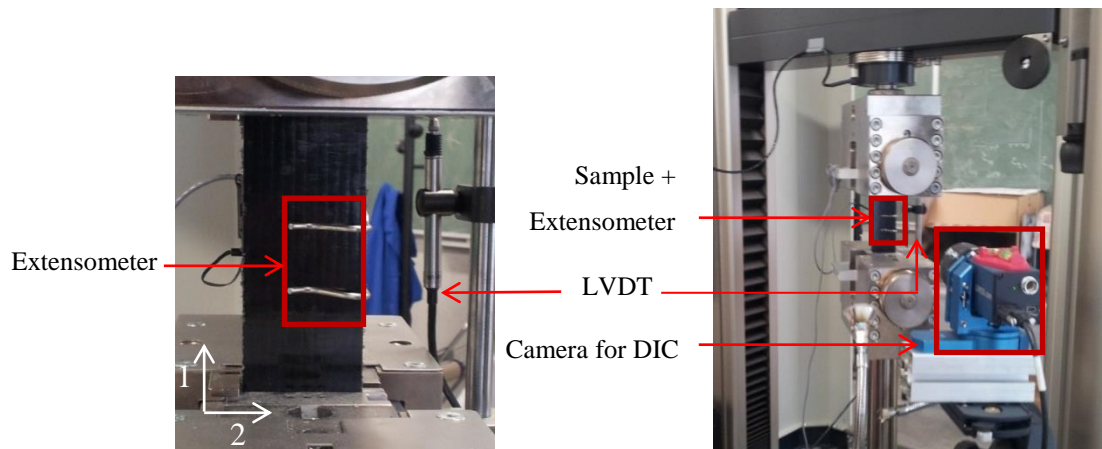
Figure 49 : Experimental set-up of the tensile test with all the displacement measurement sensors

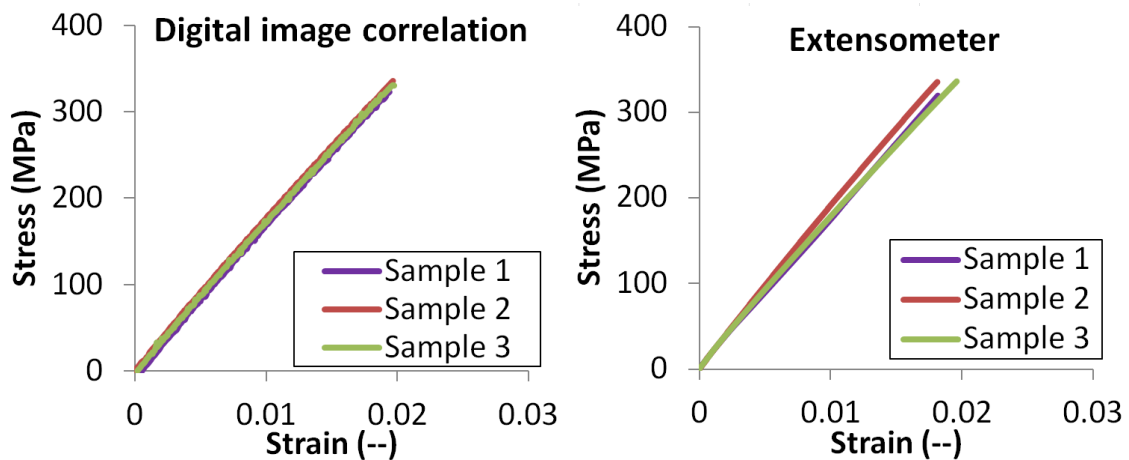
Figure 52 : Stress/Strain curve obtained with DIC (Left) and Extensometer (Right) for the three tested samples oriented at 0° from fiber's axis

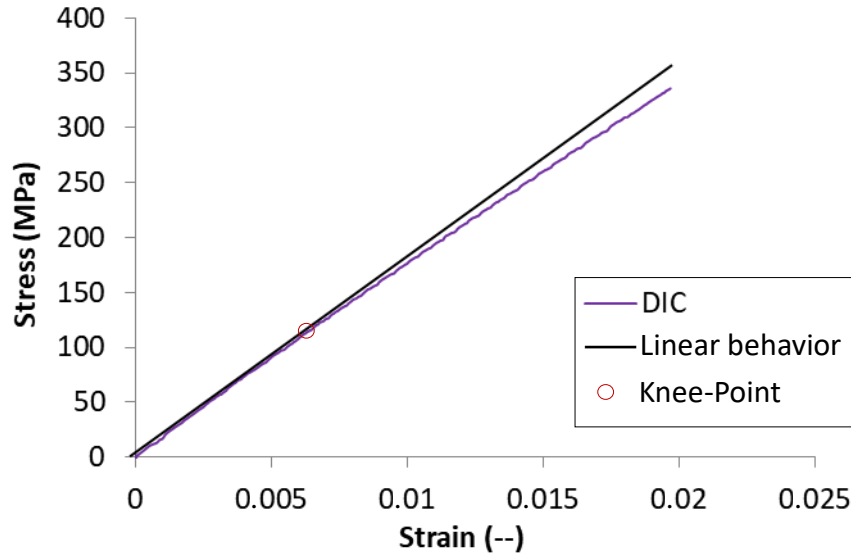
Figure 53 : Nonlinearity point on the stress-strain curve from DIC acquisitions

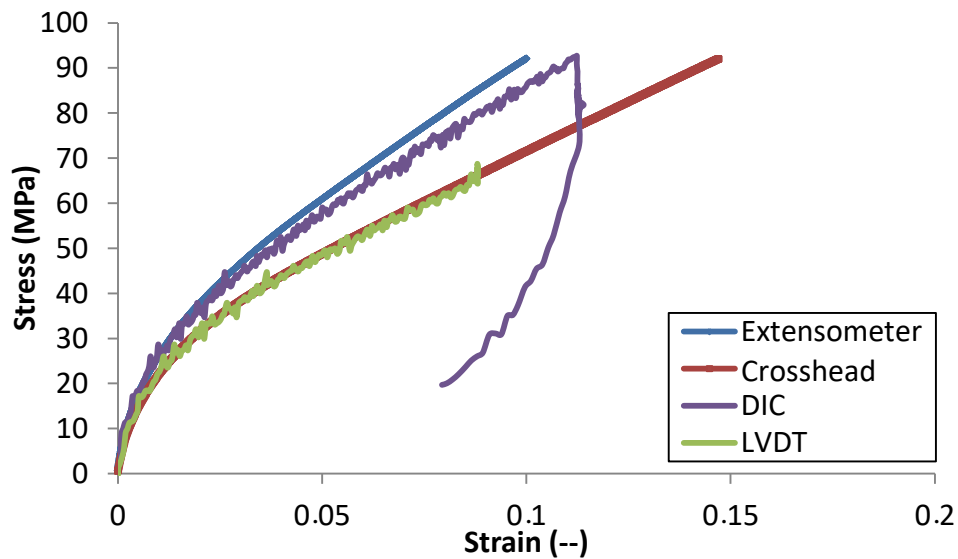
Figure 56 : Stress/Strain curves for the 45° orientation for the entire displacement sensor considered (Here the sample was not solicited until

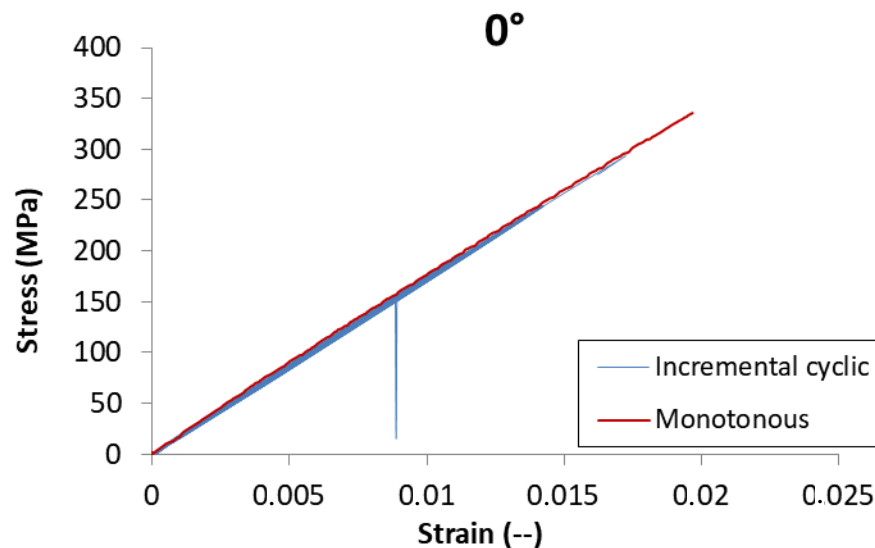
Figure 62 : Monotonic tensile test and incremental (20 MPa) cyclic test for the 0° configuration

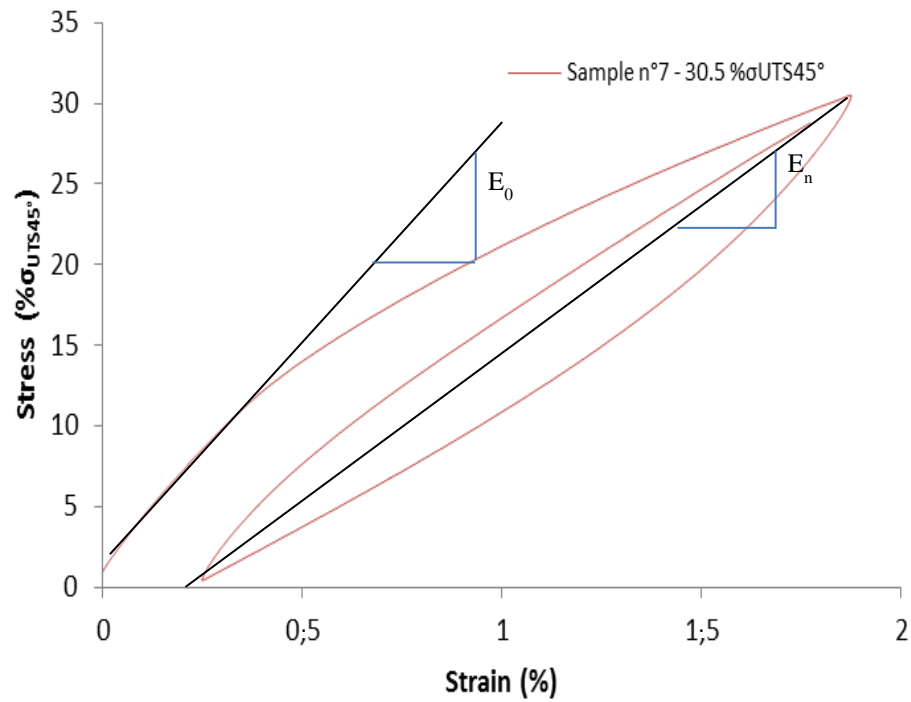
Figure 64 : Measurement of the E_0 and E_n moduli on a loading unloading curve

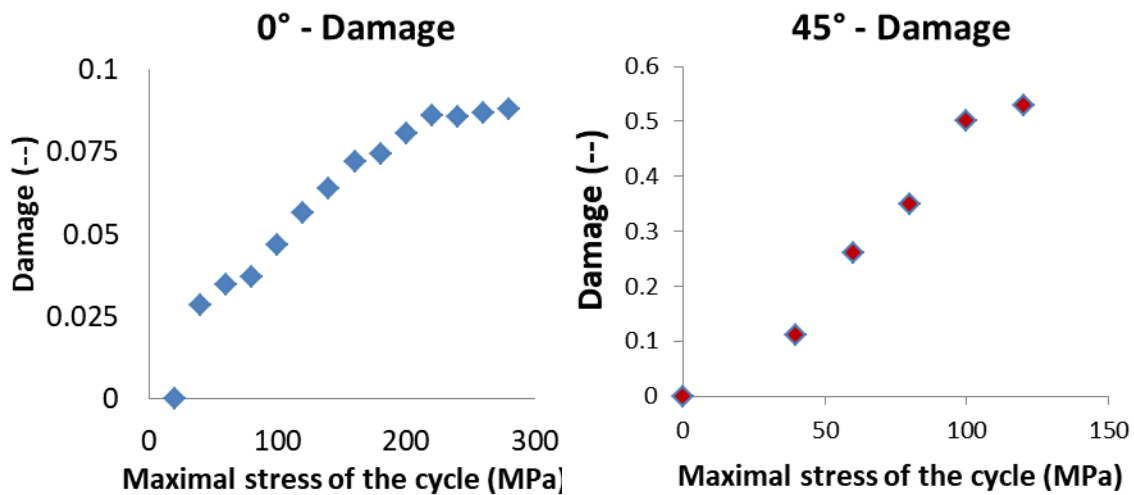
Figure 65 : Evolution of damage function of the maximal stress of the cycle for a 0° (Left) and 45° (Right) oriented sample

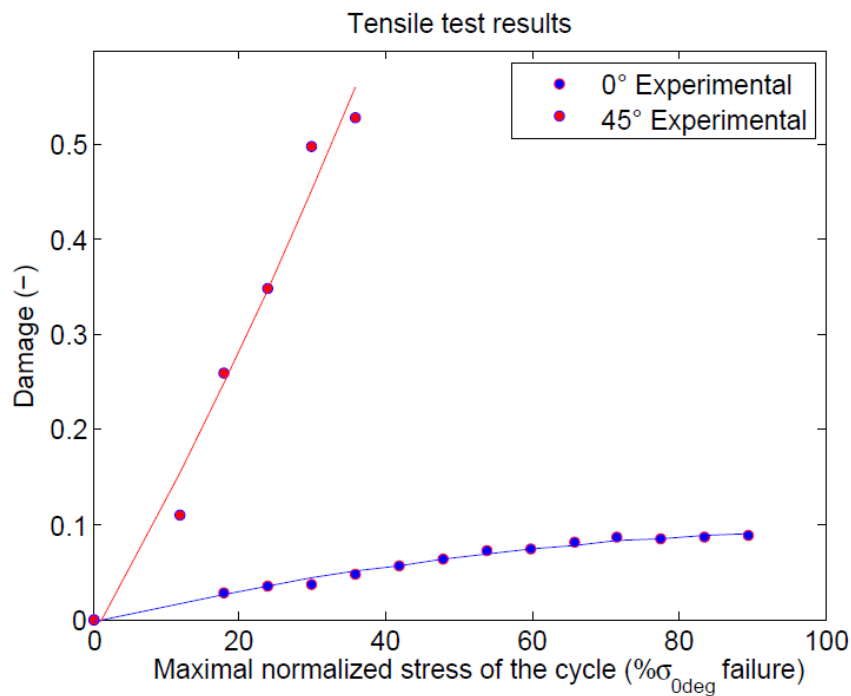
Figure 66 : Comparison of the Young modulus reduction during incremental cyclic test for 0° and 45° oriented samples

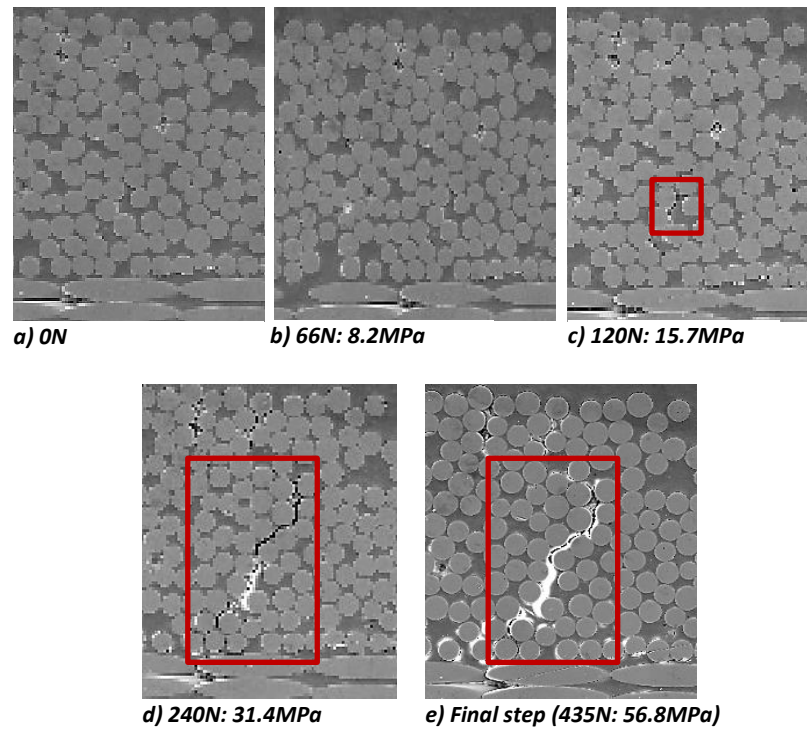
Figure 69 : Transversal yarns during SEM in-situ tensile test for different applied force

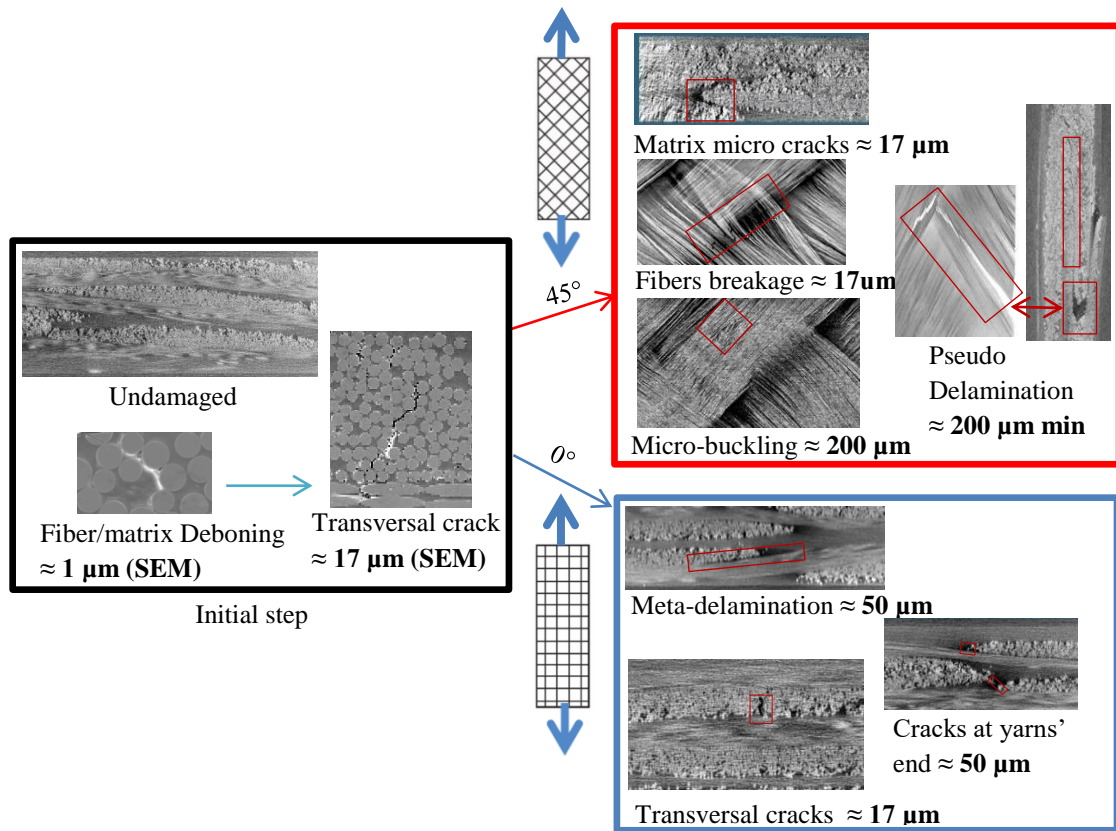
Figure 85 : Summary of the damage mechanisms and their associated typical scale for both 0° and 45° oriented samples.

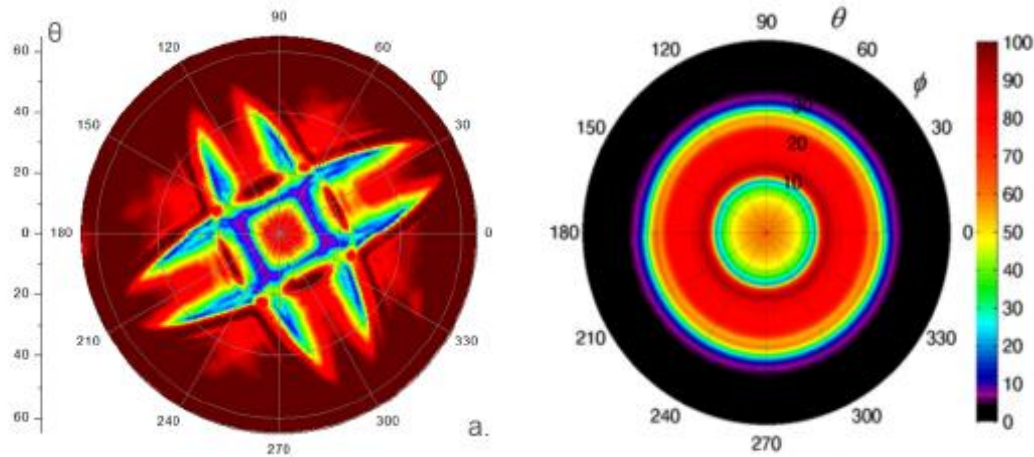
Figure 95 : Left: Pulsed polar scan on a satin weave carbon fabric/PPS laminate [67]; Right: Pole figure for an aluminum sample [119]

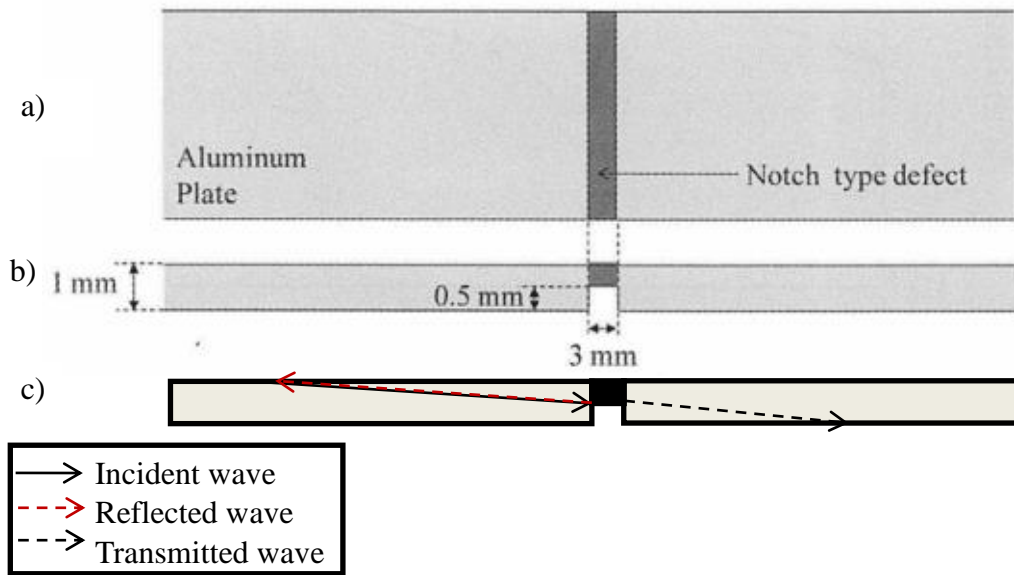
Figure 103 : Schematic representation of the considered aluminum sample with a notch type defect. a) Top observation, b) Side observation, c) Side observation + ultrasonic wave's propagation through the sample (Based on [77])

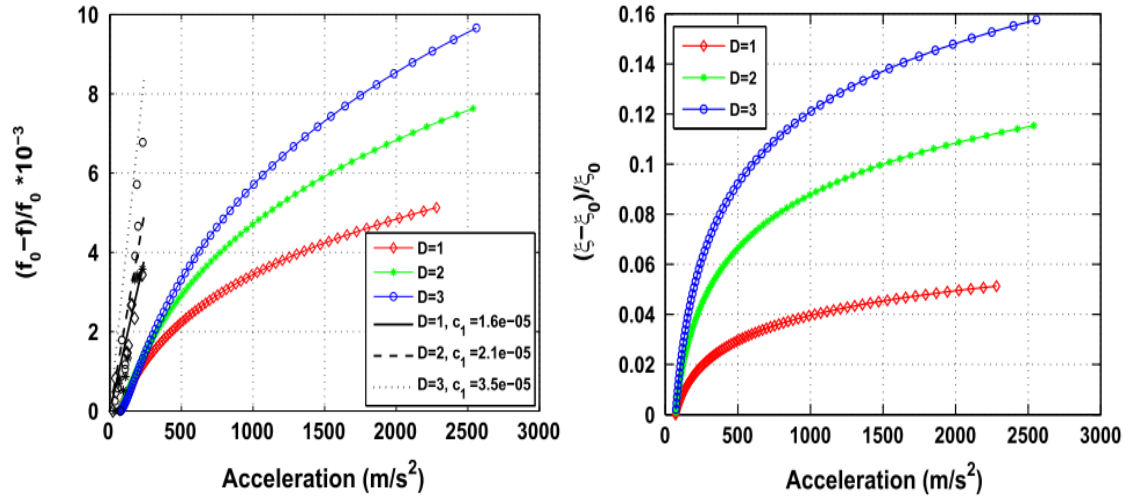
Figure 108 : Numerical results obtained after identification of the attenuation model parameters for concrete

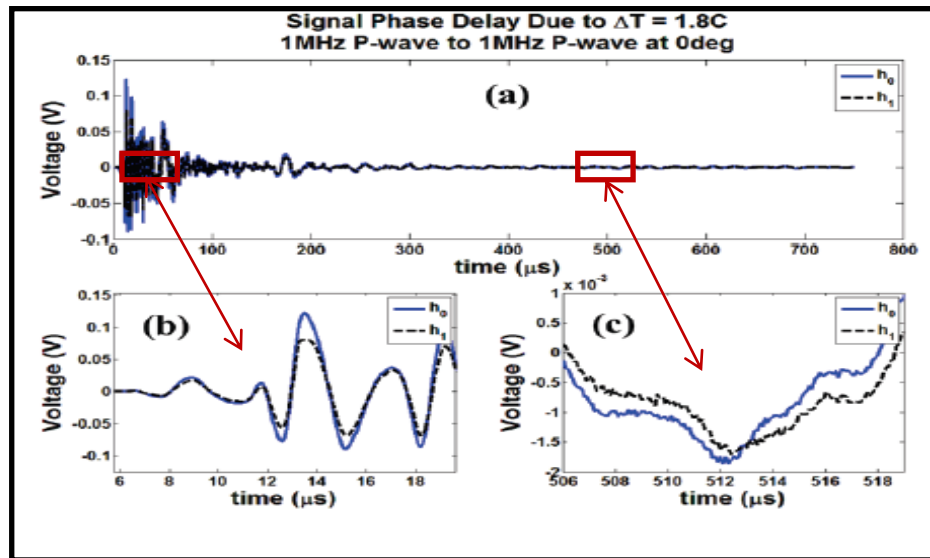
Figure 110 : Signal waveforms collected on a CRFP composite before (h_0) and after (h_1) an increase of temperature [96]

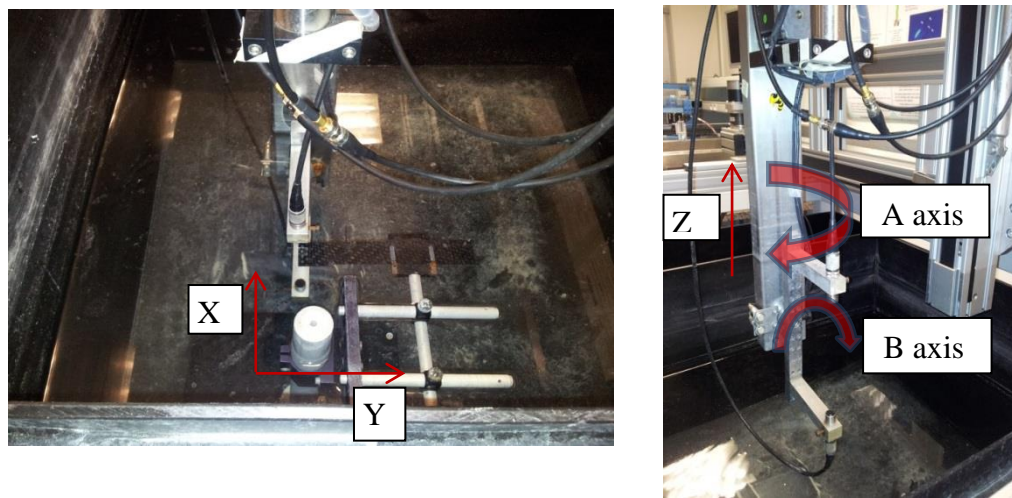
Figure 113 : LUNE lab's 5 axis ultrasonic robot from Inspection Technology

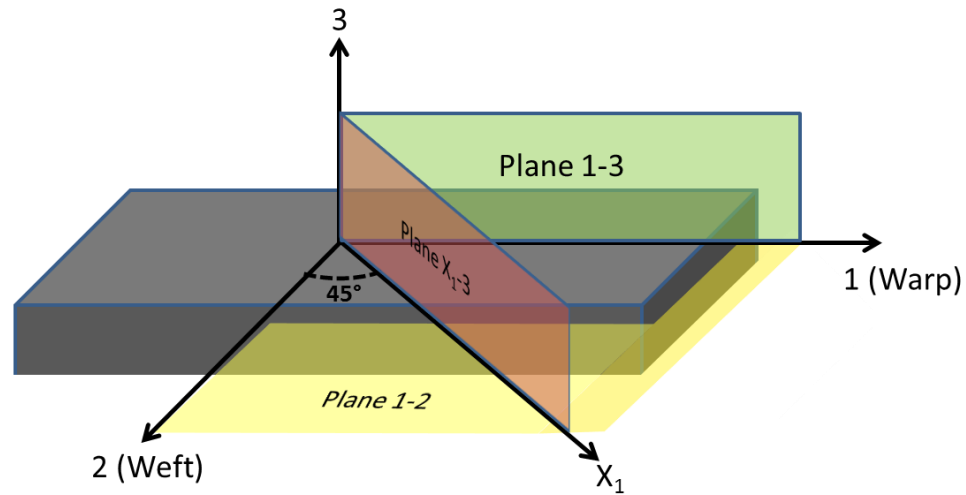
Figure 128 : Schematic representation of the different propagation planes of ultrasonic waves. For samples in the 0° configurations, the planes 1-3 and 1-2 were used. For the samples in the 45° configuration, the plane X_1 -3 and 1-2 were used.

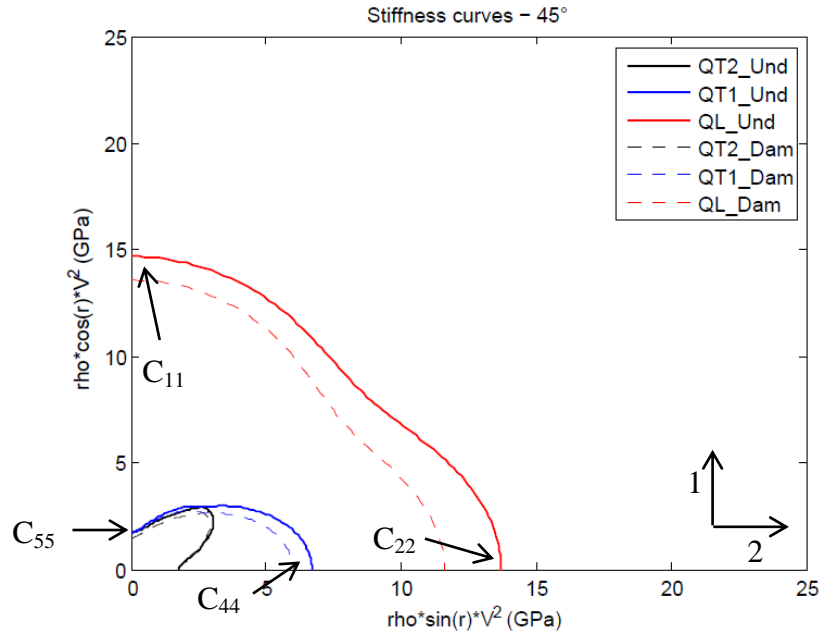
Figure 131 : Stiffness curves for two samples oriented at 45° from the fiber's axis. An undamaged sample and a sample loaded in tension at 120MPa

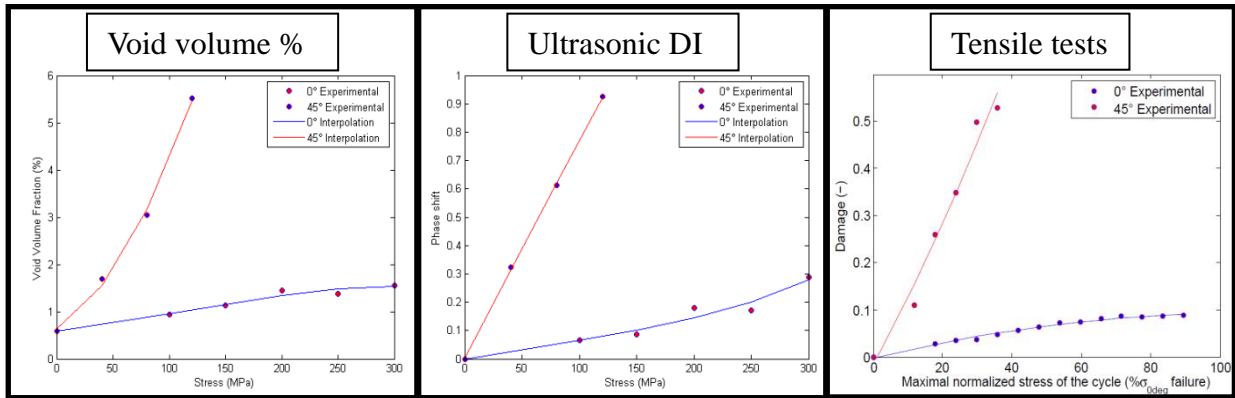
Figure 136 : Evolution of the void volume fraction evolution measured with X-ray tomography; Signal phase shift measured with an ultrasonic method and the elastic modulus loss measured during incremental cycling tensile tests

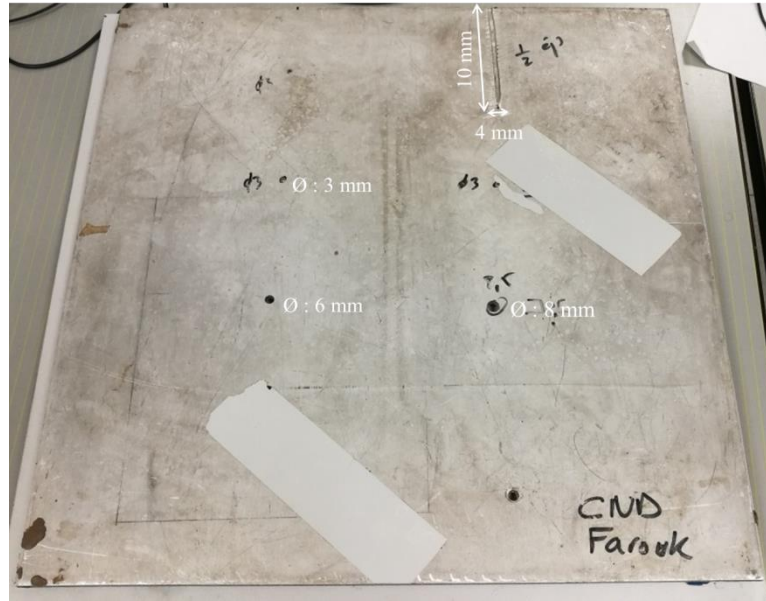
Figure 137 : Investigated aluminum plate. Several defects are appearing in the plate, mostly holes of different diameter. A large notch is also visible

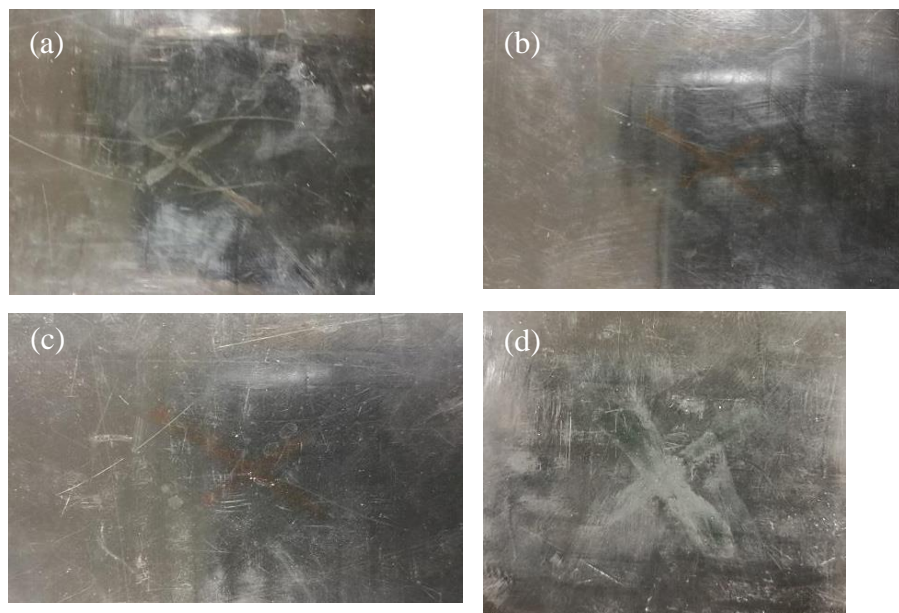
Figure 157 : Visual observation of the plates on the impacted side for an impact energy of (a) 10, (b) 15, (c) 17.5 and (d) 20 J

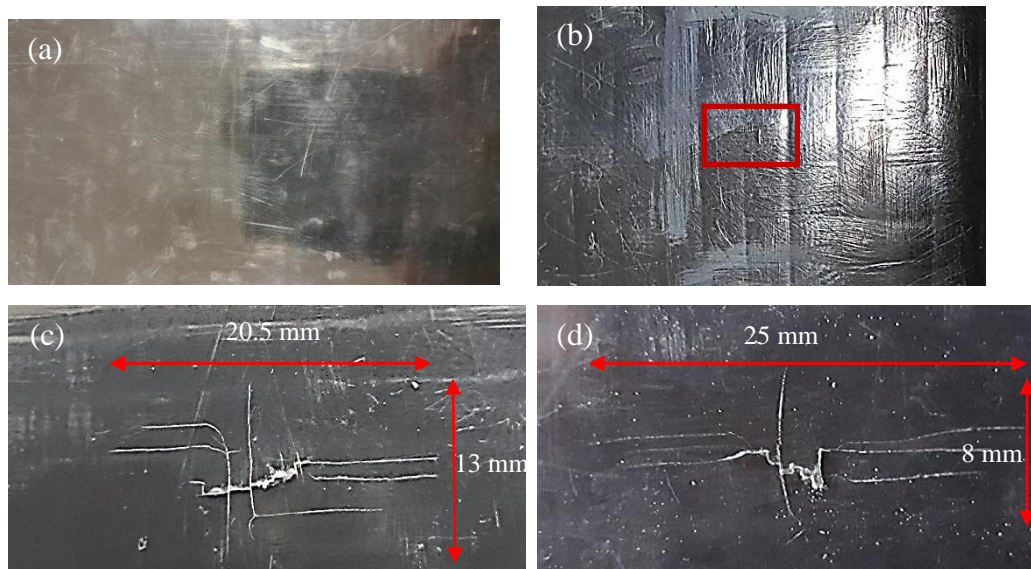
Figure 158 : Visual observation of the damage in the plates on the opposite of the impacted side for an impact of (a) 10, (b) 15, (c) 17.5 and

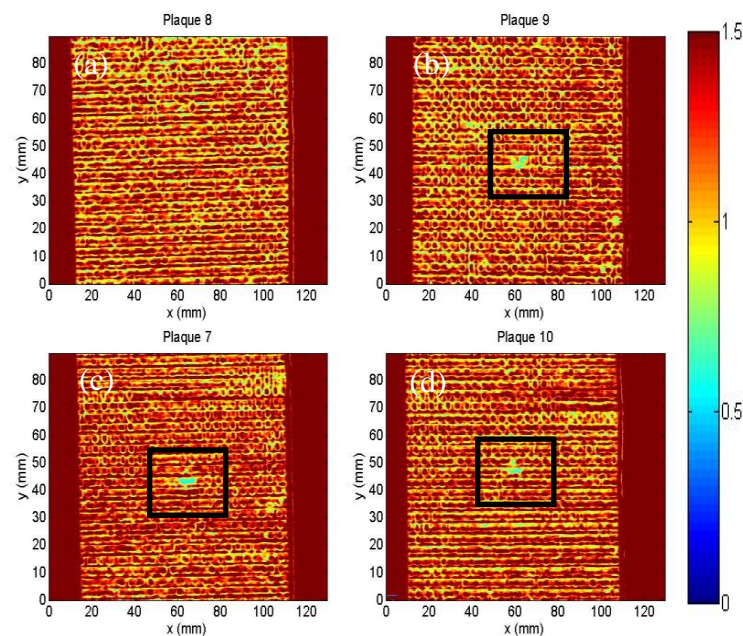
Figure 162 : Ultrasonic C-scan imaging in transmission with 10 MHz transducers for the plates impacted at an energy level of (a) 10, (b) 15, (c) 17.5 and (d) 20 J

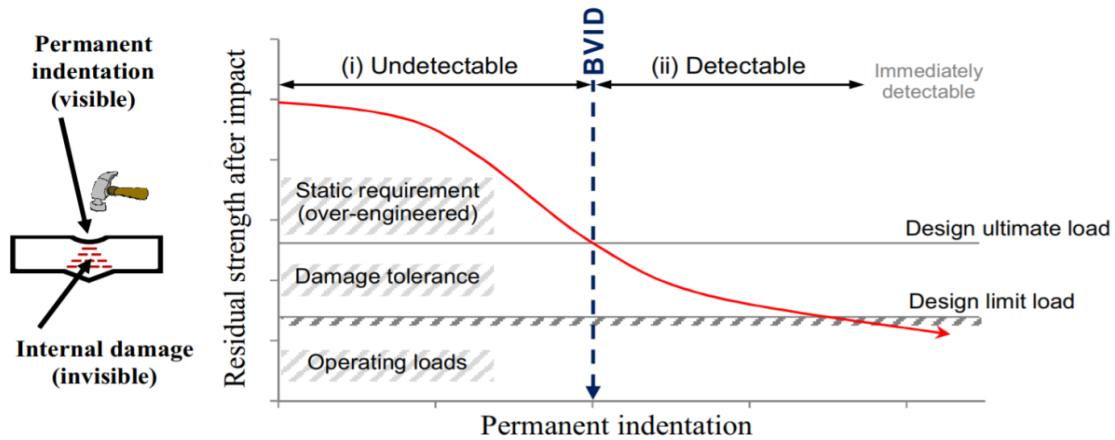
Figure 165 : Impact damage tolerance and permanent indentation concept [123]

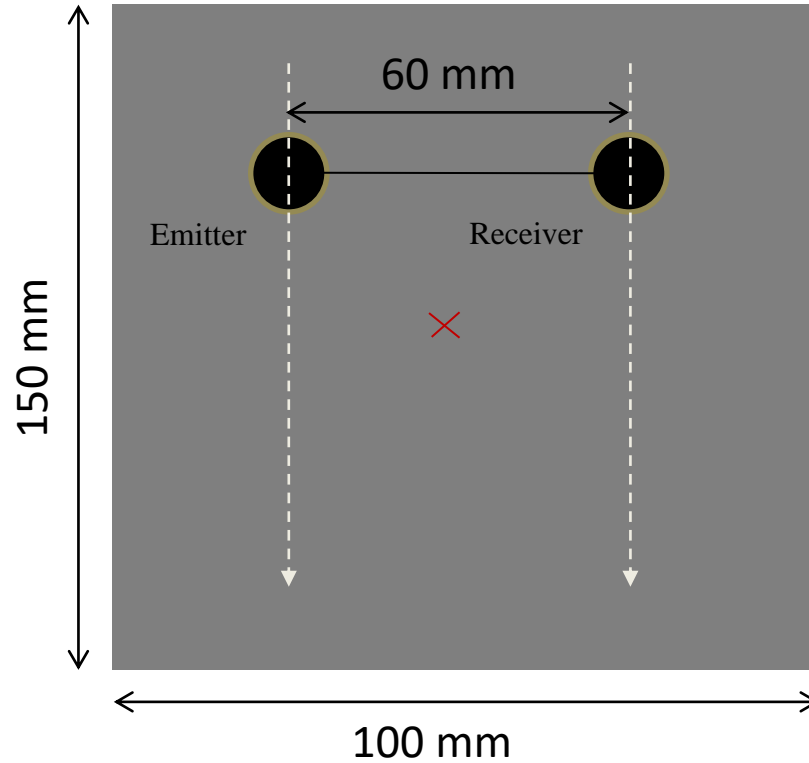
Figure 170 : Schematic representation of the experimental set-up for the guided waves investigations of the plate

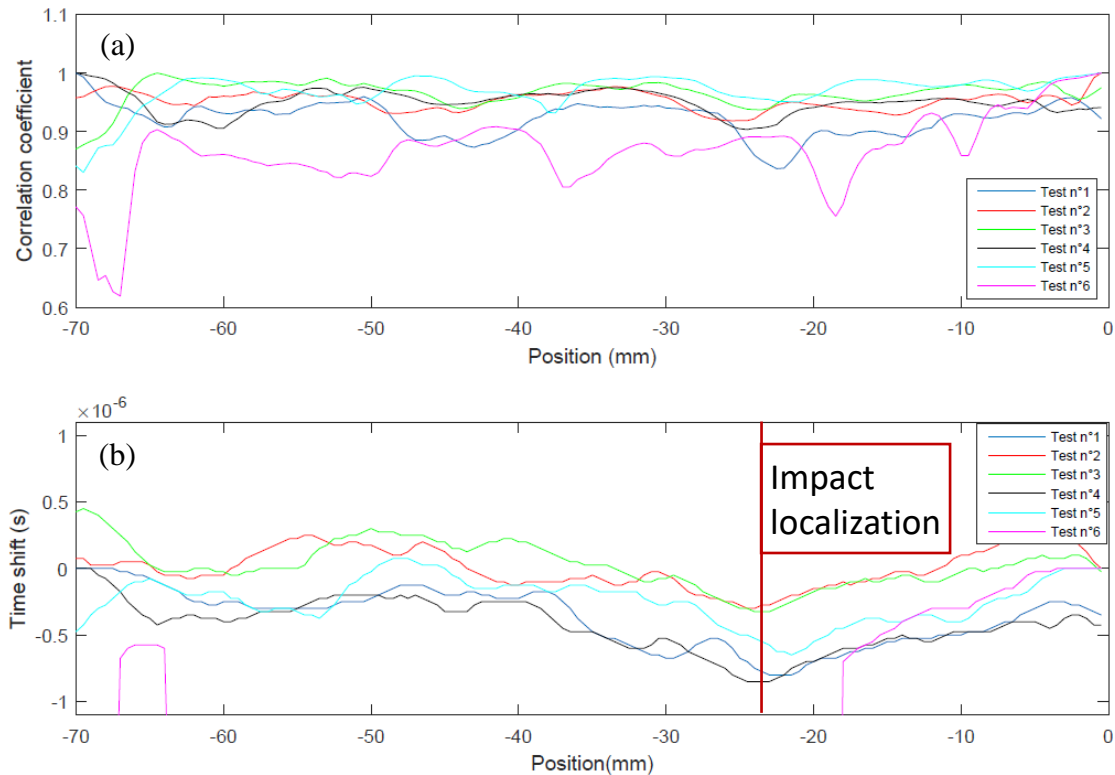
Figure 171 : (a) Evolution of the maximum correlation coefficient with the transducers position. (b) Evolution of the time lag with the transducers position

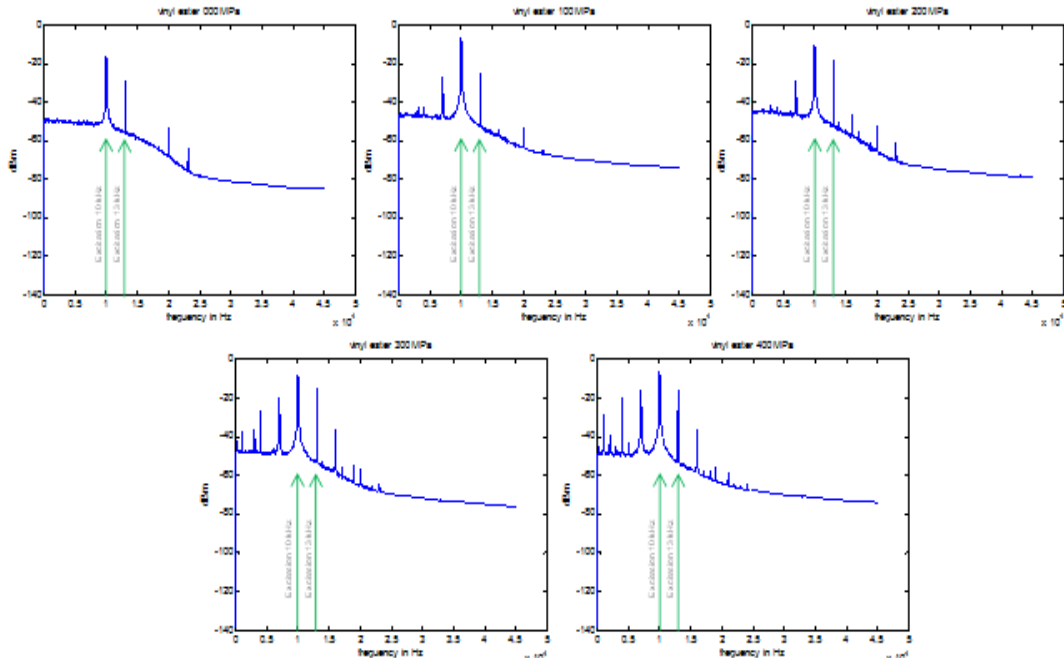
Figure 177 : Frequency response of the vinylester/glass composite submitted to different loading value. The input frequencies are indicate by the green arrow

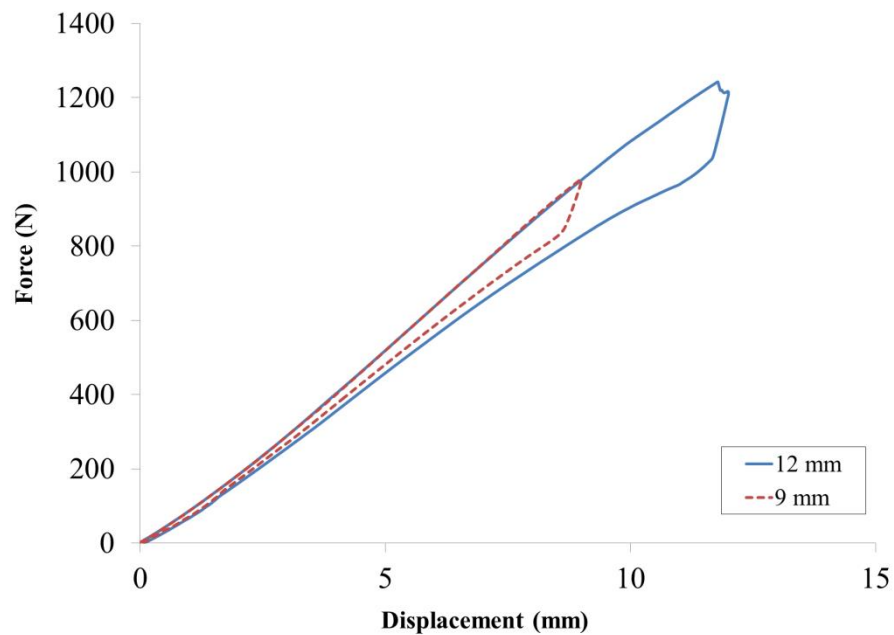
Figure 185 : Force displacement curve for the 12mm and 9mm four points bending tests

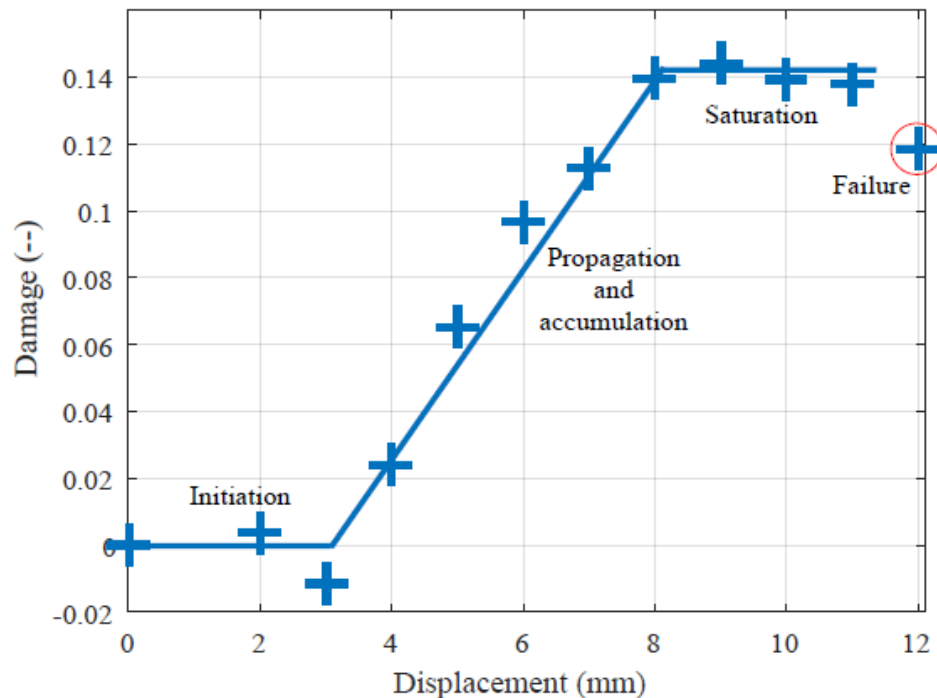
Figure 186 : Evolution of damage, calculated as the reduction of the bending modulus, with increasing the magnitude of the 4 points bending applied displacement

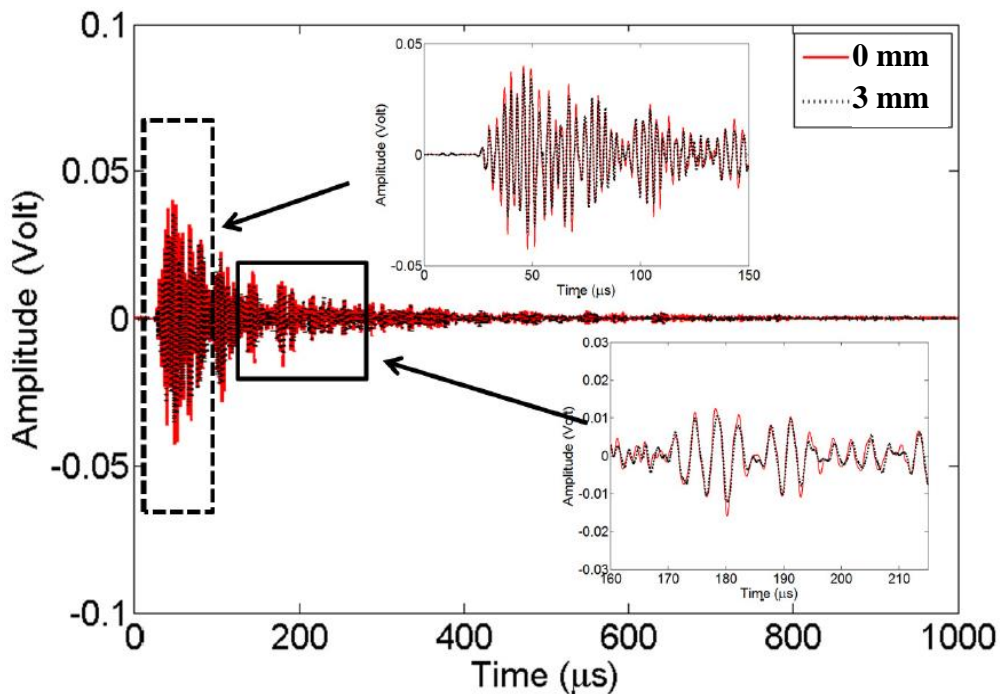
Figure 188 : Signal waveform recorded (in red continuous line) before any loading and (in dashed black line) after 3mm of four points bending applied

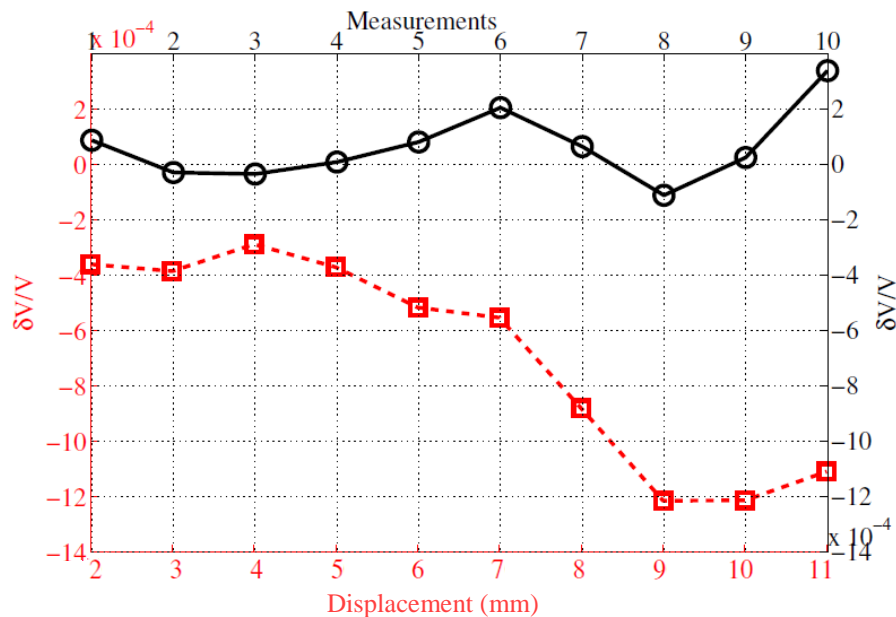
Figure 190 : Variation of $\delta V/V$ over the whole recorded signals for the sample 1 (in dashed red line) and the sample 2 (in continuous black line)
