**GIS Evaluation of the Impacts on the Built and the ‘Natural’ Environment of the 11 March 2011 Tsunami in Rikuzentakata, Iwate Prefecture, Japan**

The 11 March 2011 a Mw 9.0 earthquake triggered a tsunami off the Tohoku coast (Japan). To the north of the infamous Sendai plain area, a series of small bays stretches from the North of Miyagi prefecture to mid-Iwate prefecture. At the border between both prefectures, the municipality of Rikuzentakata lies close to the river-mouth of the Kesen River. Both the built and the 'natural' environment of the municipality have been wiped off the map. In order to create more resilient communities, it is important to reduce the costs of reconstruction and restructuring by integrating lessons learned from the present tsunami. Therefore, this contribution provides a GIS evaluation of the different impacts in order to improve further planning. We have used remote-sensing based GIS - ESRI ArcGIS suite – using spatial data from July 2010 and March 2011. The GIS analysis has been completed using data collected in Japan during the period 2006 – 2010. The results show that the shoreline has retreated up to 501 m with the disappearance of the lagoon bar

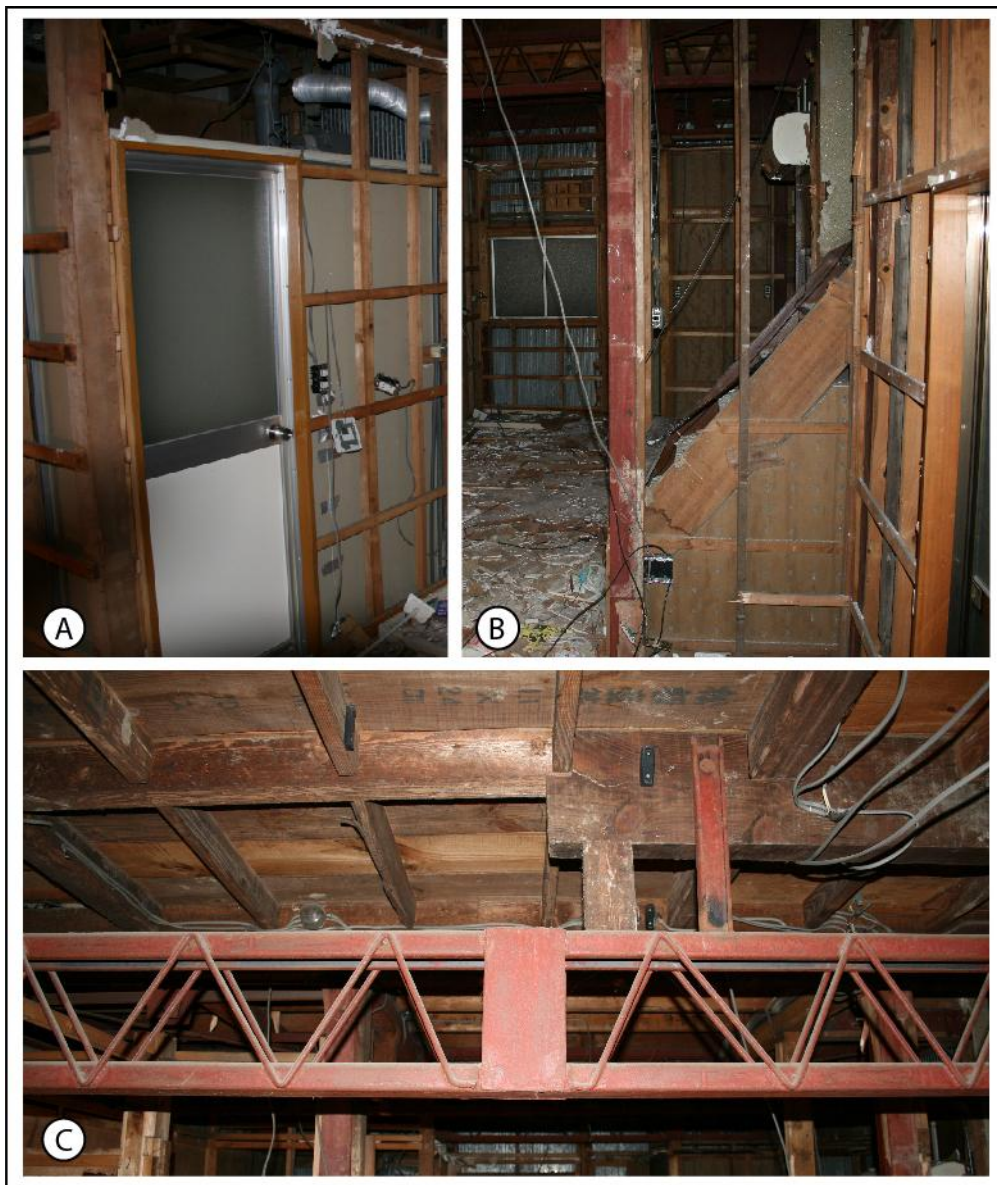
Constructions in Japan are either supported: (1) by a timber-frame structure – typically traditional buildings and one to two storeys habitation buildings; (2) by a metallic structure – recent habitations or commercial buildings; or (3) by a reinforced concrete (RC) structure or a steel reinforced concrete structure (SRC). Some buildings also display a mixture of these, often with a metallic structure superimposed on the traditional timber structure. This type of improvement is adopted to reinforce buildings or further the life of aging buildings (Fig. 8). Such improvement is part of the process called ‘refo-mu’ in Japanese, which consists in modifying, repairing and restoring houses instead of rebuilding a new one. Hooked to the timber and metallic structure, external walls are traditionally light and may be made of wood planks, compressed wood panels, aluminium (Fig. 8-B at the back of the photograph) or plastic sheets (Fig. 9). Light panelling is also found in the houses with either plaster-board, projected plaster on boards or traditionally on bamboo webs, well-known ‘light wood and paper’ mobile /or not separations. The structures are usually anchored to a concrete slab or concrete walls. For the buildings less than 3 storeys high that form the majority of the constructions in the area of Rikuzentakata, the links between the structure and the foundations are either metallic threads less than 2 cm in diameter or bolts, which do not resist the upward and lateral load well.

Fig. 8 Typical timber-frame structure house, which has been reinforced by a metallic structure during the Showa period (1926-1989). We can also appreciate the external wall panels made of painted steel. (Photos: C. Gomez, 2006)
