# EXPERIMENTAL ANALYSIS OF FAILURES IN FILLED HOLE COMPRESSION TESTS OF CARBON/EPOXY LAMINATE

Bruno Castanié, Serge Crézé, Jean-Jacques Barrau, Frederic Lachaud,  
Laurent Risse

Bruno Castanié, Serge Crézé, Jean-Jacques Barrau, Frederic Lachaud, Laurent Risse. EXPERIMENTAL ANALYSIS OF FAILURES IN FILLED HOLE COMPRESSION TESTS OF CARBON/EPOXY LAMINATE. Composite Structures, 2010, 92 (5), pp.1192-1199. hal-02048231

In this study, failure modes occurring during Filled Hole Compression (FHC) tests were analysed using post-mortem analysis for failure pattern identification and high-speed cameras for failure scenario (damage initiation and progress). Two different failure scenario were experienced depending upon the stacking sequence :

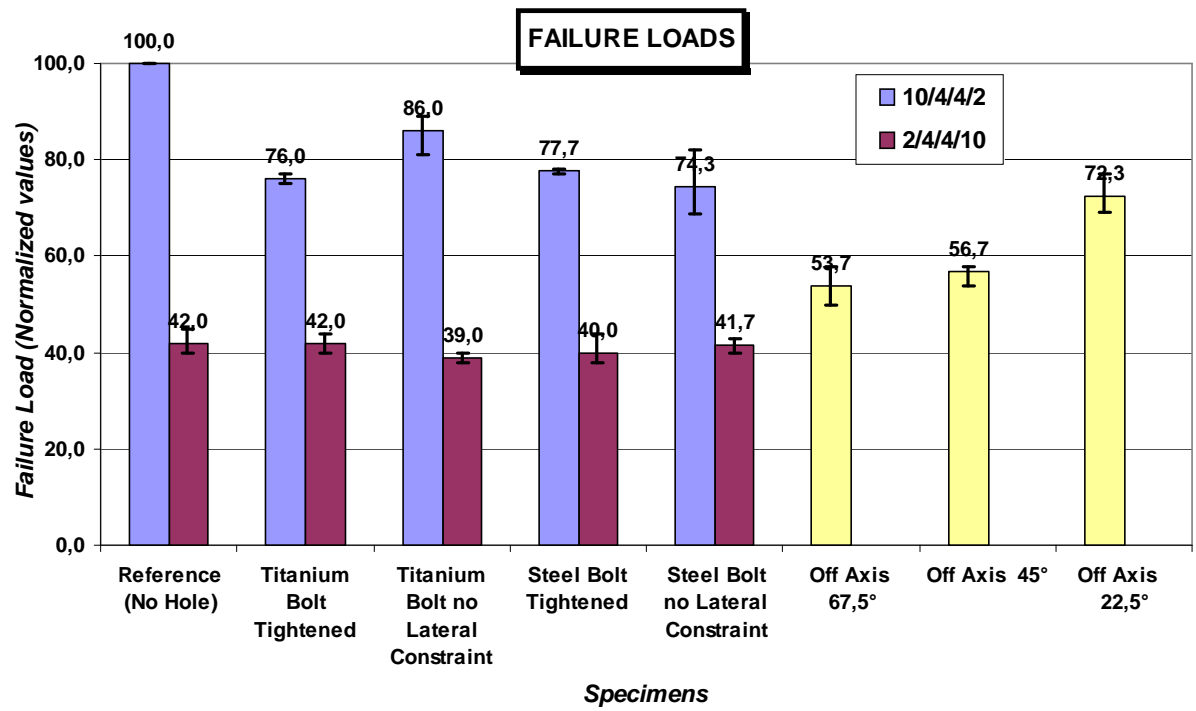
Figure N°6: Failure loads for FHC Tests.

The strain gauges measurement are not provided here since the response is quasi linear until failure. Only parasitic bending moments were identified due to a small curvature of the specimens. The failure loads with scatter bars are given Figure N° 6. The values are the average of the three tests carried out for each configuration and are normalized by respect to the value of the [10/4/4/2] stacking reference specimen fixed to 100.
