# Detectability Assessment of Optical Fiber Sensor Based Impact Damage Detection for Composite Airframe Structures

Noriyoshi Hirano, Hiroshi Mamizu, Akira Kuraishi, Toru Itoh, Nobuo Takeda, Kiyoshi Enomoto

**KEYWORDS :** *Optical fiber sensor, Fiber Bragg grating (FBG), Impact damage, Composite airframe structure*

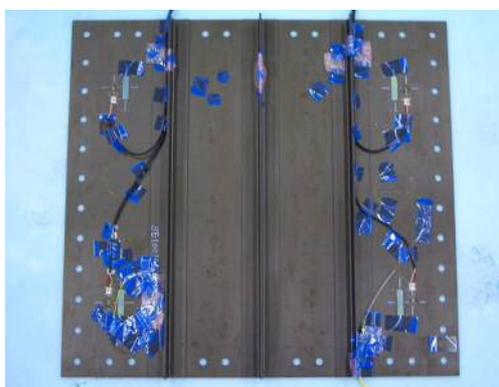
Figure 2: CFRP stiffened panel for simulated vibration test (Looking from stringer side)

The impact tests under vibration were performed to assess the impact detectability of IDDS under simulated vibration condition. In this test, a quasi-isotropic Carbon Fiber Reinforced Plastics (CFRP) stiffened panel shown in Figure 2 was used. The panel has three T-shape stringers. The size of the skin is 600x630x3mm. One optical fiber with 4 FBG sensors was bonded on the stringer side surface of the specimen. The sensor directions were aligned parallel with the stringers. The diameter of bonded optical fiber is 125 micro meter. The applied vibration condition was vertical random vibration of 5.83 Grms with the frequency range of 10Hz to 2000Hz. This condition is based on RTCA DO-160, Section 8, Category R, which is applicable to the fuselage of fixed wing turbojet airplane. The stiffened panel was set to the shaker by the test fixture as shown in Figure 3. Impacts were applied using an impact hammer under the random vibration. The impact load was approximately 1.5kN, which did not cause any impact damage.

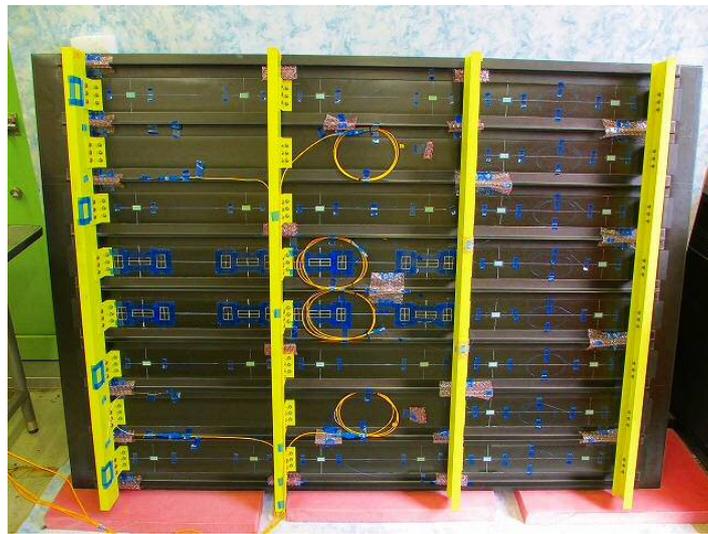
Figure 6: CFRP stiffened panel (Looking from stringer side)

In the study on the optimal FBG sensor direction, impact tests were performed for three types of FBG sensor alignment patterns using a CFRP stiffened panel imitating an actual aircraft structure as shown in Figure 6. This stiffened panel consists of quasi-isotropic CFRP skin, 9 CFRP T shaped stringers, 4 aluminium frames and 32 aluminium shear ties. The frames were fastened to the skin via shear ties. The size of the skin is 1800x1300x3mm. 12 FBG sensors were bonded on the stringer-side skin surface. The diameter of the bonded optical fibers are 125 micro meter. The arrangement of FBG sensors is similar to a rosette type strain gage, aligned in the stringer direction, frame direction (perpendicular to the stringer) and at 45-degree direction as shown in Figure 7. FBG sensor signals were obtained at 800kHz sampling rate using high speed FBG measurement system AR5011A developed by Anritsu corporation in Japan. Localization errors were compared between three types of FBG alignment patterns and suitable sensor direction for impact localization was evaluated. 16 impacts were applied to the web and stringer foot of the stiffened panel, as shown in
