Study of fatigue crack mechanism on an armco iron in the gigacycle fatigue by temperature recording and microstructural observations

Chong Wang, Danièle Wagner, Claude Bathias

Abstract: Whatever the fatigue domain, the fatigue crack mechanism consists of an initiation crack stage (stage I) and a propagation stage (stage II). For materials without inclusions with a single phase, the first damage events in the stage I are due to the occurrence of Slips Marks (SM) on the specimen surface.

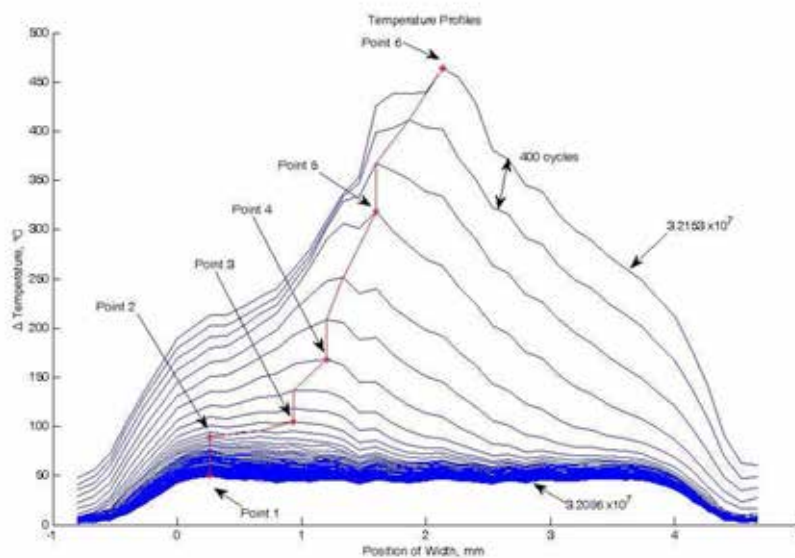
Figure 3 : Temperature profile along the specimen width

From these data, the temperature profile (Figure 3) along the specimen width was extracted for the 168 latest pictures captured by the camera, that is to say from $3.2086 \cdot 10^7$ cycles to $3.2153 \cdot 10^7$ cycles (number of the cycles at the failure).

Between each profile, 400 cycles are performed. The red line on the figure 3 is the location where the temperature is maximum along the profile. Before 3.2086×10^7 cycles, it was not possible to determine a location where the temperature was maximum along the profile. For this test, the crack initiation site appeared on the left side of the specimen (on the left side of the figure 3). The locations of the points 1/2,3,4,5,6 where the maximum temperature rapidly increases were determined. From the specimen corner, the locations of the different points are : points 1 et 2 at 267 μm , point 3 at 933 μm , point 4 at 1200 μm , point 5 at 1600 μm , point 6 at 2000 μm . The corresponding numbers of cycles are : N_1 (point 1) at 3.2086×10^7 cycles, N_2 (point 2) at 3.2148×10^7 cycles, N_3 (point 3) at 3.2149×10^7 cycles, N_4 (point 4) at 3.2151×10^7 cycles, N_5 (point 5) at 3.2152×10^7 cycles, N_6 (point 6) at 3.2153×10^7 cycles and the number of cycles at fracture N_f to 3.2155×10^7 cycles.

During the end of this test, the maximum temperature location moves from the left to the right of the specimen width in agreement with the increase of the fatigue crack length and the increase of the plastic zone ahead the fatigue crack tip.

- At the number of cycles $N = 3.2086 \times 10^7$, the temperature profile on the specimen width shows a point (point 1, figure 3 and 7a) with a higher temperature. At this number of cycles, there is a rapid coalescence of PSB on specimen surface. Probably, the microcrack (due to the PSB) is also opened on the surface thickness of the specimen (point 1bis, figure 7a), and then, there is a coalescence between microcracks on the two surfaces (width and thickness). These points (1 and 1bis) correspond to the transition between crack initiation stage and short crack propagation stage (figure 6b). On the figure 7a, according to the all SEM observations (not presented here), this transition on the fracture surface has been reported. From the point 1, the temperature maximum increases, but this point does not move on the specimen width. This due to the formation of the crack initiation area between point 1 and 1bis. When the crack spreads from point 1 to point 1bis, the ΔK threshold is reached. The calculation according to the blue line is $4.1 \text{ MPa}\sqrt{\text{m}}$, which correspond to a plastic zone size of $\sim 47 \mu\text{m}$. The number of cycles $N = 3.2086 \times 10^7$ is the number of cycles at the crack initiation N_i . This allows to calculate the ratio N_i/N_f equal to 0.9978. So, 99.8% of the total life is devoted to the initiation of the crack. As previously reported for the subsurface crack initiation in the gigacycle fatigue domain [4-5, 9-11], the major part of the total life is devoted to the crack initiation.
