Experimental investigation of impact behavior of wood-based sandwich structures

John Susainathan, Florent Eyma, Emmanuel De Luycker, Arthur Cantarel, Bruno Castanie*

Low carbon emission and sustainable development are shared goals throughout the transportation industry. One way to meet such expectations is to introduce lightweight materials based on renewable sources. Sandwich panels with plywood core and fiber reinforced composite skins appear to be good candidates. Additional properties of wood such as fire resistance or thermal and acoustic insulation are also essential for many applications and could lead to a new interest for this old material. In this paper, Sandwich panels with two different types of plywood and four different skins (aluminum and glass, CFRP, or flax reinforced polymer) are tested under low-velocity/low energy impacts and their behavior is discussed.

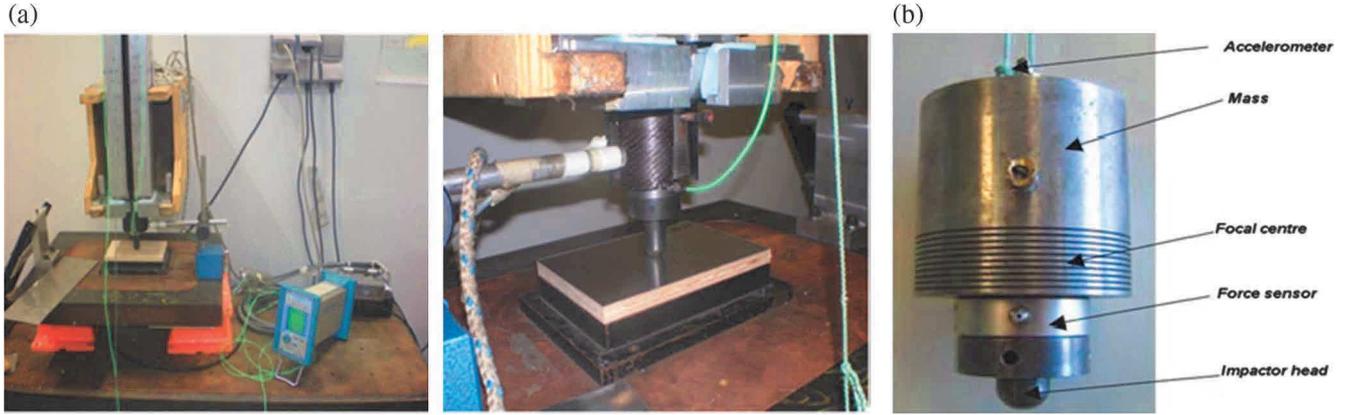
Fig. 2. (a) Drop-weight impact test set-up and aluminum wood specimen installed, (b) Impactor head. (For interpretation of the references to colour in this figure legend, the reader is referred to the web version of this article.)

Impact tests were performed using a drop weight apparatus (Fig. 2) followed by tomography analysis. The principle of the falling weight is to drop an instrumented mass, guided in a tube, onto a sample plate held by a clamping window. In our test, the main components were:

- A mass of 2.08 kg. This value was set so as to achieve the desired impact energy with speeds of up to 5 m/s;
- A load sensor located under the mass, to measure the force between the impactor and the specimen during the impact;
- A hemispherical impactor 16 mm in diameter;
- An optical sensor measuring the speed of the impactor immediately before impact;
- A support window, of internal dimensions $125 \times 75 \text{ mm}^2$, on which the specimen was positioned (standard specimen dimensions: $100 \times 150 \text{ mm}^2$). These dimensions were determined based on Airbus standards AITM 1-0010;
- A clamping window having inner dimensions identical to those of the lower window ($125 \times 75 \text{ mm}^2$) to hold the specimen during the impact;
- A kickback system to prevent multiple shocks on the specimen (same as in [24]).

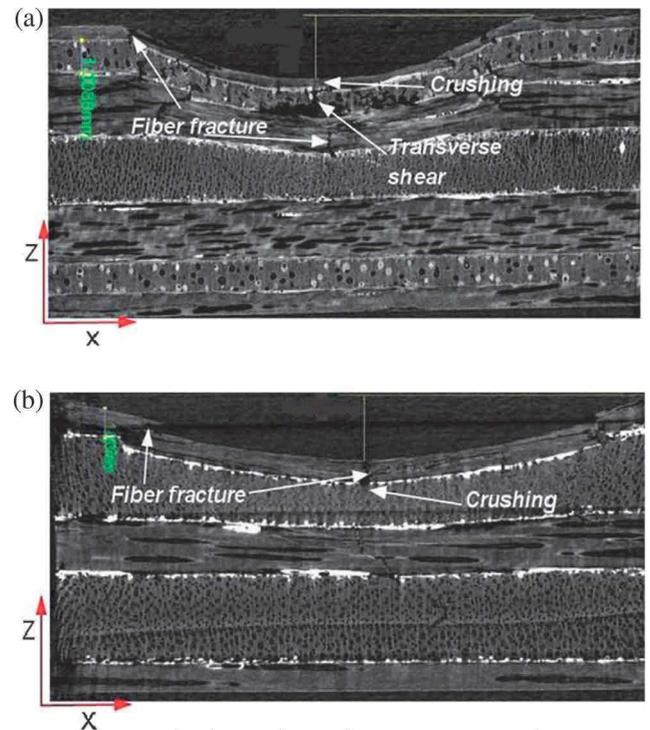
Fig. 3. Failure modes of impacted plywood core at 10 J. (a) Plywood A, (b) Plywood B. (For interpretation of the references to colour in this figure legend, the reader is referred to the web version of this article.)

Firstly, it was observed that crack initiation always occurred in the plywood close to pre-existing damage in the plywood. These pre-existing damages are due to the peeling cutting process used to obtain wood plies from the log. This process generates pre-cracks in the radial/longitudinal plane that may propagate in the same direction or rotate to propagate in the tangential/longitudinal plane because of transverse shear [31]. A tomography analysis on damaged samples of plywood A and B is shown in Fig. 3(a) & (b). In the case of plywood structures, a permanent indentation occurred at all energy levels through deformation due to plasticity or fracture of wood ply. Maximum deformation occurred at the top ply due to crushing. Only one third of the sample was concerned at 5 J but permanent deformation occurred in up to one half of the sample for a 10 J impact test. For 15 J tests, perforation occurred and the impactor hangs in the plywood which creates the

second peak. In summary, for both plywoods (A and B), we identified fiber fracture, transverse shear, crushing, permanent indentation and deformation as predominant failure modes, with propagation to one half of the plywood core with increasing energy levels.

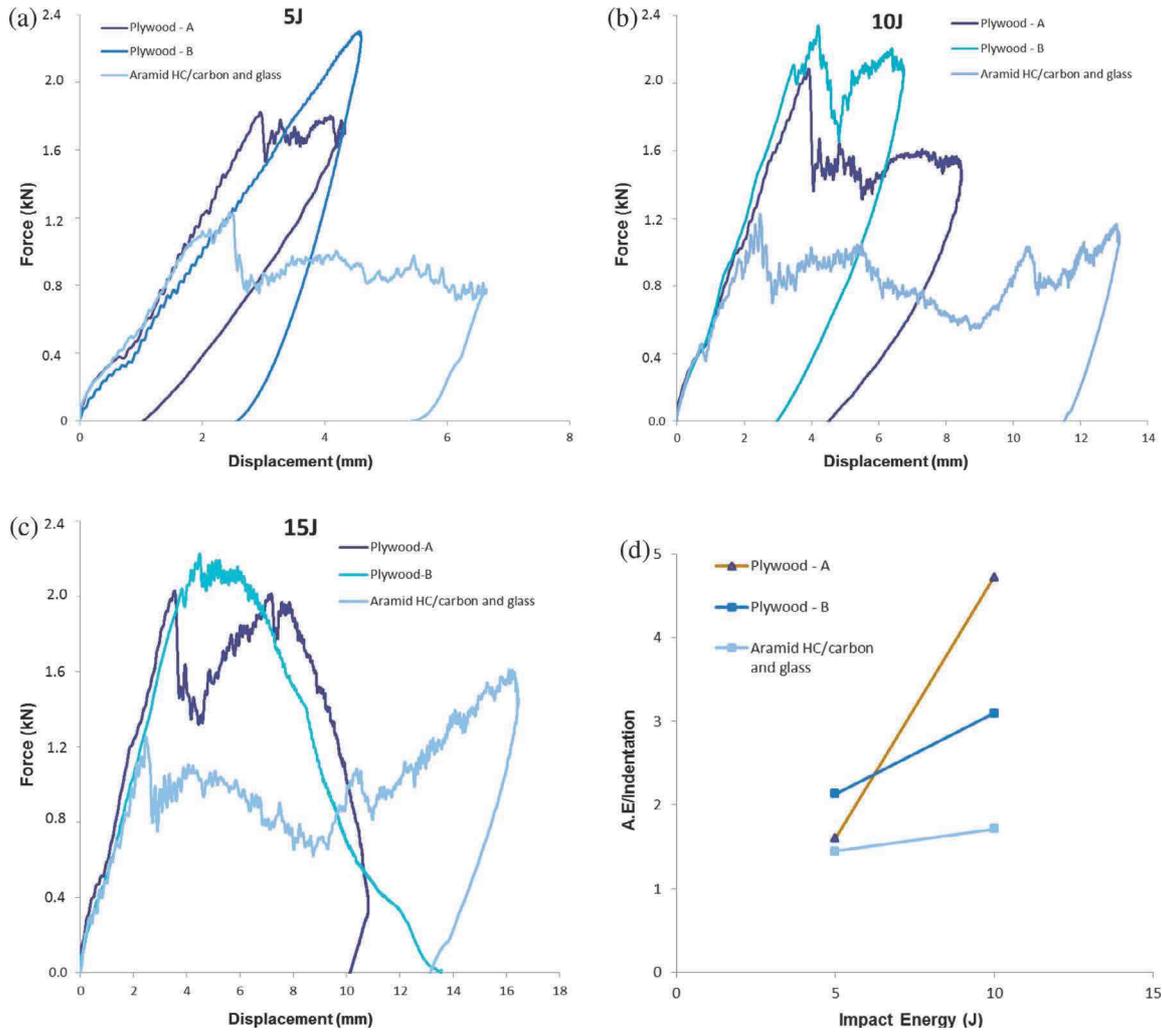
Fig. 4. Force-displacement plot for plywood structure (a) 5 J, (b) 10 J, (c) 15 J, and (d) Ratio of Absorbed energy to indentation (J/mm). (For interpretation of the references to colour in this figure legend, the reader is referred to the web version of this article.)

The impact response in terms of the energy absorbed at different energy levels (5 J, 10 J and 15 J) is presented in Fig. 4 a, b and c respectively. The influence of permanent indentation on absorbed energy is illustrated in Fig. 4 d and Table 3. In this table, the relative absorbed energy column represents the ratio between the absorbed energy and the measured impact energy in percent. The specific absorbed energy is obtained from the ratio of absorbed energy to the density. It is found that the force-displacement histories of plywood structures exhibit

common trends, such as linear increase of force as the impactor contacts the panel, and a plateau that indicates crushing through radial compression of cell walls. Then, due to loss of stiffness caused by fiber fracture, transverse shear or debonding, the peak force starts to decrease after attaining the peak value.

The ratios of absorbed energy to indentation are plotted in Figs. 4(d), 6(d) and 11 and are noted in Tables 3–5. The specific energy

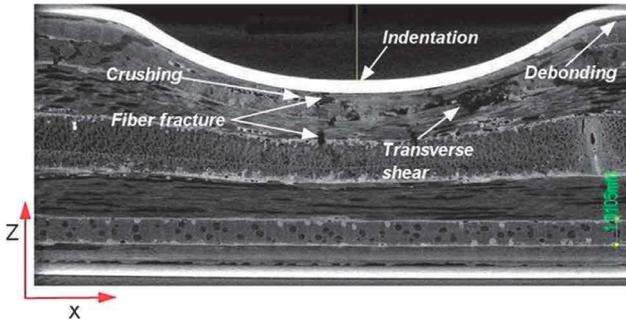
Fig. 5. Tomography images of impacted plywood with aluminum skin – Failure modes at 15 J. (For interpretation of the references to colour in this figure legend, the reader is referred to the web version of this article.)

With aluminum skins, a permanent indentation was observed for all impact energies due to the ductile property of this material and the smaller elastic spring back effect as shown in Fig. 5. Delamination between skin and core was not observed under the impactor but very slightly around it. In the case of 5 J impact, crushing, fiber fracture and transverse shear were observed in one third of the depth of the plywood core, i.e. down to the top okoume 0° ply. At 10 J, the same failure modes were observed on half the depth of the plywood core, down to the poplar 0° ply. At 15 J, the delamination and damage area increased

around the impactor. The same phenomenon as above, with maximum deformation, occurred down to two thirds of the depth of the plywood core, i.e. to the middle poplar 90° ply in plywood – A, as shown in Fig. 5.

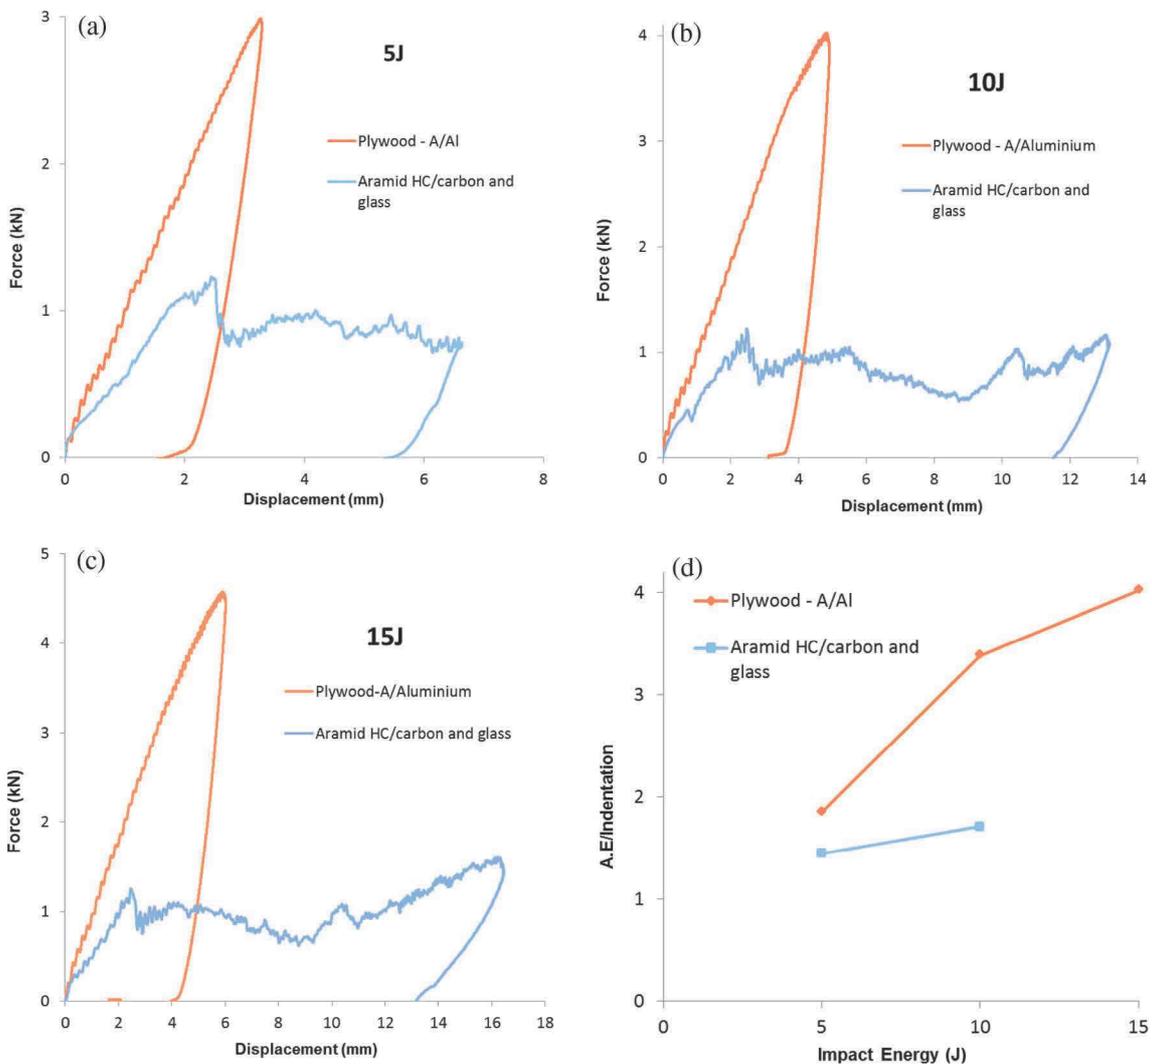
Fig. 6. Force-displacement plot for Plywood A/Aluminum skin (a) 5 J, (b) 10 J, (c) 15 J, and (d) Ratio of absorbed energy to indentation (J/mm). Comparison with the reference sandwich panel impacted at same energy levels. (For interpretation of the references to colour in this figure legend, the reader is referred to the web version of this article.)

The force-displacement history of plywood with aluminum skin at different energy levels (5 J, 10 J and 15 J) is shown in Fig. 6 a, b and c and compared with our reference material of aramid honeycomb with carbon and glass skin. Globally, the shape shows that there is a little part of crushing (no plateau in the curve) for this sandwich. The mechanism of absorption is mainly plasticity of the skins. We found that plywood structures with aluminum skin had energy absorption capabilities comparable to those of our reference material (see Fig. 6 a and b and Table 4). However, in terms of specific energy absorption, aramid honeycomb/carbon and glass skin yielded higher results due to its low density. At higher energy levels, the rate of indentation increased rapidly, causing moderate indentation without perforation of the aluminum skin, due to its ductile behavior, whereas aramid honeycomb was perforated and lost its structural integrity.

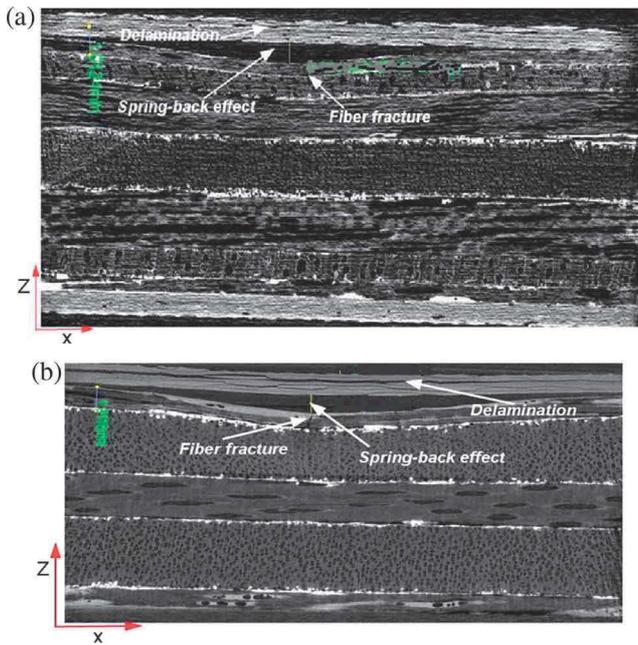
Fig. 7. Tomography images of impacted plywood with Carbon skins – Failure modes at 15 J, (a) plywood A, (b) plywood B. (For interpretation of the references to colour in this figure legend, the reader is referred to the web version of this article.)

With carbon fiber composite as shown in Fig. 7 a and b, small permanent indentation was observed under the impactor and top carbon skin, due to crushing of the core and elastic spring back of the skin. It also caused indentation and a damage area on the ply below the

top skin. The amount of damage and indentation area on the top skin were lower than in the wooden ply below the top skin. At 5 J, delamination was observed in the carbon fiber composite skins and at the interface between the core and the skin. Fiber fracture and crushing were observed in the top fifth of the plywood core. At 10 J, delamination inside the skin and between the impacted skin and the core increased. Crushing, fiber fracture and deformation were observed in a quarter of the depth of the plywood core, down to the top okoume 0° ply. At 15 J, all the above failure modes spread into the top third of the plywood core, down to the top poplar 90° ply in plywood - B (see Fig. 7b).

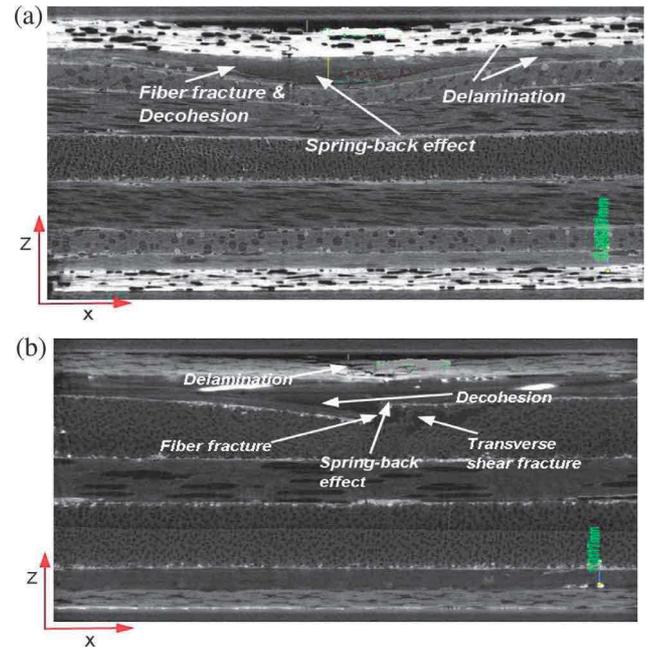
Fig. 8. Tomography images of impacted plywood with glass skins – Failure modes at 15 J, (a) plywood A, (b) plywood B. (For interpretation of the references to colour in this figure legend, the reader is referred to the web version of this article.)

With glass fiber reinforced composite skins as shown in Fig. 8 a and b, the phenomena were quite different, with no delamination between the top skin and the core, thanks to their perfect adhesion. The delamination thus occurred at the ply below the top skin. Elastic spring back of the composite skin also caused damage at the poplar 90° ply and fiber fracture at the top okoume 0° ply below the skin, which led to higher deformation at the third ply from the top (poplar 90°) than at the second one. At 5 J, slight indentation and crushing occurred under the impactor, delamination and fiber fracture were observed in the glass fiber skin, and fiber fracture was observed in one tenth of the plywood

core, i.e. in a quarter of the cross section. In the case of 10 J, crushing occurred in a one quarter of the plywood core, delamination was observed between the skins and the core, but fiber and transverse shear fracture occurred in one quarter of the plywood core, down to the top okoume 90° ply. At 15 J, fiber fracture occurred in the composite skin, and transverse shear, crushing and maximum deformation occurred in one third of the plywood core, down to the top poplar 0° ply in plywood A (Fig. 8a & b).

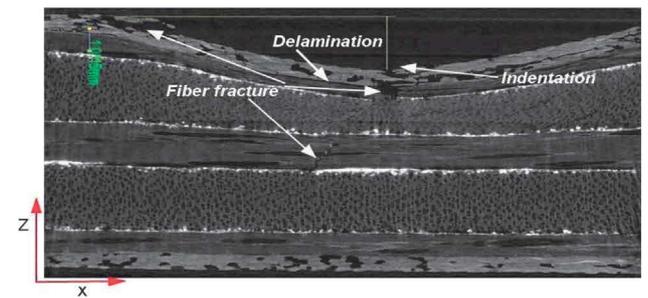
Fig. 9. Tomography images of impacted plywood with flax skins – Failure modes at 15 J, plywood B. (For interpretation of the references to colour in this figure legend, the reader is referred to the web version of this article.)

Considering flax fiber reinforced composite skins, the damage modes were slightly different, as shown in Fig. 9. At 5 J, delamination between the skin and the core, and moderate indentation occurred under the impactor due to elastic spring back of the composite skin. Fiber fracture was observed on the one tenth of the plywood core, down to the top okoume 0° ply, while crushing appeared on one third of the plywood core, down to the top poplar 90° ply. In the case of 10 J, delamination increased under the impactor, crushing was observed on 40% of the plywood core (down to the top poplar 90° ply) and fiber fracture appeared in the flax composite top skin. At 15 J, fiber fracture and indentation was found in one half of the depth of the plywood core, down to the middle okoume 0° ply in plywood B. Delamination increased and fiber fracture occurred in the flax skin.

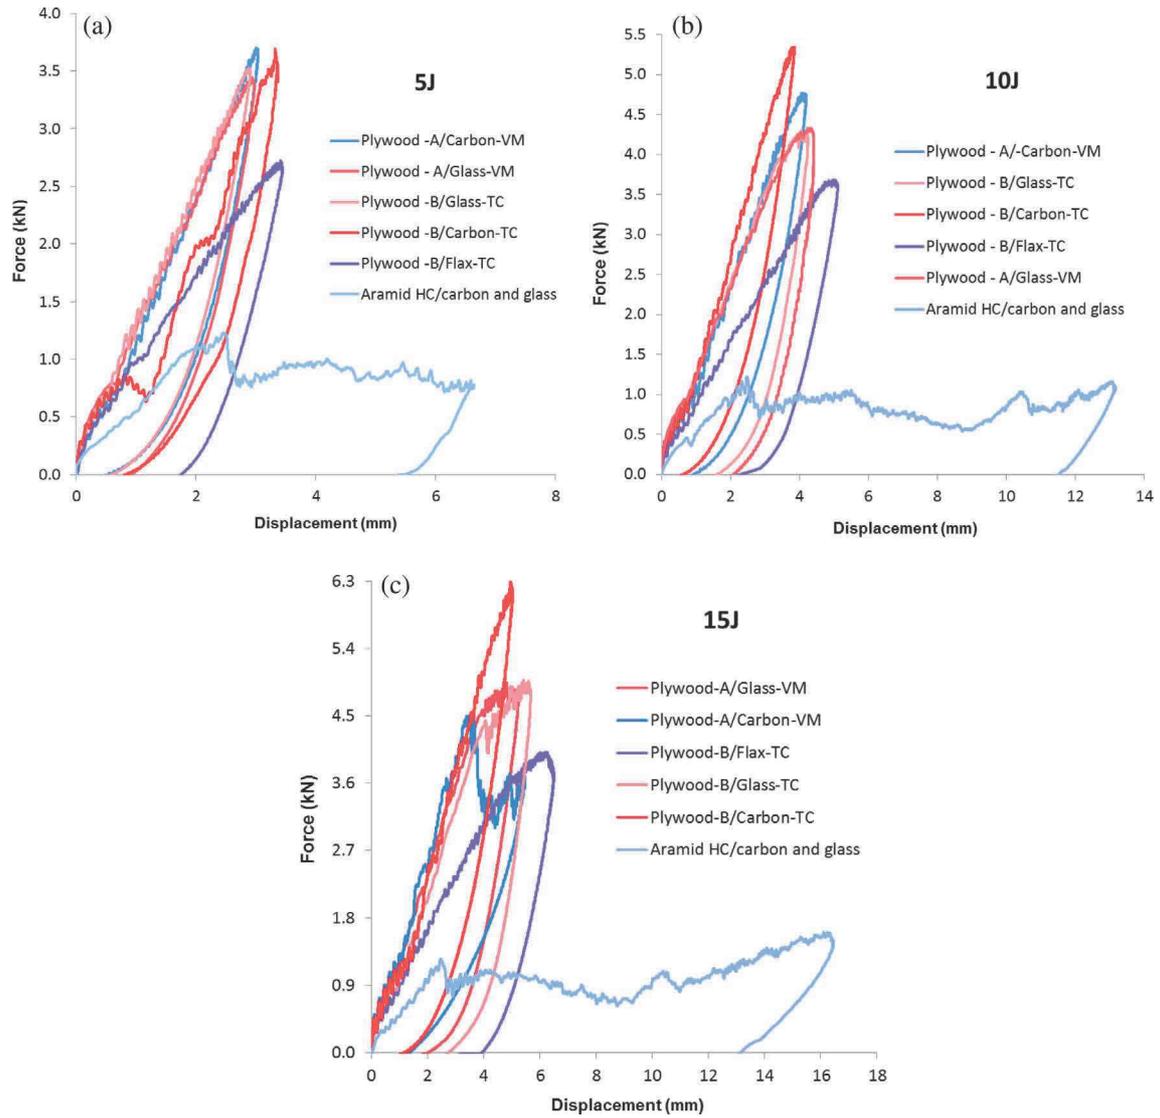
Fig. 10. Force displacement plot for Sandwich panels with plywood core and composite skins at 5 J (a), 10 J (b), 15 J (c). (For interpretation of the references to colour in this figure legend, the reader is referred to the web version of this article.)

Regarding energy absorption and indentation, the impact responses of plywood with composite skin at 5 J, 10 J and 15 J in terms of force vs displacement and ratio of absorbed energy to indentation are shown in Fig. 10 and also in Table 5. In the case of carbon skins, the higher stiffness of the skins and the lack of internal damages resulted in small indentation and the smallest absorbed energy as shown with sharp shapes of the curves. This composite also resisted the highest impact load but with more delamination in the skin and extreme crushing of the plywood core due to its elastic spring back and the poor adhesion attained in the case of vacuum molding, where air can be trapped during vacuum creation. Regarding the glass fiber skins, absorbed energy was comparable to that for flax, with also a smaller indentation than for carbon because of the higher strength of the skins and perfect adhesion obtained with the samples manufactured by thermo-compression as compared to plywood with carbon skin manufactured by both vacuum molding and thermo-compression. Despite a lower indentation than for the reference material, the ratio of absorbed energy to indentation (Fig. 11) was not much higher for the flax composite skin structure.

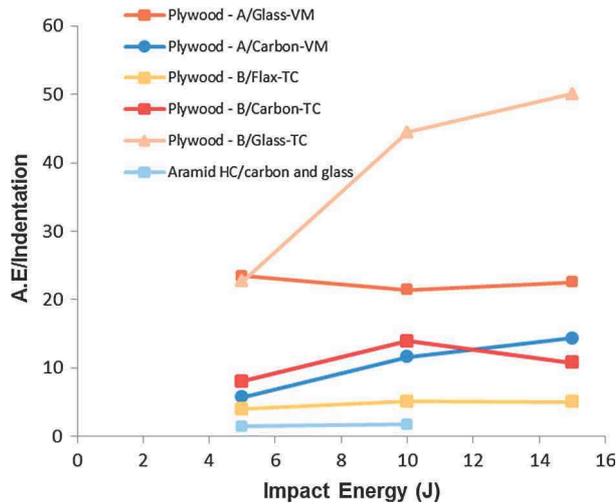
Fig. 11. Ratio of absorbed energy to indentation for plywood with composite skins (J/mm). (For interpretation of the references to colour in this figure legend, the reader is referred to the web version of this article.)

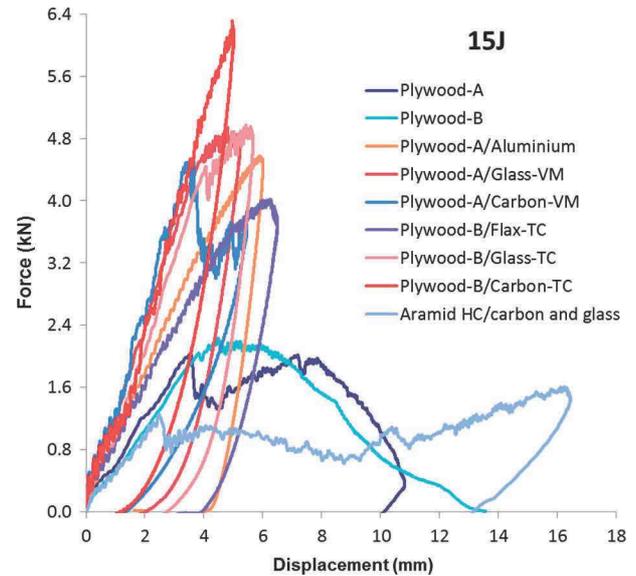
Fig. 12. Force-displacement plot for the different wood based sandwich structures at 15 J. (For interpretation of the references to colour in this figure legend, the reader is referred to the web version of this article.)

The impact response of the eight different wood based sandwich structures and our reference materials are presented in Fig. 12 in terms of a force-displacement plot for the 15 J case only. In general, the initial slope of force-displacement varies with the skin materials, thus indicating variation in stiffness of the different wood based sandwich structures. As expected, the skin properties influence the impact behavior of these sandwich structures even at lower displacement values. Concerning plywood structures, plywood A is found to yield slightly better results than plywood B in terms of absorbed energy and indentation, due to its longer plateau. Its higher number of interfaces causes better transverse behavior, which leads to smaller permanent indentation than in plywood B. Both plywood structures have comparable energy absorption capabilities and lower indentation in comparison to the reference material (see Tables 3–5). In terms of specific energy absorption, despite the good results of the materials under test, the reference material yields the highest results due to its low density. However, at 15 J, all these materials undergo perforation with heavy loss of structural integrity, which are incompatible with most applications. The plywood also gives good results regarding specific energy absorption because of its low density.

For plywood structures with aluminum skins, compared to plywood structures alone, there is an absence of plateau and peak force oscillation occurs due to the high strength and stiffness of the skin. This structure has comparable energy absorption and better resistance to indentation than the reference material but is not as good in terms of specific energy absorption, because of the high density of aluminum skin. Moreover, this structure results in a deeper indentation than in any of the other structures with composite skin, which can be undesirable in some applications.

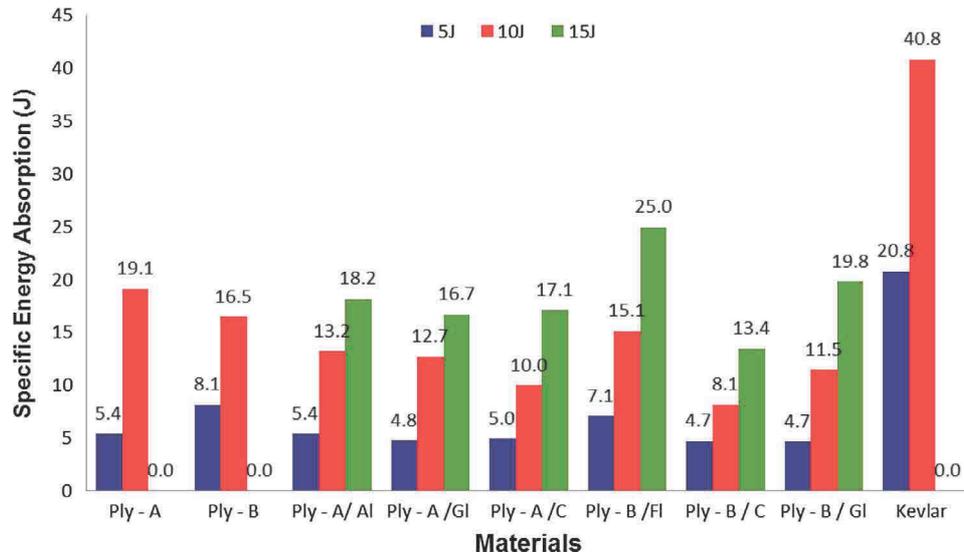
Fig. 13. Specific energy absorption for the 8 configurations tested plus the reference one. (For interpretation of the references to colour in this figure legend, the reader is referred to the web version of this article.)

absorptions at three energy levels for different sandwich structures are shown in Fig. 13. Two different processes, thermo-compression and vacuum molding with prepreg, were used to manufacture our panels of plywood structure with carbon/epoxy and glass/epoxy composite skins. In general, we found that the plywood with glass skin fabricated by the thermo-compression process had minimum defects, and better adhesion and structural integrity than that obtained by vacuum molding, as a result of the high operating temperature, the absence of trapped air, and the pressure used in the thermo-compression process.

Finally, regarding specific energy absorption (see Fig. 13), the reference material, aramid honeycomb with carbon and glass composite skins, yields the highest results because of its low density but undergoes perforation and loses its structural integrity for high energy impacts (15J). In comparison, in the case of plywood with aluminum skin, crushing is transformed into indentation without perforation. Regarding newly developed wood based sandwich structures; a very
