Comparison of long-term natural aging to artificial aging in Duralumin

Comparison of long-term natural aging to artificial aging in Duralumin.

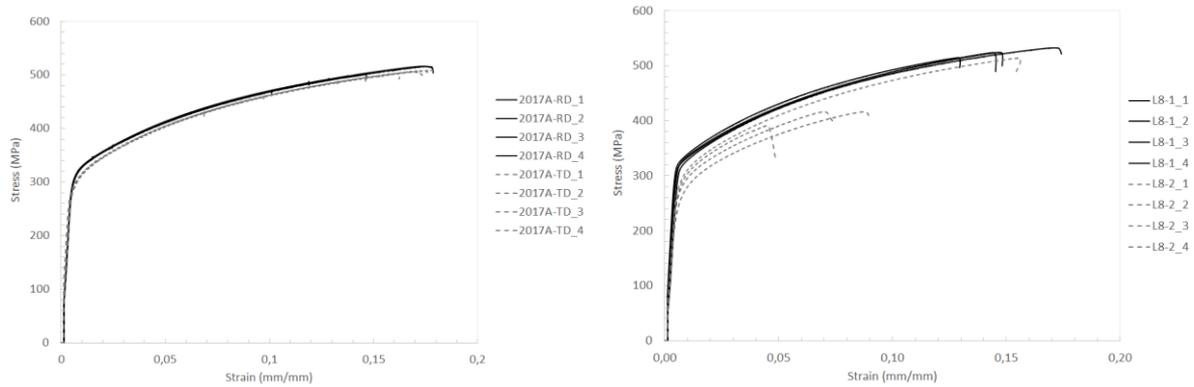
Fig. 1. True Stress/Strain curve in two orientations a) RD and TD for 2017A and b) D1 and D2 for L8 in as-received state.

The engineering stress-strain curves for the modern plate (2017A) and the old plate (L8), both in the as-received state are shown in Figure 1 for two directions: rolling direction (RD) and transverse direction (TD). For L8, a circular plate, it was not possible to identify straightforwardly the directions [10]: a labelling D1

and D2 was thus used. They are supposedly the rolling and transverse direction respectively. Figure 1.a reveals that tensile strength curves exhibit good reproducibility for 2017A. On the old alloy however, a heterogeneous behaviour is observed. Early failure occurs quite often in direction D2, the estimated transverse direction. Table 1 summarizes the main mechanical properties. If early-failed specimens are not taken into account, the yield strength (YS), the ultimate tensile strength (UTS) and the elongation are conformed to the expectation for such alloy [15].

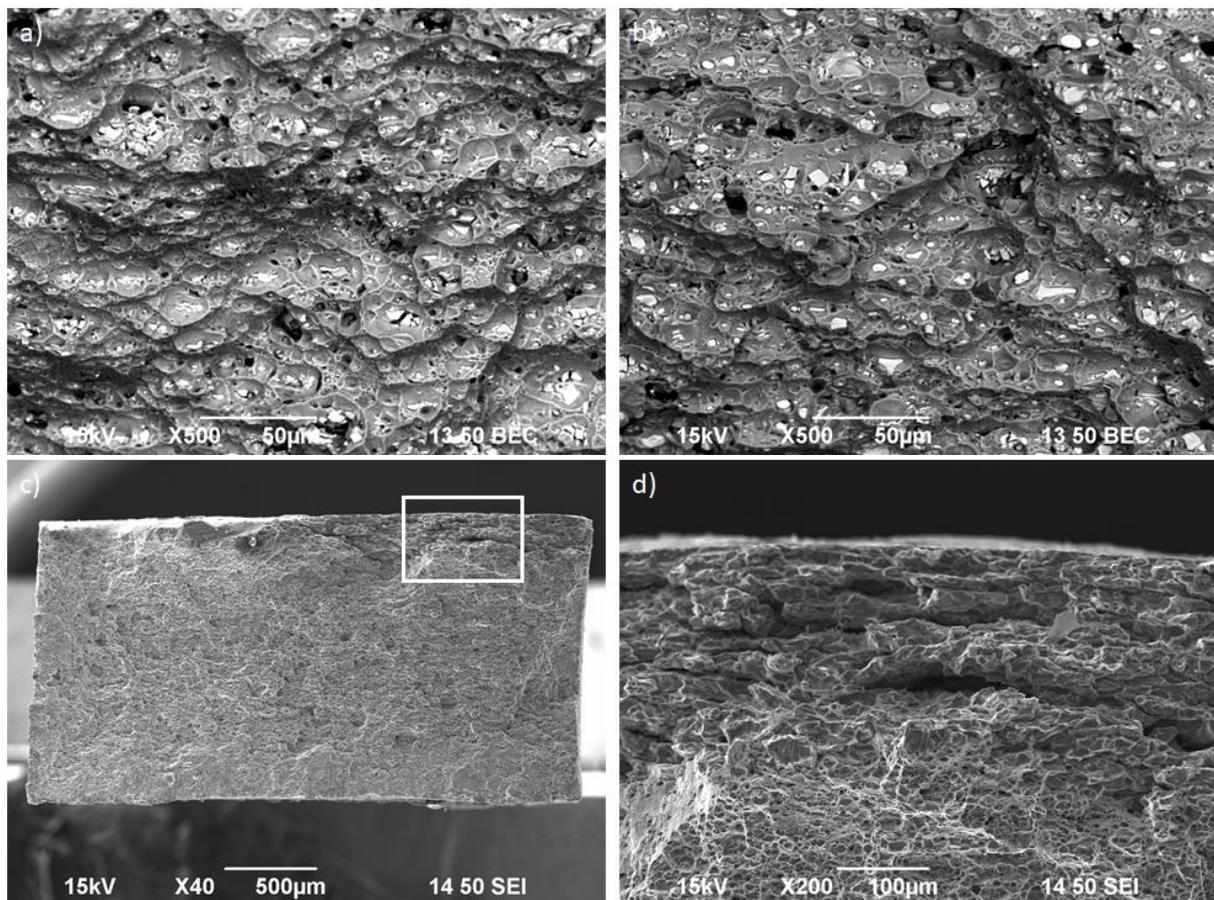
Fig. 2. SEM photographs of fracture surface in back-electron scattering mode for a) 2017A-AR, b) L8-AR. Images c) and d) in secondary electron mode, show fracture due to intergranular corrosion on L8-AR in the transverse direction.

Fracture surface analysis was carried out by SEM on post-mortem specimens. Figure 2 presents images representative of each alloy. On both alloys, equiaxed dimples were observed, typically present for ductile fracture caused by uniaxial tensile load. This type of fracture processes by microvoid coalescence. Microvoids nucleate at particles such as precipitates. After nucleation, the voids grow in the direction of the applied tensile stress. The dimples caused by coarse intermetallics are clearly visible in the microstructure of both alloys. Coarse intermetallics in 2017A-type alloys are well-identified: AlMnFeSi mostly (large, grey particles with faceted morphology) together with Al_2Cu (round and bright) and Mg_2Si (dark). They are quite numerous in both samples. Extremely small dimples were also present which could be caused by intragranular precipitation.

In the old alloy (L8), on all the early-failed specimens occurring mainly in the transverse direction, decohesive fracture along grain boundaries were observed (see framed area in Figure 2c and d.). Intergranular corrosion, unspotted before testing on the specimens, seems to be the main cause of this rupture mode. It is known that alloys of the 2xxx series are susceptible to stress-corrosion cracking and that the sensitivity depends strongly on the grain orientation. The transverse direction is thus the most susceptible to cracking, which is observed here.

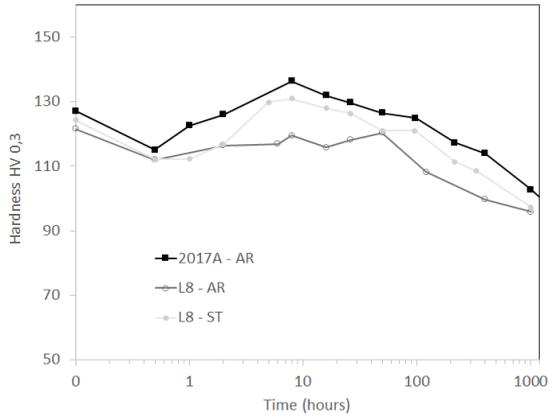
Fig. 3. Hardness HV0.3 measurement in the rolling direction of modern alloy 2017A and L8 (A-U4G) when aging at 180°C from an as-received state (AR) and after solution treatment (ST).

Microhardness was measured versus the aging time at 180°C for both plates, in as-received state (AR) and after a solution treatment (ST). Because the materials exhibit similar hardness in three orientation (RD, TD and ND), only hardness in RD is plotted in Figure 3. Artificial aging (180°C) was first applied on the as-received samples. For 2017A alloy, in the early stages of the treatment at 180°C, the hardness is decreasing

Aging treatment at 180°C was then re-applied. In this case, hardness of the old alloy follows the behaviour of the alloy 2017A, reaching a maximum after 8h (see curve L8-ST in Figure 3). It can be concluded that the history of the Breguet's plate was erased. Its aging is thus reversible.

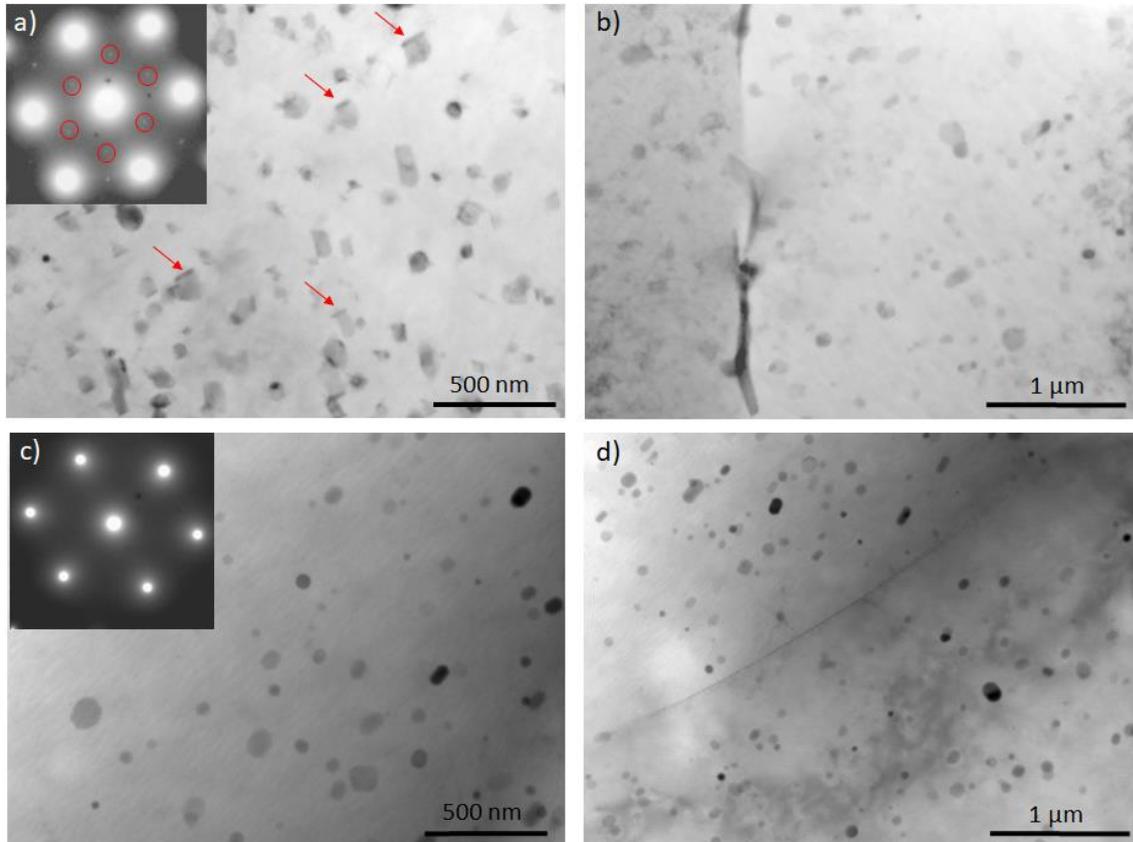
Fig. 4. BF-TEM images in $[110]_{Al}$ zone axis with corresponding SAD patterns of a) and b) L8-AR; c) and d) L8-ST.

On L8-AR, TEM observations (see Figure 4.a and 4.b) reveal a precipitation at grain boundaries and the presence of a precipitation on dispersoids. The precipitation is marked by arrows in BF-TEM image (Figure 4a) and circles in the corresponding selected area diffraction (SAD) pattern. This phase corresponds to Ω -Al₂Cu phase, as identified in [13] on similar Duralumin. No other precipitation is observed in this sample by TEM but it was verified by small angle X-ray scattering (SAXS) that GPZ/clusters are present in this state (see Figure 5). The results show indeed two main contributions: one in the low q-range ($0.002 < q < 0.1 \text{ \AA}^{-1}$) with a q^{-4} contribution, attributed to large precipitates (dispersoids) and one at high q-range ($0.1 < q < 1 \text{ \AA}^{-1}$), a plateau attributed to GPZ or small clusters in the alloy matrix.

At grain boundaries, the precipitation nature is Al₂Cu. Precipitation on dispersoids and at grain boundaries could be the sign of the heat experienced by the plate during its life-time. After solution treatment (ST), precipitation on dispersoids and at grain boundaries has disappeared: see Figure 4.c and 4.d.

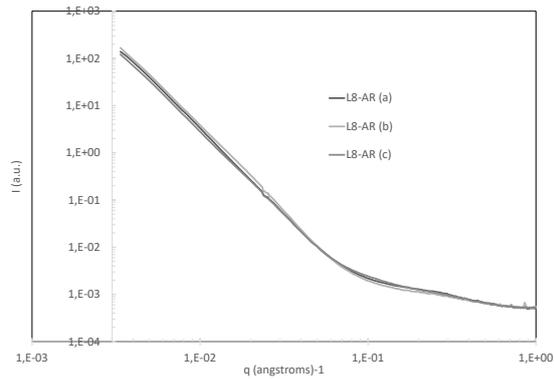
Fig. 5. SAXS curves for L8 (3 different zones) in the as-received state.

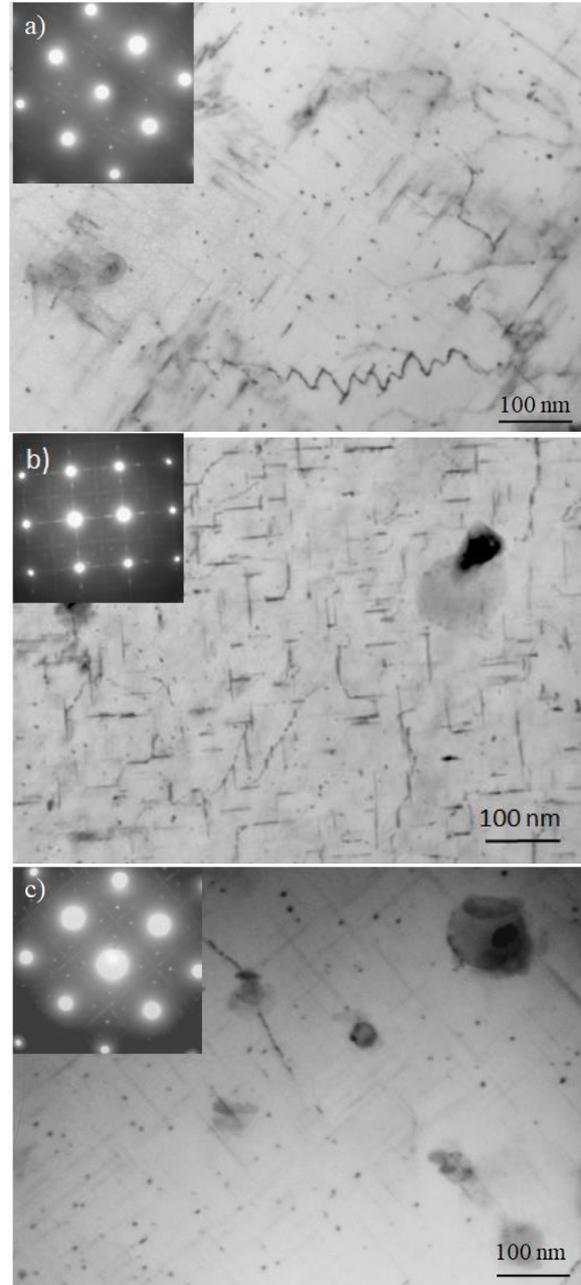
Fig. 6. BF TEM images in [110]_{Al} zone axis a) L8_180°C/8h; b) 2017A_180°C/8h; c) L8_ST-180°C/8h

The nanostructure is then observed for 2017A and L8 after treatment at 180°C for 8h corresponding to peak hardening. It is shown in Figure 6. The observations of the old plate (Figure 6.a) reveals the presence of a variety of phases:

- the hardening θ'' -Al₃Cu phase identified in the SAD patterns thanks to the discontinuous streaks along [200]_{Al} [16],
- the θ' -Al₂Cu phase (platelets) identified thanks to faint spots (110)_{θ'} at 1/2 of (220)_{Al},
- the Q'(Q)-AlCuMgSi phase which are rods observed end-on in the [100]_{Al} direction in the BF images,
- the Ω -Al₂Cu phase with diffraction spots at 1/3 and 2/3 of the [022]_{Al} orientation.

This precipitates zoology is equivalent to the one found in the modern 2017A alloy in the same aging conditions (Figure 6.b and [13]). Measurements of the hardening precipitates (θ'' -Al₃Cu and θ' -Al₂Cu platelets) are reported in Table 3. On average, platelets are 86 ± 29 nm long for L8_180°C/8h and 60 ± 15 nm long for 2017A_180°C/8h. The difference is not significant enough to conclude. However, a much higher number of dislocations are found in the old plate indicating some work-hardening of the L8 plate during its shaping or during its lifespan.

After ST followed by aging at 180°C for 8h, the nanostructure is observed again: see Figure 6.c. The platelets are measured: in the old plate, they are 65 ± 18 nm, and dislocations have disappeared.

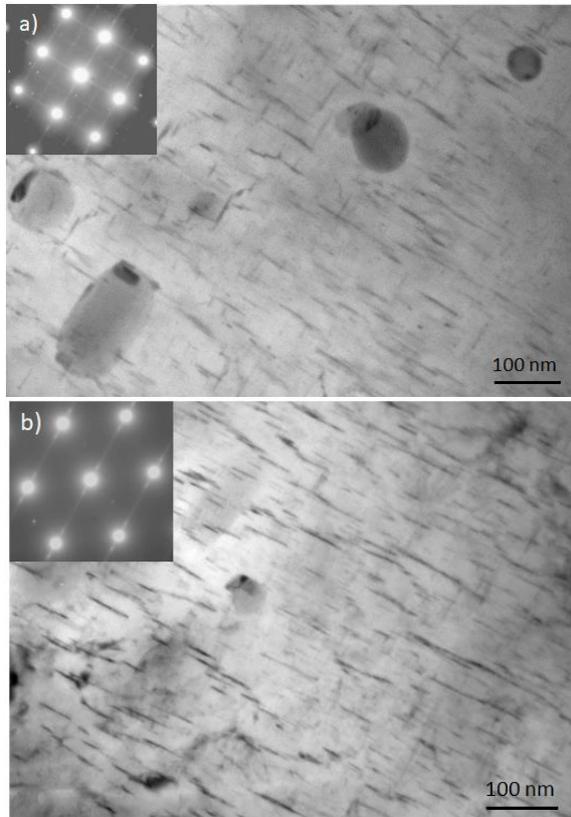
Fig. 7. BF-TEM images of 2017A alloy thermally aged at 100°C for 10,000h in a) $[100]_{Al}$ zone axis and b) in $[110]_{Al}$ zone axis.

The microstructure corresponding to an aging time of 10 000h at 100°C is shown in Figure 7 and the one for 5h at 180°C in Figure 8.

In the SAD patterns in two zone axes ($[100]_{Al}$ and $[110]_{Al}$), for the 2017A alloy heat treated at 100°C for 10,000h, we observe discontinuous streaks along $[200]_{Al}$ with maximum intensities at $(100)_{Al}$ corresponding to the θ'' - Al_3Cu phase. The θ' - Al_2Cu precipitates, if present, have a low volume density. The $Q'(Q)$ - $AlCuMgSi$ phase was observed in the BF images (rods seen end-on oriented along $[001]_{Al}$ direction) but the precipitates are also very few. The diffraction patterns, similar as the ones seen in [16], indicate that the alloy is just before peak hardening. Figure 8 provides the confirmation of a nanostructure very close to the one previously presented (for 8h at 180°C). The length of the hardening precipitates in the two aging conditions, is of the same order of magnitude (see Table 4). A major difference can be found for the Ω - Al_2Cu phase: this phase was hardly seen in the 2017A alloy aged at 100°C for 10,000h: diffraction spots are not visible in the SAD patterns (inserts of Figure 7.a and 7.b). However, the phase can be seen on dispersoids in BF-TEM images. It is concluded that the phase is present but in very little quantities and with no significant influence.

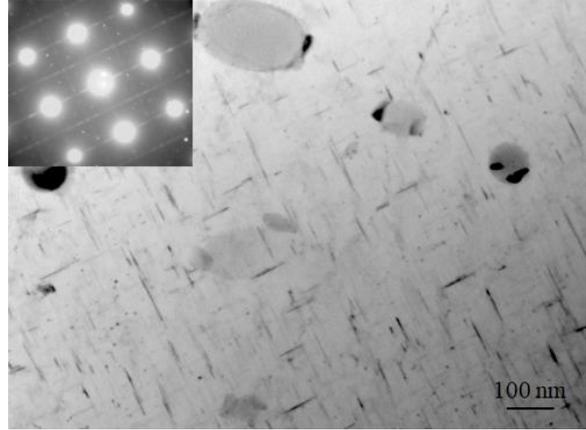
Fig. 8. BF-TEM images of 2017A alloy thermally aged at 180°C for 5h in $[100]_{Al}$ zone axis.
