# Experimental characterization of the self-healing of cracks in an ultra high performance cementitious material: Mechanical tests and acoustic emission analysis

S. Granger<sup>a</sup>, A. Loukili<sup>a</sup>, G. Pijaudier-Cabot<sup>a</sup>, G. Chanvillard<sup>b</sup>

Keywords: Self-healing; Microcracking; High performance concrete; Mechanical properties; Acoustic emission

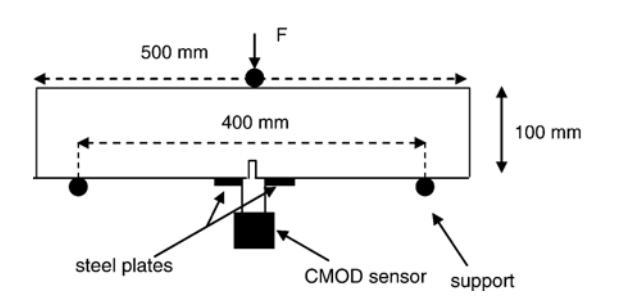
Fig. 1. Three points bending tests configuration.

The specimens are loaded under three points bending. The tests are notch opening controlled with a constant rate of 0.05  $\mu$ m/s. The crack mouth opening displacement (CMOD) is measured (Fig. 1), with a sensor placed between two steel plates stuck on each side of the notch on the bottom face of the specimen. The aim of this preliminary phase is to get a controlled cracking of the specimen. The objective of the study is to quantify the mechanical behaviour of healed concrete specimens, so, it was decided to aim a single residual crack width of approximately 10  $\mu$ m, which permits to get a fast selfhealing. It is worth noting that the influence of the crack width [4,12] on the phenomenon is not investigated here. Pre-cracking is performed in the post peak regime: after having reached the peak load (comprised between 3 and 4 kN), unloading is performed when the applied force reaches 2 kN, which

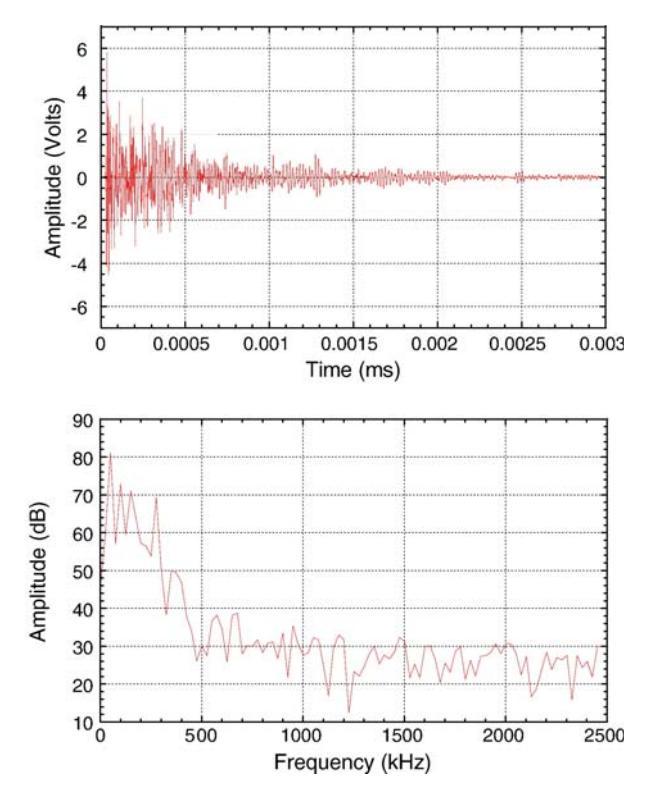
Fig. 2. Typical waveform of an acoustic event (top), and corresponding Fourier transform (bottom).

In the present study, all the specimens are instrumented with an AE system, during the pre-cracking and reloading phases. The instrumentation consists of four piezoelectric transducers, with a band characteristic (50–200 kHz) and resonant frequency 150 kHz, placed in a rectangular array just above the notch of the specimens, in order to cover the expected zone of the process zone. The dimension of the rectangular array is  $140 \times 65 \text{ mm}^2$ . The transducers are placed on one side of the specimen, and coupled to the material with silicon glue. Fig. 2 shows the wave form and Fourier transform of a typical acoustic event whose measured frequency content, above what can be considered as a noise recorded by the sensor, is below 400 kHz.

The detected signals are amplified with 40 dB gain amplifiers. The frequency range of the acquisition of wave forms is set from 20 kHz to 400 kHz. The signal detection value (in amplitude) is set to 5 dB over the background noise in order to overcome it. In the present case it was 35 dB. It is clear that the number of detected events is dependent on the value of this threshold. The lower it is, the larger the number of detected event (including very weak and possibly spurious ones). One should keep in mind, however, that the purpose of the present study is to compare data between healed and non-healed

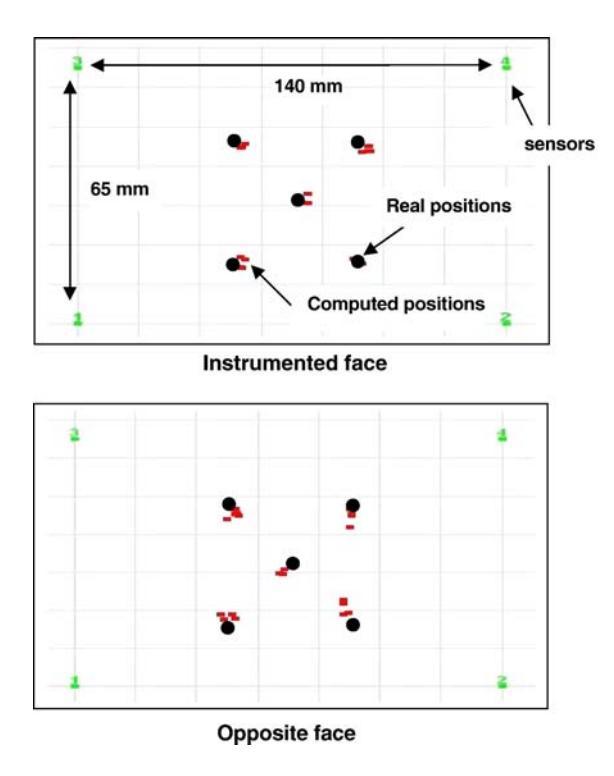
Fig. 3. Accuracy of the 2D planar localisation scheme measured with a Hsu– Nielsen source: a) source placed on the instrumented side of the beam; b) source placed on the back surface of the specimen.

A planar location algorithm, from the commercial software AEWin [14], is used for AE localisation. It is based on arrival time differences, the origin time corresponding to the first hit sensor for each located event (beside there is very little difference between the true origin time and this one in view of the close distance between recorded sources and the sensors). As explained above, onset time picking is performed with a fixed threshold technique. In this planar location technique, we have three unknowns (two coordinates and the origin time), and we use 4 sensors. The event location is obtained by minimisation according to standard Simplex search. Before the tests, the accuracy of the event location is evaluated. An event is generated, with a standard reproducible Hsu-Nielsen source (in practise a conventional pencil lead broken), at several positions on the surface of the specimen on which the transducers are placed, and the position calculated by the algorithm is compared to the true location of the event. For the ultra high performance concrete used in this study, the statistical accuracy of event location (based on 20 simulations on 5 different places in the location area) is  $\pm 3$  mm as shown in Fig. 3a. This is correct in comparison with the diameter of the transducers (15 mm). Note that this is the accuracy with respect to a standardised acoustic source, and not to real acoustic events due to microcracking. It is expected that the accuracy should deteriorate as the amplitude (or energy) of the events decreases and is not as strong as the standardised source. Again since weak events will be further filtered out, one may consider that the accuracy does not deteriorate a lot in the present analysis.

Since we use a 2D planar localisation algorithm, it is important to determine the effect of the specimen thickness. In fact, this algorithm provides a projection of all the events onto a single plane. Hence the projection may generate a bias and some additional error in the localisation scheme. The same accuracy tests as above have been conducted on the opposite side of the specimens, which is not instrumented. Results are reported in Fig. 3. We can observe that the accuracy (with respect to a standardised acoustic source) is about the same and does not depend on the face of the specimen on which the source is located. Therefore, we may conclude that the bias induced by the specimen thickness is within the accuracy of the localisation algorithm.

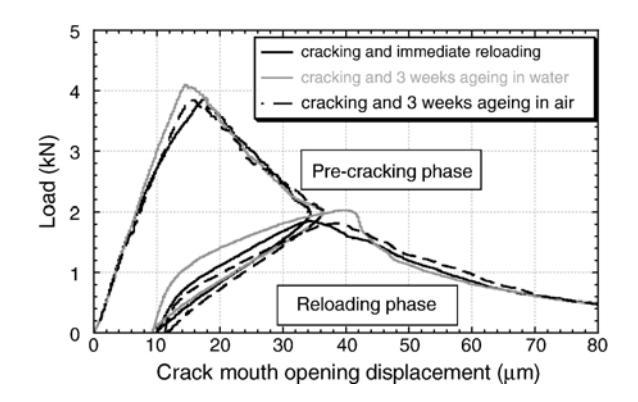
Fig. 4. Mechanical behaviour of a specimen cracked and immediately reloaded, of a specimen cracked and aged 3 weeks in water before reloading, and of a specimen cracked and aged 3 weeks in air before reloading — pre-cracking and reloading phases.

Three kinds of mechanical results are presented in Fig. 4. These are curves for a specimen pre-cracked and then immediately reloaded, and for specimens cracked and aged during 3 weeks (before reloading) respectively in water and in air. The objective of this figure is to show the effect of storage in water, and to compare with the storage in air and with the immediate reloading of the specimen. The curves display the applied load versus the crack mouth opening displacement. Each curve presents two parts: the pre-cracking phase, consisting in loading and unloading when the applied load reaches 2 kN in the post peak regime, and the reloading phase, immediate or after ageing. The reproducibility of the pre-cracking phase of the tests can be seen on this figure. It also shows that the cracked specimen immediately reloaded, and the

specimen aged in air, have the same mechanical behaviour, which is the typical reloading after cracking. On the contrary, there is a difference with the mechanical behaviour for the specimen stored in water, on the reloading stiffness and the reloading peak load especially. This result confirms that water is needed for the self-healing phenomenon.

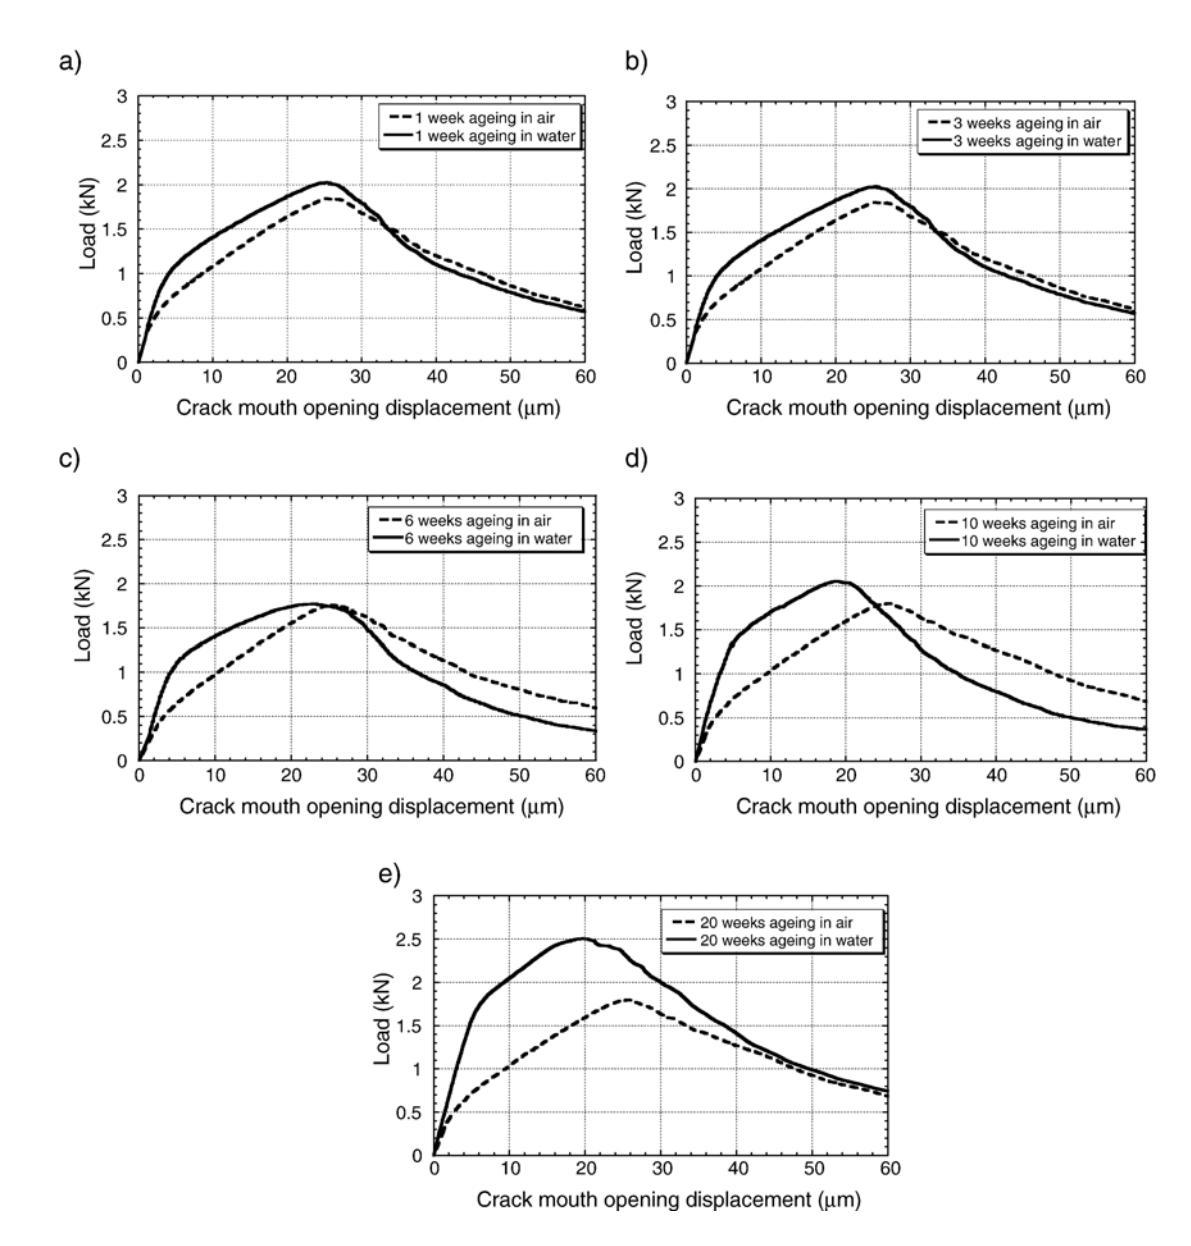
Fig. 5. Mechanical reloading behaviour of aged specimens for different ageing times — comparison ageing in water and ageing in air; average curves: (a) 1 week, (b) 3 weeks, (c) 6 weeks, (d) 10 weeks, and (e) 20 weeks.

We now have to discuss the influence of the ageing time, which is, of course, an important parameter. Fig. 5 presents the average reloading curves for three specimens stored in water and for three specimens stored in air, for the 5 different periods of ageing. For the sake of clarity, only the reloading parts of the total curves are presented. The CMOD at the beginning of the tests is set to 0, in order to have the same initial state, but in reality we should have the value of the residual CMOD at the end of the pre-cracking phase.

We can notice that specimens stored in air exhibit very similar mechanical behaviours for the 5 periods of ageing. It

means that air has no influence on the mechanical properties of cracked specimens, even for a long period of ageing. After the usual hysteresis at the begining of reloading (until 0.3 kN), the reloading part corresponds to the re-opening of the existing crack until the peak load, followed by the continuation of the crack propagation. On the contrary, there is a clear evolution of the mechanical behaviour of specimens stored in water with the time of ageing. The reloading stiffness is not the same as for specimens aged in air, and it increases. There is also a slight improvement of flexural strength and a change in stiffness in the pre-peak phase, which evolves with time.

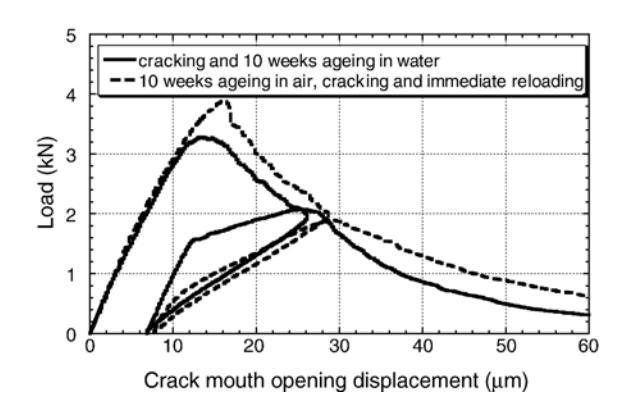
Fig. 6. Average mechanical behaviour of reference specimens (stored without crack in water for 10 weeks, and then cracked and immediately reloaded) and of cracked specimens stored in water for 10 weeks before reloading.

In order to get a confirmation that these observed mechanical behaviours are due to the self-healing of the pre-existing crack and not to the evolution of concrete itself in water, Fig. 6 presents the average mechanical result of tests conducted on specimens which have been stored in water for 10 weeks, and then cracked and immediately reloaded, in comparison with the average mechanical behaviour of specimens pre-cracked and aged 10 weeks in water. It shows that storage in water without crack does not improve the mechanical properties of the specimen. We have the same mechanical behaviour as those of a non-aged specimen cracked and initially reloaded: there is no curing effect by storing in water, and it is a consequence of the thermal treatment. Indeed, the hydration reactions have been significantly slowed down and final porosity has been reduced due to the pozzolanic reaction [9]. Water can not penetrate significantly in concrete, except through cracks. So the evolution of the mechanical behaviour established for cracked specimens stored in water can indeed be explained by the selfhealing of cracks phenomenon, and not bulk material improvement upon ageing.

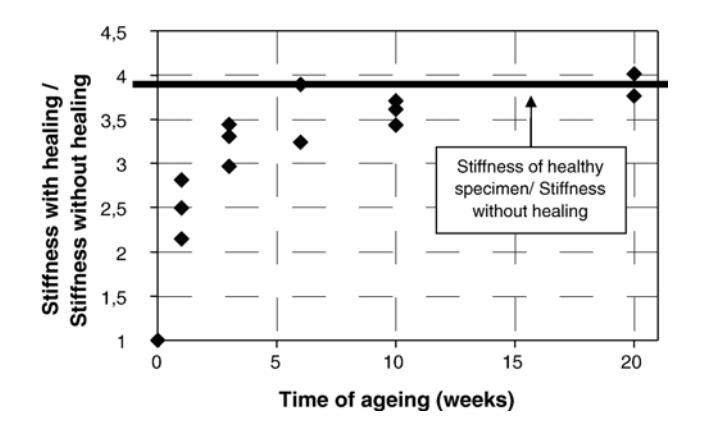
Fig. 7. Evolution of the ratio between the reloading stiffness with healing (in water) and the reloading stiffness without healing, as a function of time of ageing — comparison with the average stiffness of healthy specimens.

Fig. 7 shows the evolution of the ratio between the reloading stiffness with healing, and the reloading stiffness without healing, as a function of the ageing time. Stiffness is calculated by a linear regression for load ranges from 0.4 kN to 0.8 kN. It is noticeable that there is a fast recovery by self-healing, and this stiffness tends to those of healthy specimen, which is represented on the graph by the straight line. These results can be explained by the fact that new products are formed in the crack, especially, if we consider the low water/cement ratio, new C–S–H. These crystals make a bridge between the two faces of the crack and progressively fill it. The stiffness of these crystals is certainly close to those of primary C–S–H (formed by normal hydration) and when the crack is fully filled, the global stiffness of the specimens can reach the initial one, before damage.

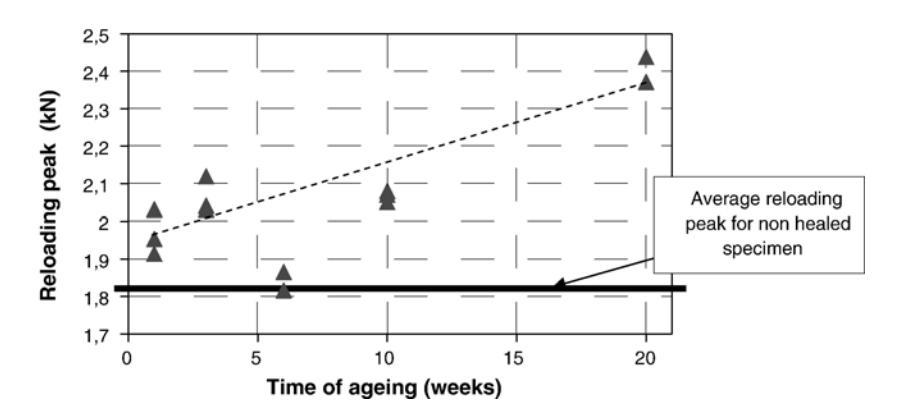
Fig. 8. Evolution of the reloading peak for healed specimens (storage in water) with the time of ageing — comparison with the average reloading peak of non-healed specimen.

Concerning the flexural resistance, Fig. 8 represents the evolution (with the ageing time) of the peak load upon reloading for healed specimens. It shows that self-healing provides a slight improvement of the resistance, compared with the resistance of non-healed specimens. Nevertheless, the initial flexural resistance is not reached and this could be explained by the fact that crystals formed in the crack bridge it but can not form the complex microstructure which provides the strength of the material initially, especially all the links between C–S–H. We may wonder what could be the evolution of the mechanical behaviour for longer ageing periods. It is probable that constrained crystal growth in between the crack surfaces and within the FPZ may not provide the same strength as for the initial hydration of the material.

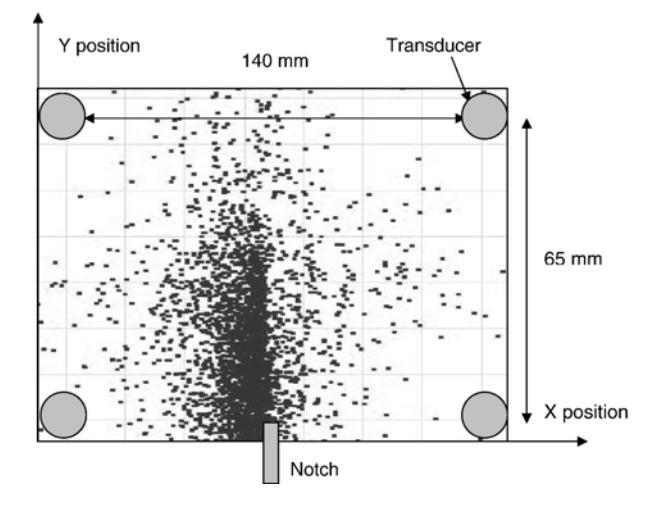
Fig. 9. Microcracking map of a specimen after the pre-cracking phase — result without all events.

Fig. 9 presents the typical microcracking map of a specimen, just after the pre-cracking phase. The transducers which form the rectangular array are represented in the corners, and the other points are the microcracks detected. It shows a very dense area of acoustic events, due to the development of the fracture process zone. Even in the particular material used for this experimental program, the fracture process in not limited to the macrocrack but also spreads around it.

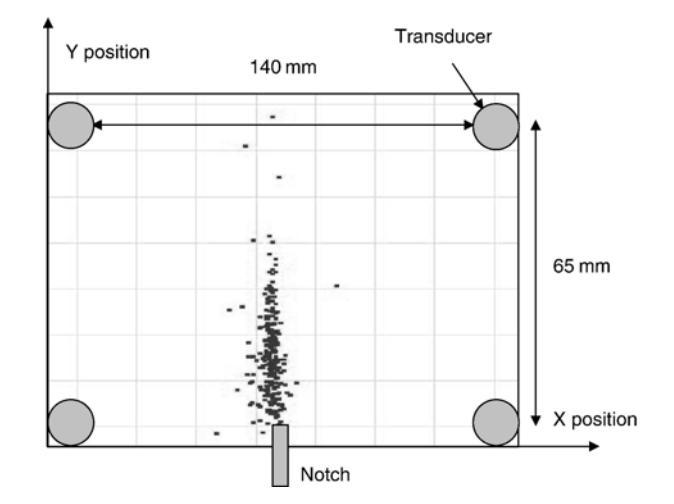
Fig. 10. Microcracking map of a specimen after the pre-cracking phase — result with selection in energy: events with an energy higher than 1000 aJ.

In order to have a more accurate location of the macrocrack in this area, which is of interest if we want to locate the microcracking of new crystals in this crack during the reloading phase, selection of the signals detected is necessary. Otsuka and Date [20] have shown that 95% of the dissipated acoustic energy is located in the fracture process zone, and that the less energetic events contribute only a little to the fracture of concrete. After having selected the event with the most important energy (energy calculated by integrating the whole signal), we have chosen to eliminate the events with an energy less than 2% of this maximal energy. Doing this, we keep only the most energetic events, associated with fracture. It also improves accuracy, because the most energetic signals are located with a better accuracy. The selection energy criterion is thus set to 1000 atto-Joule (aJ). Fig. 10 presents the result of this data processing. Compared to Fig. 9, we can see that most of the events are located in a narrower band which follows more closely the macrocrack surface. In 2D AE localisation analysis, a warped crack surface, or a rough crack surface, when projected onto a plane provides a band of events occurring within the specimen thickness. This systematic bias of a few

millimeters (maximum 3 to 4 mm) should added to AE localisation accuracy. In Fig. 10, the maximum thickness of this band is about 10 mm, still a bit larger than the crack surface warping and crack roughness, but in the present cementitious material some FPZ of finite size should be expected.

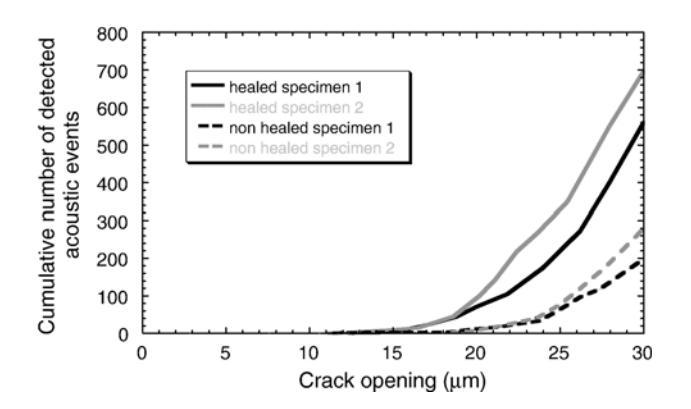
Fig. 11. Cumulative number of acoustic events during the reloading phase for healed and non-healed specimens.

According to the same data processing of the AE as in Section 4.1, we consider first the cumulative number of detected events. Fig. 11 shows the evolution of this number with crack opening for four specimens cured during 10 weeks. The reloading phase corresponds to crack openings less than 20  $\mu$ m approximately and there is a significant difference between healed and non-healed specimens responses in this range. For crack openings larger than 20  $\mu$ m, the crack length is greater than the initial one, prior to healing. The number of events recorded on healed specimens (cured into water) is at least twice the number observed for unhealed specimens.

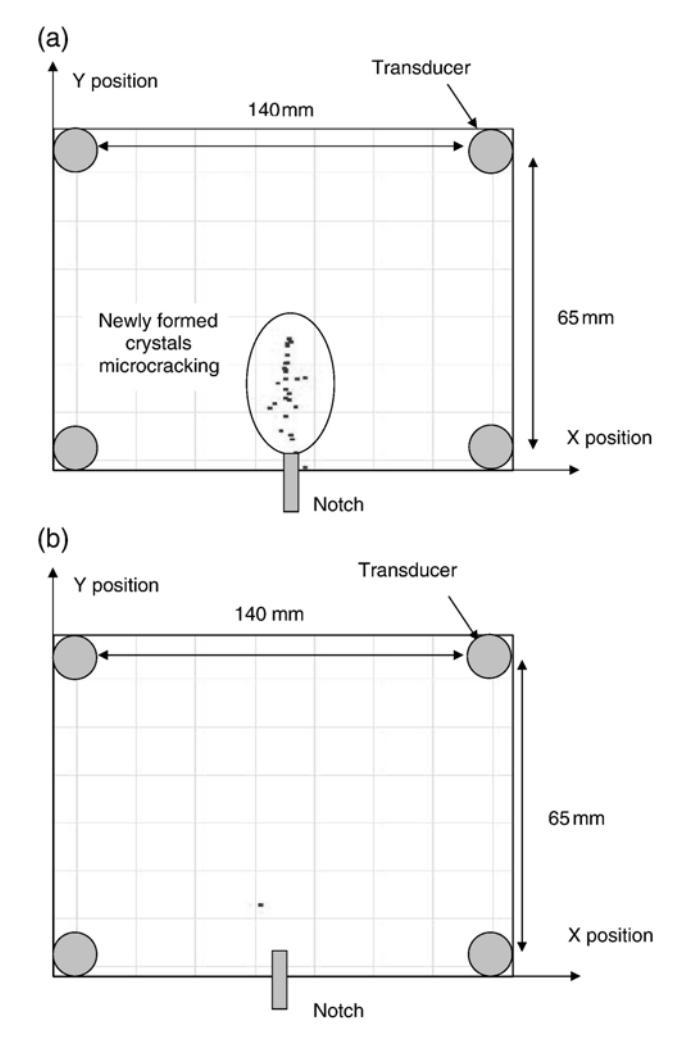
Fig. 12 presents the maps for a specimen aged in water and for a specimen aged in air, both during 10 weeks. It is noticeable that acoustic activity appears for the healed specimen in the region of the initial crack, while nearly nothing is detected for a non-healed specimen. In view of the mechanical results which exhibit stiffness and strength recovery, one can say that in the first case, there is a damage of the newly formed crystals in the crack, and in the second case, there is only the re-opening of the existing crack, with very little acoustic activity (some due to friction probably). Note that for non-healed specimens, performing the same AE localisation analysis without removing the less energetic events would still provide little acoustic activity, less than that observed for healed specimens.

AE location maps have been obtained for aged specimens. In the first analysis, they are performed during the reloading phase (in the pre-peak phase) until 18 µm crack mouth opening.

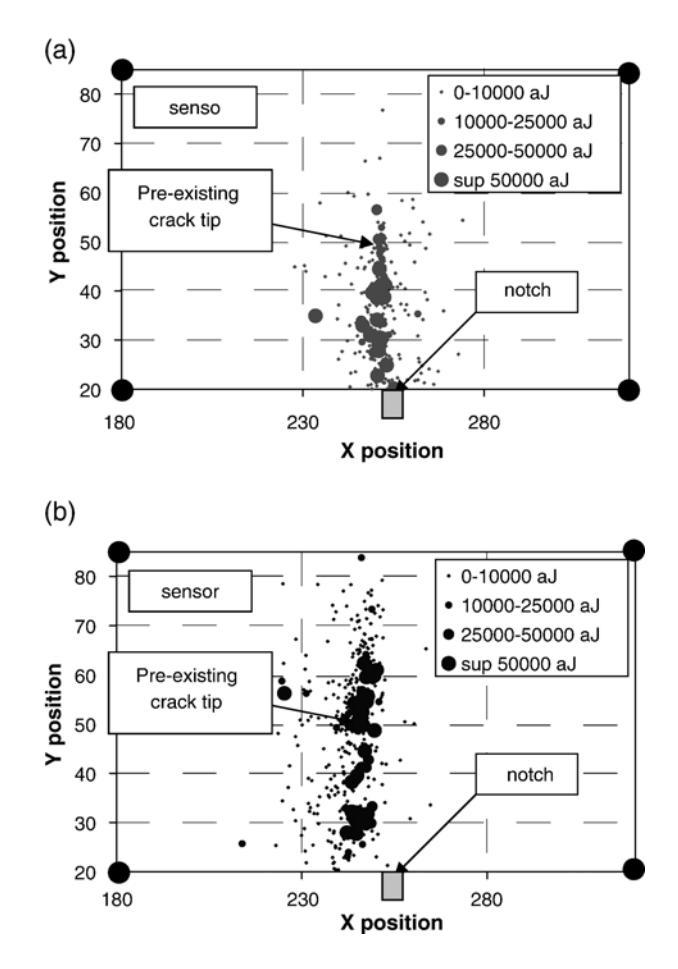
Fig. 13. Energy location maps at 90% of the peak load in the post peak regime; (a) healed specimen, (b) non-healed specimen.

We may now consider the comparison during the reloading phase, not at the same CMOD, but at the same load level. Results at 90% of the peak load, in the post peak regime are analysed. Fig. 13 represents the location maps in terms of energy. Points representing the microcracks are plotted according to their acoustic energy in aJ (the analysis is carried out after having removed less energetic events): the bigger the point, the larger the energy. If we now sum these energies for events located below and above the pre-existing crack tip (which is for

height of 50 mm from the bottom face of the specimen), we can notice that 97% of the acoustic energy dissipated until 90% of the peak load is located in the pre-existing FPZ, for the specimen which has been stored in water, although it is 48% for a non-healed specimen. This acoustic energy dissipated in the crack for a healed specimen should be due mainly to microcracking of newly formed crystals inside the initial crack. Friction would provide some acoustic activity, but probably not the stiffness and strength recovery that was observed on the mechanical response at the same time. For the non-healed specimen, the acoustic activity is due to further propagation of existing microcracks (note that the specimen is again in the post peak regime).
