Behaviour of a highly pressurised tank of GH2 submitted to a thermal or mechanical impact

Jacques Chaineaux, C. Devillers, Pierre Serre-Combe

BEHAVIOUR OF A HIGHLY PRESSURISED TANK OF GH₂, SUBMITTED TO A THERMAL OR MECHANICAL IMPACT

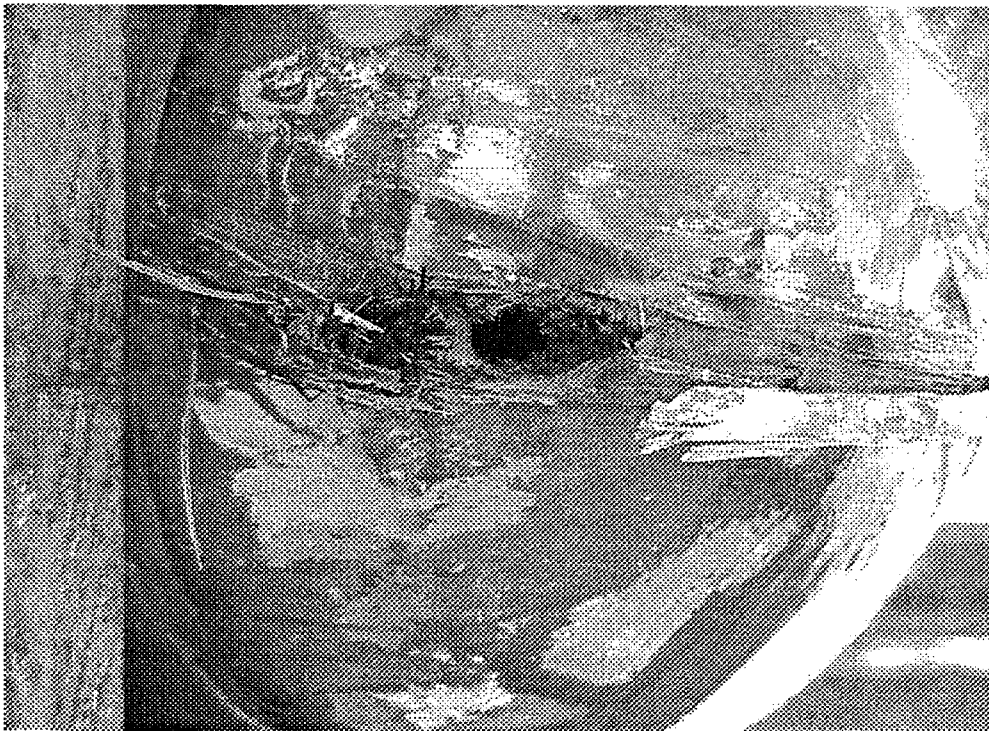
Photo 4 : One of the bullet holes in the cylinder in test n°4

A hydrogen-pressurised cylinder was submitted to the impact of a gun bullet, shot at point-blank range and having an initial speed of about 850 m/s. The angle between the shooting axis and the cylinder axis was 45° and the impact zone was at the bottom of the bottle.

The bullet has passed trough the cylinder, which did not burst (photo n°4). Hydrogen discharged through both holes as two jets, but did not ignite.
