Multi-scale analysis of water alteration on the rockslope stability framework

Sandra Dochez, Farid Laouafa, Christian Franck, Sylvine Guedon, François Martineau, et al.. Multi-scale analysis of water alteration on the rockslope stability framework. 16. French-Polish Colloquium of Soil and Rock Mechanics, Jul 2013, Montpellier, France. pp.NC. ineris-00973700

MULTI-SCALE ANALYSIS OF WATER ALTERATION ON THE ROCKSLOPE STABILITY FRAMEWORK

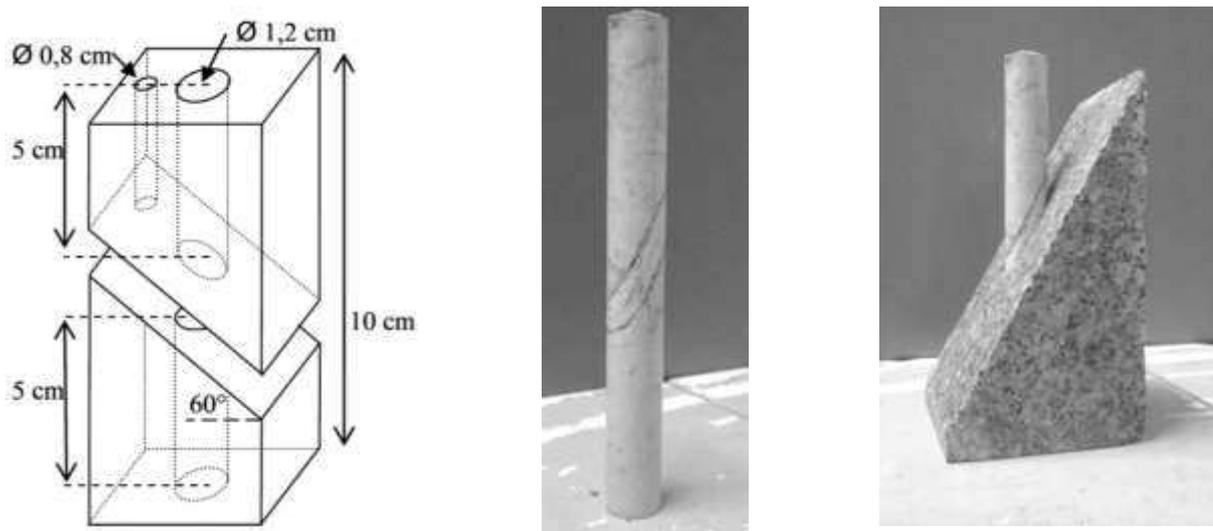
Figure 7: Shape of the granite base with dimension (left) the sample of limestone (middle) are inserted into the granite for the test (right) (after Druon)

In order to the observation and measurement of chemical degradation an evaluation of the mechanical response of the sample submitted to a shear loading is performed. The measurements are made with a uniaxial cell in order to evaluate the influence of alteration on the mechanical properties of limestone samples. We used cylindrical samples (Figure 7) as samples in the alteration in quasi-static experiment. Each sample is positioned in a shaped granite base (Figure 7) and put in the uniaxial cell (Figure 8).

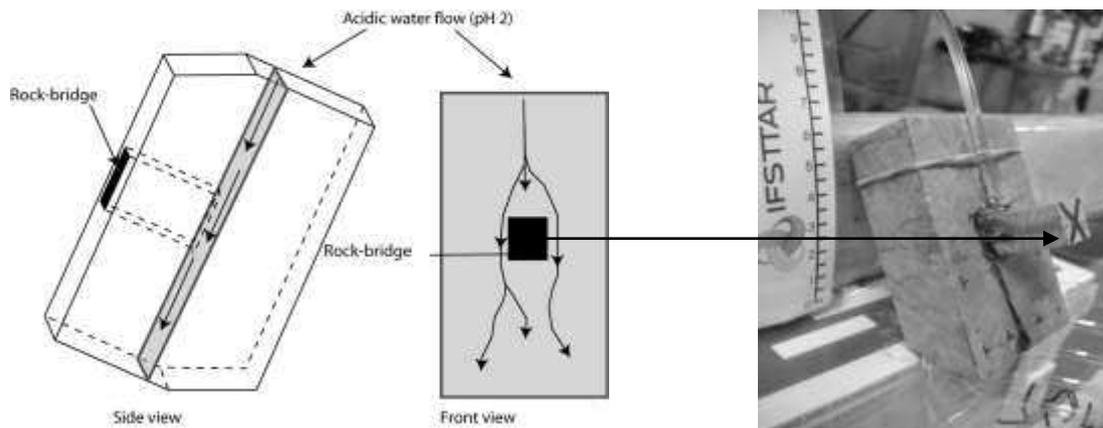
Figure 12: Schemes of the shape limestone samples for the experiment Alteration in the case of “flowing water”, the acid solution is in drip system, the flow is one liter of solution per day, and run along the discontinuity and around the rock bridge (left). Picture of the runoff along the discontinuity and around the rock-bridge (right).

It exists [11] [12], part in the rock mass which is connected to the block ready to fall. These parts are called *rock-bridge* and they constitute the block stability. In this experiment, the shape of the sample and the water flow are different from the first one. Limestone's blocks are sawn so as to leave a continuous part, called rock bridge. The rectangular geometry of the bridge is connected to the surface of the block. The above part is taken off. The experiment is realized in open system where CO_2 of the atmosphere can influence the interaction between the acidic solution and the surface of the block because CO_2 is known to acidify water. The acidic solution is stored in tins and the solution flows via a drip system. The water flow is about one liter per day (Figure 12).

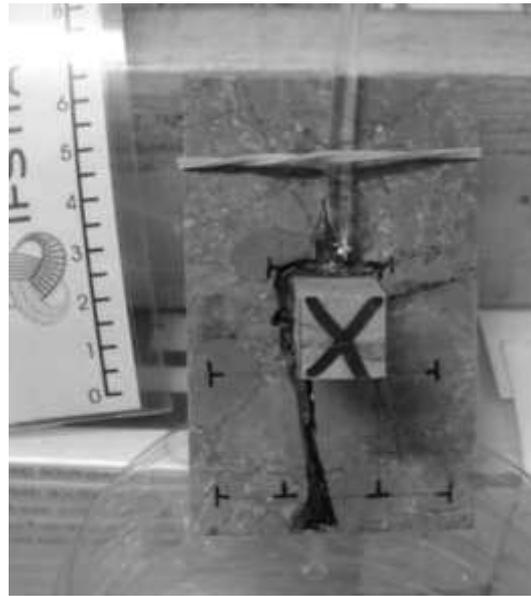
Figure 14: Picture of Montagnole limestone (CaCO_3) sample surface degradation by acidic solution (H_2O ; H_2SO_4)

The experiment is performed in an open system, which means the sample in contact with ambient air. The interaction with the CO_2 of the ambient air increases the phenomenon. The flow of water causes a material dissolution and deconstruction (Figure 14). Fine particles are observed in the water of the recovery basin as

observed by Kupper [13]. The picture shows also an asymmetric flow of the solution. Indeed we observed during the period of runoff that water followed different paths. It is obvious that water prefers the easier path to dissolve crystals less competent than the rest of the rock sample.

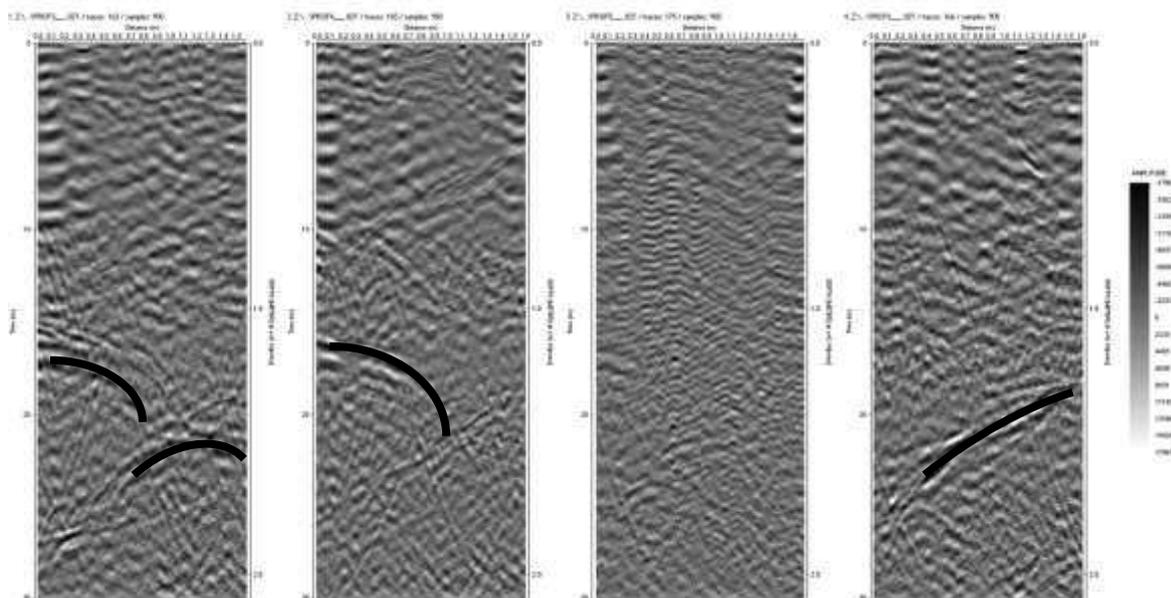
Figure 19: Radar gram acquired after profiles from the block, profile 3 to 6, the black lines represented the weirdness observed and used for the 3D representation.

The first observation in situ reveals many discontinuities; the major ones represented in black on Figure 17 are those where we suppose there are rock bridges to maintain the stability of the rock mass. The white ones appear to be just on the surface but they are important for the surface degradation. The GPR reveals the possibility to identify the surface discontinuity (Figure 19). As a matter of fact radar-gram present some weirdness, these ones are the proofs of different environment as air or rock mass. These are analyzed and after a treatment, a 3D view of the discontinuity surface could be made as Figure 20 shows.
