Experimental characterization of the self-healing of cracks in an ultra high performance cementitious material: Mechanical tests and acoustic emission analysis

S. Granger ^a, A. Loukili ^a, G. Pijaudier-Cabot ^a, G. Chanvillard ^b

Self-healing of cracks in an ultra high performance concrete, considered as a model material, is investigated in this paper. An experimental program is carried out in order to quantify the phenomenon, which has been mainly highlighted by means of water permeability tests until now. Mechanical behaviour of self-healed concrete under three points bending, and acoustic emission analysis of the cracking mechanisms are reported. The mechanical tests demonstrate a recovery of the global stiffness, depending on the time of healing, for specimens initially cracked and then self-healed, and a slow improvement of structural strength. The acoustic emission (AE) analysis is performed in order to show that the mechanical response is due to new crystals precipitating in the crack. The microcracking of these products during three points bending tests is highlighted and an energy analysis provides insights about the cracking process of healed concrete, including damage

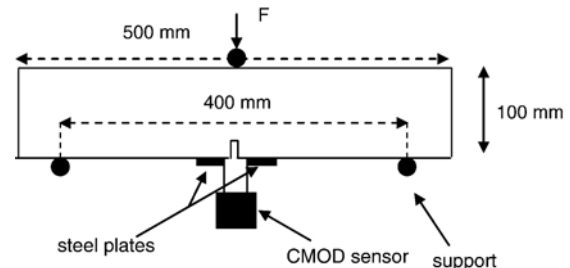
Fig. 1. Three points bending tests configuration.

The specimens are loaded under three points bending. The tests are notch opening controlled with a constant rate of $0.05 \mu\text{m/s}$. The crack mouth opening displacement (CMOD) is measured (Fig. 1), with a sensor placed between two steel plates stuck on each side of the notch on the bottom face of the specimen. The aim of this preliminary phase is to get a controlled cracking of the specimen. The objective of the study is to quantify the mechanical behaviour of healed concrete specimens, so, it was decided to aim a single residual crack width of approximately $10 \mu\text{m}$, which permits to get a fast self-healing. It is worth noting that the influence of the crack width [4,12] on the phenomenon is not investigated here. Pre-cracking is performed in the post peak regime: after having reached the peak load (comprised between 3 and 4 kN), unloading is performed when the applied force reaches 2 kN, which

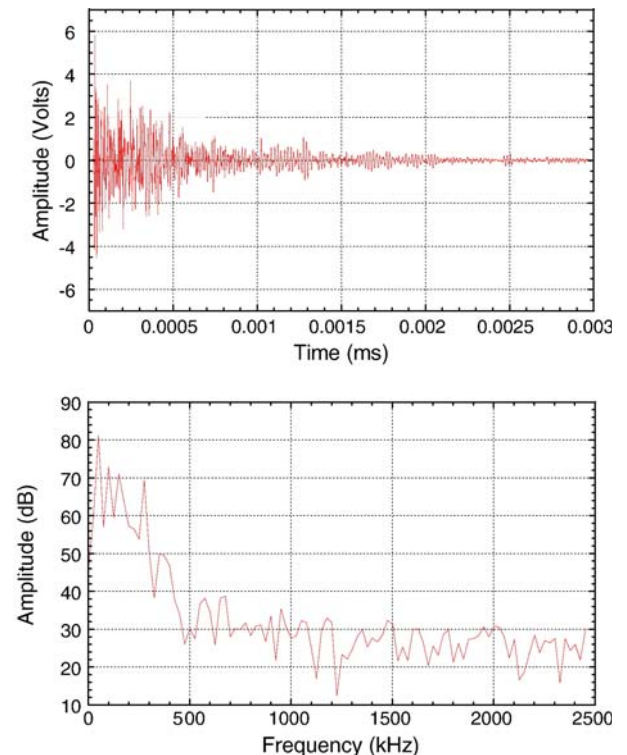
Fig. 2. Typical waveform of an acoustic event (top), and corresponding Fourier transform (bottom).

The detected signals are amplified with 40 dB gain amplifiers. The frequency range of the acquisition of wave forms is set from 20 kHz to 400 kHz. The signal detection value (in amplitude) is set to 5 dB over the background noise in order to overcome it. In the present case it was 35 dB. It is clear that the number of detected events is dependent on the value of this threshold. The lower it is, the larger the number of detected event (including very weak and possibly spurious ones). One should keep in mind, however, that the purpose of the present study is to compare data between healed and non-healed

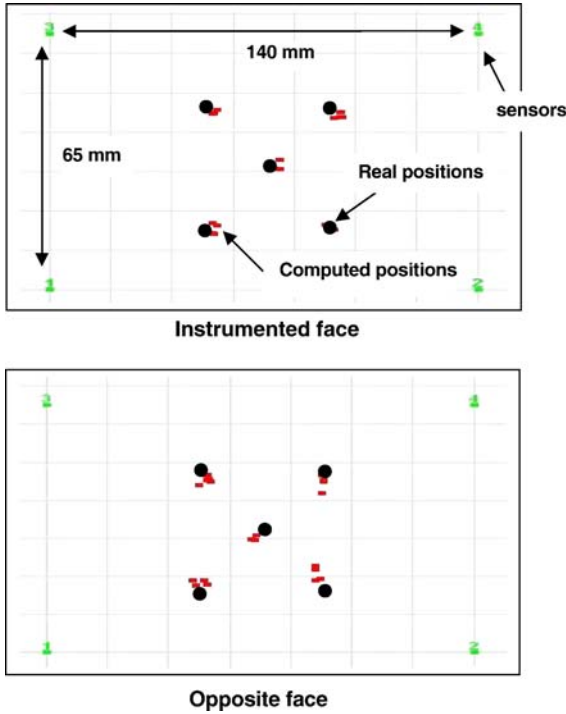
Fig. 3. Accuracy of the 2D planar localisation scheme measured with a Hsu–Nielsen source: a) source placed on the instrumented side of the beam; b) source placed on the back surface of the specimen.

location (based on 20 simulations on 5 different places in the location area) is ± 3 mm as shown in Fig. 3a. This is correct in comparison with the diameter of the transducers (15 mm). Note that this is the accuracy with respect to a standardised acoustic source, and not to real acoustic events due to microcracking. It is expected that the accuracy should deteriorate as the amplitude (or energy) of the events decreases and is not as strong as the standardised source. Again since weak events will be further filtered out, one may consider that the accuracy does not deteriorate a lot in the present analysis.

Since we use a 2D planar localisation algorithm, it is important to determine the effect of the specimen thickness. In fact, this algorithm provides a projection of all the events onto a single plane. Hence the projection may generate a bias and some additional error in the localisation scheme. The same accuracy tests as above have been conducted on the opposite side of the specimens, which is not instrumented. Results are reported in Fig. 3. We can observe that the accuracy (with respect to a standardised acoustic source) is about the same and does not depend on the face of the specimen on which the source is located. Therefore, we may conclude that the bias induced by the specimen thickness is within the accuracy of the localisation algorithm.

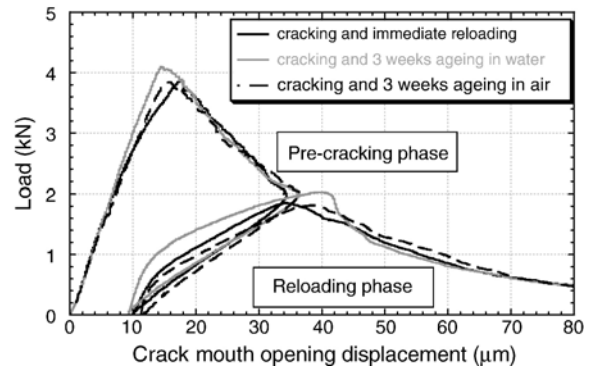
Fig. 4. Mechanical behaviour of a specimen cracked and immediately reloaded, of a specimen cracked and aged 3 weeks in water before reloading, and of a specimen cracked and aged 3 weeks in air before reloading — pre-cracking and reloading phases.

Three kinds of mechanical results are presented in Fig. 4. These are curves for a specimen pre-cracked and then immediately reloaded, and for specimens cracked and aged during 3 weeks (before reloading) respectively in water and in air. The objective of this figure is to show the effect of storage in water, and to compare with the storage in air and with the immediate reloading of the specimen. The curves display the applied load versus the crack mouth opening displacement. Each curve presents two parts: the pre-cracking phase, consisting in loading and unloading when the applied load reaches 2 kN in the post peak regime, and the reloading phase, immediate or after ageing. The reproducibility of the pre-cracking phase of the tests can be seen on this figure. It also shows that the cracked specimen immediately reloaded, and the

specimen aged in air, have the same mechanical behaviour, which is the typical reloading after cracking. On the contrary, there is a difference with the mechanical behaviour for the specimen stored in water, on the reloading stiffness and the reloading peak load especially. This result confirms that water is needed for the self-healing phenomenon.

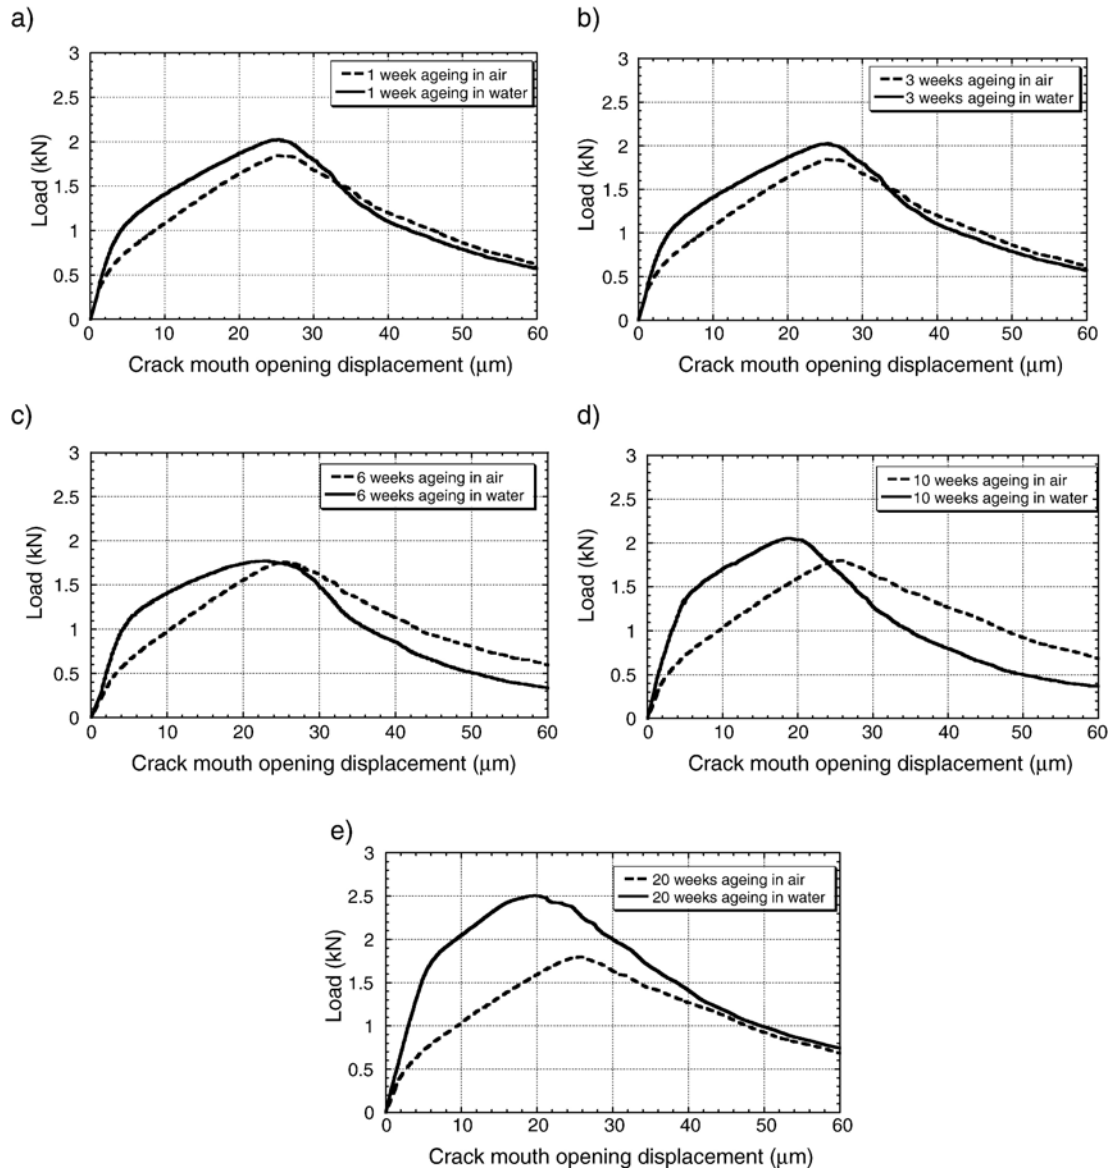
Fig. 5. Mechanical reloading behaviour of aged specimens for different ageing times — comparison ageing in water and ageing in air; average curves: (a) 1 week, (b) 3 weeks, (c) 6 weeks, (d) 10 weeks, and (e) 20 weeks.

We now have to discuss the influence of the ageing time, which is, of course, an important parameter. Fig. 5 presents the average reloading curves for three specimens stored in water and for three specimens stored in air, for the 5 different periods of ageing. For the sake of clarity, only the reloading parts of the total curves are presented. The CMOD at the beginning of the tests is set to 0, in order to have the same initial state, but in reality we should have the value of the residual CMOD at the end of the pre-cracking phase.

We can notice that specimens stored in air exhibit very similar mechanical behaviours for the 5 periods of ageing. It

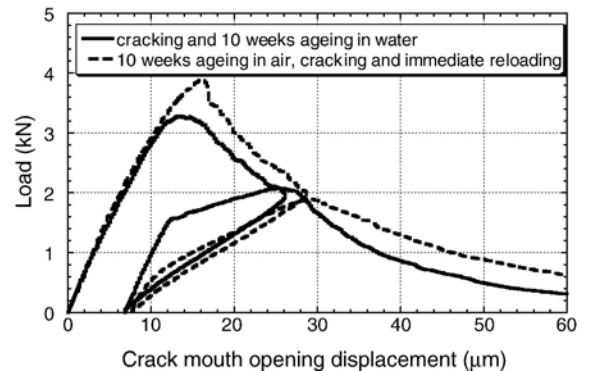
Fig. 6. Average mechanical behaviour of reference specimens (stored without crack in water for 10 weeks, and then cracked and immediately reloaded) and of cracked specimens stored in water for 10 weeks before reloading.

In order to get a confirmation that these observed mechanical behaviours are due to the self-healing of the pre-existing crack and not to the evolution of concrete itself in water, Fig. 6 presents the average mechanical result of tests conducted on specimens which have been stored in water for 10 weeks, and then cracked and immediately reloaded, in comparison with the average mechanical behaviour of specimens pre-cracked and aged 10 weeks in water. It shows that storage in water without crack does not improve the mechanical properties of the specimen. We have the same mechanical behaviour as those of a non-aged specimen cracked and initially reloaded: there is no curing effect by storing in water, and it is a consequence of the thermal treatment. Indeed, the hydration reactions have been

significantly slowed down and final porosity has been reduced due to the pozzolanic reaction [9]. Water can not penetrate significantly in concrete, except through cracks. So the evolution of the mechanical behaviour established for cracked specimens stored in water can indeed be explained by the self-healing of cracks phenomenon, and not bulk material improvement upon ageing.

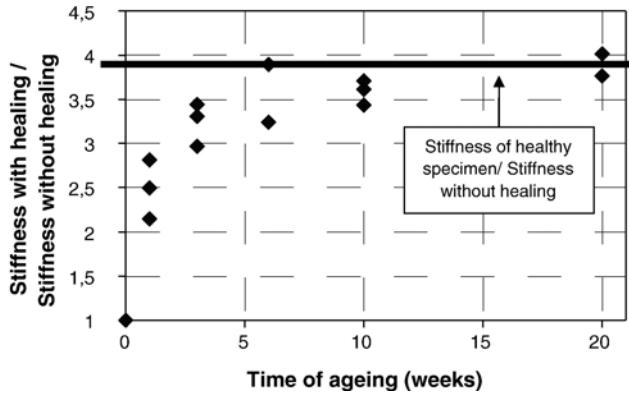
Fig. 7. Evolution of the ratio between the reloading stiffness with healing (in water) and the reloading stiffness without healing, as a function of time of ageing — comparison with the average stiffness of healthy specimens.

Fig. 7 shows the evolution of the ratio between the reloading stiffness with healing, and the reloading stiffness without healing, as a function of the ageing time. Stiffness is calculated by a linear regression for load ranges from 0.4 kN to 0.8 kN. It is noticeable that there is a fast recovery by self-healing, and this stiffness tends to those of healthy specimen, which is represented on the graph by the straight line. These results can be explained by the fact that new products are formed in the crack, especially, if we consider the low water/cement ratio, new C-S-H. These crystals make a bridge between the two faces of the crack and progressively fill it. The stiffness of these crystals is certainly close to those of primary C-S-H (formed by normal hydration) and when the crack is fully filled, the global stiffness of the specimens can reach the initial one, before damage.

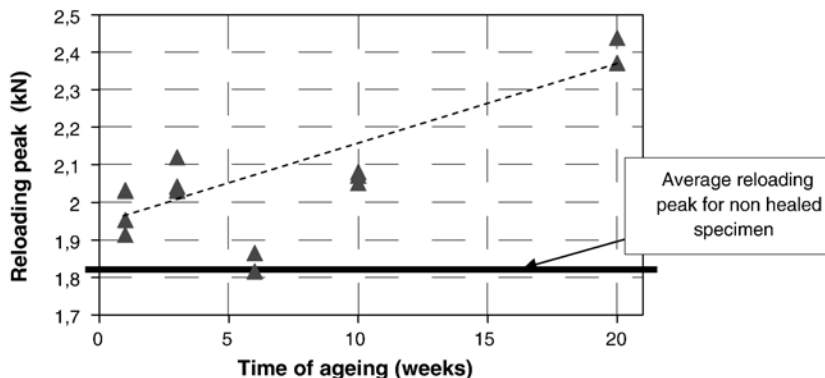
Fig. 8. Evolution of the reloading peak for healed specimens (storage in water) with the time of ageing — comparison with the average reloading peak of non-healed specimen.

Concerning the flexural resistance, Fig. 8 represents the evolution (with the ageing time) of the peak load upon reloading for healed specimens. It shows that self-healing provides a slight improvement of the resistance, compared with the resistance of non-healed specimens. Nevertheless, the initial flexural resistance is not reached and this could be explained by the fact that crystals formed in the crack bridge it but can not form the complex microstructure which provides the strength of the material initially, especially all the links between C-S-H. We may wonder what could be the evolution of the mechanical behaviour for longer ageing periods. It is probable that constrained crystal growth in between the crack surfaces and within the FPZ may not provide the same strength as for the initial hydration of the material.

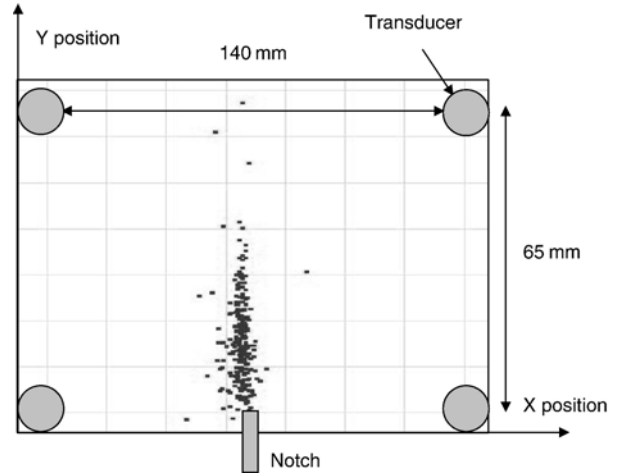
Fig. 10. Microcracking map of a specimen after the pre-cracking phase — result with selection in energy: events with an energy higher than 1000 aJ.

In order to have a more accurate location of the macrocrack in this area, which is of interest if we want to locate the microcracking of new crystals in this crack during the reloading phase, selection of the signals detected is necessary. Otsuka and Date [20] have shown that 95% of the dissipated acoustic energy is located in the fracture process zone, and that the less energetic events contribute only a little to the fracture of concrete. After having selected the event with the most important energy (energy calculated by integrating the whole signal), we have chosen to eliminate the events with an energy less than 2% of this maximal energy. Doing this, we keep only the most energetic events, associated with fracture. It also improves accuracy, because the most energetic signals are located with a better accuracy. The selection energy criterion is thus set to 1000 atto-Joule (aJ). Fig. 10 presents the result of this data processing. Compared to Fig. 9, we can see that most of the events are located in a narrower band which follows more closely the macrocrack surface. In 2D AE localisation analysis, a warped crack surface, or a rough crack surface, when projected onto a plane provides a band of events occurring within the specimen thickness. This systematic bias of a few

millimeters (maximum 3 to 4 mm) should be added to AE localisation accuracy. In Fig. 10, the maximum thickness of this band is about 10 mm, still a bit larger than the crack surface warping and crack roughness, but in the present cementitious material some FPZ of finite size should be expected.

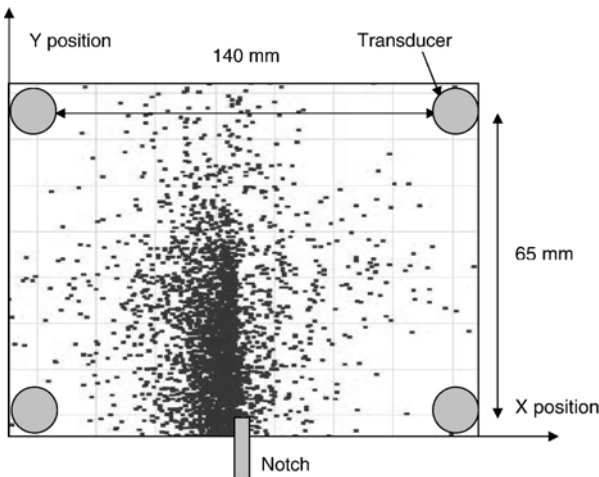
Fig. 9. Microcracking map of a specimen after the pre-cracking phase — result without all events.

Fig. 9 presents the typical microcracking map of a specimen, just after the pre-cracking phase. The transducers which form the rectangular array are represented in the corners, and the other points are the microcracks detected. It shows a very dense area of acoustic events, due to the development of the fracture process zone. Even in the particular material used for this experimental program, the fracture process is not limited to the macrocrack but also spreads around it.

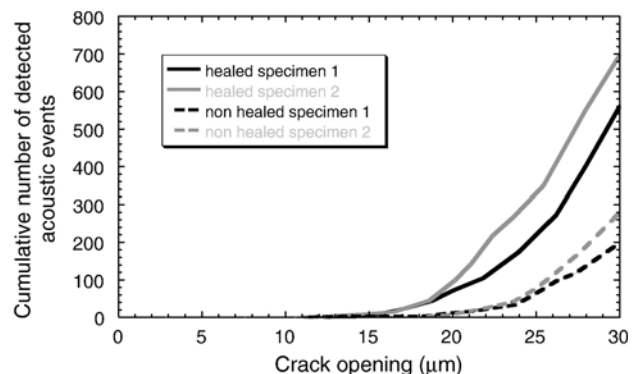
Fig. 11. Cumulative number of acoustic events during the reloading phase for healed and non-healed specimens.

According to the same data processing of the AE as in Section 4.1, we consider first the cumulative number of detected events. Fig. 11 shows the evolution of this number with crack opening for four specimens cured during 10 weeks. The reloading phase corresponds to crack openings less than 20 μm approximately and there is a significant difference between healed and non-healed specimens responses in this range. For crack openings larger than 20 μm , the crack length is greater than the initial one, prior to healing. The number of events recorded on healed specimens (cured into water) is at least twice the number observed for unhealed specimens.

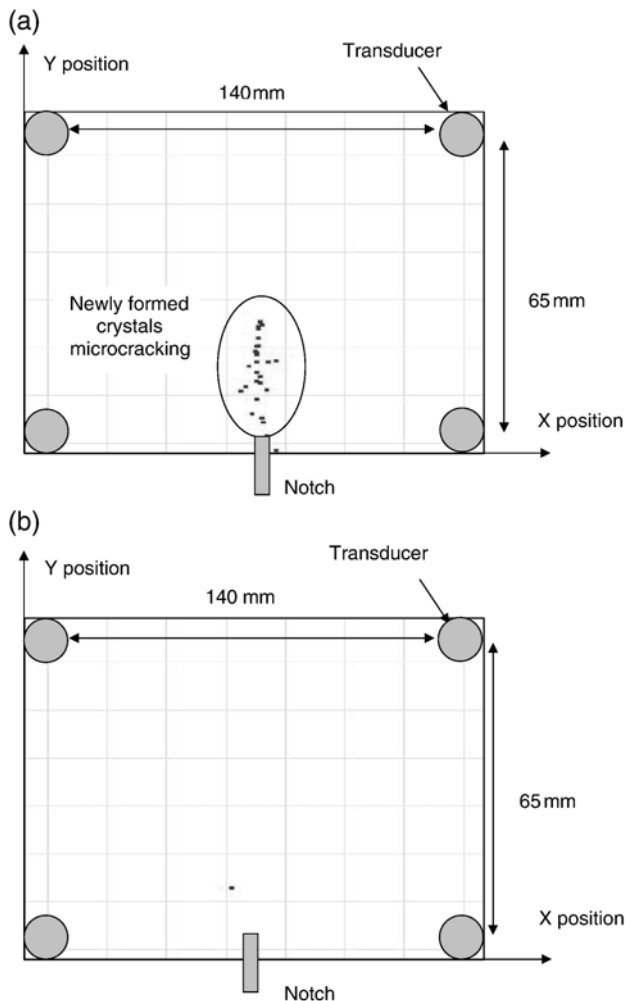
Fig. 12. Microcracking maps, during the reloading phase (until $18 \mu\text{m}$ — pre-peak regime) of specimens aged for 10 weeks; (a) ageing in water, (b) ageing in air.

Fig. 12 presents the maps for a specimen aged in water and for a specimen aged in air, both during 10 weeks. It is noticeable that acoustic activity appears for the healed specimen in the region of the initial crack, while nearly nothing is detected for a non-healed specimen. In view of the mechanical results which exhibit stiffness and strength recovery, one can say that in the first case, there is a damage of the newly formed crystals in the crack, and in the second case, there is only the re-opening of the existing crack, with very little acoustic activity (some due to friction probably). Note that for non-healed specimens, performing the same AE localisation analysis without removing the less energetic events would still provide little acoustic activity, less than that observed for healed specimens.

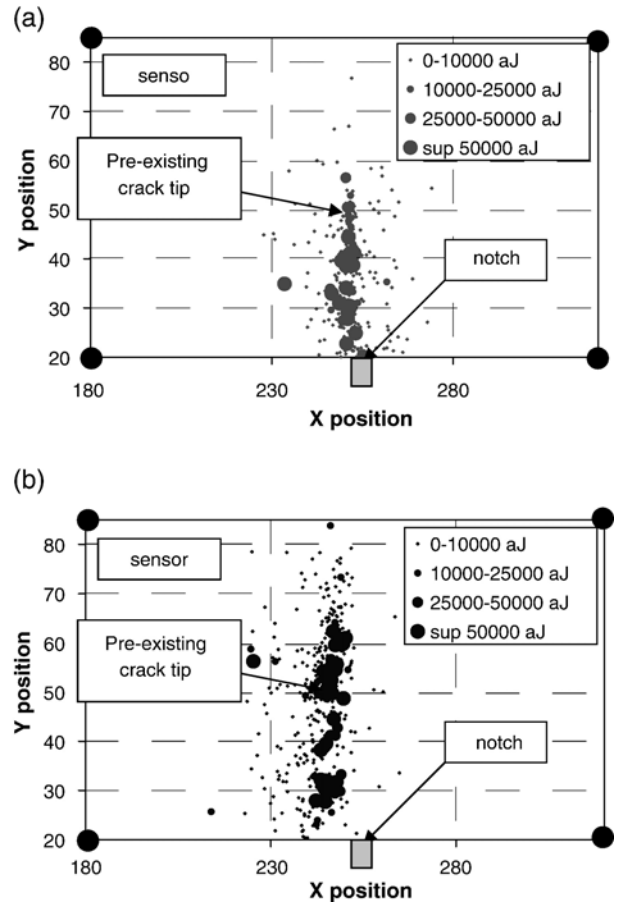
Fig. 13. Energy location maps at 90% of the peak load in the post peak regime; (a) healed specimen, (b) non-healed specimen.

We may now consider the comparison during the reloading phase, not at the same CMOD, but at the same load level. Results at 90% of the peak load, in the post peak regime are analysed. Fig. 13 represents the location maps in terms of energy. Points representing the microcracks are plotted according to their acoustic energy in aJ (the analysis is carried out after having removed less energetic events): the bigger the point, the larger the energy. If we now sum these energies for events located below and above the pre-existing crack tip (which is for

height of 50 mm from the bottom face of the specimen), we can notice that 97% of the acoustic energy dissipated until 90% of the peak load is located in the pre-existing FPZ, for the specimen which has been stored in water, although it is 48% for a non-healed specimen. This acoustic energy dissipated in the crack for a healed specimen should be due mainly to microcracking of newly formed crystals inside the initial crack. Friction would provide some acoustic activity, but probably not the stiffness and strength recovery that was observed on the mechanical response at the same time. For the non-healed specimen, the acoustic activity is due to further propagation of existing microcracks (note that the specimen is again in the post peak regime).
