# Experimental response and vibrational characteristics of a slotted rotor

Jean-Jacques Sinou

Jean-Jacques Sinou. Experimental response and vibrational characteristics of a slotted rotor. *Communications in Nonlinear Science and Numerical Simulation*, 2009, 14, pp.3179-3194. 10.1016/j.cnsns.2008.10.024 . hal-00361665

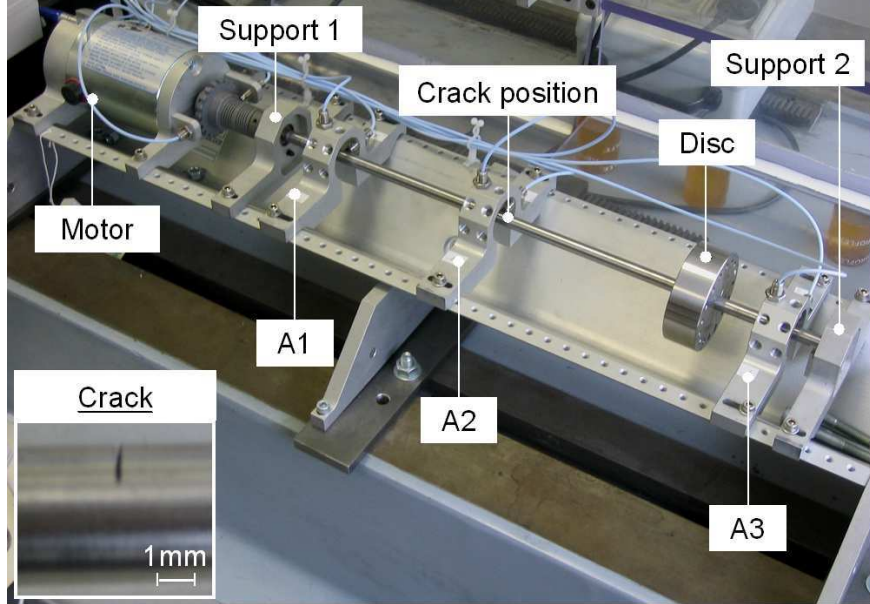
Figure 1: Picture of the experimental rig and the transverse crack

The picture of the experimental rig is shown in Figure 1. This test rig that consists of a steel shaft of  $480mm$  long and  $10mm$  diameter, is simply supported at both ends by two bush bearings. The experimental system is directly mounted on a rigid massive concrete table isolated from the environment. The left end of the rotor is coupled with an electric motor by means of a flexible coupling. The shaft carries one disc made of steel and placed at  $382mm$  from the left end of the shaft. Disc dimensions are  $75mm$  diameter and  $35mm$  thickness. The disc has sixteen holes that are separated by regular degree angle in order to be able to investigate the influence of the unbalance and angle between the front crack and imbalance intensity. Before the experimental tests, the level of the residual unbalance of the healthy rotor has been estimated at  $0.18gm$  and  $168deg$ .

The location of the open crack is at  $243mm$  from left end of the rotor. The rotor's cracks are made by cutting a piece of width  $0.2mm$  with a jeweler's saw. Runs are done at five different crack depths (from the small crack  $\mu = 0.2$  to depth equals to the half of the shaft diameter  $\mu = 1$ , with intervals of non-dimensional crack depth  $\delta\mu = 0.2$ ) and with the uncracked rotor.  $\mu$  defines the non-dimensional crack depth and is given by  $\mu = \frac{h}{R}$  where  $R$  is the radius of the shaft and  $h$  the depth of the crack. Each cutting is realized on the complete rotor without dismantling operations in order to be able to compare all the experimental tests with various crack depths. The cut introduces an open crack in the rotor. Indeed the lateral deflections being small, the slot may not completely close and would not eventually breathe. So the rotor under study may be considered as a slotted rotor (i.e. a rotor with an open crack) due to the cut which in turn may give different dynamic response from a rotor having a breathing crack. However, this experimental procedure has been chosen to be sure that changes in the  $n^{th}$  orders, the non-linear responses and the orbits are only due to the evolutions of the slot depth and not to structural modifications that may be introduced by dismantling operations.

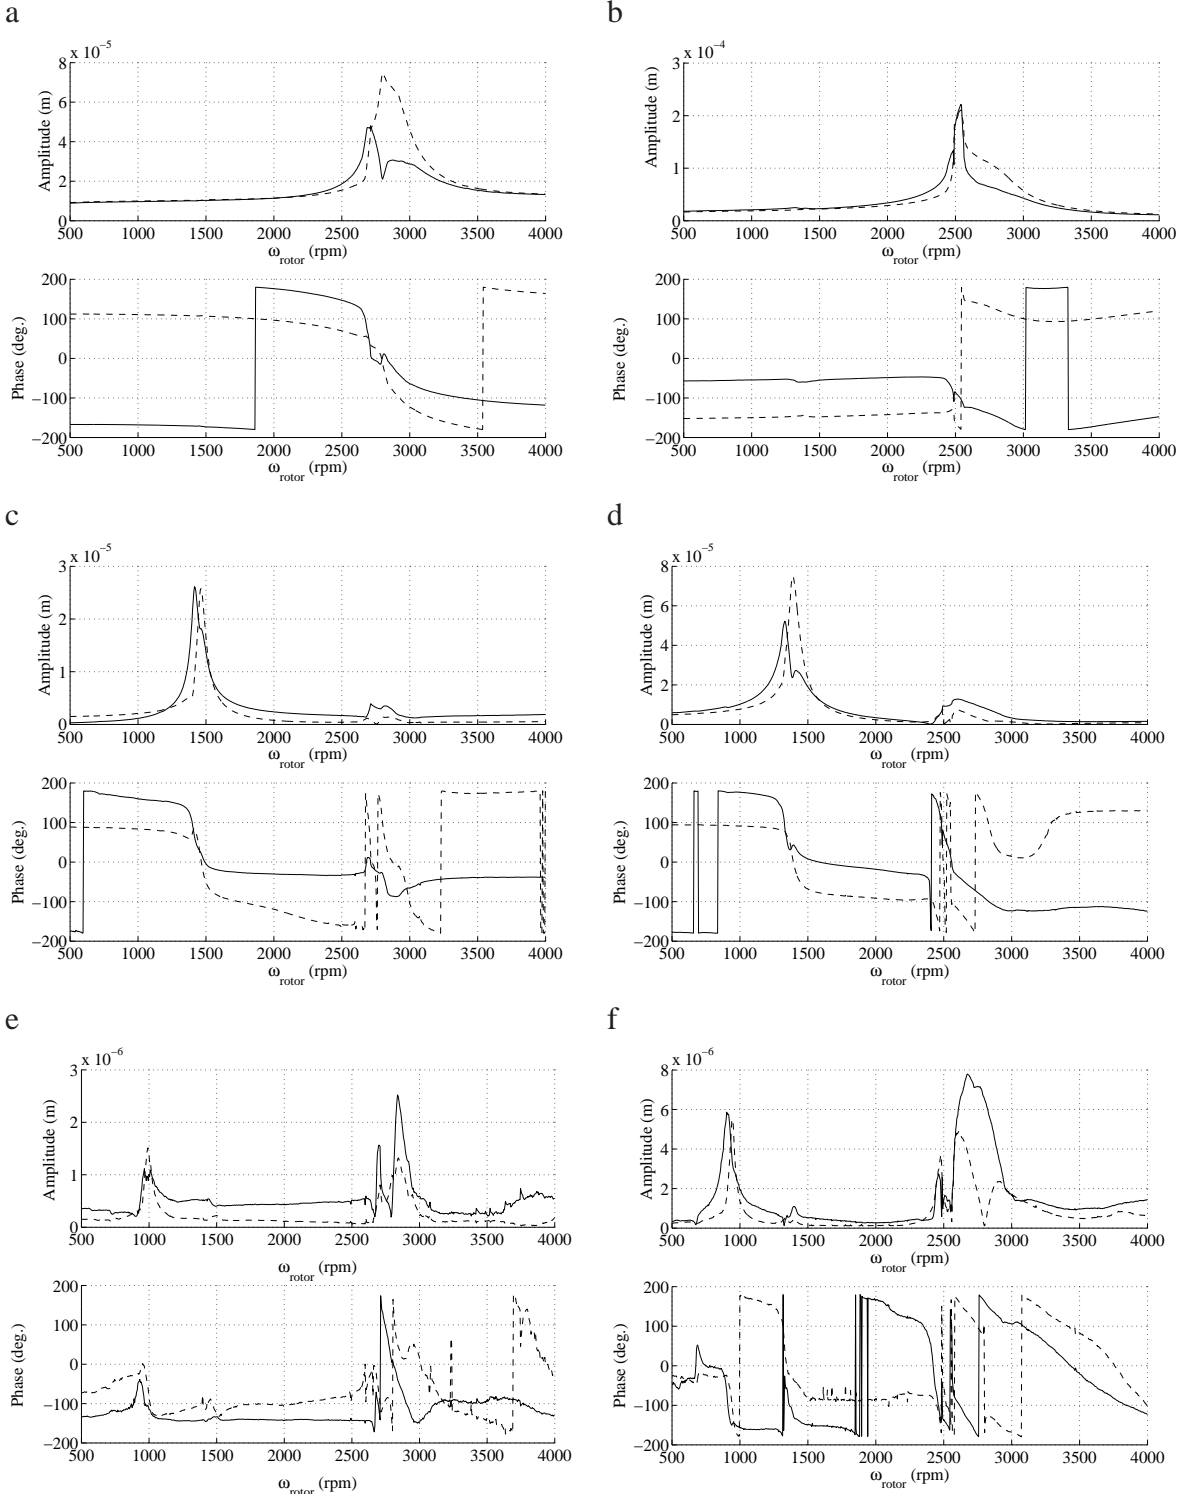
Figure 2: Evolution of  $n\times$  amplitudes and phase in plane A2 for the healthy and slotted rotors ( $\mu = 1$ ) with the initial residual unbalance (a)  $1\times$ , healthy rotor (b)  $1\times$ , slotted rotor (c)  $2\times$ , healthy rotor (d)  $2\times$ , slotted rotor (e)  $3\times$ , healthy rotor (f)  $3\times$  slotted rotor (solid lines = horizontal direction, dashed lines = vertical direction)

The order 1 response peaks (Figures 2(a) and the blue lines in Figures 4) correspond to the first critical speeds of the healthy rotor. These figures show that the first rotor critical speed is around  $2500rpm$ .

From the phase evolution of the vertical and horizontal plots in Figure 2(a), the precession of the rotor is forward below  $2700rpm$  and above  $2800rpm$ : the vertical vibration leads the horizontal vibration. Between  $2700rpm$  and  $2800rpm$ , the rotor vibrates in reverse in the period between the two principal resonances (i.e. the precession is reverse) and the horizontal vibration leads the vertical vibration. The simplest and predominant reason for this reverse orbiting is the asymmetric (i.e. anisotropic) support stiffness of the rotor system, as showing in the picture of the rotor system (see Figure 1). This is typically the case of most horizontal machines that are weaker horizontally.

The effects of an open crack on the response curves of the rotor system are first considered in the present section. Figures 2 and 3 indicate changes of the  $1\times$ ,  $2\times$  and  $3\times$  amplitudes and phases for the healthy and slotted rotor in plane A2 (two unbalance configurations are given: the first case concerns the initial residual unbalance of  $0.18gm$  at  $168deg$ . and the second corresponds to an added unbalance of  $1gm$  at  $0deg$ ). Then, Figures 4 show the evolutions of the non-linear responses and the  $1\times$ ,  $2\times$  and  $3\times$  amplitudes for both the healthy and slotted rotor at the locations A1 and A3 for the second unbalance case ( $1gm$  at  $0deg$ ). In the case of the open cracked rotor, the crack is situated at the middle of the shaft (as shown in Figure 1) and the non-dimensional crack depth is equal to 1, which corresponds to the case of half the area of the cross-section is missing due to the open crack.

The same conclusions can be done from the analysis of the  $2\times$  and  $3\times$  amplitudes in Figures 2. The peaks of the horizontal and vertical  $2\times$  amplitudes change from  $25\mu m$  and  $24\mu m$  to  $52\mu m$  and  $75\mu m$  at one-half of the first critical speed, respectively. At one-third of the first critical speed, the  $3\times$  amplitudes changes from  $1\mu m$  to  $6\mu m$  in both the vertical and horizontal directions. Then, the rotating speeds where the  $2\times$  and  $3\times$  maximum amplitudes are observed (at one-half and one-third of the first critical speed, respectively) decrease significantly (from  $1465rpm$  to  $1410rpm$  for the  $\frac{1}{2}$  sub-critical resonant speeds, and from  $980rpm$  to  $960rpm$  for the  $\frac{1}{3}$  sub-critical resonant speeds from the analysis of the  $2\times$  amplitudes in Figures 4). Moreover, the  $3\times$  amplitudes increase at  $\frac{1}{2}$  sub-critical resonant speed and at the first critical speed due to the presence of the open crack.

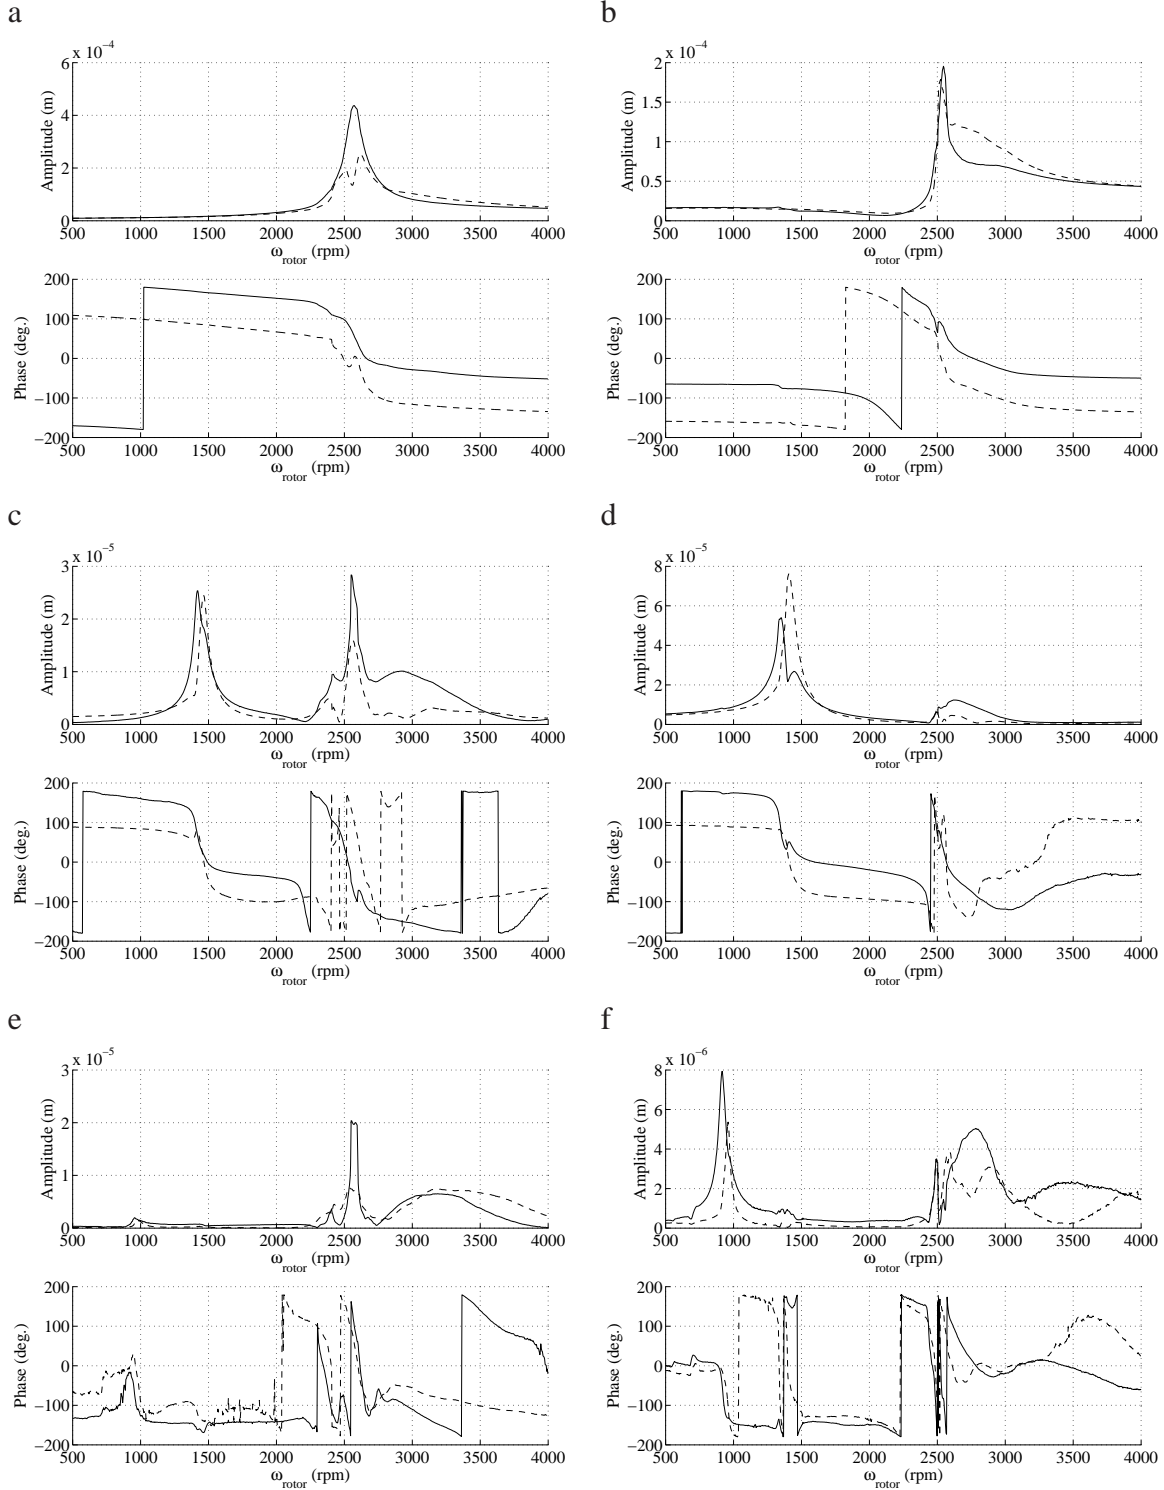
Figure 3: Evolution of  $n \times$  amplitudes and phase in plane A2 for the healthy and slotted rotors ( $\mu = 1$ ) with the unbalance of  $1gm$  at  $0deg$ . (a)  $1 \times$ , healthy rotor (b)  $1 \times$ , slotted rotor (c)  $2 \times$ , healthy rotor (d)  $2 \times$ , slotted rotor (e)  $3 \times$ , healthy rotor (f)  $3 \times$  slotted rotor (solid lines = horizontal direction, dashed lines = vertical direction)

In regards to the  $1\times$  amplitudes, an offset at very low rotating speeds is observed (see Figure 3(b) or Figures 4 (a) and (b) for example). This fact indicates a significant and permanent bow in the rotor. Then, the change in  $1\times$  amplitudes at the first critical speed is clearly observed in all cases. From the analysis of the results for the initial residual unbalance ( $0.18gm$  at  $168deg$ ) in Figures 2(a) and (b) for the plane A2, the vertical and horizontal synchronous amplitudes varies from  $75\mu m$  and  $48\mu m$  to  $210\mu m$  and  $220\mu m$ , respectively. With an added unbalance of  $1gm$  at  $0deg$ , the horizontal and vertical  $1\times$  amplitudes change from  $440\mu m$  and  $250\mu m$  to  $200\mu m$  and  $180\mu m$ , respectively. Typically these changes in synchronous amplitudes are caused by the shaft bowing due to the asymmetric transverse open crack. The bow is introduced by the slot and so the effect of the slot is equivalent of an additional unbalance. In our case, it can be observed that the offset due to this bow is important. For the slotted rotor, the bow generate around  $10\mu m$  and  $15\mu m$  in the horizontal direction for the planes A1 and A2 (see Figures 4(a) and (c) or Figure 3(b)).

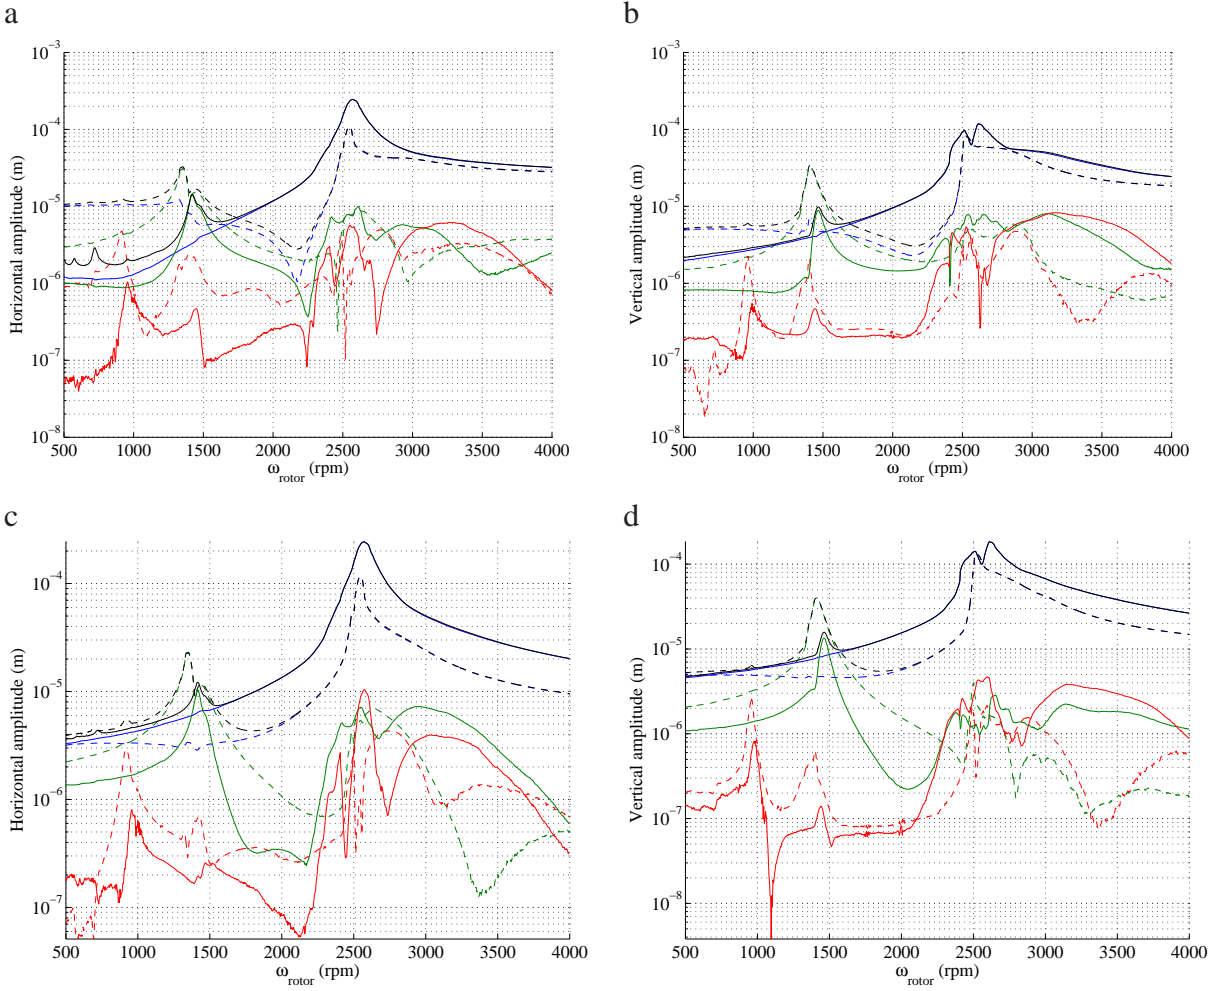
Figure 4: Evolution of the global response,  $1\times$ ,  $2\times$  and  $3\times$  amplitudes for the healthy and slotted rotors ( $\mu = 1$ ) with an unbalance of  $1gm$  and a phase between the unbalance and the crack front of  $0$  degree. (a-b) plane A1 (c-d) plane A3 (solid lines = uncracked rotor, dashed lines = cracked rotor, black = global amplitudes, blue =  $1\times$ , green=  $2\times$ , red =  $3\times$ )

Some of the order tracking plots (the whole signal magnitude called the composite power, orders 1, 2 and 3) are presented in Figures 4 at the locations A1 and A3 in both the horizontal and vertical directions for the second unbalance case (i.e.  $1gm$  at  $0deg$ .).

From the analysis of the  $2\times$  and  $3\times$  amplitudes in Figures 4, it appears that the  $2\times$  and  $3\times$  amplitudes are multiplied by three due to the presence of the open crack. So the differences of  $2\times$  and  $3\times$  harmonic components between the healthy and slotted rotors are significant enough in order to be used as a diagnostic tool.

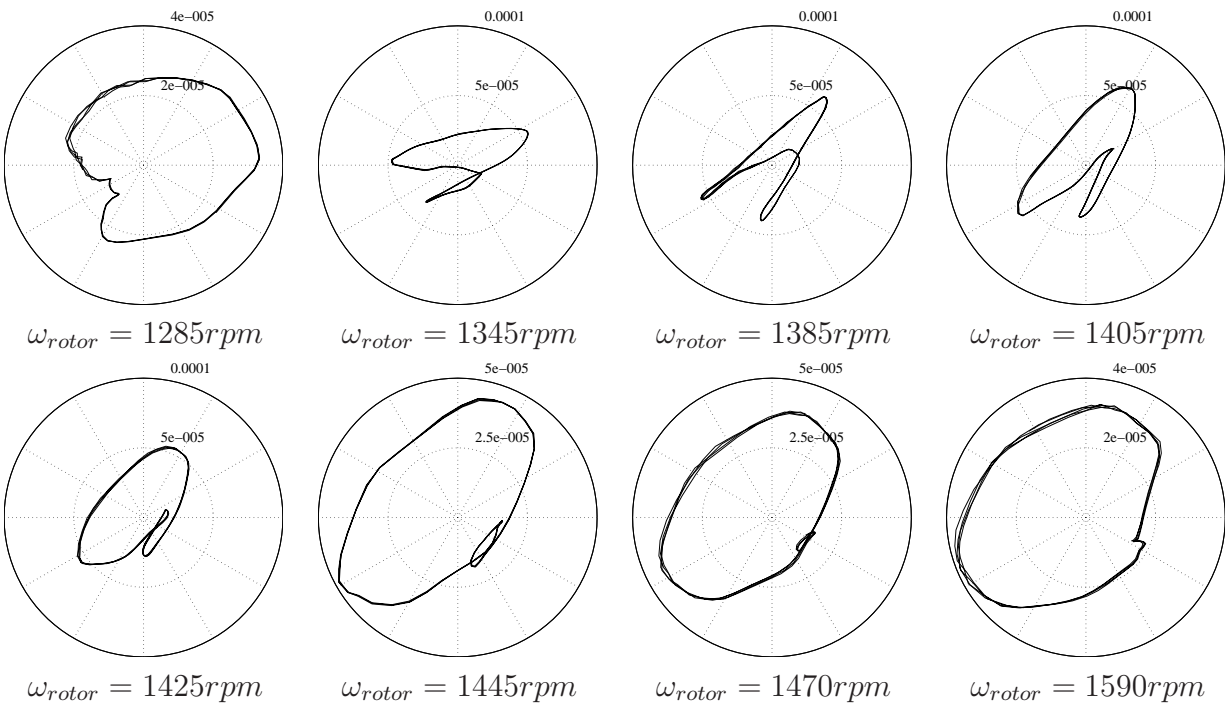
Figure 5: Orbital evolutions for the healthy rotor for the plane A2 around one-half of the first critical speed with an unbalance of 1gm and a phase between the unbalance and the crack front of 0 deg.

By comparing the evolutions of the healthy and slotted rotors' orbits (see Figures 5 and 12), it clearly appears that the presence of an open crack generates a strong evolution of the vibration characteristics of the rotor when the rotating speed passes through nearly half of the machine critical speed. Not only the maximum amplitudes of the orbits are modified, but also the size of the inner loop. In regards to the orbits of slotted rotor in Figures 12, it is shown that the speed range where the inside loop is present is larger than that of the healthy rotor (given in Figures 5). So the intensity of the inside loop can be used for the detection of an open crack in rotor.

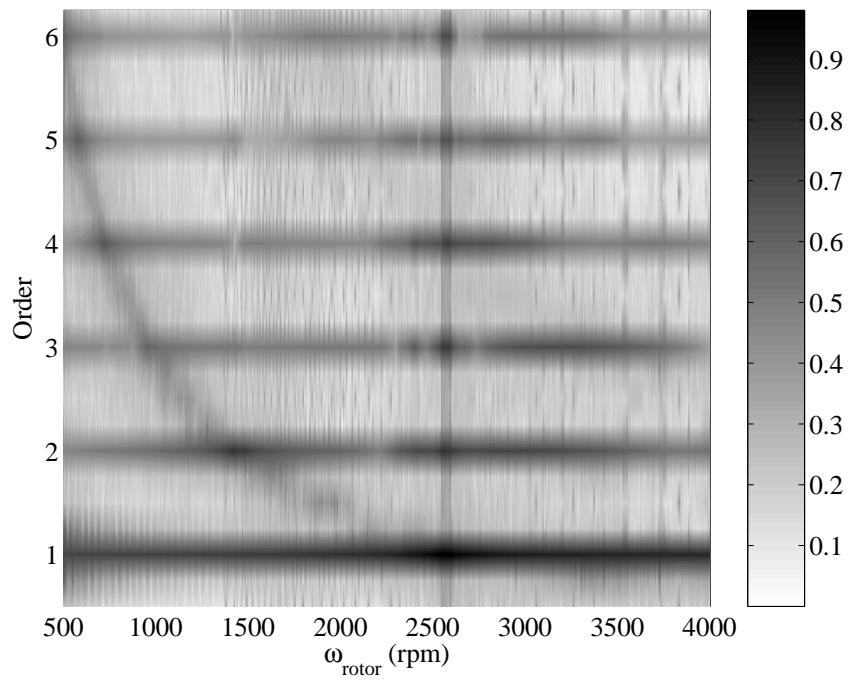
Figure 6: Evolutions of the  $n^{\text{th}}$  orders for the healthy rotor with an unbalance of 1gm and a phase between the unbalance and the crack front of 0 deg.

In regards to the  $2\times$  amplitudes in Figures 6 and 7, it is observed that the speed range where  $2\times$  amplitudes are recognisable increases due to the presence of the open crack: for the slotted rotor, the  $2\times$  amplitudes are important from  $500rpm$  to  $2000rpm$ , whereas they are only recognisable between  $1300 - 1700rpm$  for the healthy rotor.

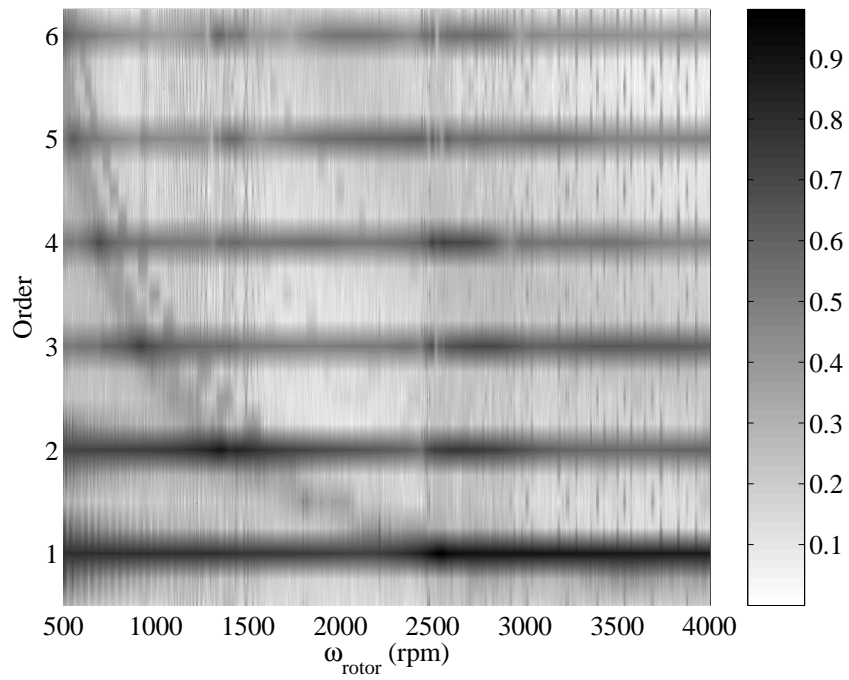
Figure 7: Evolutions of the  $n^{\text{th}}$  orders for the slotted rotor with  $\mu = 1$  (unbalance = 1 gm, phase between the unbalance and the slot front = 0 deg.)

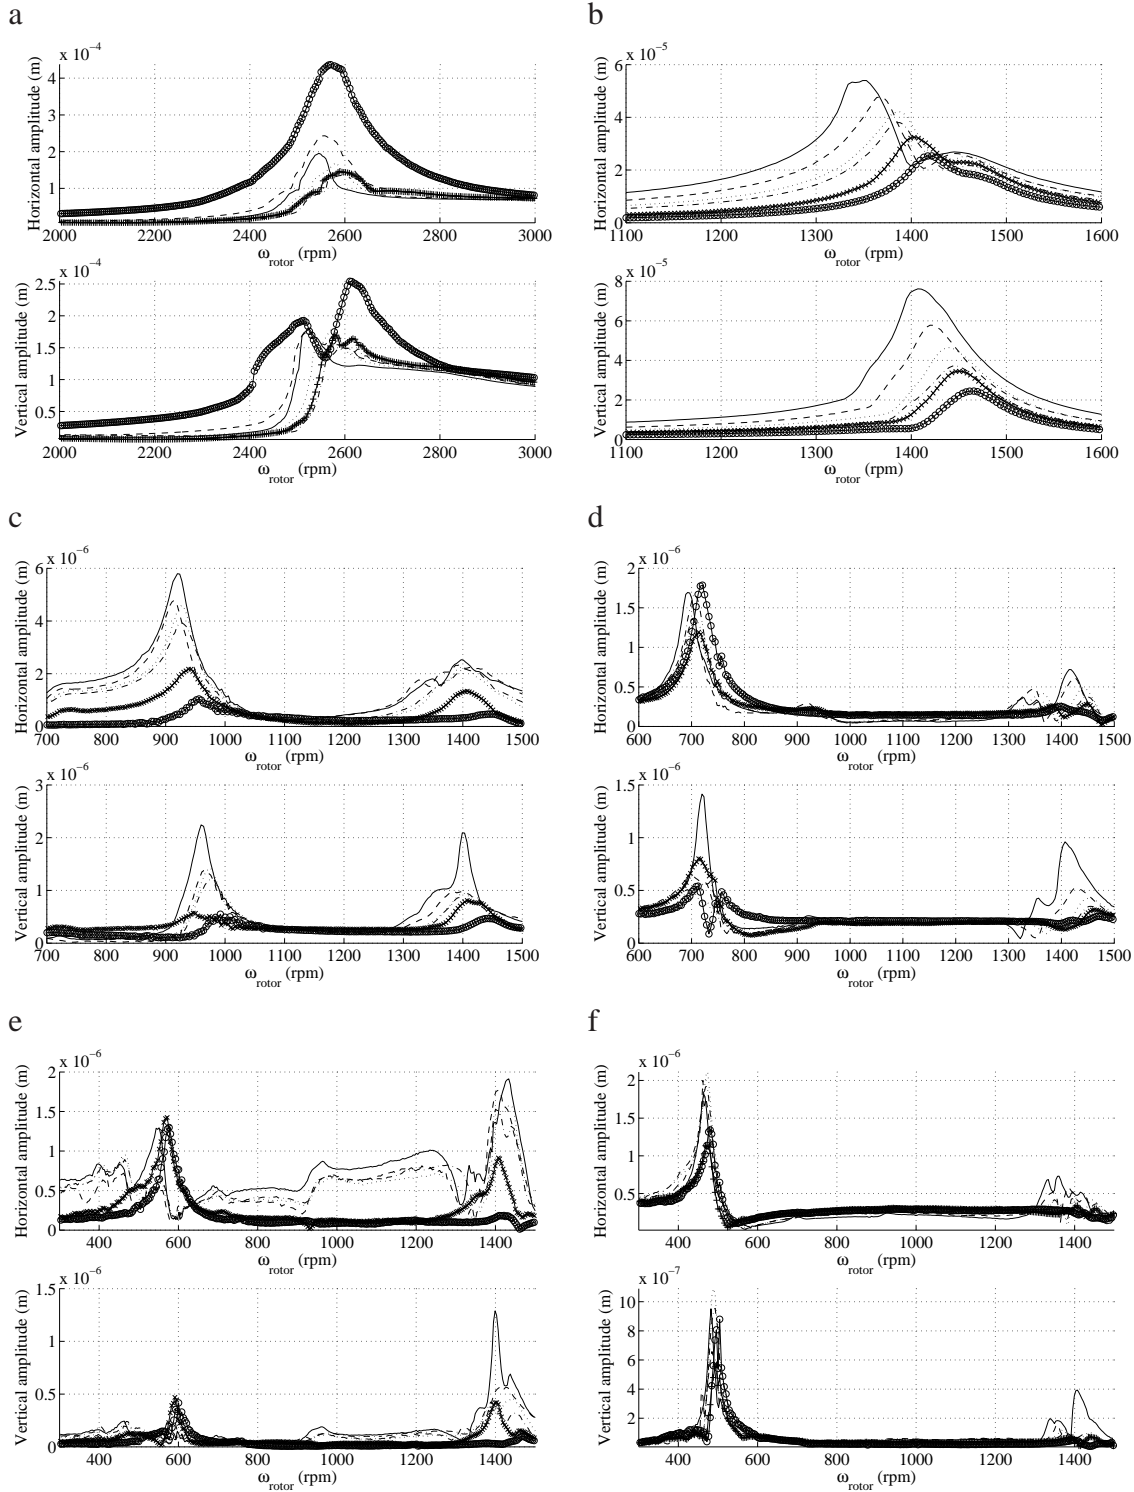
Figure 8: Evolutions of the  $n \times$  amplitudes for various crack depths with an unbalance of 1gm and a phase between the unbalance and the slot front of 0 deg. (a)  $1 \times$  - plane A2, (b)  $2 \times$  - plane A2, (c)  $3 \times$  - plane A1, (d)  $4 \times$  - plane A3, (e)  $5 \times$  - plane A1, (f)  $6 \times$  - plane A3 (-o- uncracked, +-  $\mu = 0.2$ , -.-  $\mu = 0.4$ ,  $\cdots$   $\mu = 0.6$ , - -  $\mu = 0.8$ , -  $\mu = 1$ )

From the analysis of the  $2\times$  and  $3\times$  amplitudes in Figures 8(b) and (c), it is observed that the horizontal and vertical maximum amplitudes of the  $2\times$  and  $3\times$  orders growth gradually with the non-dimensional open crack depth at the  $\frac{1}{2}$  and  $\frac{1}{3}$  sub-critical resonant speeds, respectively. Moreover, increasing the transverse slot depth decreases the rotating speed where the  $2\times$  and

3× maximum amplitudes are observed (at one-half and one-third of the first critical speed respectively). These experimental results reflect the fact that the natural frequencies of the rotor system are changed due to the reduced stiffness resulting from the transverse slot. If the open crack is not very deep (i.e. the slot is equal to  $\mu = 0.4$ ), the 2× amplitudes in the horizontal direction are twice more important than in the case of the healthy rotor as indicated in Figure 8(b). Moreover, the vertical and horizontal peaks at one-half of the rotating speed are very important and exceed  $40\mu m$ . Showing the evolutions of the 3× amplitudes in the horizontal direction (see Figure 8(c)), the 3× amplitudes appear to be four times more important than in the case of the healthy rotor. So the evolutions of the 2× and 3× amplitudes can be used for the detection of an open crack even if the crack is not deep. However, it can be observed that it can be difficult to detect a transverse slot that is inferior to  $\mu = 0.4$  in the present study.

In regards to the 3× amplitudes in Figures 8(c), it is observed that the 3× amplitudes increase at  $\frac{1}{2}$  sub-critical resonant speed with increasing the slot depth. As previously shown, the evolution of the 3× amplitudes at  $\frac{1}{2}$  sub-critical resonant speed is significant even if the transverse slot depth is not deep and is clearly recognisable if the slot depth is superior to  $\mu = 0.4$  (see the horizontal direction in Figure 8(c)). However, it may be noted that the amplitudes of the 3× amplitudes are small (about  $4\mu m$ ). Consequently, the detection of variations in the 2× and 3× amplitudes at one-half and one-third of the first critical speeds can be used as a diagnostic tool for the detection of slotted rotor if the open crack is superior  $\mu = 0.4$ . We recall that the conclusions presented in this study are consistent with our test rig and limited to the case of an open crack. All the results that are presented in the study only give general tendencies for the vibration characteristics of slotted rotors. For a real machine, some researchers have demonstrated that it is possible to detect smaller cracks (14% of the diameter for the study of Pennacchi et al. [12] for example).

Finally, evolutions of the 4×, 5× and 6× harmonic components are given in Figures 8(d-f). In these cases, the increases of the 4×, 5× and 6× maximum amplitudes at  $\frac{1}{4}$ ,  $\frac{1}{5}$  and  $\frac{1}{6}$  sub-critical resonant speeds are not observed or not significant enough to be used as diagnostic tools. However, it is observed that increasing the crack depth increase the 4× and 5× amplitudes in both the vertical and horizontal directions when the cracked rotor is passing through one-half of the first critical speed. Nevertheless, these variations are not important enough (about 1-2  $\mu m$ ) and can not be used to detect the presence of a transverse crack in rotors.

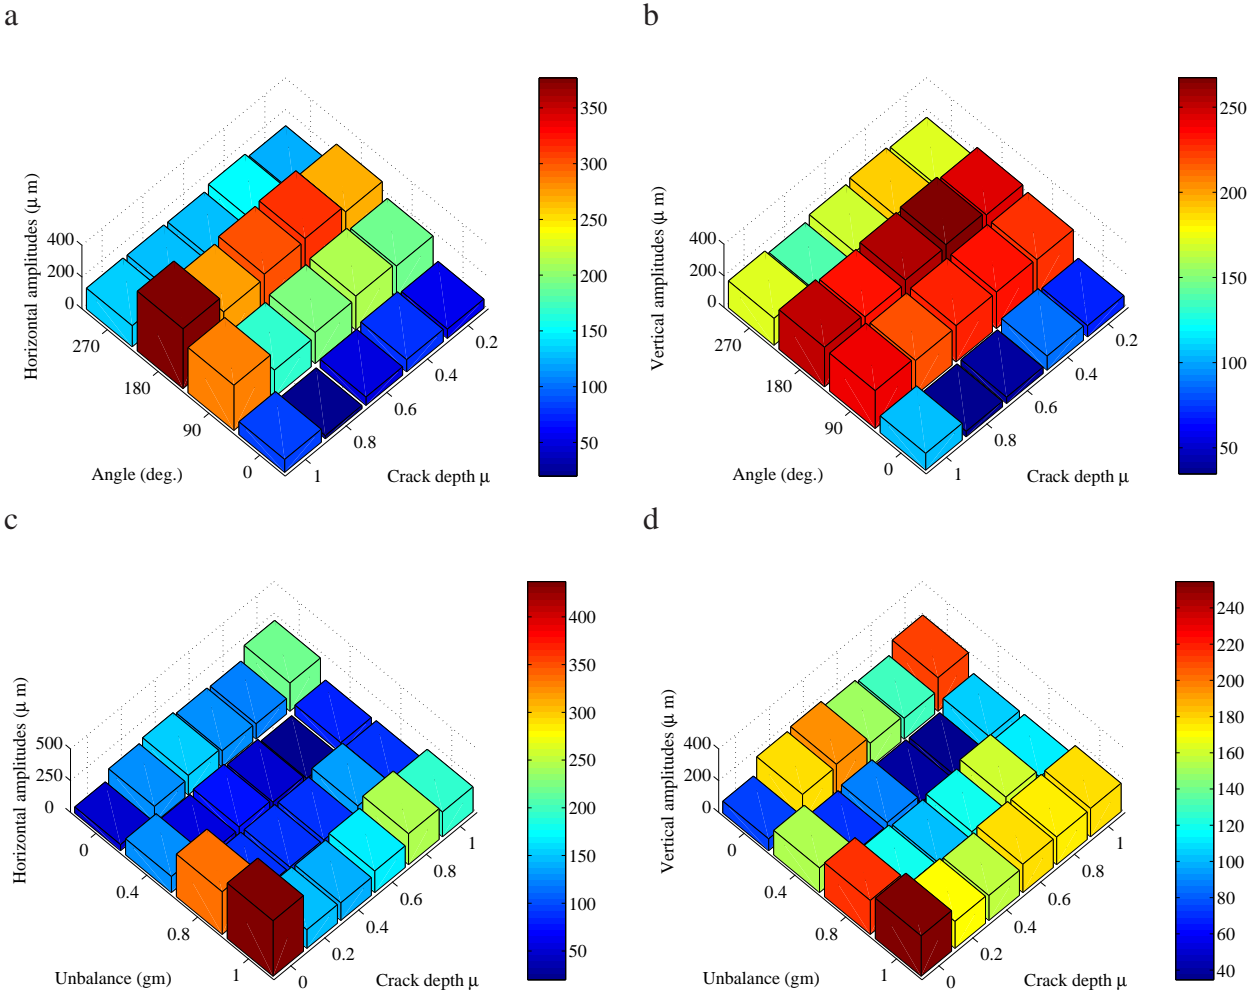
Figure 9: Evolutions of the  $1 \times$  maximum amplitudes at the first critical speed for the horizontal and vertical directions at the plane 2 (a,b) versus the slot depth and the phase between the unbalance and the slot front for an unbalance of 0.4gm (c,d) versus the slot depth and the unbalance with a phase between the unbalance and the slot front of 0 deg.

and the unbalance (for  $0.4gm$ ) is more important than the effects of the slot depth (for this present study) in regards to the  $1\times$  maximum amplitudes at the first critical speed. All these results are in agreement with the level of residual unbalance that has been estimated for the healthy rotor ( $0.18gm$  at  $168deg$ ). By comparing with the experimental results previously published by Darpe [13], it is noted that the variation of the peak response with phase of unbalance does not match exactly but looks similar to his case with a lower unbalance of  $0.53gm$  and a slotted crack of  $\mu = 0.23$ .

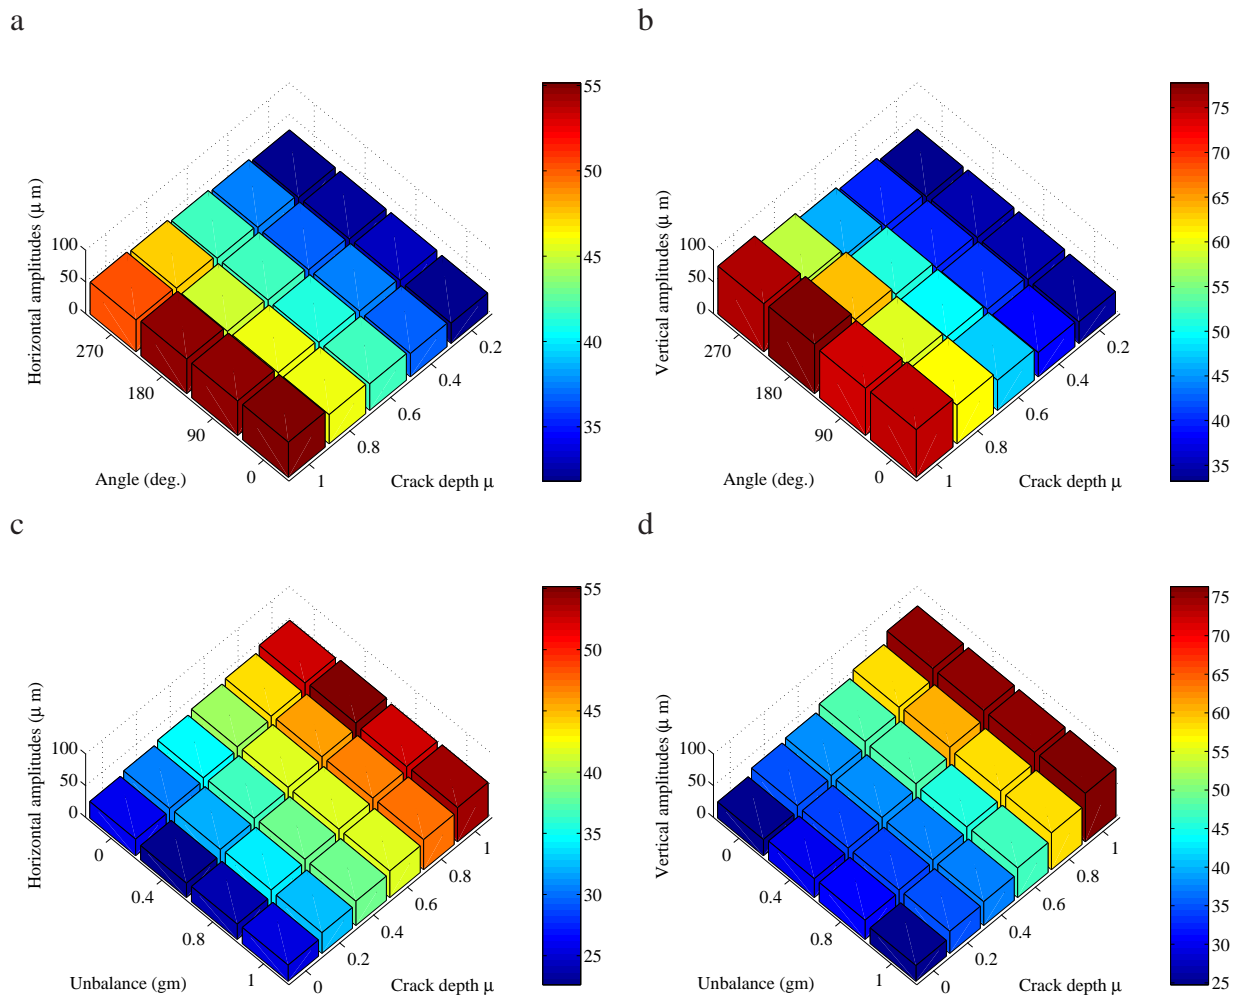
Figure 10: Evolutions of the  $2\times$  maximum amplitudes at one-half of the first critical speed for the horizontal and vertical directions at the plane 2 (a,b) versus the slot depth and the phase between the unbalance and the slot front for an unbalance of 0.4gm (c,d) versus the slot depth and the unbalance with a phase between the unbalance and the slot front of 0 deg.

Secondly, the effects of the relative angle between the transverse slot and the unbalance for the  $2\times$  maximum amplitudes when the rotor is passing through one-half of the first critical speed respectively, are shown in Figures 10(a-b) for various non-dimensional crack depths (with an unbalance of  $0.4gm$  at  $0deg$ .) in both the vertical and horizontal directions. Then, the effects of the crack depth and the amount of unbalance is given in Figures 10(c-d) (in this case the phase between the unbalance and the crack front is chosen to be  $0deg$ ).

It is observed that for a given slot depth, the  $2\times$  peak amplitudes at  $\frac{1}{2}$  sub-critical resonant speed do not depend upon the angle between the unbalance and the slot front. Increase of the slot depth induces an increase of the  $2\times$  amplitudes for all the slot-unbalance configurations. These results are in perfect agreement with the previous study of Mayes and Davis [15]: they observed that the  $2\times$  harmonic component increases monotonically with the slot depth and that there is no variation in the  $2\times$  amplitude with out-of-balance distribution. However, it can be remembered that some numerical studies [7, 19] demonstrated that the orientation between the unbalance and the crack can affect the amplitudes of the  $2\times$  peak amplitudes at  $\frac{1}{2}$  sub-critical resonant speed. For example, Jun et al. [19] observed an increase of the amplitude of the second harmonic components with increasing the crack depth, but they indicated that the  $2\times$  harmonic components tend to have maximum or minimum amplitudes when the unbalance is in phase and out of phase with respect to the crack. As explained by Sinou [7], the intensity of unbalance is one of the key factors that can induce changes (or not) of the  $2\times$  harmonic component with the orientation between the crack and unbalance.

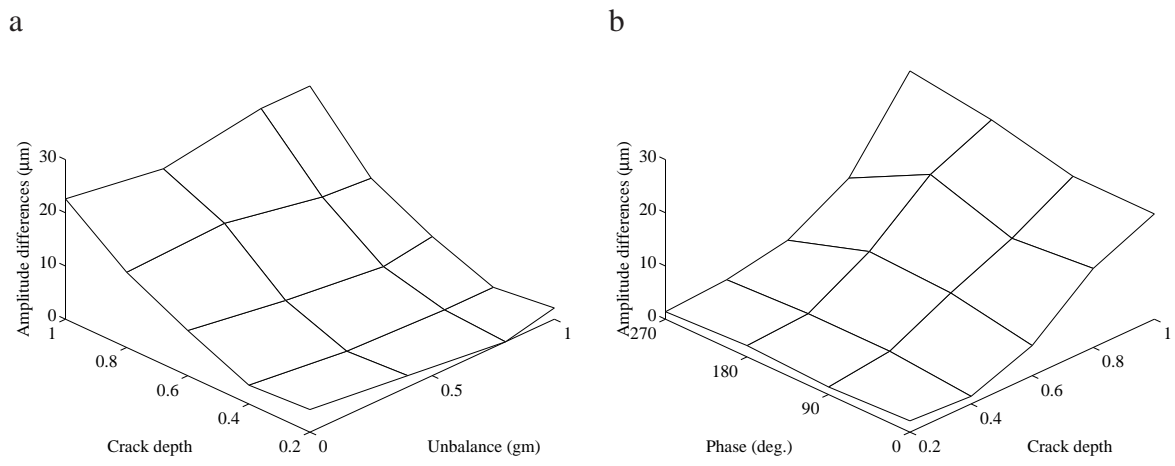
Figure 11: Differences between the horizontal and vertical directions of the  $2\times$  maximum amplitudes at one-half of the first critical speed on plane A2 (a) for various crack depths and unbalance with a phase of 0 deg. (b) for various crack depths and phases between the unbalance and the crack front with an unbalance of 0.4gm

horizontal amplitudes with regard to the transverse slot depth and phase between the crack and the unbalance, and the slot depth and the unbalance intensity respectively. These results demonstrate that the differences between the  $2\times$  vertical and horizontal amplitudes increase monotonically with the increase of the slot depth, when the rotor is passing at one-half of the first critical speed. This phenomenon is due to the increased asymmetry as slot depth increases. These results also indicate that the effects of the slot depth are stronger than those of the unbalance intensity or those of the phase between the slot front and the unbalance.

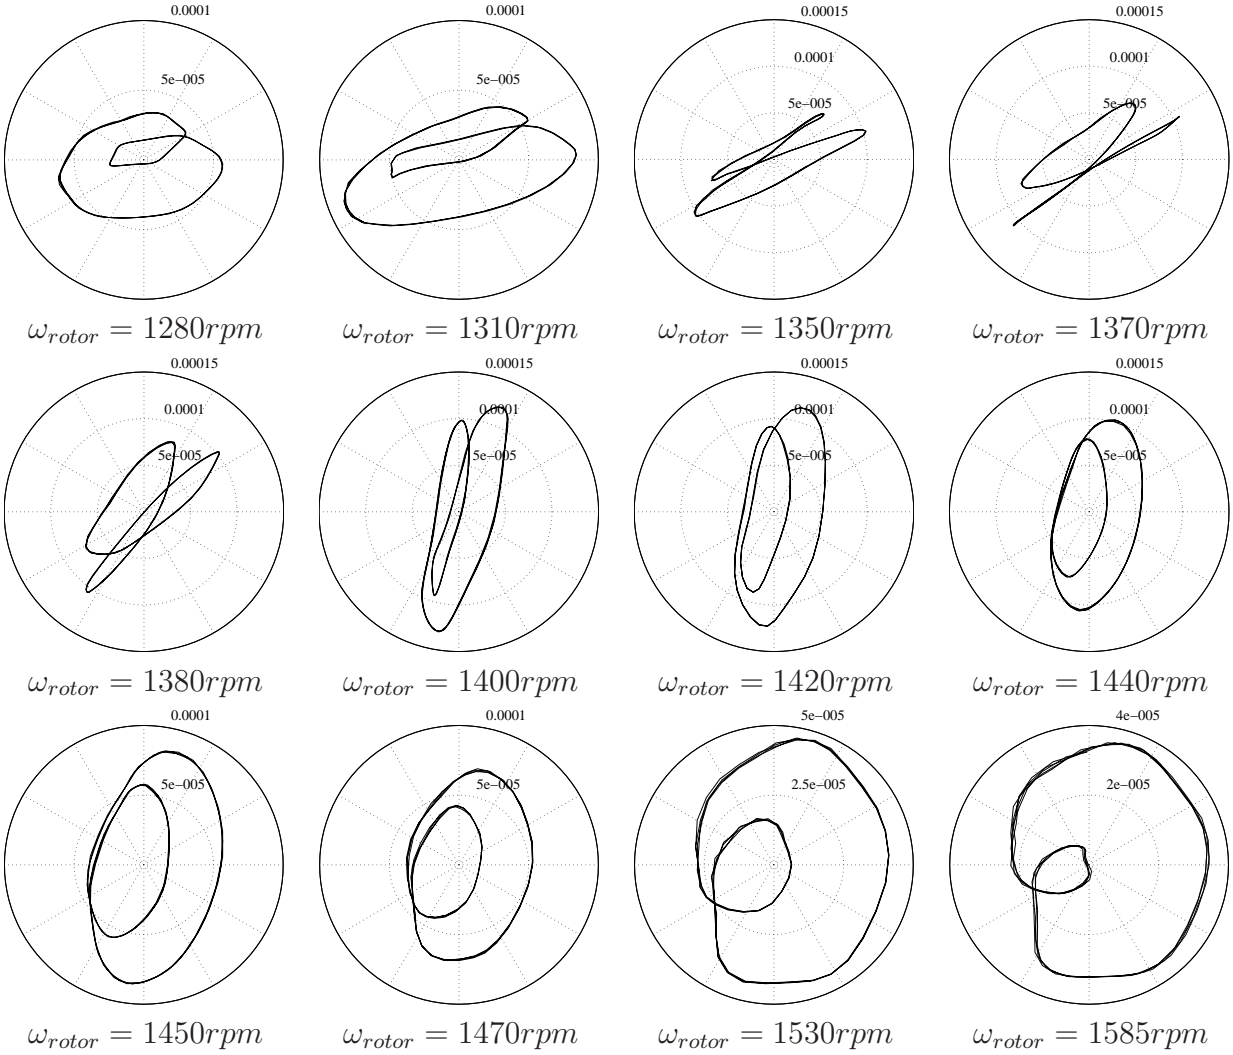
Figure 12: Orbital evolutions of the cracked rotor for plane A2(with  $\mu = 1$ ) around one-half of the first critical speed with an unbalance of 1gm and a phase between the unbalance and the crack front of 0 deg.

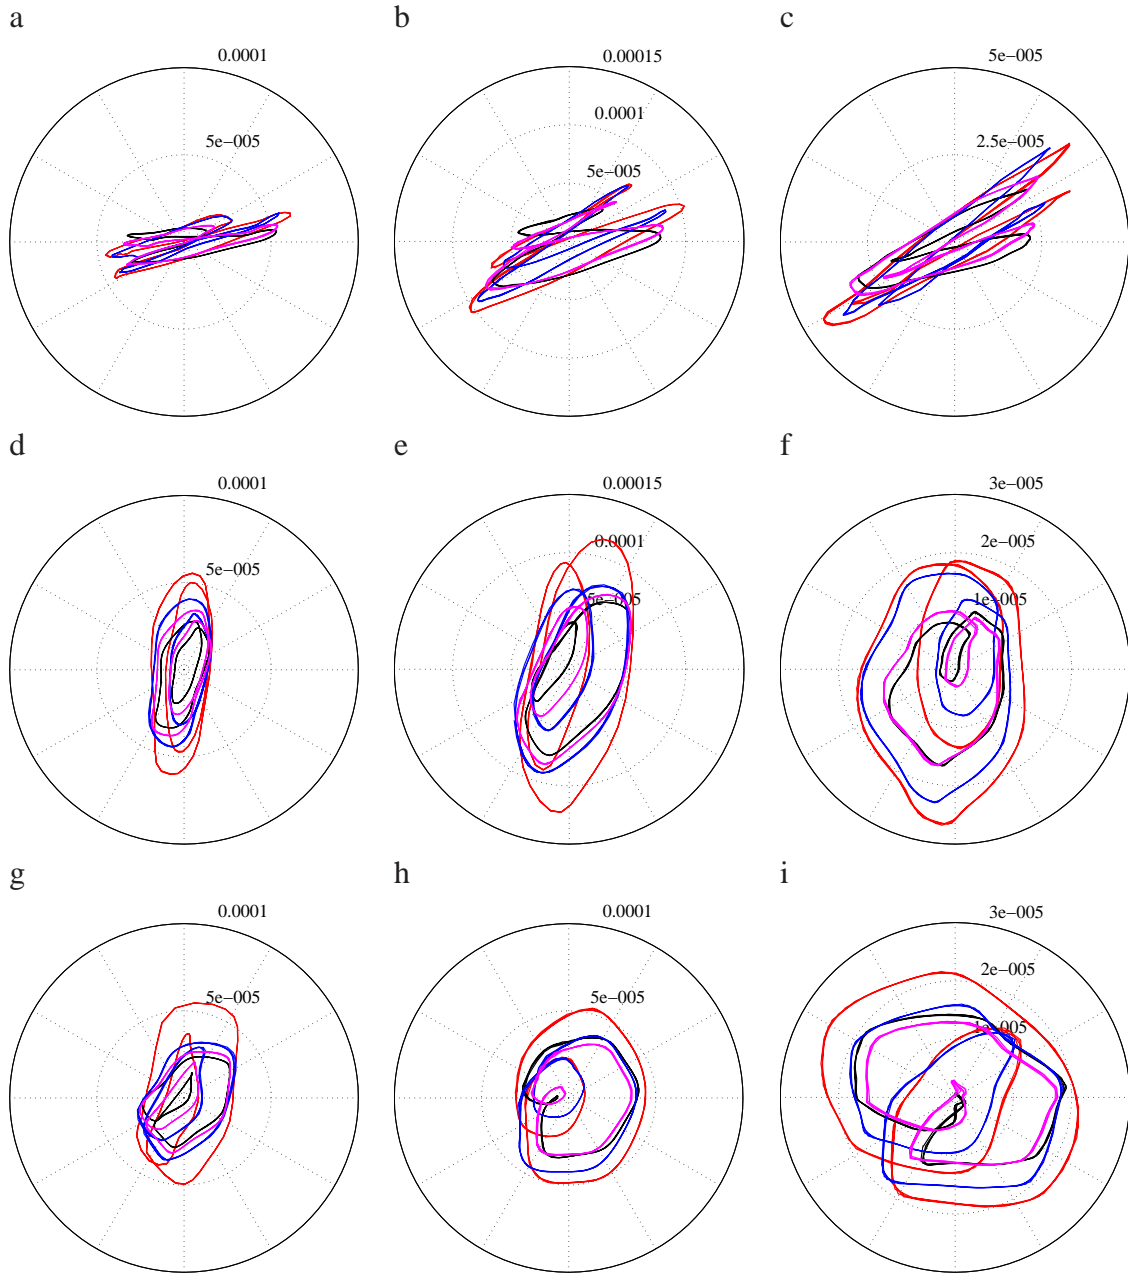
Figure 13: Orbits of the cracked rotor around one-half of the first critical speed with an unbalance of 1gm and a phase between the unbalance and the crack front of 0 deg. (red:  $\mu = 1$ , magenta:  $\mu = 0.8$ , blue:  $\mu = 0.6$ , black:  $\mu = 0.4$ ). (a) Plane A1 -  $\omega_{rotor} = 1340rpm$ , (b) Plane A2 -  $\omega_{rotor} = 1340rpm$ , (c) Plane A3 -  $\omega_{rotor} = 1340rpm$ , (d) Plane A1 -  $\omega_{rotor} = 1410rpm$ , (e) Plane A2 -  $\omega_{rotor} = 1410rpm$ , (f) Plane A3 -  $\omega_{rotor} = 1410rpm$ , (g) Plane A1 -  $\omega_{rotor} = 1530rpm$ , (h) Plane A2 -  $\omega_{rotor} = 1530rpm$ , (i) Plane A3 -  $\omega_{rotor} = 1530rpm$

Then, when the orbit changes from a double loop to an inside loop (i.e just before crossing  $\frac{1}{2}$  sub-critical resonance), the inside loop increases with increasing the transverse slot depth for the three positions of the shaft at the left, middle and right of the rotor, as illustrated in Figures 13(d), (e) and (f) respectively (for the rotating speed  $\omega_{rotor} = 1410rpm$ ). After crossing  $\frac{1}{2}$  sub-critical resonance (at  $\omega_{rotor} = 1530rpm$ ), Figures 13(g), (h) and (i) show that the same results are observed: increasing the slot increases monotonically the inside loop for the three planes A1, A2 and A3. This results are in perfect agreement with the numerical study of Jun et al. [19]. In regards to the orbital patterns at  $\omega_{rotor} = 1410rpm$  (see Figures 13(d), (e) and (f)), it can be concluded that the vibration characteristics of the slotted rotor are different from those of the healthy rotor even if the slot depth is not deep. Moreover, the size of the inside loop is a good indicator of the slot depth. From the analysis of the evolutions of the orbital patterns from  $\omega_{rotor} = 1410rpm$  to  $\omega_{rotor} = 1530rpm$ , it is observed that the rotation of the inside loop indicating a significant change in both the phase and amplitude of the  $2\times$  vibration is recognisable and significant enough to be the signature of the presence of a transverse slot in rotor. For example, Figures 13(d) and (g) indicate that the inner loop changes its orientation by almost  $180^\circ$ .

Showing Figures 13(d), (e) and (f), the difference between the horizontal and vertical sizes of the inside loops increase with the increase of the slot depth. These results agree with the previous observations done in Section 3.2.2 for the evolutions and differences of the  $2\times$  amplitudes in the vertical and horizontal amplitudes. So it clearly appears that the orbital changes of the inside loop can be one of the most efficient and robust signature for detecting the presence of a transverse crack in rotors.

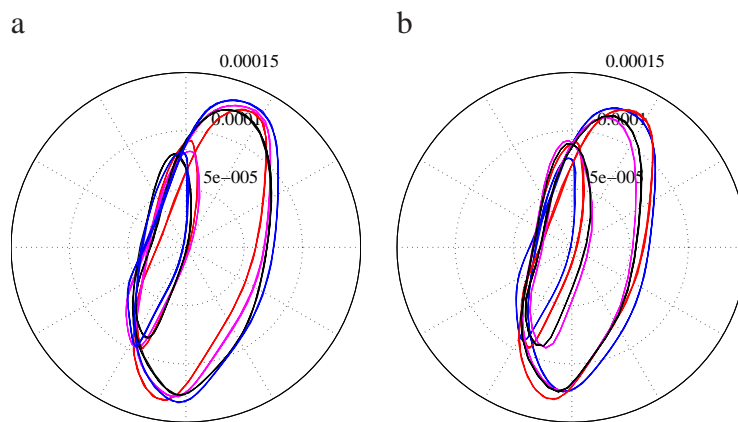
Figure 14: Changes in the orbital patterns at the one-half of the first critical speed as a function of (a) the phase with  $\mu = 1$  and an unbalance of 1gm ( red: 0 deg., magenta: 90 deg., blue: 180 deg., black: 270 deg.), (b) the unbalance with  $\mu = 1$  and a phase of 0 deg. (black: 0gm, blue: 0.4gm, magenta: 0.8gm, red: 1gm)
