Durability of fibre ropes for deep sea handling operations

BEND OVER SHEAVE DURABILITY OF FIBRE ROPES FOR DEEP SEA HANDLING OPERATIONS

ABSTRACT

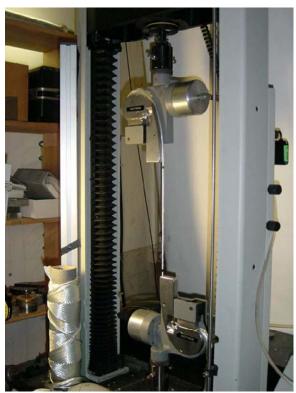
Assembled yarn samples were tested on a 10 kN tensile test machine. The main originality of this equipment is the pneumatic grips, developed for testing yarn samples, and the two digital cameras used to follow the movement of two markers attached to the yarn. These provide non-contact extensometry when analyzed using in-house image analysis software. Figure 1 shows the test set-up.

Figure 1. Tensile test set-up

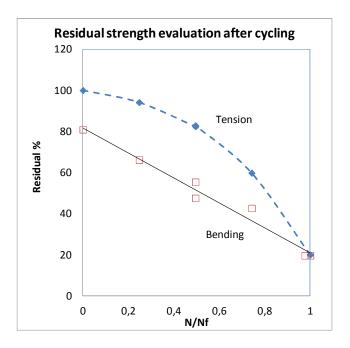
A first series of tests was performed to examine the influence of the technique used to measure residual strength on safety factors. This is a key issue for a test program, so both straight tensile pull and cycling to failure on the sheave at increasing load levels were examined. An example of the results is shown in Figure 9. Residual strength is plotted versus the number of cycles N normalized by the cycles to failure $N_{\rm f}.$

Figure 9. Residual strengths (% of initial tensile strength) measured after cycling to different percentages of lifetime at 20% break load. Residual values evaluated by either tensile direct pull (filled diamond symbols) or by cycling on sheave at increasing load (open squares).

These results are very important as they clearly show that it is dangerous to rely on residual tensile strengths to evaluate the influence of cyclic bending damage, as they will provide an over-optimistic value of residual strength. Cyclic bending on the sheave at increasing load was therefore used in all subsequent tests to evaluate remaining lifetime.

The determination of data such as those in Figure 9 can then be used in an empirical life prediction model. For this it is essential to run additional tests with more complex loading sequences, in order to validate the predictions. Such tests are underway.

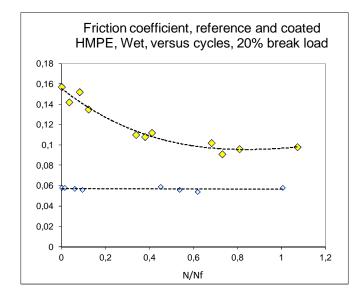
A number of materials have been tested on this device in order to examine their external friction behavior under cyclic loading conditions at different load levels, both wet and dry. It is very important to determine how these materials behave throughout their lifetime, not just initially, as the rope evolves with time. Figure 12 shows one example of a result for both the reference HMPE (no coating) and an improved friction coating.

Figure 12. Example of sheave/rope friction coefficients versus cycles (N/Nf) for reference (blue symbols) and modified ropes (yellow symbols).

Friction coefficients were determined by cycling and progressively increasing the applied couple until slipping occurred. The coefficient μ was determined from the measured loads (T) in the two outer rams at slippage and the contact angle θ , using the expression: $T_{high}/T_{low} = .e^{\mu\theta}$.

In this case the friction coefficient of the modified material is clearly significantly higher than that of the reference rope, even at the end of its lifetime.

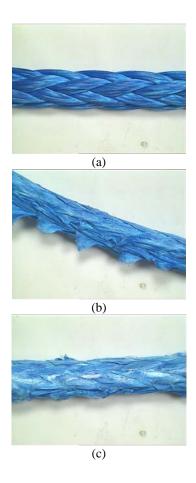
In order to extend the model to include changes resulting from damage development, the different damage mechanisms and their development during cycling must be understood. This is a complex task due not only to the many geometrical interactions, both between the individual rope elements and between the rope and the sheave, but also to the possibility of coupling between rope properties and temperature changes. Various techniques have been applied to examine rope damage, including interrupting tests at various stages and examination. Microscopy studies provide a first indication of damage processes; Figure 18 shows two aspects, the smooth inner contact surface with the sheave, where local melting has occurred, and the extruded fibers on the outer surface which reduce the load-carrying capacity of the rope.

Figure 18. Optical microscopy images of HMPE rope a) New

- b) External surface damage, interrupted CBOS test
- Smooth internal surface (in contact with sheave), interrupted CBOS test.
