Mechanism of Fatigue Crack Growth in Carbon Black Filled Natural Rubber

J.-B. Le Cam, B. Huneau, E. Verron,* and L. Gornet

ABSTRACT: The present paper deals with the fatigue crack growth in a carbon black filled *cis*-1,4-polyisoprene rubber under relaxing loading conditions. The study focuses on the determination of the scenario of crack growth. For this purpose, an original "microcutting" method is employed to observe microscopic phenomena involved in the growth of the crack with a SEM. It reveals that the cavitation induced by the decohesion between zinc oxides and rubber matrix is the major fatigue damage and that the crack tip is composed of stretched elliptical areas surrounded by highly stretched and crystallized ligaments. Finally, the observations are considered to establish the fatigue crack growth mechanism.

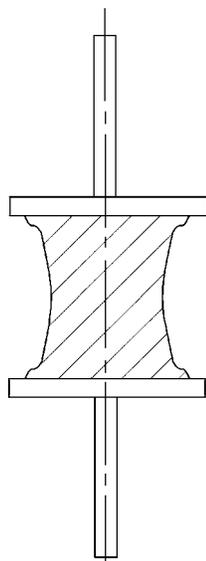
Figure 1. Geometry of the “diabolo” sample.

The sample geometry is similar to the one proposed by Beatty;¹² it is presented in Figure 1. The sample is axisymmetric and is usually called the "diabolo" sample. Its significant radius of curvature leads to a higher local deformation state in its middle than the enforced nominal deformation. Consequently, the predominant fatigue crack is initiated in the lowest diameter section, i.e., at the center of the sample.

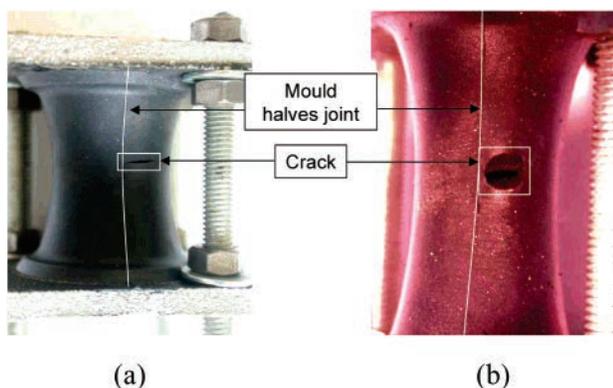
Figure 2. Sample and fatigue crack in the (a) undeformed and (b) deformed configurations.

2.4. Observation Method. The sample is fixed in a rudimentary static tensile apparatus (see Figure 2a), and it is statically stretched to the same ratio than the one enforced during the fatigue test (1.33) in order to open the crack (see Figure 2b). Then, this apparatus is placed in the SEM to observe the crack growth. As mentioned previously, the fatigue test led to initiation and propagation of a crack in the sample, and it involved a fatigue damage in the crack tip vicinity. Thus, the crack tip should be notched to reveal the fatigue damaged zones and to determine their origin. During SEM observations, it is obviously irrelevant to use a laboratory cutting tool to notch the crack. Nevertheless, it is possible to “microcut” the crack tip by imparting in situ a sufficient amount of energy to break cross-links between macromolecules. Two energy sources are used simultaneously: the first one is mechanical and consists of statically stretching the sample to a ratio equal to 1.67, i.e., higher than the level set during the cyclic loading, and the second one consists of locally concentrating the electron beam in the observation zone. In fact, the amount of energy needed to break cross-links cannot easily be determined since the number and nature of cross-links as well as the number of macromolecules in the irradiated zone are not well-known. However, the acquired experience enables us to correctly set the power of the electron beam and to recur experiments. The most favorable zones to perform microcut-

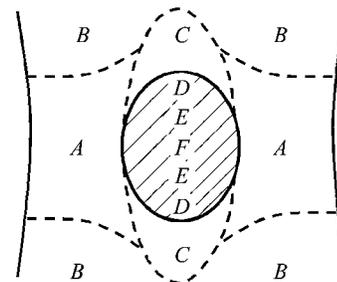
Figure 3. Schematic view of the crack (D–F) and its surroundings (A–C).

3.1. Crack Description. Figure 3 presents a schematic view of the crack and its surroundings. Six different areas are observed in the deformed configuration, i.e., as the sample is stretched to 1.67. Before the occurrence of the crack, there were only two zones: the central zone of the sample, denoted A in the figure, that is the most stretched part of the specimen, and the area situated on both sides of it and denoted B. When the crack occurs, four new zones appear: area C, which corresponds to the parts of area A relaxed during crack opening, and areas D, E, and F that stand for the crack itself. The photomicrographs of the three zones D, E, and F are shown in Figure 4. Area F stands for the crack tip, area D represents the material surfaces that were broken during the previous growth of the crack, and area E is the frontier between the former ones (see Figure 4a). The major difference between surfaces D and F is their stretching level. As shown in Figure 4b, area D is overlaid with wrenchings which are a typical feature of fracture surfaces observed under fatigue loading conditions.^{14,15} Here, the term “wrenchings” refers to highly stretched ligaments which break and shrink. Area F is composed of highly stretched ligaments which delimit elliptical smooth surfaces, and area E contains both wrenchings and ligaments. With regard to these observations, the number and size of ligaments in a zone seem closely related to its stretching level.

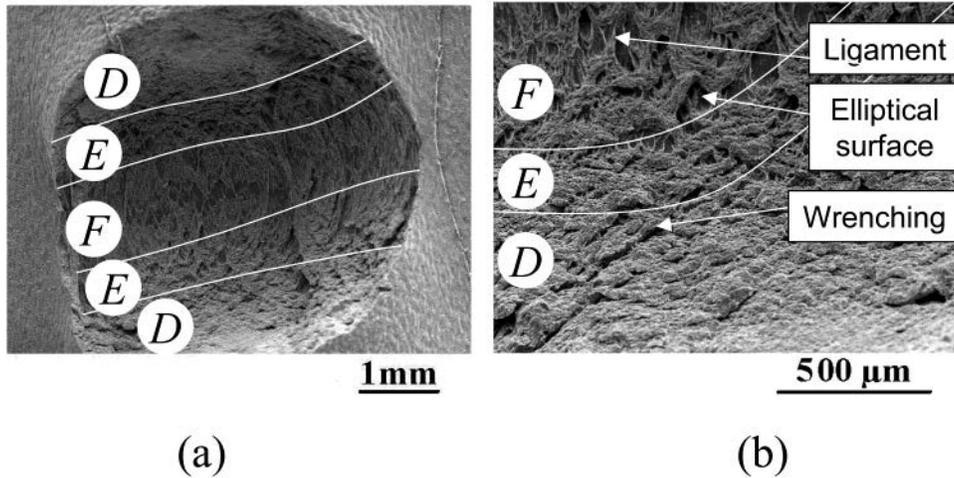
Figure 4. Details of areas D–F for two magnifications.

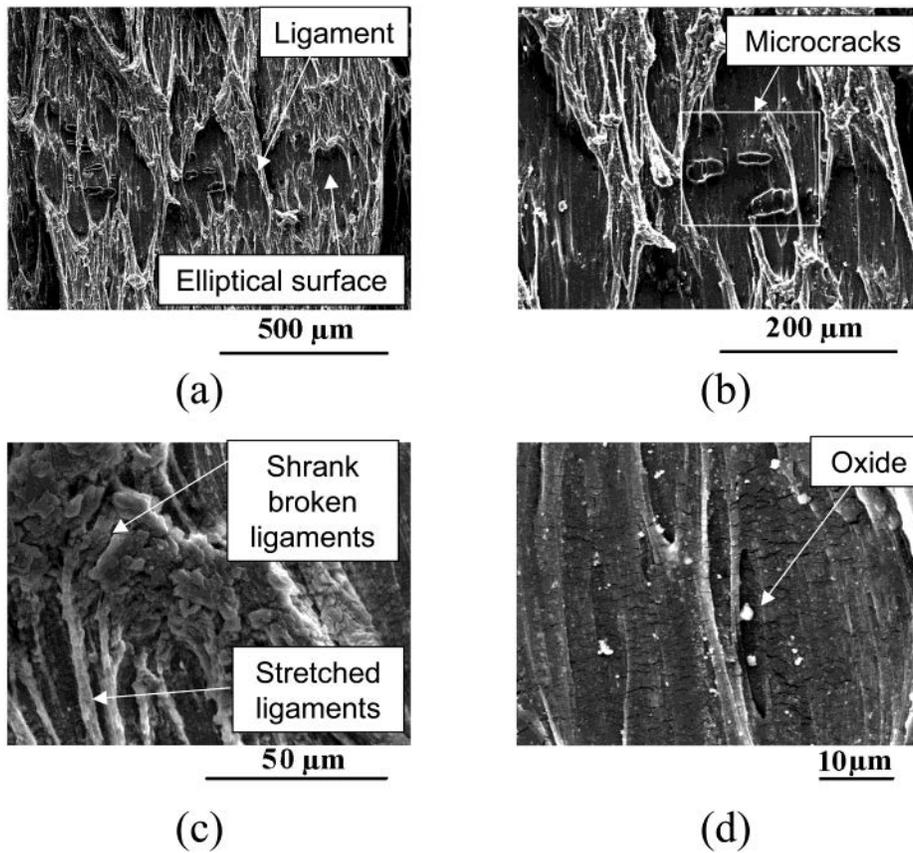
Figure 5. Details of the crack tip for four magnifications.

After this brief description of the crack, the crack tip F, in which our microcutting method will be applied, has to be more precisely examined. Figure 5 shows it for different magnifications. The crack tip is composed of a few hundred micrometers long ligaments which are highly stretched and surround smooth elliptical surfaces (see Figure 5a). Figure 5b–d presents the morphology

of these elliptical surfaces and their surroundings. First, microcracks take place in their middle part; their orientation is perpendicular to the stretch axis (see Figure 5b). The presence of these microcracks shows that the smooth areas are propitious to the propagation of the crack. This property will be used in the following to apply our microcutting method. Moreover, these smooth areas are delimited by ligaments whose extremities are located at their top and bottom. As an example, the photomicrograph in Figure 5c shows the top of any surface. It contains both stretched ligaments and a rough surface that corresponds with broken ligaments which shrank. Finally, using a larger magnification, Figure 5d shows that some zinc oxides are embedded in the relief of smooth elliptical areas. Oxides can be

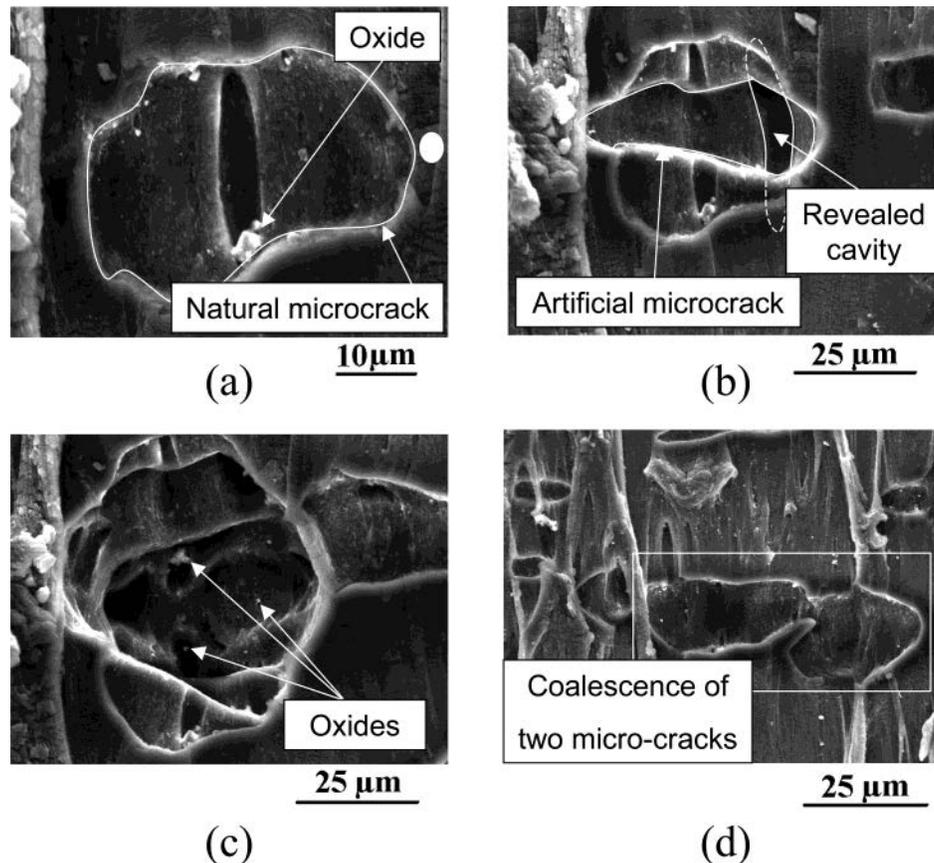
Figure 6. Chronology of the microcut experiment.

5b). Figure 6 presents the chronology of the real-time observation. The observation zone is shown in Figure 6a. It contains a natural microcrack near a ligament. In the middle of this microcrack, a stretched cavity containing an oxide takes place. Then, the electron beam is focused a few seconds beside the microcrack (see the white circle in Figure 6a). It leads to an artificial microcrack which initiates at the beam concentration point, slowly propagates to the other side of the natural microcrack, and stops at the ligament, as shown in Figure 6b. During its propagation, this artificial microcrack revealed a cavity similar to the one observed in the natural microcrack. By continuing to focus the electron beam, new microcracks are propagating in the sample depth and are revealing cavities. Most of these cavities contain oxides (see Figure 6c). Moreover, note that this microcutting can also be used to induce the coalescence of existing microcracks by concentrating the electron beam between them (see Figure 6d). Finally, it should be mentioned that, as the electron beam is focused on ligaments (the SEM power settings being unchanged), they do not break even if they are exposed for a long time. It seems to indicate that the microstructures of ligaments and elliptical areas between them are different. More precisely, this difference might be mainly due to the distribution of the crystallization ratio: the highly stretched ligaments represent the most crystallized zones of the crack tip. These results obtained under fatigue loading conditions are quiet similar to those recently established under static conditions by Trabelsi et al.,¹⁶ who demonstrate that a crystallized zone appears at crack tip of initial cut lengths 0.5 and 1 mm for stretch ratios greater than $\lambda = 1.3$.

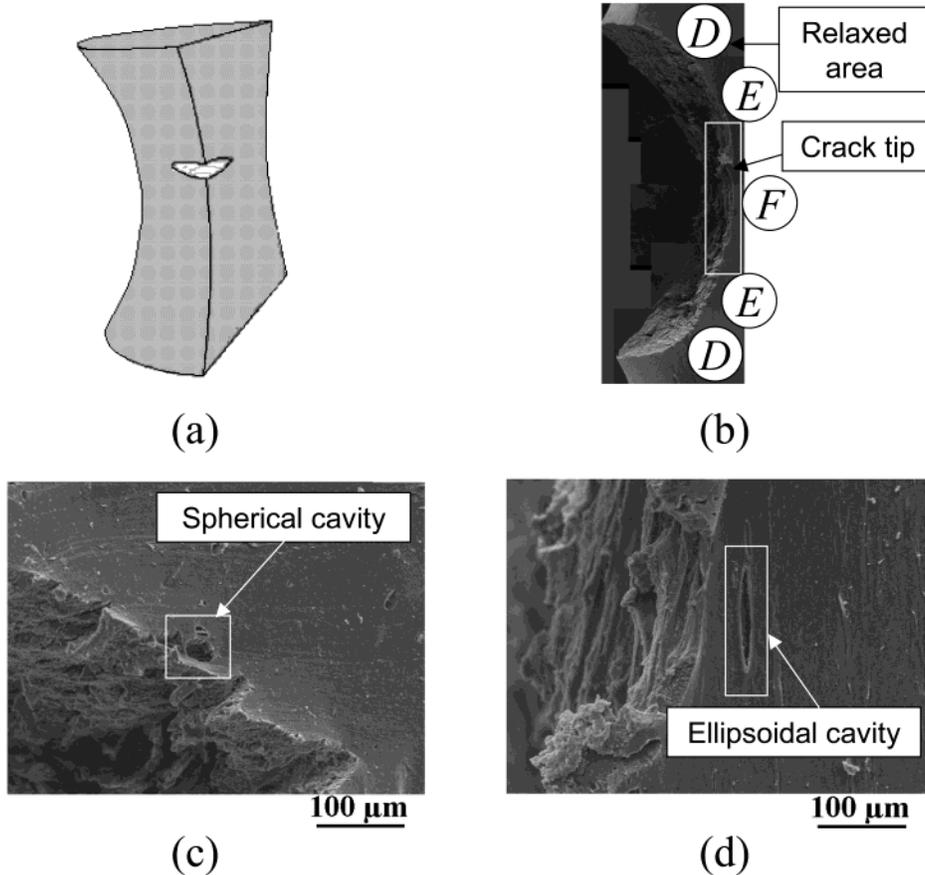
Figure 7. Second experiment: (a) cut sample, (b) global view of the crack, (c) details of relaxed areas, (d) details of the crack tip.

Figure 7 summarizes this second experiment. To observe cavities in the sample, it is cut in its undeformed configuration, as shown in Figure 7a. Afterward, it is stretched using the tensile apparatus presented above and introduced in the SEM. Figure 7b shows the opened crack tip and its surroundings. One can again distinguished relaxed zones with numerous wrenchings at the top and the bottom of the crack, and the most stretched area, i.e., the crack tip, in the middle. Large cavities are observed in both areas near the crack faces, and their shapes highly differ: they are spherical in the relaxed zones (see Figure 7c) and ellipsoidal (due to the stretching level) behind the crack tip (see Figure 7d).

Moreover, it is important to notice that the size of the large spherical cavity in Figure 7c (as compared with the size of an oxide) demonstrates that this cavity grew under cyclic loading. Examining the cut surface of the sample, a large number of cavities are revealed; most of them contain oxide, and their size rapidly decreases with their distance from the crack. From a sufficiently long distance, no more cavities are observed.

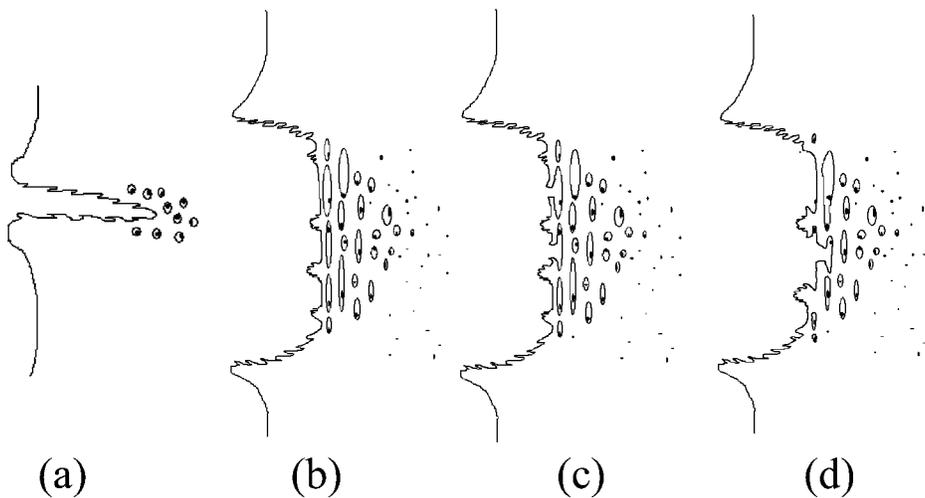
Figure 8. Crack growth mechanism: side view.

3.3. Crack Growth Mechanism. Using the previous observations, the scenario of fatigue crack growth is proposed in this section. It will be described thanks to two chronological sketches which correspond to two views of the phenomenon. Figures 8 and 9 present respectively the side and front views of crack growth. These two views will be used to accurately describe the three-dimensional nature of the phenomenon. It is to note that the chronology of the two figures are different; i.e., the stage of Figure 8a does not correspond to the one of Figure 9a.

The crack growth phenomenon can be seen as the succession of elementary sequences from initiation to final failure. Before examining this elementary sequence, let us recall that both fatigue loading and the stress state in the neighborhood of the crack tip generate cavitation due to the decohesion between oxides and rubber matrix as shown in Figure 8a. The elementary sequence is composed of three steps:

(i) As the crack tip is stretched, elliptical areas take place with ligaments on both sides and wrenchings at the top and bottom. Cavities are situated behind these areas, and their shape is ellipsoidal (see Figure 9a). As shown in Figure 8b, the wall that separates the crack tip and cavities is thin, such that it can be considered as a membrane.

(ii) This membrane tears and reveals most of the cavities situated behind it (see Figure 8c). The corresponding microcracks propagate perpendicularly to the crack growth direction (see Figure 9b).

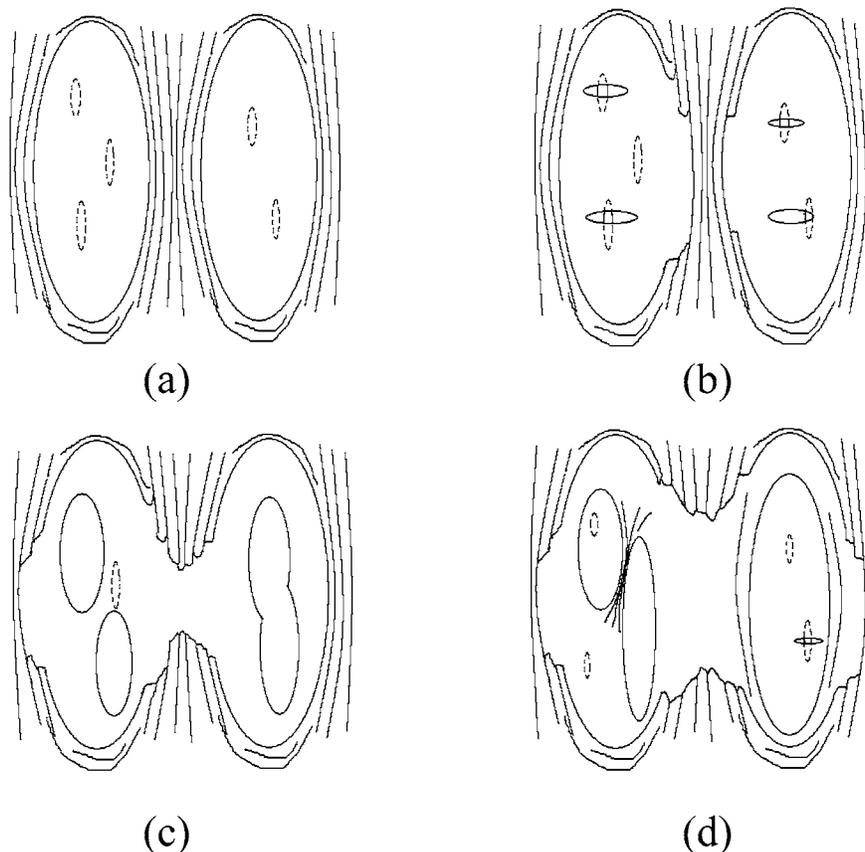
Figure 9. Crack growth mechanism: front view. Hidden parts are represented by dotted lines.

(iii) Then, microcracks grow and eventually coalesce until the destruction of the elliptical areas. Moreover, ligaments break and relax to form the wrenchings which lie at the top and bottom of these elliptical zones (see Figure 9c). This fracture may be due to the fatigue of ligaments or/and to the new stress state in ligaments generated by their neighborhood. Schematically, the crack tip breaks, the crack grows, and the processus restarts at (i) (see Figure 8d). It should be noted that the coalescence of microcracks can be limited with the result that the elliptical zones are not completely destroyed and that ligaments occur between microcracks, the consequence being the formation of several new elliptical areas (see Figure 9d).
