Step-by-step investigation of degradation mechanisms induced by CMAS attack on YSZ materials for TBC applications

Guillaume Pujol, Florence Ansart, Jean-Pierre Bonino, André Malié, Sarah Hamadi. Step-by-step investigation of degradation mechanisms induced by CMAS attack on YSZ materials for TBC applications. Surface and Coatings Technology, 2013, vol. 237, pp. 71-78. 10.1016/j.surfcoat.2013.08.055. hal-01169841

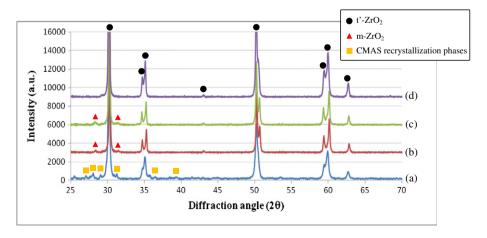
For tests performed at 1100 °C, we can notice the presence of diffraction peaks corresponding to the CMAS recrystallization. On the other hand, for tests performed at 1250 °C or 1350 °C, no additional diffraction peaks other than those of zirconia are present. However, the interaction between YSZ aerogel powder and CMAS exhibits a tendency to peak transformation corresponding to a possible crystalline modification. Rietveld refinement was performed on the sample exposed to CMAS for 2 h at 1350 °C. Result of this refinement is presented in Fig. 7.

Fig. 6. X-ray diffraction patterns at room temperature of YSZ aerogel powder after 2 h of exposure to CMAS for different temperatures: (a) 1100 °C, (b) 1250 °C, (c) 1350 °C and (d) YSZ aerogel powder heat-treated at 1350 °C for 2 h without CMAS powder.

An intimate mixing was made between YSZ aerogel powder and CMAS in a 1:1 weight ratio. This mixture was then heat-treated in a Pt crucible at temperatures ranging from 1100 °C to 1350 °C for 15 min to 2 h. The XRD patterns performed on the YSZ powder exposed to the model CMAS powder for 2 h at some selected temperatures in the same range are presented in Fig. 6.

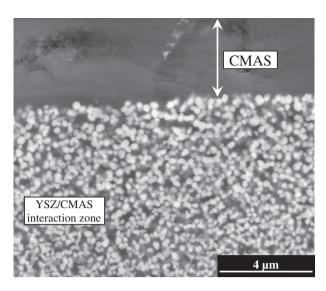
The first, at the extreme surface (referred 1) which is in direct contact with CMAS deposit, consists of nanometric spherical and monodisperse zirconia particles as shown in Fig. 10. The thickness of this mixed zone is around 20 μ m. This can be correlated to the dissolution/re-precipitation process which takes place when YSZ is put in interaction with molten CMAS.

Fig. 10. Polished cross-section showing zone 1 of the YSZ sol–gel pellet exposed to CMAS at 1250 $^{\circ}$ C for 15 min.

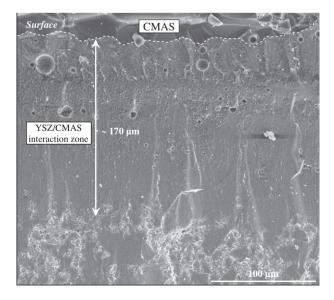
increase of the interaction zone and a faster kinetics of infiltration but the mechanisms seem to be similar. The thickness extends up to $\sim 160~\mu m$ under pellet surface. However, this sample exhibits the same morphology than the previous one.

Fig. 11. SEM micrograph of the fracture surface of YSZ sol–gel pellet exposed to CMAS at 1350 $^{\circ}\text{C}$ for 15 min.

The fracture surface of the sample exposed to CMAS for 15 min at 1350 °C is shown in Fig. 11. Higher test temperature reveals a great

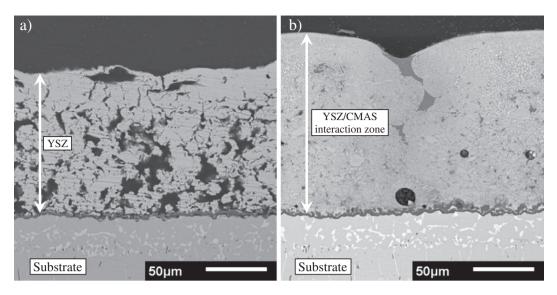
Fig. 12. SEM cross-section of YSZ sol-gel coating after 1 h at 1250 °C a) without CMAS and b) after CMAS exposure.

The entire coating seems to be fully densified after CMAS infiltration with a significant decrease of the coating porosity. Elemental mapping of the main chemical elements (Fig. 13) shows that CMAS infiltrated the whole coating thickness down to the TBC/TGO interface.

SEM cross-section of the unaffected sol–gel coating and after CMAS exposure is shown in Fig. 12 (a and b respectively).

Nevertheless, it is important to underline the significant difference between EBPVD and sol–gel coatings after interaction with CMAS. Indeed, the non-oriented porosity of sol–gel TBC leads to a uniform and homogeneous infiltration. The coating exhibits an important loss of porosity and acts as a dense layer (Fig. 12). By contrast, the columnar

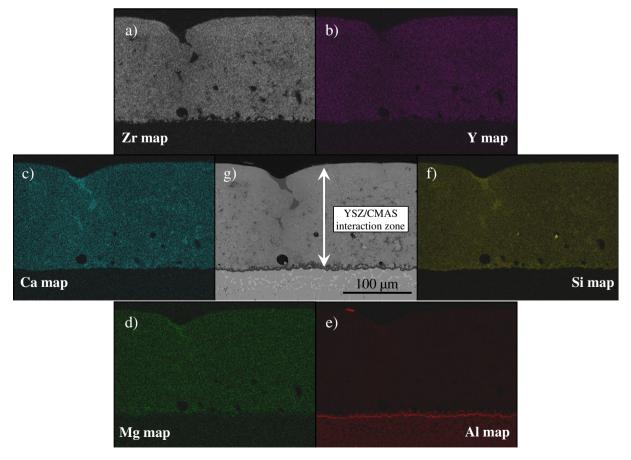
Fig. 13. Elemental maps of a) Zr, b) Y, c) Ca, d) Mg, e) Al, f) Si and g) SEM cross-section of the sol-gel coating after interaction with CMAS at 1250 °C for 1 h.

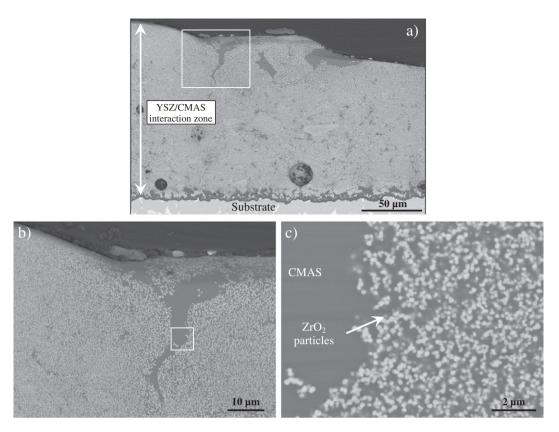
SEM micrographs at higher magnification (Fig. 14) revealed significant microstructural modification. The entire coating thickness is made of spherical particles of zirconia embedded in CMAS glass

and reflects that the dissolution/reprecipitation process occurred during the interaction.

Fig. 14. SEM cross-section of YSZ coating exposed to CMAS at 1250 °C for 1 h (a) and higher magnifications of the CMAS/YSZ interaction zone (b and c).

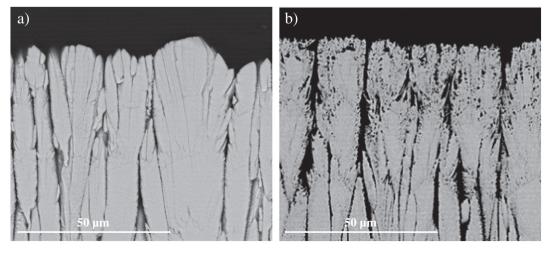
The column tips showed an important microstructural degradation on the first 50 µm compared to the unaffected zone. The elemental

Fig. 15. SEM cross-section of YSZ EBPVD coating after 1 h at 1250 °C a) without CMAS and b) under CMAS exposure.

The same experiment and characterization were carried out on EBPVD TBC. SEM cross-section of the unaffected EBPVD coating and after CMAS exposure is shown in Fig. 15 (a and b respectively).

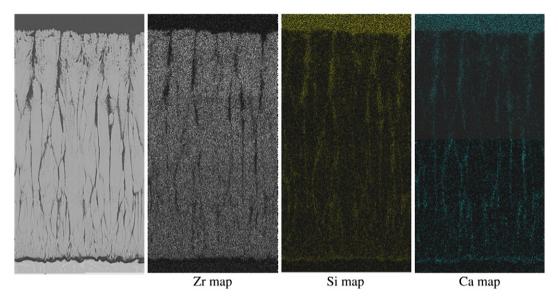
analysis shows that CMAS reached, as previously indicated for sol–gel coating, to the bottom of the ceramic coating along the inter-columnar gaps (Fig. 16).

Fig. 16. Cross-sectional SEM micrograph of EBPVD TBC after CMAS exposure for 1 h at 1250 °C and corresponding elemental map.
