Step-by-step investigation of degradation mechanisms induced by CMAS attack on YSZ materials for TBC applications

Guillaume Pujol ^{a,*}, Florence Ansart ^a, Jean-Pierre Bonino ^a, André Malié ^b, Sarah Hamadi ^c

Over the past decades, Thermal Barrier Coatings (TBCs) have become essential parts in gas turbine engines. In working conditions, TBCs are subject to many kinds of degradation (erosion, foreign object damage (F.O.D), oxidation, etc.) which deteriorate integrity and mechanical properties of the whole system. Moreover, with the aim to increase the turbine inlet temperature, a new type of damage has been highlighted: corrosion by molten Calcium–Magnesium–Alumino Silicates, better known as CMAS. In this paper, interactions between yttria-stabilized zirconia (YSZ) materials synthesized via sol–gel process and synthetic CMAS powder were investigated via a step-by-step methodology. The approach was conducted starting from the more severe conditions of interactions and then gradually gets closer to the interactions taking place in service. It was proved that CMAS can induce faster densification of the ceramic leading to a loss of strain tolerance of the protective coating. Besid

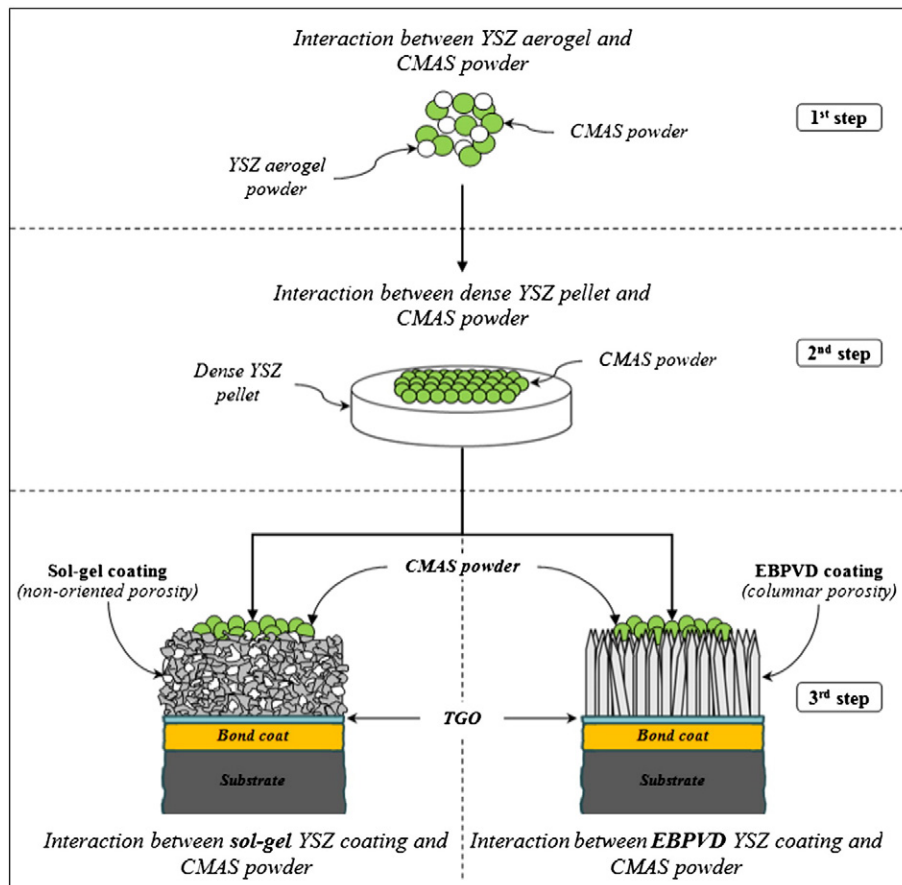
Because of the complex mechanisms involved in the interaction between CMAS and YSZ, we decided to split our investigation in three different steps starting from the more severe conditions of interactions and then gradually get closer to the interactions taking place in service. A flowchart of the methodology is presented in Fig. 1.

As shown in Fig. 1, our approach consisted in the first part to put YSZ fine powders in close contact with CMAS. This first step was set up in order to highlight if new crystalline phases can be formed after interaction. The high specific surface area of the YSZ aerogel powder increases its reactivity allowing a strong interaction with silicates. These conditions of mixture are the more severe to quantify the interactions and reactivity between CMAS and yttria-stabilized zirconia. Then, prior to studying the interaction taking place between CMAS and YSZ coatings (3rd step), an intermediate step was performed. In this case, dense YSZ pellets were exposed to the CMAS powder (2nd step) so as to evaluate the infiltration of contaminants within a dense ceramic and the microstructural changes induced by CMAS. This intermediate step allows us to understand the mechanisms and determine the interaction at the interface while avoiding capillary effects which can occur with porous TBCs. Finally, the degradation of YSZ EBPVD TBC and YSZ sol-gel coating was compared (3rd step).

According to the procedure described in Fig. 1, YSZ sol-gel powder, dense pellet and coatings were exposed to CMAS. In all the following tests, YSZ was placed under isothermal exposure to the model CMAS powder in a pre-heated furnace at the temperature of the test.

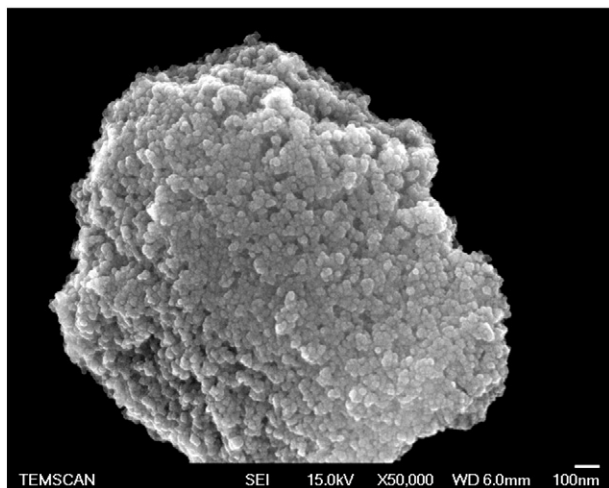
As we can see, the aerogel powder exhibits a porous microstructure made of agglomerates of nanometric particles. The specific surface area of this mesoporous zirconia determined by BET method is close to $88 \text{ m}^2/\text{g}$. This high state of division of the solid material brings a high reactivity to this powder which is a key parameter and the feature used in the first step of the present investigation. For the further steps of this study, dense pellets and coatings were made from this aerogel powder.

Fig. 2. SEM-FEG micrograph of YSZ aerogel powder after 2 h heat-treatment at $700 \text{ }^\circ\text{C}$.

used as a complexing agent and was firstly mixed with the solvent. Then, water is added to the mixture to initiate hydrolysis and condensation reactions. Volume ratios between AcAc and $Zr(OPr)_4$ and between H_2O and $Zr(OPr)_4$ are 0.8 and 9.5 respectively while zirconium concentration is kept constant at $0.5 \text{ mol} \cdot L^{-1}$. The YSZ sol is stirred for 30 min, then dried in an oven at $50 \text{ }^\circ\text{C}$ until YSZ gel was obtained. After the drying of the gel in supercritical conditions of 1-propanol, the aerogel was calcinated at $700 \text{ }^\circ\text{C}$ for 2 h. The morphology of this aerogel powder is shown in Fig. 2.

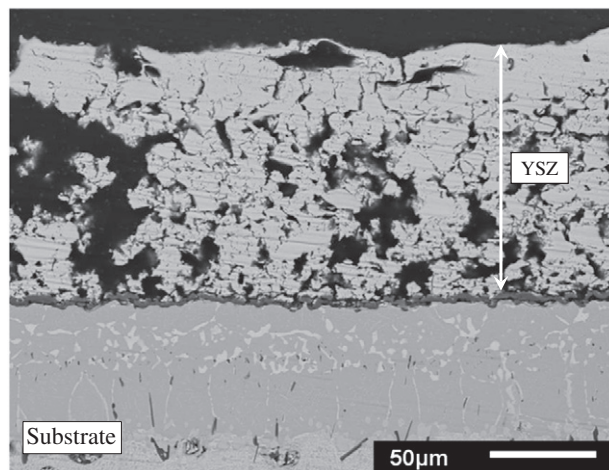
Fig. 3. SEM cross-section of YSZ sol-gel coating.

Finally, the third kind of materials, used in this study, is the YSZ coatings. These coatings were deposited onto Ni-based superalloy substrates (Hastelloy X or AM1) covered with a NiAl or NiPtAl bond-coat. Samples were firstly sandblasted with corundum 220 meshes followed by degreasing with acetone and ultrasonic cleaning in 1-propanol. YSZ top-coats were shaped by dip-coating technique. In order to realize thick coatings, the aerogel powder was firstly dispersed in the previous YSZ sol ($9.7 \text{ mol}\% \text{ YO}_{1.5}$) at a ratio of 40%wt in order to prepare the active precursor (sol loaded with powder). Then, superalloys were dipped into this composite sol and withdrawn at a controlled speed ($250 \text{ mm}/\text{min}$). Several immersion/withdrawal cycles were performed until the expected thickness was reached. Finally, samples were heat-treated for 2 h at $1100 \text{ }^\circ\text{C}$ with appropriate heating and cooling rates. This coating process leads to porous and adherent YSZ ceramic layer as shown in Fig. 3.

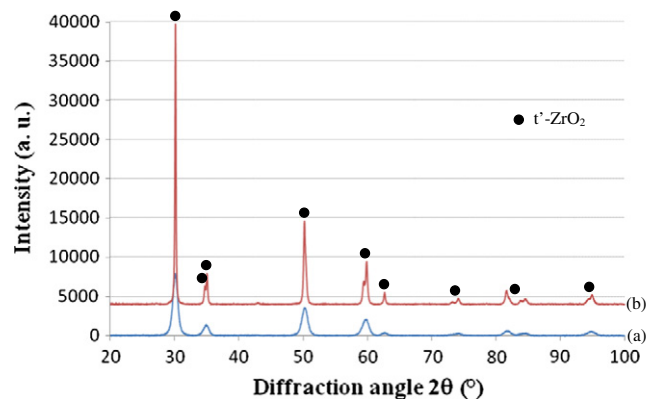
The XRD pattern of the sample heat-treated at $1100 \text{ }^\circ\text{C}$ exhibits the characteristic peaks of the well-crystallized tetragonal zirconia without any other crystalline phase.

Fig. 4. X-ray diffraction patterns of YSZ aerogel powder after 2 h at (a) $700 \text{ }^\circ\text{C}$ and (b) $1100 \text{ }^\circ\text{C}$.

Then, the aerogel powder, pellets and coatings were heat-treated at $1100 \text{ }^\circ\text{C}$ for 2 h before CMAS exposure in order to obtain the convenient crystallized tetragonal phase of zirconia [10,11]. XRD patterns of the YSZ powder after calcinations at $700 \text{ }^\circ\text{C}$ and $1100 \text{ }^\circ\text{C}$ are presented in Fig. 4.

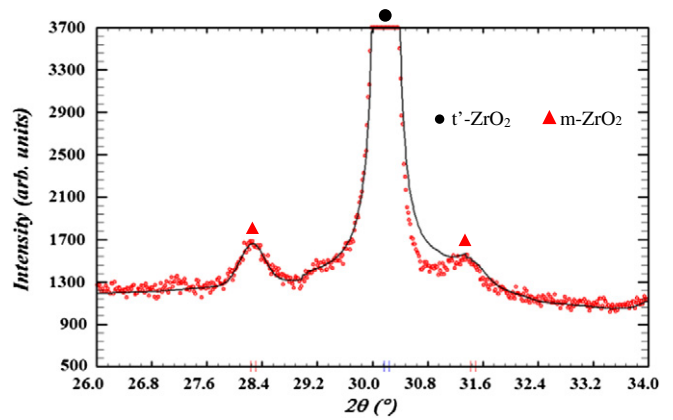
The presence of the diffraction peaks corresponding to the initial tetragonal YSZ as well as the monoclinic structure suggests that the tetragonal to monoclinic transformation has occurred during the interaction between YSZ aerogel powder and CMAS. It is now proved that CMAS induced a crystalline phase transformation of zirconia via a dissolution/re-precipitation mechanism [4,19,20]. YSZ particles in direct contact with silicates were dissolved into the molten CMAS. Once the solubility limit of zirconia is reached, yttria-depleted ZrO₂

Fig. 7. Rietveld refinement of YSZ aerogel powder exposed to CMAS after 2 h at 1350 °C. Focus on the 26° - 34° angular domain showing monoclinic zirconia diffraction peaks.

grains are able to re-precipitate. This depletion in yttria induces the destabilization of the tetragonal phase which leads to monoclinic transformation upon cooling. The volume expansion caused by the tetragonal to monoclinic transformation generates high stresses and then can induce cracks in YSZ coatings [21] leading to the failure of TBCs systems.

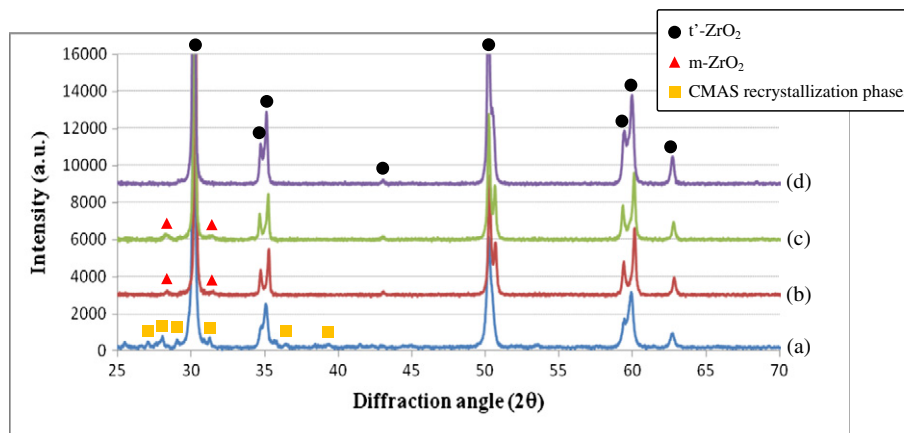
For tests performed at 1100 °C, we can notice the presence of diffraction peaks corresponding to the CMAS recrystallization. On the other hand, for tests performed at 1250 °C or 1350 °C, no additional diffraction peaks other than those of zirconia are present. However, the interaction between YSZ aerogel powder and CMAS exhibits a tendency to peak transformation corresponding to a possible crystalline modification. Rietveld refinement was performed on the sample exposed to CMAS for 2 h at 1350 °C. Result of this refinement is presented in Fig. 7.

Fig. 6. X-ray diffraction patterns at room temperature of YSZ aerogel powder after 2 h of exposure to CMAS for different temperatures: (a) 1100 °C, (b) 1250 °C, (c) 1350 °C and (d) YSZ aerogel powder heat-treated at 1350 °C for 2 h without CMAS powder.

An intimate mixing was made between YSZ aerogel powder and CMAS in a 1:1 weight ratio. This mixture was then heat-treated in a Pt crucible at temperatures ranging from 1100 °C to 1350 °C for 15 min to 2 h. The XRD patterns performed on the YSZ powder exposed to the model CMAS powder for 2 h at some selected temperatures in the same range are presented in Fig. 6.

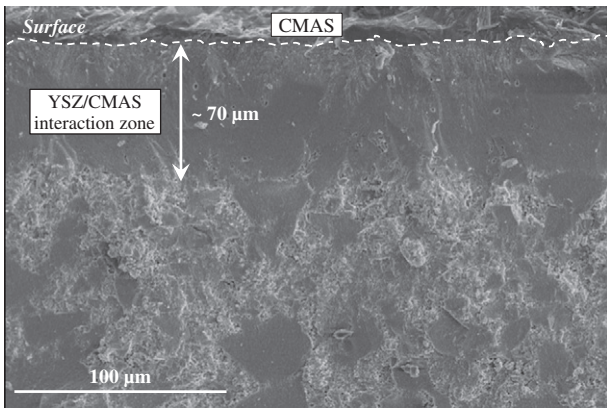
All the samples exhibit very similar microstructures after high temperatures exposure to CMAS powder. The fracture surface of the YSZ pellets exposed to CMAS for 15 min at 1250 °C is shown in Fig. 8. A lot of morphological changes occur in the YSZ pellet after CMAS interaction.

Fig. 8. SEM micrograph of the fracture surface of YSZ sol-gel pellet exposed to CMAS at 1250 °C for 15 min.

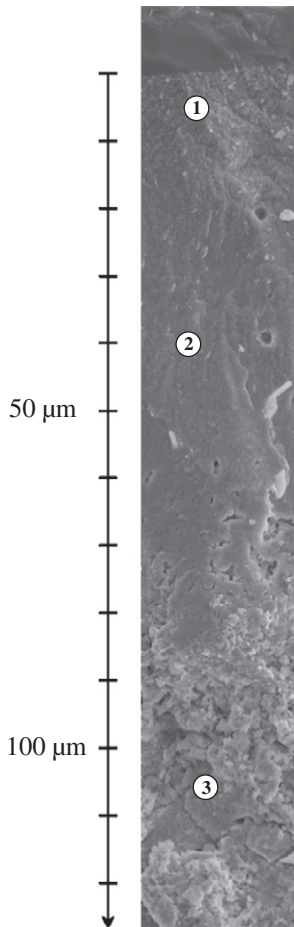
The micrograph at higher magnification (Fig. 9) reveals that the fracture surface can be divided into three distinct zones.

The second zone (quoted 2) shows a significant decrease of porosity and microcavities are observed locally. This indicates that CMAS interaction can induce faster densification of the YSZ material and thus lead to a change in mechanical properties sufficient to cause degradations, such as cracks, in YSZ coatings [7]. The third zone exhibits the typical microstructure of the aerogel powder used to realize the pellet, meaning that in this zone, powder has not been altered.

Fig. 9. SEM micrographs of the fracture surface of YSZ sol-gel pellet exposed to CMAS at 1250 °C for 15 min.

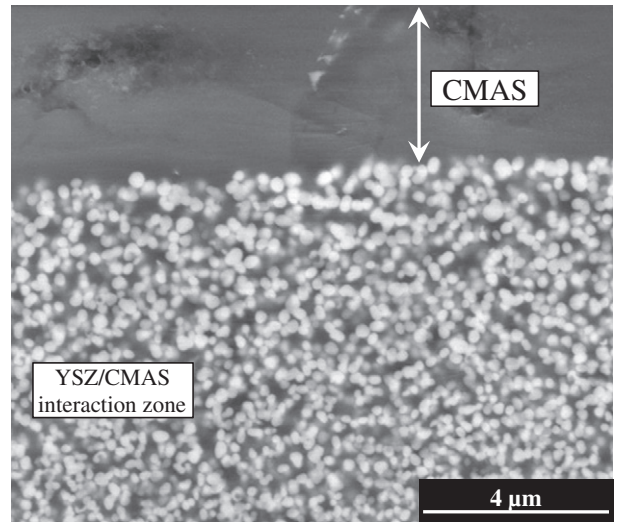
The first, at the extreme surface (referred 1) which is in direct contact with CMAS deposit, consists of nanometric spherical and monodisperse zirconia particles as shown in Fig. 10. The thickness of this mixed zone is around 20 μm. This can be correlated to the dissolution/re-precipitation process which takes place when YSZ is put in interaction with molten CMAS.

Fig. 10. Polished cross-section showing zone 1 of the YSZ sol-gel pellet exposed to CMAS at 1250 °C for 15 min.

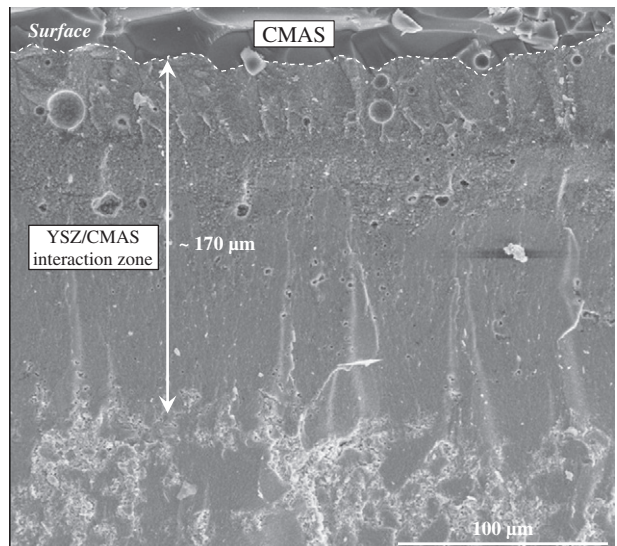
The fracture surface of the sample exposed to CMAS for 15 min at 1350 °C is shown in Fig. 11. Higher test temperature reveals a great

increase of the interaction zone and a faster kinetics of infiltration but the mechanisms seem to be similar. The thickness extends up to ~160 μm under pellet surface. However, this sample exhibits the same morphology than the previous one.

Fig. 11. SEM micrograph of the fracture surface of YSZ sol-gel pellet exposed to CMAS at 1350 °C for 15 min.

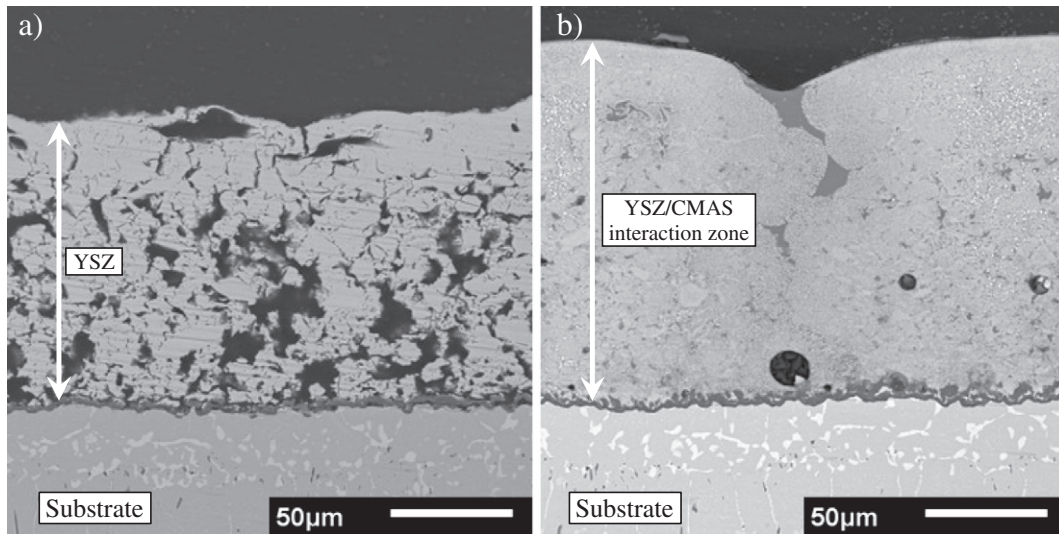
SEM cross-section of the unaffected sol-gel coating and after CMAS exposure is shown in Fig. 12 (a and b respectively).

Fig. 12. SEM cross-section of YSZ sol-gel coating after 1 h at 1250 °C a) without CMAS and b) after CMAS exposure.

The entire coating seems to be fully densified after CMAS infiltration with a significant decrease of the coating porosity. Elemental mapping of the main chemical elements (Fig. 13) shows that CMAS infiltrated the whole coating thickness down to the TBC/TGO interface.

Nevertheless, it is important to underline the significant difference between EBPVD and sol-gel coatings after interaction with CMAS. Indeed, the non-oriented porosity of sol-gel TBC leads to a uniform and homogeneous infiltration. The coating exhibits an important loss of porosity and acts as a dense layer (Fig. 12). By contrast, the columnar

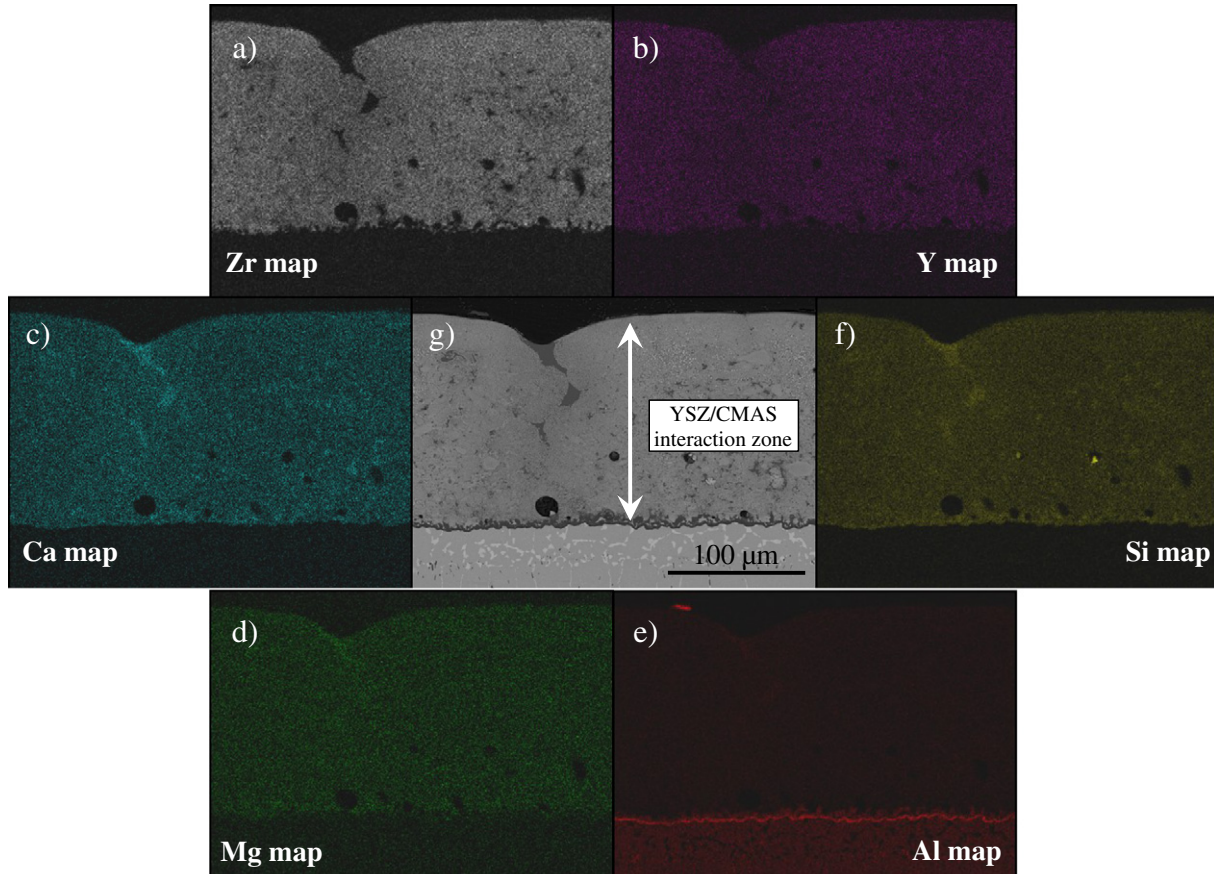
Fig. 13. Elemental maps of a) Zr, b) Y, c) Ca, d) Mg, e) Al, f) Si and g) SEM cross-section of the sol-gel coating after interaction with CMAS at 1250 °C for 1 h.

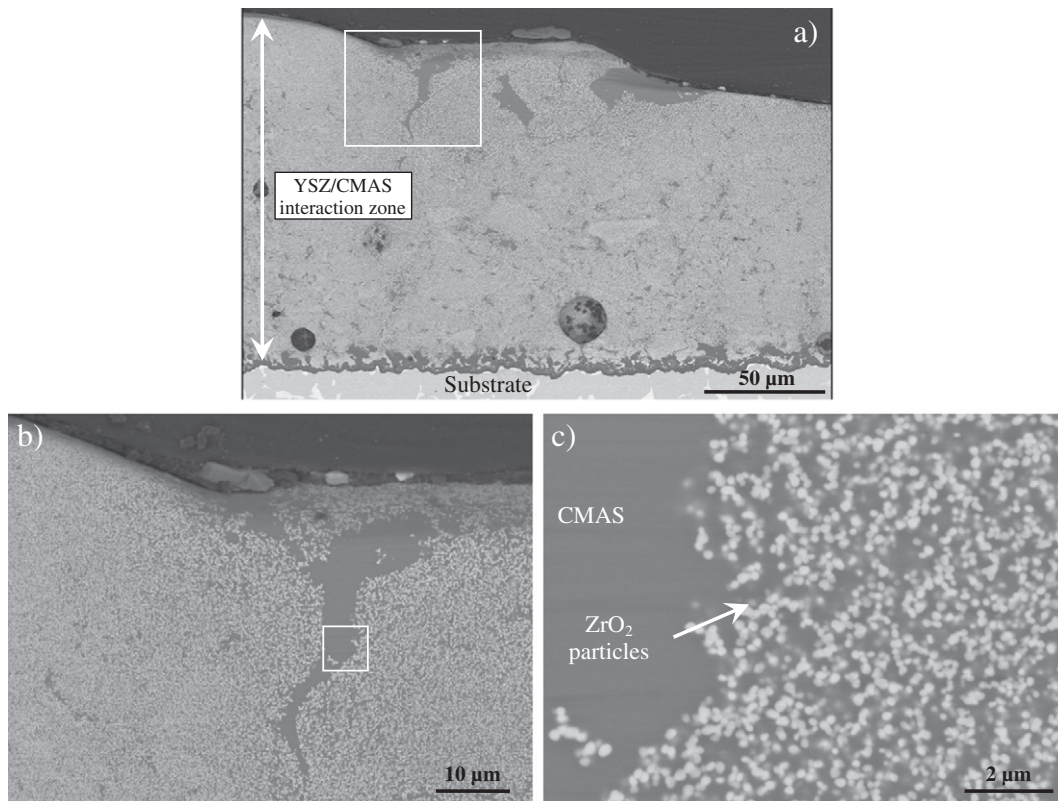
SEM micrographs at higher magnification (Fig. 14) revealed significant microstructural modification. The entire coating thickness is made of spherical particles of zirconia embedded in CMAS glass

and reflects that the dissolution/reprecipitation process occurred during the interaction.

Fig. 14. SEM cross-section of YSZ coating exposed to CMAS at 1250 °C for 1 h (a) and higher magnifications of the CMAS/YSZ interaction zone (b and c).

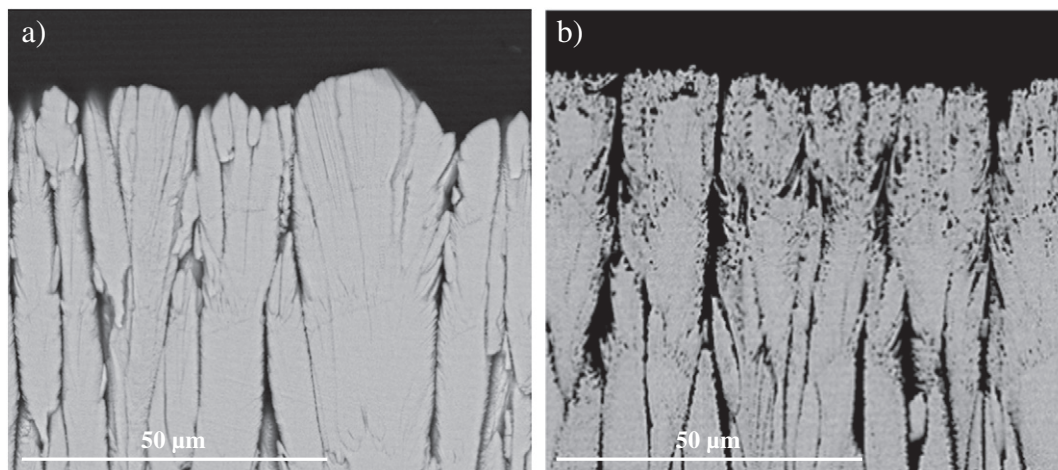
The same experiment and characterization were carried out on EBPVD TBC. SEM cross-section of the unaffected EBPVD coating and after CMAS exposure is shown in Fig. 15 (a and b respectively).

The column tips showed an important microstructural degradation on the first 50 μm compared to the unaffected zone. The elemental

Fig. 15. SEM cross-section of YSZ EBPVD coating after 1 h at 1250 °C a) without CMAS and b) under CMAS exposure.

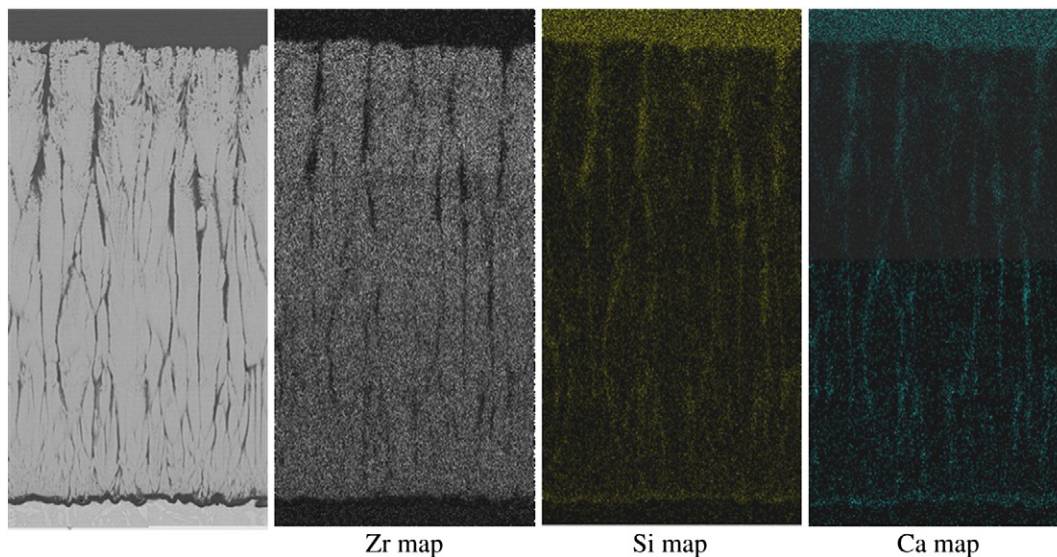
analysis shows that CMAS reached, as previously indicated for sol-gel coating, to the bottom of the ceramic coating along the inter-columnar gaps (Fig. 16).

Fig. 16. Cross-sectional SEM micrograph of EBPVD TBC after CMAS exposure for 1 h at 1250 °C and corresponding elemental map.

microstructure of EBPVD TBCs leads to preferential infiltration path along the columns.
