Behavior of pre-cracked deep beams with composite materials repairs

M Boumaaza, A. Bezazi, H Bouchelaghem, N Benzennache, Sofiane Amziane,
F. Scarpa

M Boumaaza, A. Bezazi, H Bouchelaghem, N Benzennache, Sofiane Amziane, et al.. Behavior of pre-cracked deep beams with composite materials repairs. *Structural Engineering and Mechanics*, 2017, 63 (5), pp.575-583. 10.12989/sem.2017.63.5.575 . hal-01631559

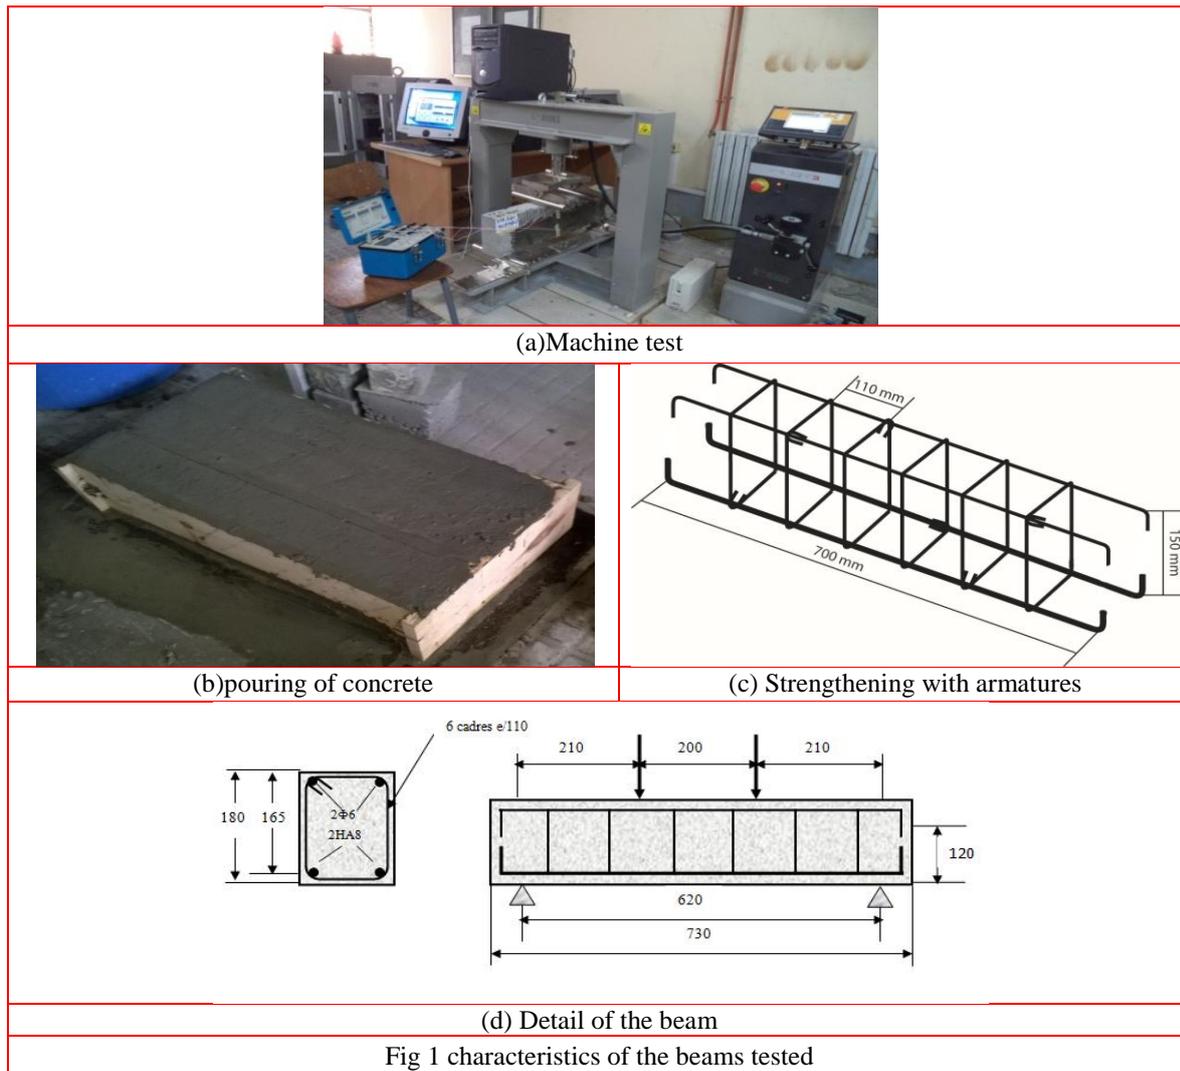
Fig 1 characteristics of the beams tested

The experimental tests have been carried out on deep beams whose ratio between the distance of between the application of the point loads and the support at the height of the beam is small (only 1.3) so that shear failure is predominantly. These investigations are useful to identify the contribution of the GFRP in terms of strength gain and failure modes. The tests were conducted in accordance with the ASTM C78-00 (2004) using a four-point bending device with a capacity of 150 kN (Fig. 1 (a)).

The manufacturing of the beams was performed at the Laboratory of Civil Engineering and Hydraulics (LGCH) of Guelma University. In order to characterize the compressive strength In order to characterize the concrete, six cylindrical and cubic specimens having dimensions of 160x320 and 150x150 mm² respectively were also produced. After 24 hours the specimens are removed from the mould and stored in tanks of water at ambient temperature up to 28 days. The beams have 730 mm long and width and height of 100 mm and 180 mm respectively, they are reinforced by two HA8 bars in the tensioned zone and by two HA6 bars in the compressed one. For vertical steel (steel frames), 6 mm of diameter rods in mild steel and spaced by 110 mm have been used (Fig.1 (b)-(d)).

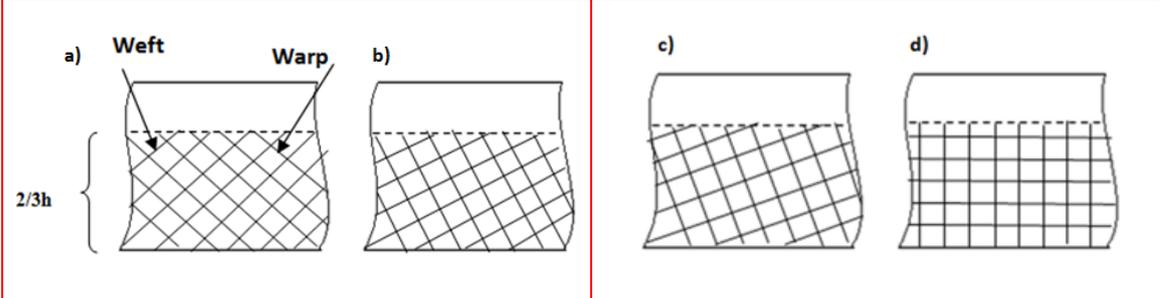
Fig. 2 Reinforcement with U shape patch following orientations a) +45/-45 b) 30/60 c)20/70 d) 0/90.

To better understand the behaviour of the reinforced concrete beams preloaded and repaired by glass bidirectional fiber fabrics (GFRP), a testing program was established by using two specific rehabilitation methods. The activities related to the first series of tests have focused on strengthening or repairing by using a continuous configuration of the reinforcement consisting in GFRP with a U-shaped recovery system following orientations (0/90, 20/70, 30/60 et +45/-45) (Fig. 2).

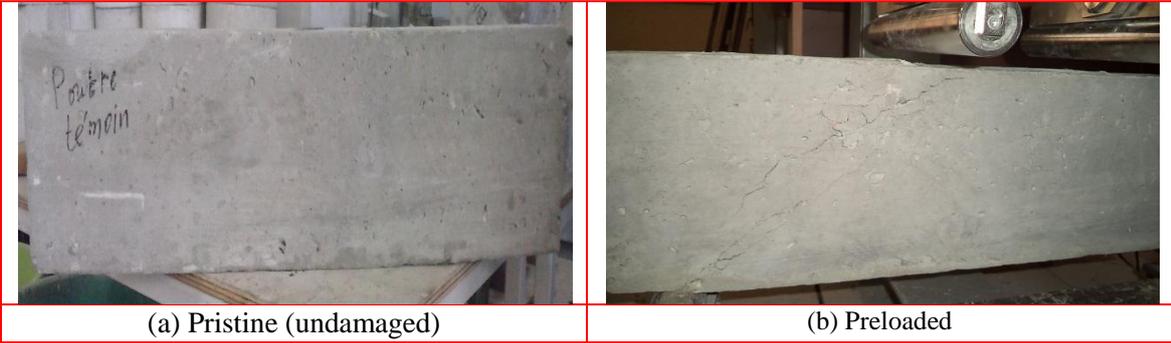
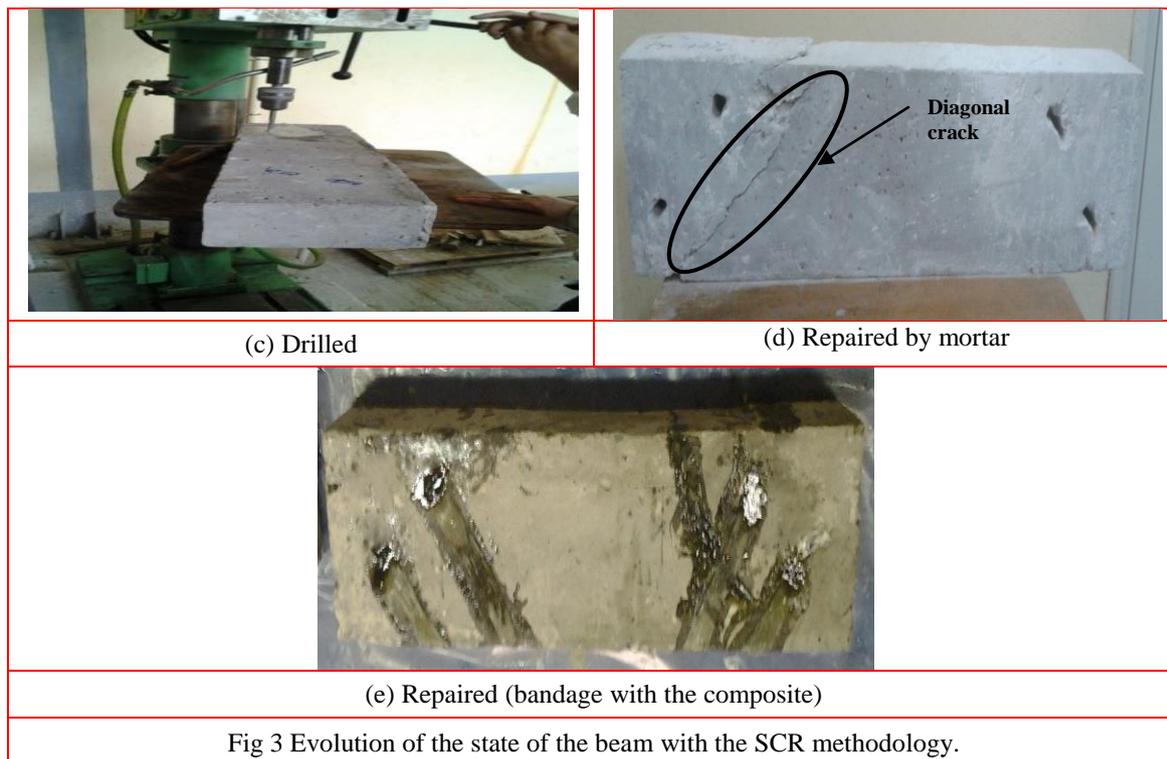
The second series of tests consists in placing reinforcements made from composite materials according to the new proposed procedure. The composite patches are placed as to intersect the cracks produced by the shear force in order to improve the brittle failure mode of the reinforced concrete. In this way the glass fibers of the composite are loaded along their longitudinal direction (tensile) and therefore maximizing the strength of the system. This method uses a composite constituted by strands of unidirectional glass fibers impregnated in polyester resin and applied as a wrapping system on the beam by bonding.

After drilling the holes the damaged beams have been repaired using mortar concrete. This repair was performed in order to improve the aesthetics and the surface finish before the bonding of the composites (see Fig. 3 (d) and (e)). The various reinforcements were arranged to intercept the diagonal cracks as accurately as possible. To facilitate the setting of the unidirectional fabric with the resin in the holes, the fibers are interlaced and centered in each hole. It is necessary that the holes are very clean before the resin filling. As the load is symmetric, it is important to note that the non-cracked parts of the beam are also repaired in the same manner to avoid the appearance of new diagonal cracks.

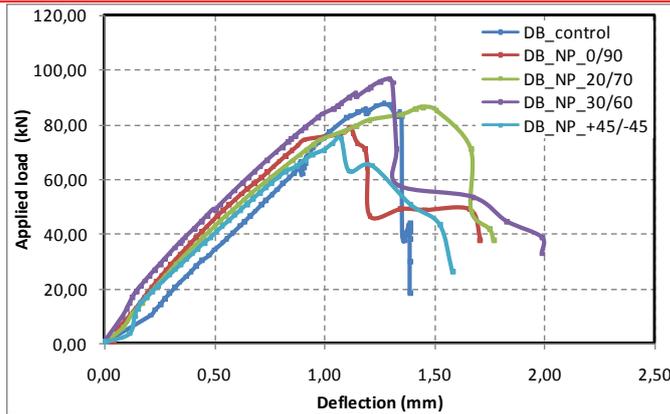
Fig. 4 Force-deflection curves of non preloaded beams obtained for the orientations (0/90,20/70,30/60 and +45/-45)

The results obtained show that the stiffness of the beams is increased by the bonding of the composite patch. The best performance is obtained for the beam reinforced with the stacking of (+30/-60) (see Fig. 4). The ultimate strength of the control beam is 87.6kN with a deflection equal to 1.27 mm. Based on the orientation of the reinforcement, the ultimate load of the beam (DB_NP_30 / 60) is increased by 10.5% compared to the reference beam (DB_control). This gain at the ultimate load is accompanied by a reduction in ductility, resulting in a decrease of the deflection by approximately 12.4% compared to the beam (DB_NP_20 / 70). This value is in good agreement with the results obtained by Bouchelaghem *et al.* (2011 a, b) for cylindrical specimens. The beams have diagonal cracks having an average orientation 34 °. The orientation of the composite fibers should be perpendicular to the cracks in order to sew them. The solicitation in the composite of the beam (DB_NP_30 / 60) presents a lesser shear effect as that of the beam (DB_NP_20 / 70) due to the difference of the directions respectively which is in the order of 4 and 14 ° to the direction of the crack (34 °) obtained experimentally after preloading. This is why the beam (DB_NP_30/60) has a higher ultimate strength compared to the beam (DB_NP_20/70).

The orientation of the fibers has a great influence on the behavior of test pieces due to the difference in rigidity which characterizes the first phase of the curves.

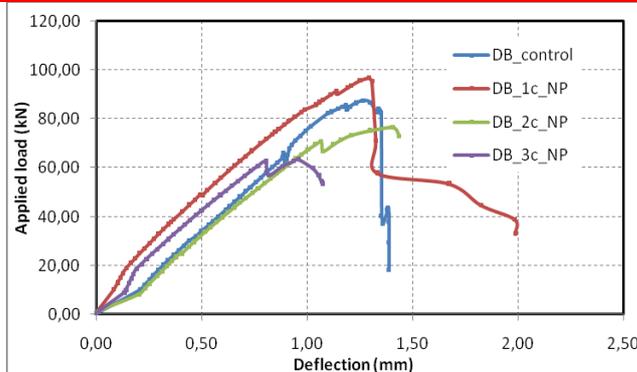
Fig. 5 Force/deflection curves of STV1 reinforced non-preloaded beams.

The beams considered in this case belong to the non-preloaded and preloaded cases reinforced with the composite STV1 patches with different thicknesses. Figure 5 shows the load history of the non-preloaded reinforced beams with one, two and three composite plies compared to the analogous behavior of the control beam.

The load drop occurring on the curves of figure 5 shows a sudden drop in resistance due to delamination of the composite. The analysis of the results shows that the rate of improvement of the ultimate strength of the beams reinforced by one ply is in the order of 10.5% compared to a control beam, whereas the application of one or two plies of the fabric PRFG leads to decreases in strength in the order of 12.5 and 27.6% respectively. The strengthening of deep beams appears therefore to be governed by the first ply only, and this is in good agreement with previous works from (Bousselham and Chaallal 2006 Contamine et al. 2013). It was also noticed that the beams bonded by three layers of STV1 show a more stable deflection behavior compared to the case of beams strengthened by one and two layers. The beams reinforced by one and three plies showed however a greater stiffness than the control beam (Sundarraja and Ganesh Prabhu 2011). In addition, it was observed that the beam reinforced by a ply STV1 showed a greater rigidity than the control beam and the beams reinforced by two and three plies which confirms the work of (Kreit 2012). The absence of bearings in the test setup explains the brittle behavior of the deep beams.

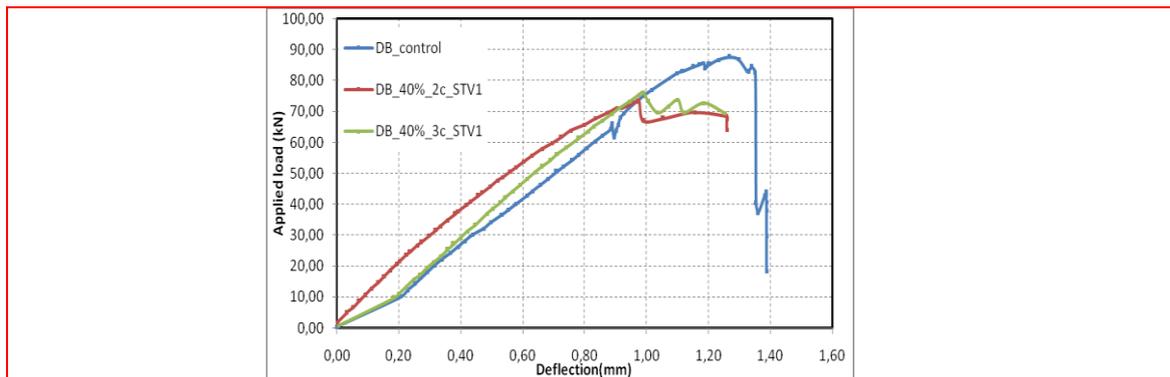
Fig. 6 Force/displacement curves charge / deflection of the beams preloaded at 40% of the ultimate load and then repaired by the STV1 patch.

The load corresponding to the appearance of diagonal cracks is in the vicinity of 40% of the ultimate load, and therefore it appears reasonable to use this value for the preloading of the beams. The responses of the beams at this level of preloading and then repaired by two or three plies of composite

with U shape are shown in Fig. 6. The preloaded and then repaired beams using one or two plies showed a less brittle behavior, with a reduction of the resistance respectively in the order of 15.3 and 12.3% ,76% and 78% for deflection respectively for specimens repaired by two and three plies and a stiffness increase compared to the control beam. These beams still show some residual compliance that provides lower brittleness compared to the control beam. The composite repairs do not appear however to provide a significant influence to the resistance of the beams. The resistance of the beam (DB-40% -3c-STV1) is greater than the resistance of the beam (DB - 3c-NP) due to the deformations of the most remote zones of compression concrete which have reached their limits near the loading area after the crushing of the concrete compression (Figs. 4, 5 and 6). Preloaded beams then repaired by U-shaped composite STV1 showed a higher rigidity than that of the control beam. The STV1 reinforcing with U-shape does not prevent diagonal cracks to appear.

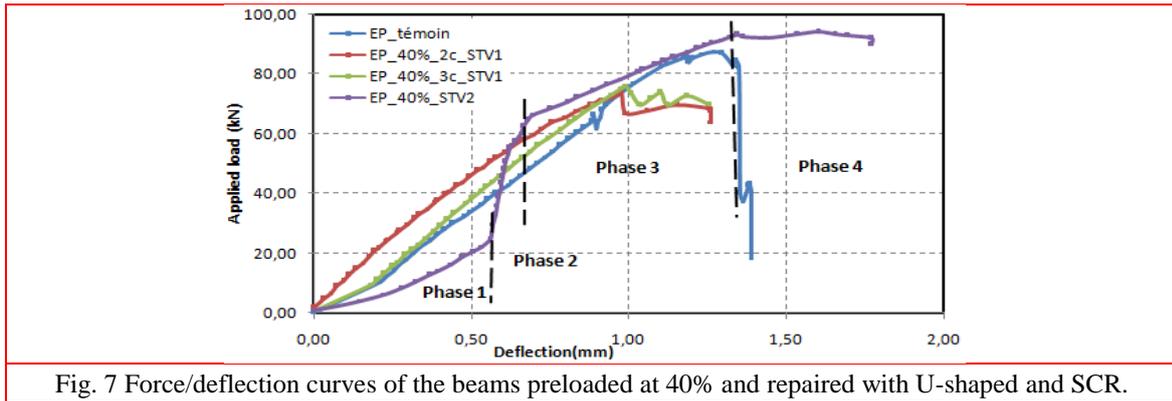
Fig. 7 Force/deflection curves of the beams preloaded at 40% and repaired with U-shaped and SCR.

The analysis of the results obtained on the beam preloaded at 40% of its ultimate load and then repaired following the new SCR method (wrapping in the cracked zone) using the composite STV2 (DB_40%_STV2) allowed an increase of the load capacity of 7.1% and a more ductile behavior with an increase in the deflection of the order of 26% compared to the control concrete beam as shown in (Fig. 7). The load deflection behavior of this beam is quite different from the others and can be divided into four phases. During the first part of the curve it is possible to notice a, **nonlinear elastic behavior nonlinear behavior** dominated by the concrete until a load of 25 kN, **Phase 1 represent the concrete behavior which its rigidity has decreased significantly due to the cracked concrete for the preloaded beam (EP_40%_STV2) comparatively of the other tested beams** followed by a very significant increase of the stiffness (increase in the slope) in the second phase until a value of 67 kN. The stiffness increase is due to the contribution of the composite patch that possesses very good tensile properties. During the third phase the curve segment is equivalent to the other curves with a slight higher increase due to the significant contribution of the composite to the resistance to shearing forces, which is characterized by a drop in stiffness followed by a quasi-plateau in the fourth phase. The latter behavior can be explained by the appearance of vertical cracks **and a sudden shear failure mode caused by the shear force, by a ductile one by bending, and therefore leading to failure mode change from brutal due to the shear to a ductile one due to bending.**

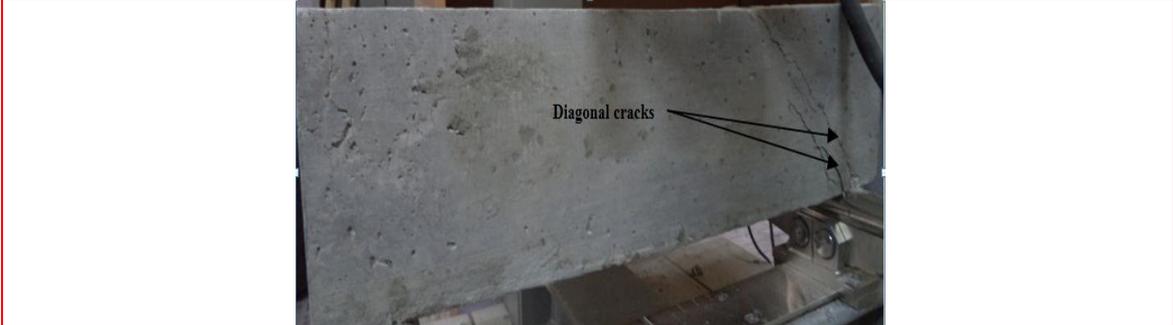
Fig. 8 Failure mode of the control beam.

Figure 8 shows that the control beam subjected to 4-point bending underwent shear failure. The reasons behind the particular failure type are two folds:

The parallel diagonal cracks created in the vicinity of the supports are located around the position of the application of the point load, and may appear on both sides and propagate with increasing load values at an angle of approximately 40°. Only the large and dominant crack progresses to reach the application point of the concentrated load where the failure of the beam is obtained only in one side. This behavior is typical of deep beams and also in good agreement with previous works carried out on beams with different and large sizes (Sayed 2014, Baggio 2014 *et al.* Boussselham *et al.* 2006).

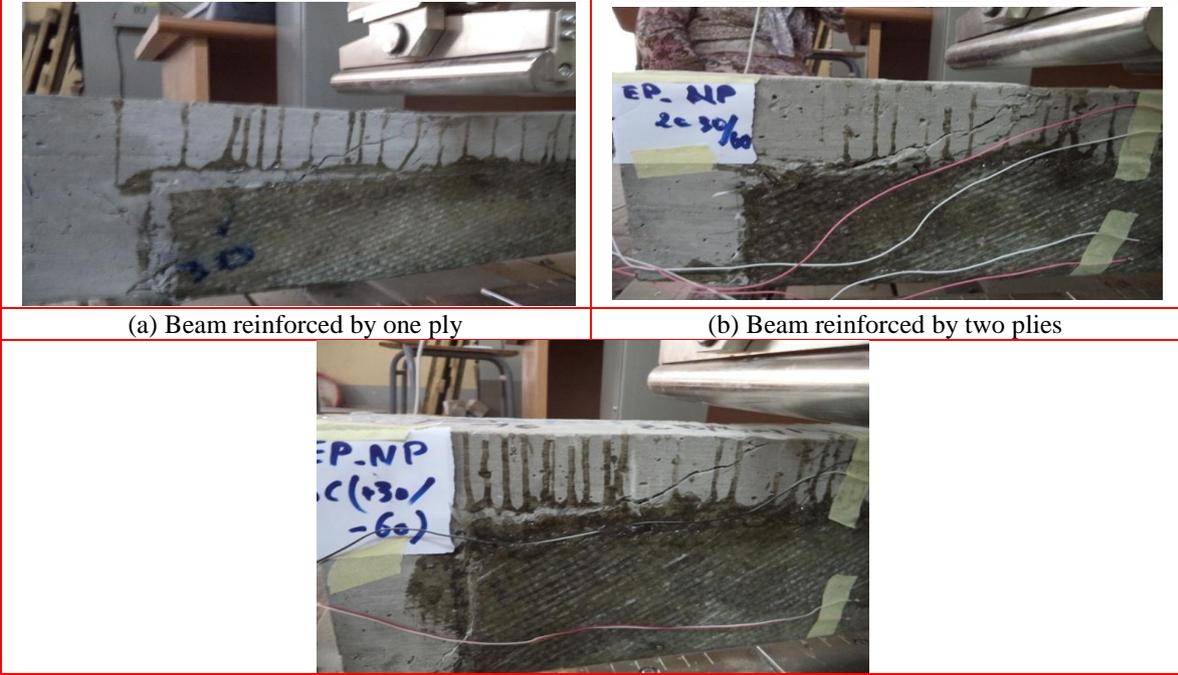
(a) Beam reinforced by one ply

(b) Beam reinforced by two plies

(c) Beam reinforced by three plies

Fig. 9 Failure modes of non preloaded beams and reinforced bythe STV1 patch

The failure mode observed in the case of the beams non-preloaded and reinforced with one, two or three composites plies of U-shaped patches was shear failure, similar to the one found in the control beam. During the tests one crack was heard followed by the delamination of the composite. In beams reinforced by one and two plies two cracks there after appeared, however only a single crack was evident for the beam reinforced by three plies **due to the amount of composites is rather large** (Figs. 9 (a) - (c)). Shear cracks could be observed in the part of the beam covered by the composite with the U-shape.

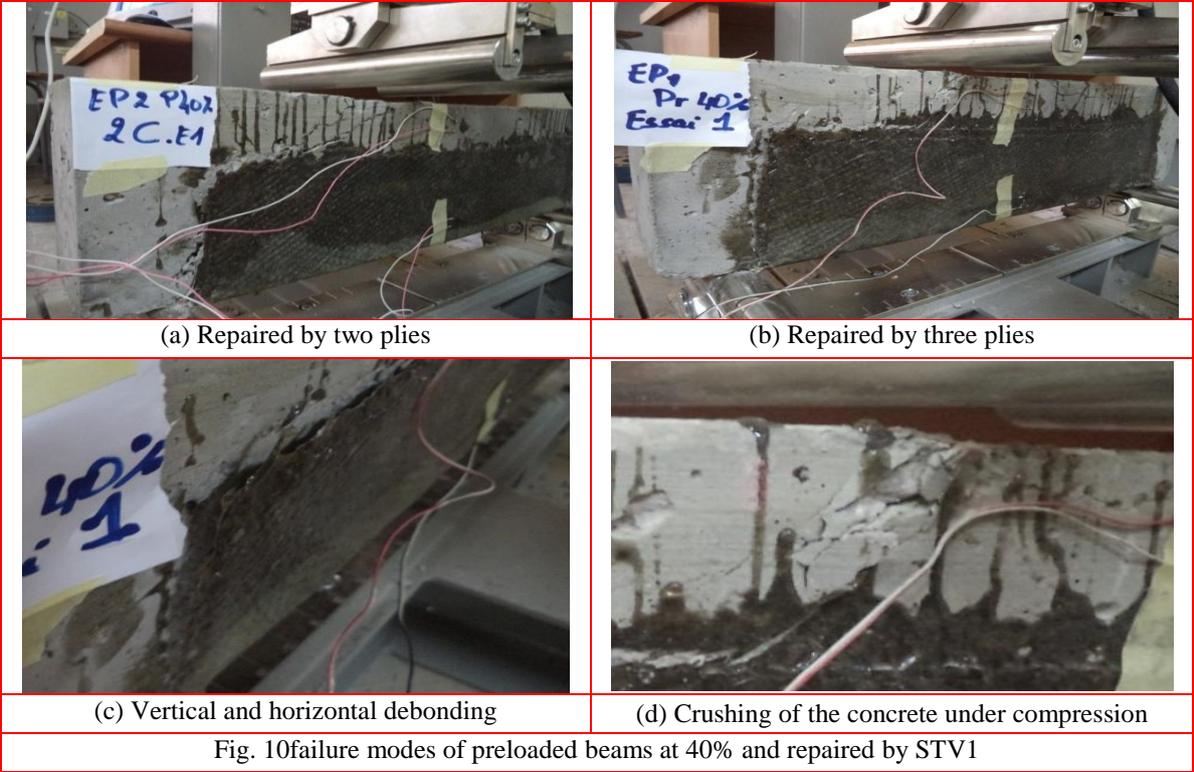
The failure mode of the beams preloaded at 40% and then repaired by two and three plies is similar to the one present in the control beam and the non preloaded STV1-reinforced one as shown in Fig. 10 (a). However, for the beam preloaded at 40% and then repaired by three plies with large composite

mass a delamination between the composite and the concrete in the horizontal and vertical direction was obtained (Figs.10(b)-(c)), followed by the deformations on the concrete in highly compressed zones that have reached their limits near to the loading point (Fig. 10 (d)).

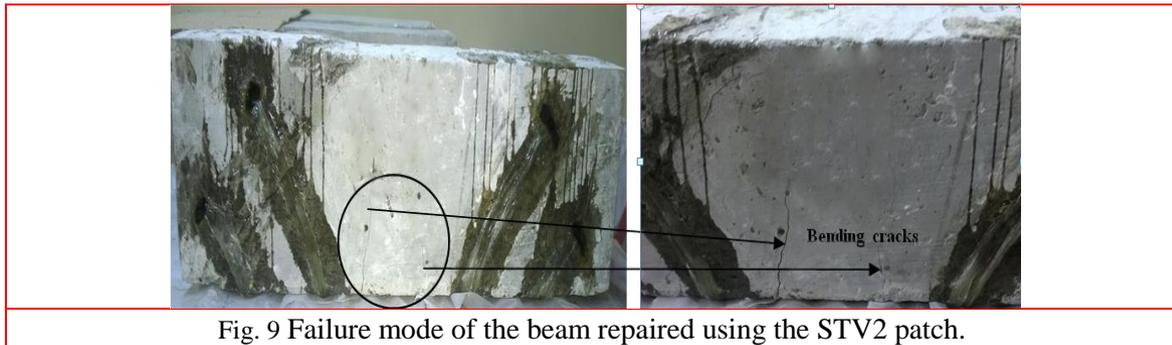
The beam belonging to the B series preloaded and then repaired using the STV2 composite failed by bending due to the appearance of vertical cracks following the formation of a bearing, therefore preventing the shear crack to appear and to develop. The experimental results of the SCR-rehabilitated beam have therefore showed the desired type of failure mode, which is the bending one (Fig. 9). Similar results were also observed by other researchers in previous investigations of reinforced concrete beams strengthened with composite materials using the ETS method by inserting FRP rods into the shear zone of the beam (Chaallal *et al.* . 2011b, Breveglieri *et al.* 2014, Mofidi and Chaallal 2014). Therefore the repair of the beams by bonding with U-shaped continuous fabric does not allow to "sew" the cracks. This is explained by the fact that the series B where the composite is subjected until its rupture, however in the series A the appearance of the delamination (composite/concrete) which does not permit to reach the ultimate strength of the composite. In addition, in the new method (SCR) the strands are continue for few turns banding the cracks, however in the U-shaped (EB), the composite is bonded in the surface only. The SCR method permit to don't have the delamination problem by the use of adequate fiber orientation (perpendicular to shear cracks), leading to tensile in the fiber direction, permitting a maximal resistance and then a rational use of the composite until its ultimate strength. Strengthening or repairing the beams using the new method has leads to change the failure mode from a fragile rupture by shear to a ductile one by bending..
