Experimental Analysis of a Shake Table Test of Timber-Framed Structures with Stone and Earth Infill

F. Vieux-Champagne, Y. Sieffert, S. Grange, C Belinga Nko'Ol, E. Bertrand,
J C Duccini, C. Faye, L. Daudeville

The seismic performance of timber-framed structures filled with stones and earth mortar has been analyzed by introducing the structural subscales (cell, wall, house) at which monotonic and cyclic loadings were considered. This article aims to present the dynamic behavior of a house as determined through shaking table tests. Based on this experimental multiscale analysis, this paper confirms that timbered masonry structures offer effective seismic resistance; moreover, such a comprehensive analysis helps enhance understanding of the seismic-resistant behavior of timber-framed structures with infill. This paper also aids ongoing development of a numerical tool intended to predict the seismic-resistant behavior of this type of structure. [DOI: 10.1193/010516EQS002M]

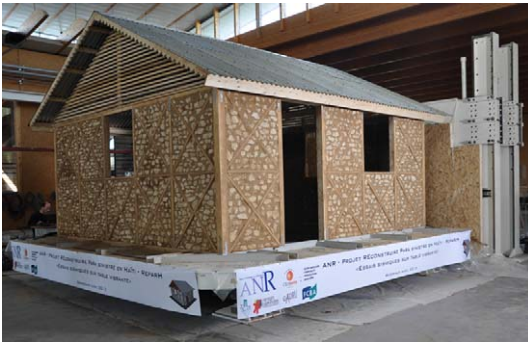
Dimensions	6 × 6	m ²
Weight	6	tons
Max. dis.	± 0.125	m
Max. vel.	0.75	m/s
Max. acc.	4	g
Frequency range	0 - 30	Hz

Figure 4. Shake table characteristics.

These dynamic tests were performed at the uniaxial earthquake simulation facility in the Mechanical Laboratory of the French Institute FCBA. The shake table is composed of a $6 \times 6 \text{ m}^2$ aluminum platform moved by a 250 kN servo-hydraulic actuator (Figure 4).
