Influence of hydrogen on electrochemical behavior of Ni-based superalloy 718

Short Communication

CIRIMAT, Université de Toulouse, CNRS, INPT, UPS, ENSIACET, 4 Allée Emile Monso, BP 44362, 31030 Toulouse Cedex 4, France

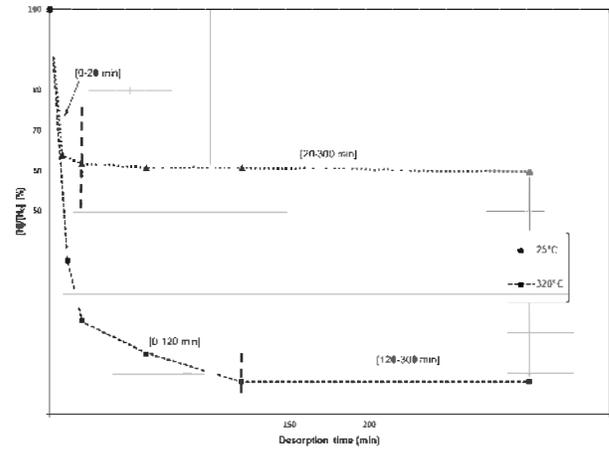
Fig. 2 – Evolution of hydrogen content in 8 h H-charged alloy 718 during 300 min at 25 °C and 320 °C.

the rupture modes. For a better understanding of the hydrogen desorption phenomena in relation with hydrogen trapping, desorption heat treatments were conducted at two temperatures, i.e. 25 °C and 320 °C, during 300 min for samples all pre-hydrogenated in molten salts at 150 °C for 8 h. To compare the evolution of the hydrogen content between each desorption temperature, the hydrogen content was measured relative to the initial hydrogen content $[H_0]$ measured for a pre-hydrogenated sample immediately after charging. All hydrogen contents were measured using a Galileo Bruker analyzer [2]. The results of this analysis are given in Fig. 2.

For both temperatures, two successive regimes were characterized. A preliminary step characterized by a strong hydrogen desorption followed by a second step corresponding to a stagnation of the hydrogen content:

- Hydrogen desorption regime: [0–20 min] at 25 °C and [0–120 min] at 320 °C.

The hydrogen desorption was relatively rapid, and the level of desorption was dependent on the temperature. Considering that the main hydrogen traps characteristic of the strengthened alloy, i.e. carbides and strengthening precipitates/matrix interfaces, are irreversible [5,22], the rapid and strong hydrogen content decrease observed in the desorption curves

- Hydrogen content stagnation regime: [20–300 min] at 25 °C and [120–300 min] at 320 °C.

The different dwells observed for each temperature correspond to the hydrogen still present in the lattice and in grain boundaries and to the hydrogen trapped irreversibly on γ' - γ'' precipitates/matrix interfaces and carbides. These results regarding hydrogen desorption clearly suggested that precipitates/matrix interfaces were saturated in hydrogen after hydrogen cathodic charging, given that hydrogen desorption is mainly due to the partial desorption of interstitial hydrogen and mainly to the hydrogen desorption by grain boundaries. Finally, after 300 min of desorption, samples heat treated at 320 °C presented a hydrogen content around 10 ppmw, i.e. 6 times lower than samples desorbed at 25 °C (hydrogen content around 60 ppmw). This difference could be explained by the increase of the hydrogen diffusion coefficients with temperature (both grain boundary and lattice diffusion coefficients) and by the fact that hydrogen trapped in grain boundaries in relation with intergranular segregations such as Nb or P could egress at 320 °C.

during 8 h and heat treated during 300 min was intercalated between the OCP values of a H-free sample and pre-hydrogenated samples. According to the desorption tests (Fig. 2), the heat treatment performed at 320 °C led to the desorption of interstitial hydrogen and mainly of hydrogen trapped in grain boundaries in a larger extent than for hydrogen desorption occurring during OCP measurements at 25 °C which explained the less negative OCP values observed. The role of diffusible hydrogen on OCP has already been observed by Shaller and Scully [28] and diffusible hydrogen undoubtedly contributes to explain the OCP values. But, the difference in OCP values between a H-free sample and a outgassed sample was probably related to the hydrogen still trapped at matrix/precipitates interfaces given it was assumed that diffusible hydrogen content was negligible after the heat desorption treatment according to the diffusion calculations and the hydrogen content measurements and tensile surface fractures. Indeed hydrogen content for H-free, H-charged and outgassed sample was respectively 0.5, 58 and 5.2 ppmw. Mechanical tests performed on H-free and H-charged tensile samples showed that hydrogen in grain boundaries induced intergranular rupture and hydrogen trapped at carbides and matrix/precipitates interfaces induced cleavage [2]. The fracture surface of the outgassed sample has shown only cleavage that reinforced the fact that hydrogen content after desorption treatment was mainly related to hydrogen trapped at matrix/precipitates interfaces

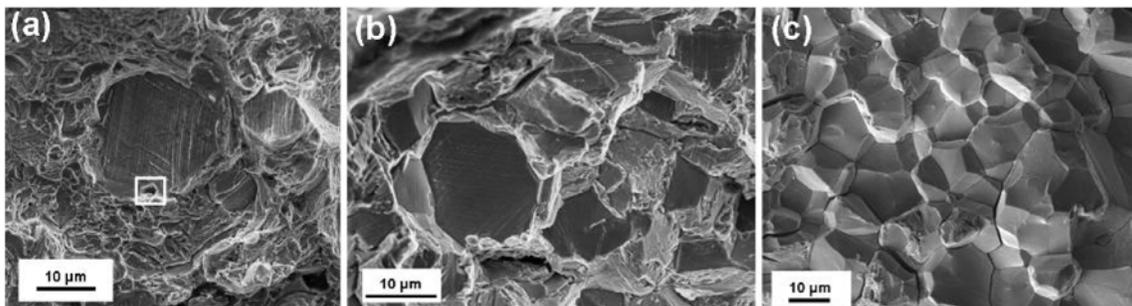
Fig. 1 – Fracture surfaces observations of pre-hydrogenated samples of strengthened alloy 718 after tensile test. Transgranular rupture (cleavage) related to hydrogen trapping (a) on carbide/matrix interfaces and (b) on strengthening precipitates/matrix interfaces and (c) intergranular rupture related to hydrogen diffusion/segregation along grain boundaries.

In this work, samples were hydrogenated by cathodic charging in molten salts at 150 °C as done by Galliano et al. [2]. All the characteristics of these chargings are detailed in this previous work as well as hydrogen content measurements using a Galileo Bruker analyzer and the procedure of hydrogen desorption tests [2]. The fracture surfaces obtained after tensile tests performed at 25 °C and $\dot{\epsilon} = 10^{-3} \text{ s}^{-1}$ for pre-hydrogenated samples of strengthened alloy 718 are presented in Fig. 1 and showed both transgranular (cleavage) (Fig. 1a and b) and intergranular brittle fracture (Fig. 1c).

Two main HE mechanisms in relation to the hydrogen-trapping mechanism are generally considered to explain the fracture surfaces: the hydrogen-enhanced localized plasticity (HELP) and hydrogen-induced decohesion (HID) mechanisms [15]. The HELP mechanism corresponds to an increase in dislocation mobility by the reduction of the elastic interactions between obstacles and perfect and partial dislocations [16]. Associated with a hydrogen transport phenomenon facilitated by dislocations, this mechanism leads to local segregation of hydrogen on {111} planes, inducing cleavage, as well as the decohesion of particles/matrix interfaces (HID mechanism) [17,18].

Intergranular brittle fracture suggested that hydrogen preferentially diffused/segregated along grain boundaries, partly due to the hydrogen-trapping mechanism on carbides that reduced the cohesive strength of the grain boundaries structure. But, the low density of intergranular carbides suggested rather that the grain boundaries chemistry and crystallographic relations could have a strong effect on intergranular rupture too as well as the possibility of intergranular element segregations such as Nb or P [19–21].

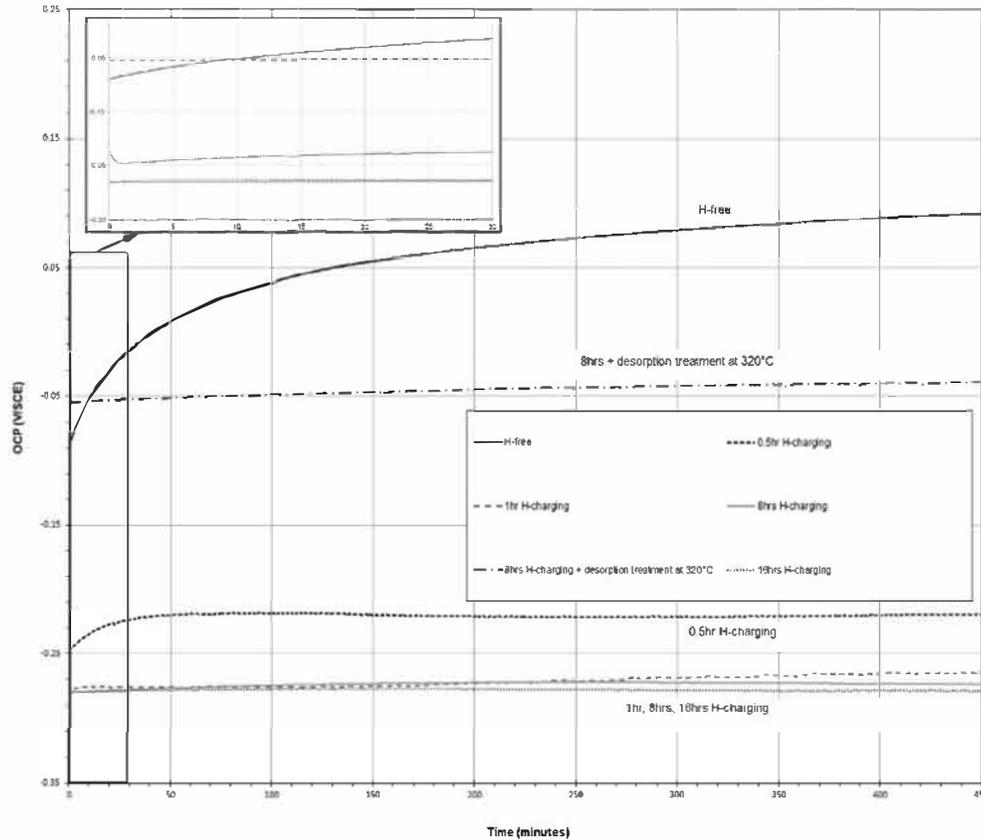
Fig. 3 – OCP (V/SCE) vs. time (minutes) of H-free, pre-hydrogenated (0.5 h, 1 h, 8 h and 16 h) and pre-hydrogenated + heat-treated at 320 °C samples.

On the basis of all these results, the effect of hydrogen on OCP of alloy 718 was investigated by measuring the OCP vs. immersion time at 25 °C in 0.5 M NaCl medium for pre-hydrogenated samples for different cathodic charging times, i.e. 0.5 h, 1 h, 8 h and 16 h and for a sample pre-hydrogenated during 8 h and then heat treated during 300 min at 320 °C before electrochemical characterization. The results of these measurements are given in Fig. 3.

The evolution of OCP vs. immersion time is given for comparison for a H-free sample (Fig. 3) and highlighted that OCP after 450 min, i.e. 0.09 V/SCE, was not stabilized. A longer test duration was required, i.e. around 1000 min as shown in Fig. 4 in order to reach an OCP stabilization in relation with a slow passivation of the material surface and with the low aggressivity of the medium for this type of Ni-based superalloy. The measurements on H-charged samples allowed to confirm the effect of hydrogen on OCP values. It was shown that hydrogen shifted the OCP values towards more negative potentials in relation with the cathodic charging time and therefore with the hydrogen content in subsurface and that hydrogen stabilized quickly the OCP. Such a result raised the question of how hydrogen could affect the OCP. It is true that changes in OCP would be indicative of changes in the surface. For example, as suggested by Protopopoff et al. [32], the adsorption of hydrogen on the metallic surface should lead to a change in OCP. However, the relationship between the amplitude of the changes in OCP and the cathodic charging time suggested that the influence of hydrogen on OCP was more complex. As suggested in the literature, by modifying the electronic output work [26–30], the hydrogen should affect the Volta Potential as well as the OCP measured in solution. Although no clear mechanism explaining the role of hydrogen on the electronic output work was established, it was assumed that hydrogen distorts the metallic lattice leading to the variations observed. It could be assumed that the influence of hydrogen on OCP should depend on the precipitation state of the material. Indeed, the precipitates which act as trapping sites distort the lattice and/or create interfaces at which the hydrogen atoms will distort the lattice less. In this sense, the influence of hydrogen on OCP should give indication about the interaction between hydrogen and precipitates/matrix interfaces in subsurface as recently shown by Oger et al. [33]. Further, analysis of the OCP curves requires to consider H desorption during OCP measurements at 25 °C, as shown in Fig. 2. According to the results of desorption treatments (Fig. 2), after 20 min at 25 °C, for a sample hydrogenated for 8 h, the hydrogen content was stabilized with only strongly trapped hydrogen present inside the material. Since OCP curves for 1, 8 and 16 h of charging are similar (Fig. 3), it was possible to confirm that a cathodic charging of 1 h was sufficient to saturate precipitates/matrix interfaces in subsurface. However, for a 0.5 h duration, the interfaces seemed to be only partially saturated that explained the less negative OCP values measured. Then, the evolution of OCP values at the beginning

of the electrochemical test performed on 8 h H-charged sample could be related to the strong hydrogen desorption at 25 °C during the first minutes of desorption test: the time required for OCP stabilization was in the same order of magnitude than diffusible hydrogen desorption time, i.e. 20–30 min, observed in Fig. 2. The most important desorption range for 0.5 h H-charged sample could be explained by the fact that OCP value was more susceptible to hydrogen desorption given that precipitates/matrix interfaces were not saturated for this duration of cathodic charging. It was also observed that the OCP value of the sample pre-hydrogenated

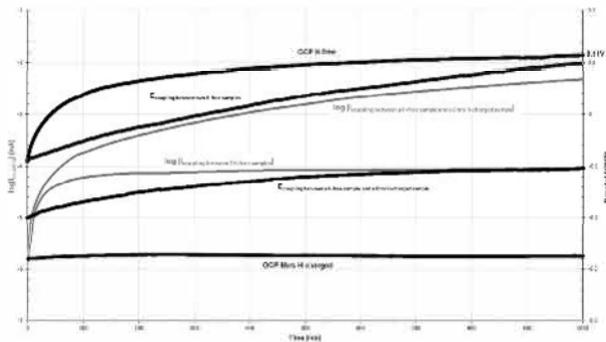
Fig. 4 – Galvanic coupling tests for two H-free electrodes and a H-free electrode coupled with a hydrogen pre-charged electrode.

These results have shown that hydrogen was able to modify the electrochemical behavior of alloy 718 in relation with diffusible and trapped hydrogen content. So it could be considered that, for a hydrogenated material presenting a heterogeneous microstructure, the local hydrogen content could strongly vary, so that local galvanic coupling between zones with different hydrogen concentrations could occur. To confirm this hypothesis, a galvanic coupling test was performed in 0.5 M NaCl at 25 °C between a sample pre-charged in hydrogen during 8 h and a H-free sample. A preliminary test was performed with two H-free samples as reference. The results are presented in Fig. 4.

At first, the coupling tests performed with two H-free samples showed that the common potential measured was logically close to the value of the OCP of a H-free sample, i.e. 0.11 V/SCE after 1000 min. Moreover, these tests allowed to determine the reference coupling current, i.e. 10^{-4} mA after stabilization. The fact that this coupling current has a non-zero value could be explained by the residual hydrogen content of H-free material, i.e. between 0.2 and 0.5 ppmw depending on the samples that could induce a slight coupling [2]. The common potential measured during coupling test between a H-free sample and a 8 h H-charged sample, i.e. -0.1 V/SCE, was logically comprised between OCPs of H-free sample and 8 h H-charged sample, and corresponded to an anodic polarization for the 8 h H-charged sample. This result showed that the H-charged sample was the sacrificial anode during the coupling test. This result was confirmed by the galvanic coupling current measured, i.e. around 2 orders of magnitude higher than the current obtained during coupling of the two H-free samples. Moreover the increase of the difference between the coupling currents as the function of time suggested that the galvanic coupling due to hydrogen led to a self-catalyzed mechanism.
