Non-destructive Evaluation of Concrete Damages of Containment Walls in Nuclear Power Plants

ABSTRACT. This paper is focused on the part of the project ANR ENDE that concerns the damage and crack characterization by means of NDT. The tests are done in 3 or 4 points bending in order to study the cracks' generation, their propagation, as well as their opening and closing. The main ultrasonic techniques developed concern linear or non-linear acoustic: acoustic emission [SBA 2015], Locadiff [LAR 2015], energy diffusion, surface wave's velocity and attenuation, DAET [3]. The recorded data contribute to providing the mapping of the investigated parameters, either in volume, in surface or globally. Digital image correlation is an important additional asset to validate the coherence of the NDT results.

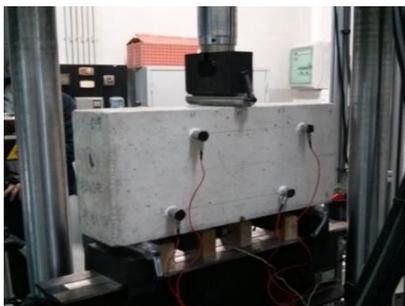
Figure 1. Three points bending test.

Follow-up testing of diffuse damage and its transition to continuous damage as well as that of interface cracks is carried out on 50x25x12 cm³ specimens (Fig. 1a).

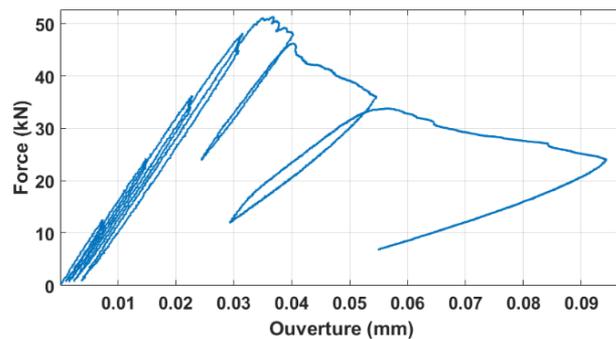
Figure 2. Force-CMOD curve.

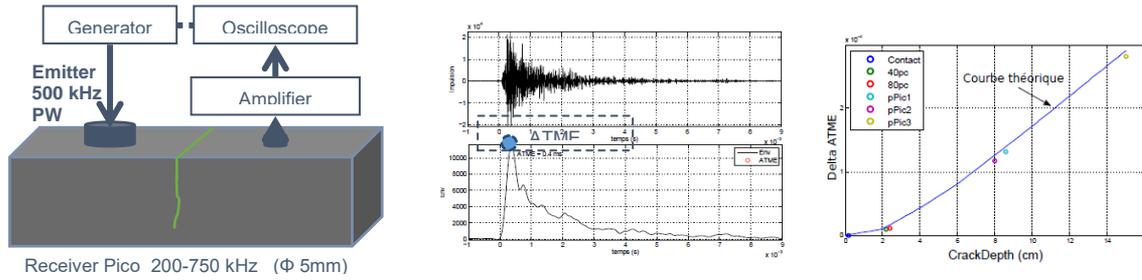
The Diffused Waves technique [QUI 2012] analyzes the wave energy transportation through the sample with a crack (Fig. 4a). One of the Non-Destructive Parameters used is the Arrival Time of the Maximum of the Energy (ATME) shown in Fig. 4b by the blue point. We can follow the increase of the crack depth through a simple model as presented in (Fig. 4c).

Figure 4. a) Diffused Waves analysis b) ATME c) Link between ATME and the crack depth

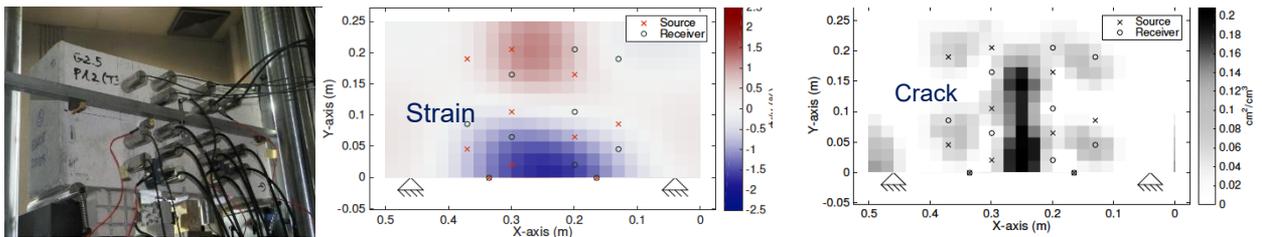
The Locadiff technique [LAR 2015] uses the evolution of the diffused waves obtained from a transducers network (Fig. 5a: 10 emitters, 10 receivers). A small perturbation in a material with multiple scattering is identified. This technique allows evaluating the strain state of the sample by the relative variation of velocity and estimating the damage and the crack by decorrelation of the wave forms. The results show the strain (Fig. 5b) and the crack length (Fig. 5c). The size of the voxels is $2 \times 2 \times 2 \text{ cm}^3$.

Figure 5. a) Transducers distribution b) Strain before the peak c) Crack propagation after the peak.

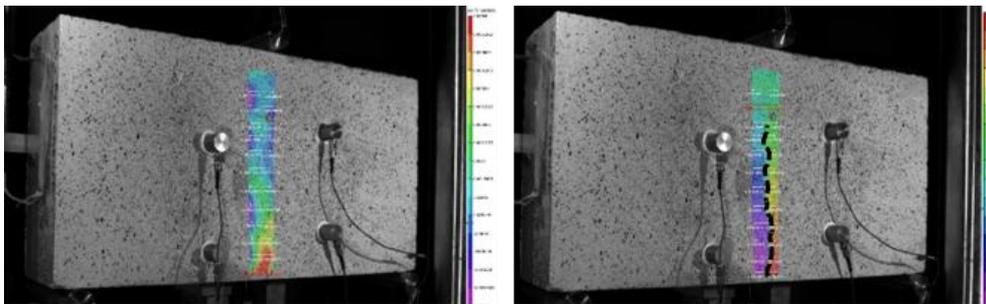
The Digital Image Correlation (DIC) works with the displacement measurement of the points of a speckle pattern (Fig. 6a), [TAH 2010]. It allows evaluating the strain state of the sample (Fig. 6a) and also by the way, the length (Fig. 6c) and the opening of the crack. From a theoretical point of view, the crack opening corresponds to the displacement jump between two points located from either side of the future crack path. This holds particularly in the case of a visible and wide-opened macro crack (more than a few micrometers).

Figure 6. a) Strain distribution, b) Crack way and opening

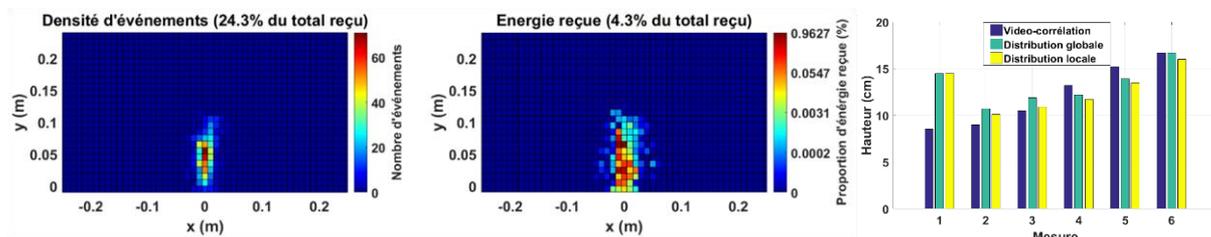
The Acoustic Emission [SBA 2015] is a passive technique that allows following all the events that occurs in the sample with 8 receivers (transducers frequency of 150 kHz). These events correspond to the generation of micro cracks of damage or to the propagation of the crack(s). The events are recorded by the transducers and counted following a cumulative or instantaneous process. Each event, under conditions, is positioned by using the information from all the transducers (Fig. 1a). The results of a continuous auscultation of one of the samples can give us the density of the damage (Fig. 7a) and or the density of the energy close to the crack (Fig. 7b). The length of the crack is also extracted based on the events density distribution. A comparison between AE results and DIC show good correlation (Fig. 7c).

Figure 7. Density distribution (a) and energy (c) of EA events, (c) comparison of crack length measurement with EA and DIC.
